Historical Arch Bridges-Deterioration and Restoration Techniques

Abstract

Keywords: Historic Bridges; Methods of Restoration; Arch Bridges; Faro Laser Scanner; Destruction.

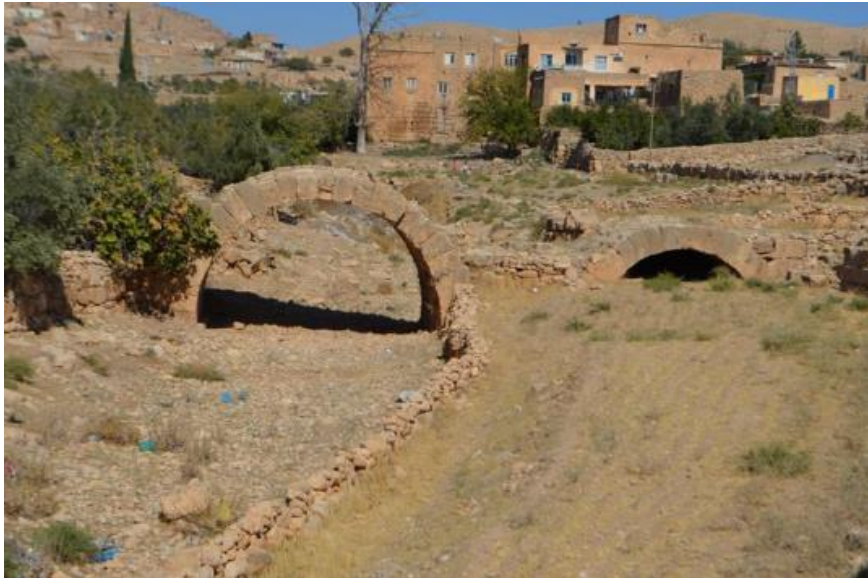
Figure 1. Dara Bridge

bridges with three arches, the central arch being wider and higher than the others, is today partially destroyed. No parapet remains were found on the east and west facades, and collapses were observed. The structure has a length of 26.60 m, a width of 7.15 m, and a height of about 5.30 m. Halilviran Bridge is 20 km away from Diyarbakir. It is located above the Devegecidi watercourse. There is considerable loss of substance on both sides of the deck. The structure is built of regularly hewn stones. The central arch of the bridge is a round arch that rises on the rocky ground in both directions of the riverbed. The bridge, built to cross the river barrier, is a masonry structure with seven arches. The total length is 132 meters, and the carriageway width is 5.10 meters. The height of the bridge above the ground is 8.50 meters. The spans of the arches are 6.80 meters, 7.00 meters, 6.90 meters, 6.95 meters, 6.90 meters, 6.95 meters and 5.95 meters from west to east. The last arch in the east (7th arch in the row) has a slightly different shape and is kept lower than the others, a pointed arch that looks very similar to the round arch.

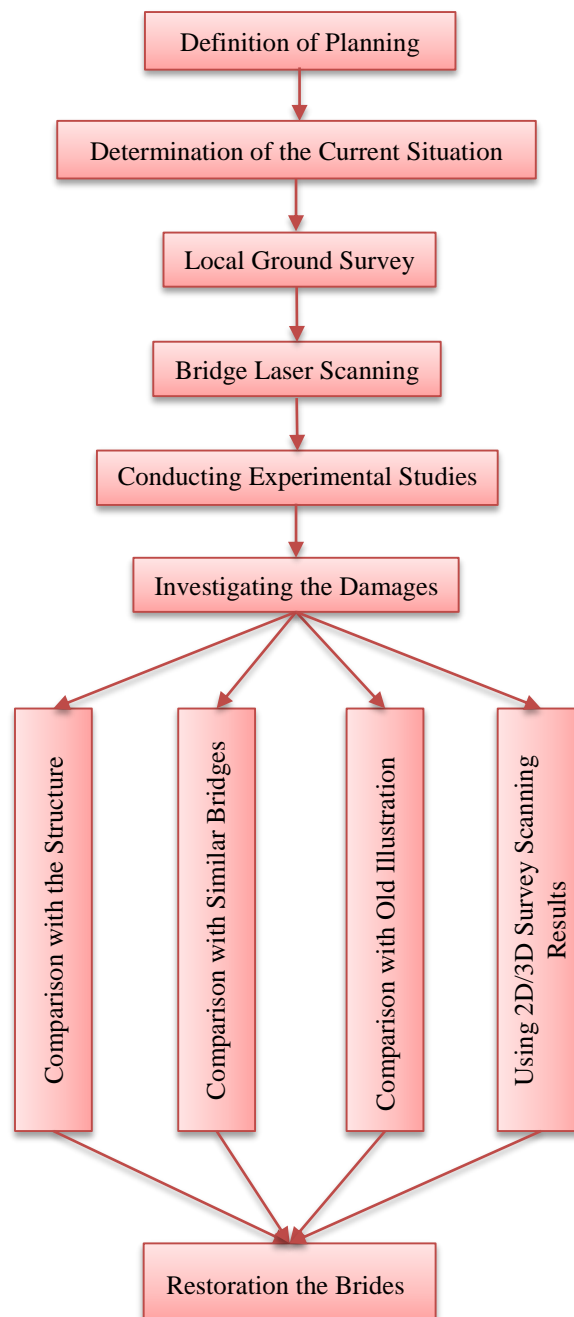
Figure 5. Clearly shows the methodology used to achieve the objective of this study

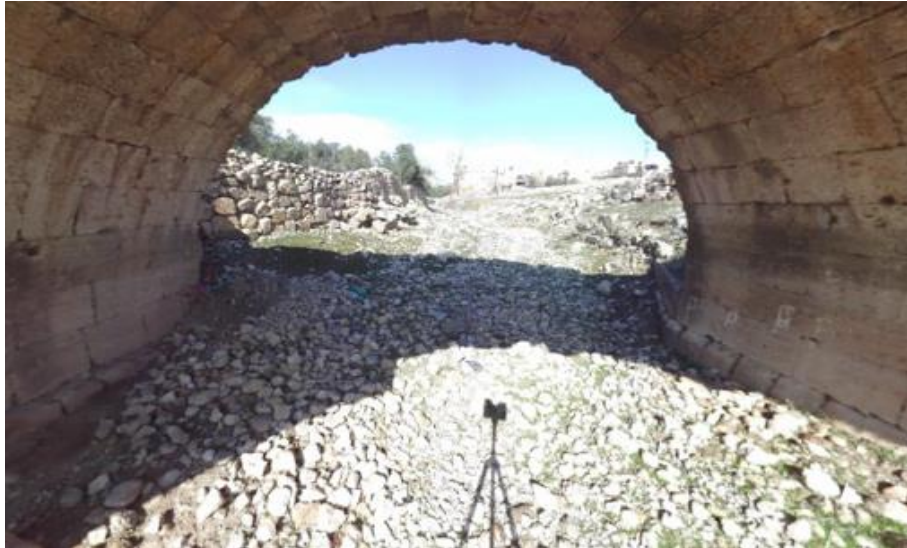
The foundation is the lowest part of a bridge. Various materials and techniques have been used for masonry bridge foundations, such as wooden piles, which are particularly suitable and ideal for bridges with weak soil properties. The foundation system of the bridges in both case studies is located on the rocky subsoil. Foundation erosion and material loss were observed in both bridges (Figures 6 and 7). This damage is usually due to changes in soil conditions, a lack of protection of the foundations, and deterioration of their materials, which can lead to serious problems with the durability of the bridge structure and, in some cases, even the destruction of the bridge. During floods, large stones are carried

away by the water and break onto the Halilviran Bridge. The bridges are subjected to the impact of these objects in addition to the hydrodynamic pressure. Weak stones are broken, and the mortar between the stones has dissolved due to these impacts. On the other hand, the height of the water causes a change in the riverbed. These phenomena damage the soil and erode the foundations of the bridges, causing cracks and fractures and damaging the piers of the two bridges. In addition, the vegetation surrounding the foundations favors the erosion of the stones. The roots have penetrated the foundations, allowing water to effectively dissolve the mortar and promote erosion of the stones through capillary moisture via groundwater to the foundation.

Figure 6. Erosion on the foundations of Bridge

- Both bridges, especially the DARA, suffered material losses due to soil conditions, a lack of foundation protection, and erosion. This condition caused serious problems with the durability of the bridge structure and led to the demise of the bridge. Proper maintenance of the riverbed near the bridge will prevent this damage, and strengthening and consolidation of the bridge foundations with a reinforced concrete layer is being considered.

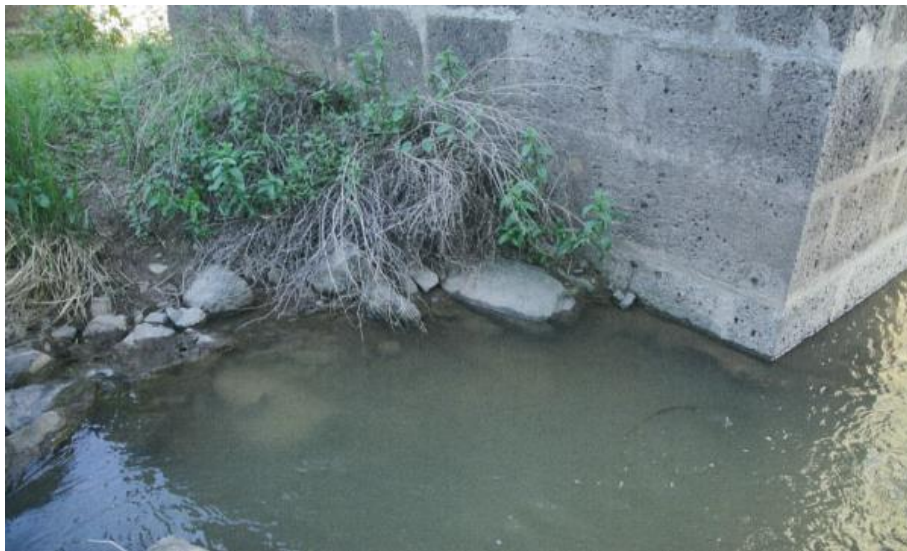
Figure 7. Large stones and trees are carried onto the bridge

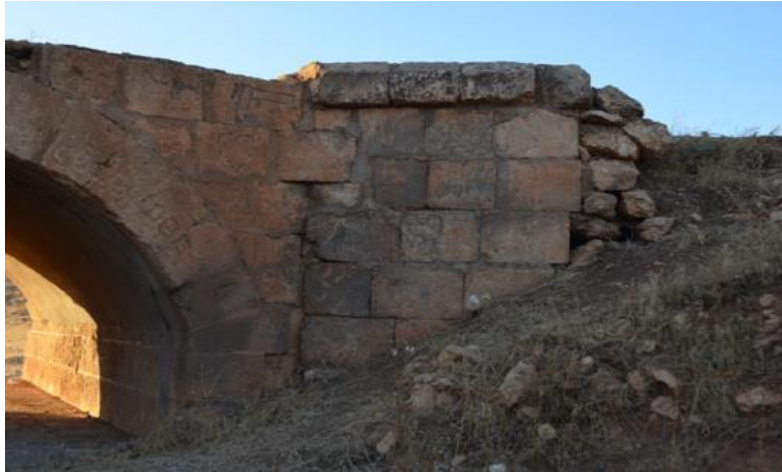
Abutment foundations transmit high pressure to the earth, subjecting them to large deformations and different displacements that endanger masonry arch structures since they lead to a lack of horizontal and rotational restraint at the base of the arch, which in turn can lead to uplift and eventual collapse. In both cases, the piers are made of rectangular, finely hewn sandstone, but the internal fills of the piers were not observed. Like the piers, the abutments in the lower part of the Dara Bridge are also severely damaged (Figure 8). The water causes corrosion of the embedded rock and a decrease in the mechanical strength of the piers and abutments. Vegetation was observed on the Halilviran piers (Figure 9). This vegetation can mask existing damage during an on-site inspection and is responsible for existing capillary cracking on the abutments and piers, both of which contribute to accelerating the deterioration of the bridge and its materials. In addition to plants damaging the structure with their roots, various species of fungi and bacteria have also been found on the stones. Moisture has also damaged the stones of the piers and abutments, as water has penetrated the masonry in both cases. At the same time, the persistent moisture in both cases leads to rot, the loss of mortar joints, and the softening of the stone in the masonry.

Figure 8. Damaged abutment of bridge

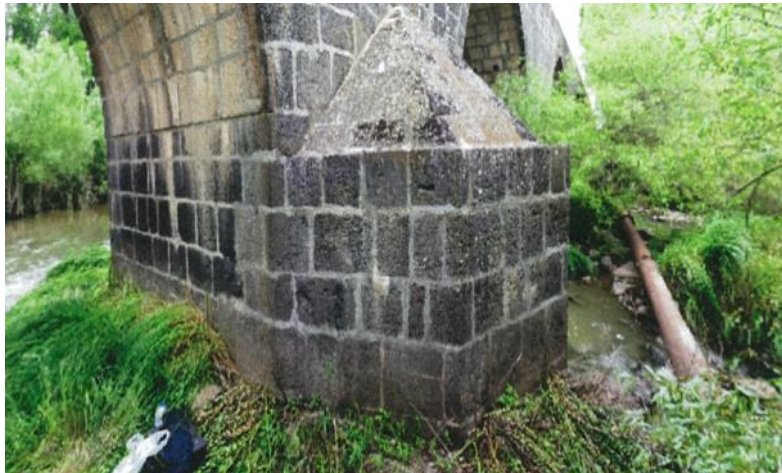
Figure 9. Growth of vegetation on the piers

- The stone surfaces of both bridges were partially affected by vegetation. The vegetation posed a significant hazard because it deepened its roots between the stone joints. They were located at the base of the bridge piers and at the front of the roadway, where water entered the stone joints in search of an exit. All elements of the masonry viaduct (arches, end walls, parapet, and wings) should be thoroughly cleaned of efflorescence with a pressure washer and water.

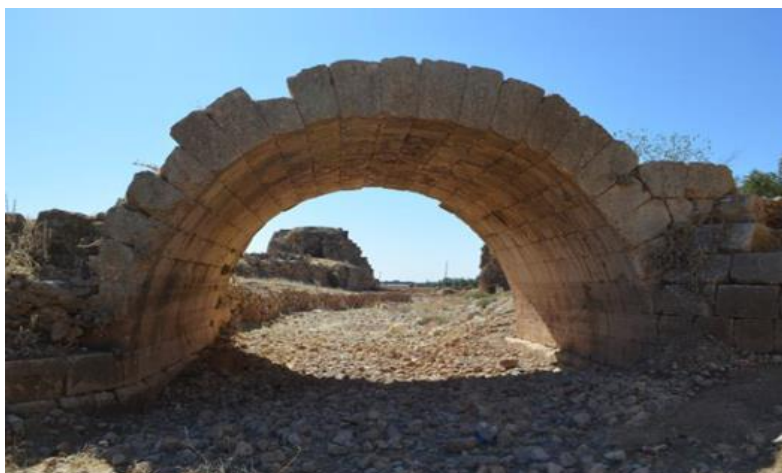
They consist of rectangular or wedge-shaped stones called voussoir. Most of the voussoir of the three round arches of the Dara Bridge (Figure 10) are damaged and have deformed over time. Overgrowth is visible on the top of the arch. Several longitudinal and transverse cracks occur on the arch of Halilviran Bridge (Figure 11) under the influence of static and dynamic forces. In addition, some parts of the DARA arch were repaired with inappropriate materials. During the earlier restoration, the poor quality of the mortar could be seen, so that some stones could be easily removed.

Figure 10. Damage arch of the Dara Bridge

- Pressure grouting is required at some locations for infills and vaults. It is very effective and economical. It also increases the load-bearing capacity and improves the condition of the vault ring by filling cracks and voids in the vaults.

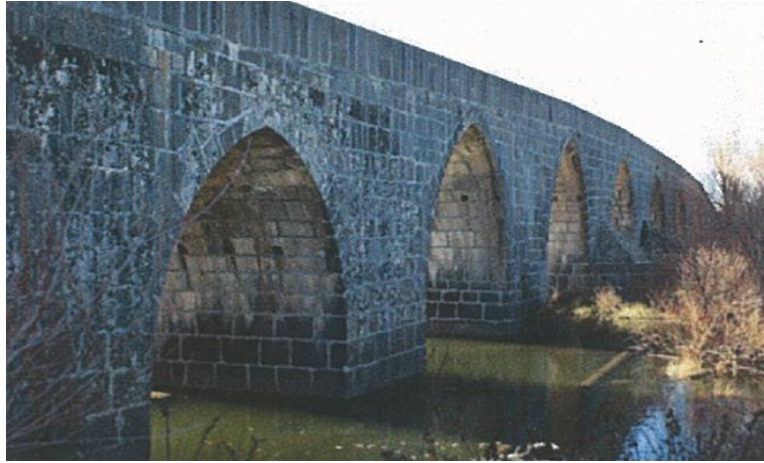
Figure 11. Arch of the Halilviran Bridge

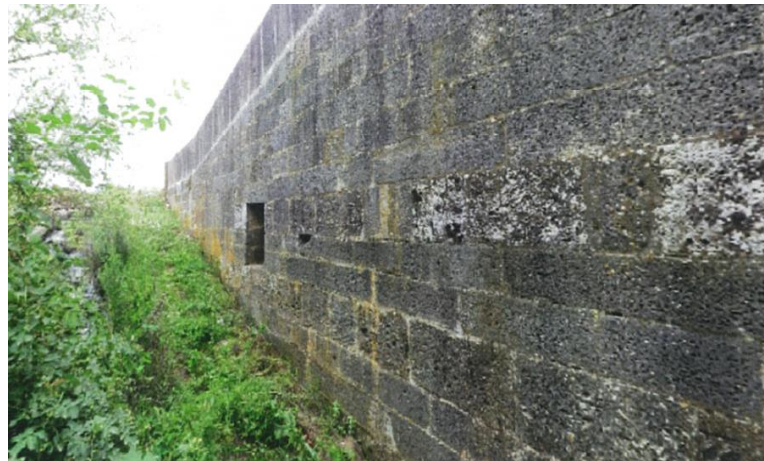
Triangular pieces of wall between the extrados of the arches and the roadway (McAfee, 1998). In the case study bridge, the construction technique observed in the abutments is repeated in the spandrel walls, which suffer from vandalism and moisture (Figure 12).

Figure 12. Spandrel wall of Halilviran Bridge

- Tie rods that must be anchored to prevent further outward movement of both cases parapet walls. They consist of a bar that runs the full width of the bridge and should be secured with a nut and washer to hold the wall in place. One of the advantages of using tie rods is that they cause little or no obstruction to traffic. The steel rods should be installed without tension in the transverse direction of the bridge after the holes have been grouted with low pressure.

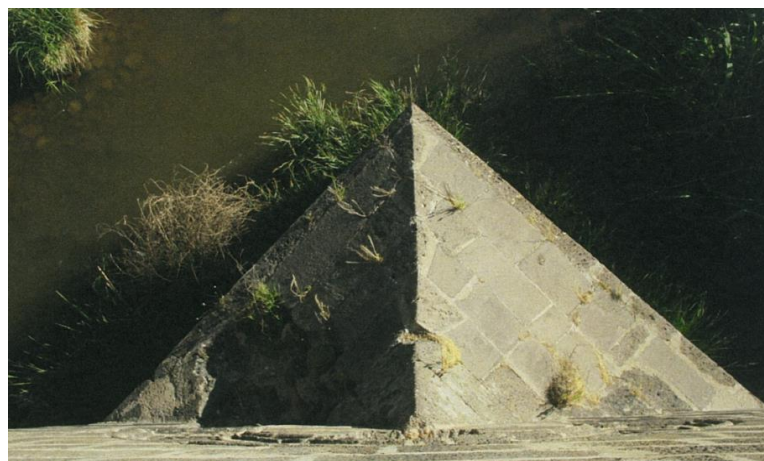
Breakwaters were built next to the upstream facade of the piers to protect the bridge from high tides and swift currents. The breakwater of Halilviran Bridge (Figure 13) suffers from fouling, which contributes to compaction, but also leads to deficiencies in the waterproofing. It suffers from softening and loss of mass due to persistent moisture. In the long run, sedimentation has effectively compensated for the erosion of the bridge breakwater. On the other hand, the breakwater of the Dara has also been completely deformed and ruined over time.

Figure 13. Breakwaters suffer from vegetation and deformation

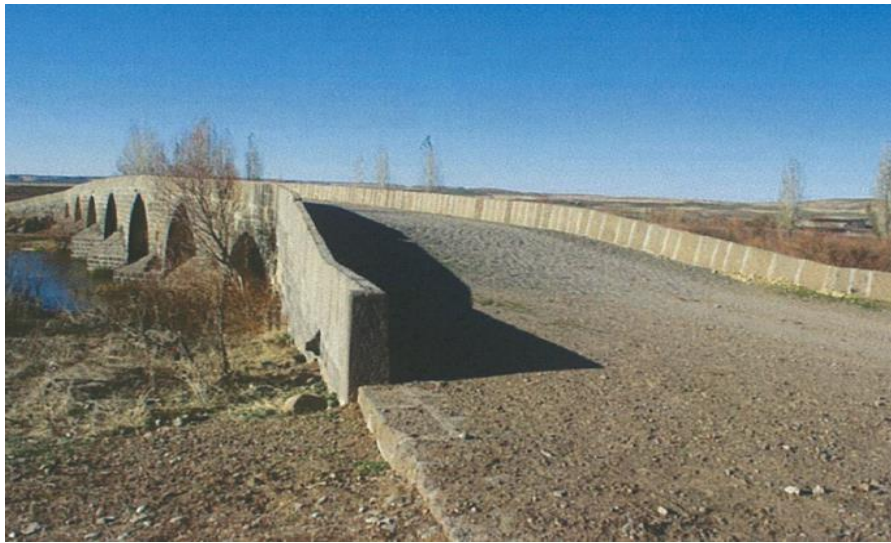
The Dara roadway has completely deformed over time, and the Halilviran alignment (Figure 14) has suffered some damage. The roads between the two case study bridges are paved with cut and small gravel stones. Vegetation was found in both cases. The existing vegetation can promote compaction, but on the other hand, it can also cause waterproofing and capillary drainage problems. The absorption of water in porous materials significantly affects the behavior and material properties of the Dara. In addition, weak cohesion between material particles, such as two adjacent elements (Figure 15), an inefficient and non-existent drainage system, a lack of waterproofing, capillary absorption of water from the soil and atmosphere, insufficient maintenance, and weak frost resistance of the material affect the stability and esthetics of the whole structure. On the other hand, inadequate covers and drainage systems can allow rainwater to enter the bridge body. The Dara is backfilled with low-quality crushed and cut stone, resulting in imbalances in fill thickness and core weight. This condition leads to an unbalanced distribution of stiffness and regional damage as the material expands during high temperatures in the summer and freezes in cold winters. On the other hand, the absence of drains leads to crystallization and consequent rotting of the steel elements embedded in the bridges, resulting in the demolition of the load-bearing section. In addition, both bridges are exposed to acid rain, which leads to various stresses and damage to the deck and other components due to inadequate drainage and waterproofing.

Figure 14. Halilviran bridge roadway

- The pavement of the bridge has suffered considerably over time due to cattle traffic. It was subject to vandalism by villagers who, on high-water days, removed stones and threw them into the river to watch the pebbles slide across the surface of the water. This vandalism, along with the effects of weather and the passage of time, has resulted in the unfortunate loss of material. Some stones in the arches are completely unconnected. Due to the deformations of the structural system and the displacements in the past, the arches in Dara made of shaped stones cannot be considered monolithic components. Moreover, loss of mass was observed in all types of stones, but especially in the stones of the upper structure. Therefore, demolition and reconstruction are considered for some parts of the bridges (Figures 20 and 21), taking into account the remaining parts, the characteristics of similar bridges, and the parts identified as a result of the comparative study. This method is efficient for repairing cracks and localized damage and improving the structural quality and load-bearing capacity of the bridge. The materials used must have the same properties as the original ones, and the mortars must have a low retraction capacity. It should be noted that before dismantling the elements, the bridge must be suitably supported to prevent its demise. All dismantled elements must be numbered beforehand so that their reconstruction can be carried out as accurately and efficiently as possible.

- It is important to consider the waterproofing and drainage of the roadway because the bridges do not have an adequate drainage system or waterproofing. If the drainage system is considered, almost all the problems associated with the lack of waterproofing, such as damage to the parapet, moisture and water infiltration, material deterioration, and mortar loss in the joints, will be eliminated.

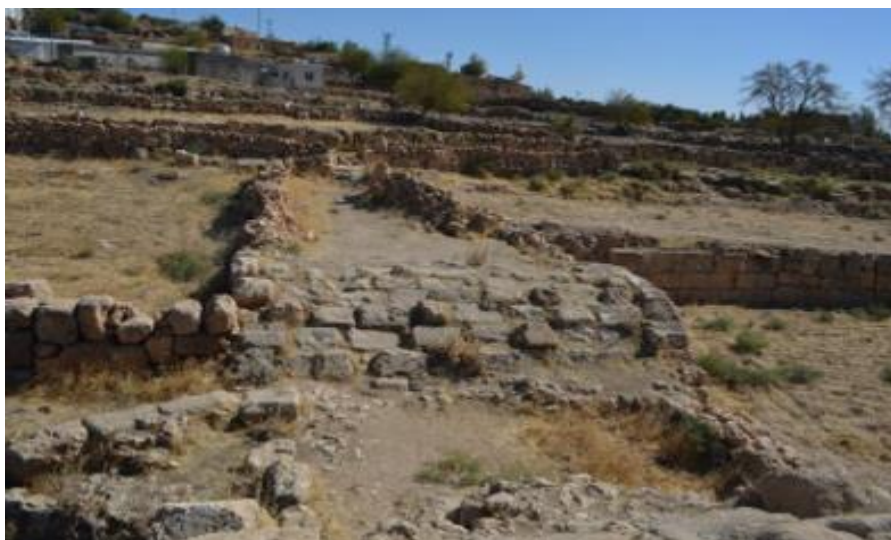
Figure 15. Weak adhesion between adjacent elements

- Due to the use of unsuitable and inferior materials, deterioration and detrimental changes were observed on both bridges. When the mortar joints were lost, resulting in a loss of mechanical strength for the elements. In order to restore the integrity of the bridge, improve its protection, and increase its resistance, a repointing of the mortar in the joints between the masonry units of the bridge was considered. The composition of the mortar used for repointing the masonry joints must be carefully considered. The lime-based mortar should match the color of the existing masonry as closely as possible. These mortars should be as resistant as possible to the severe climatic conditions of the region (high humidity, contact with waves) while being compatible with authentic materials.
