# Damage and restoration of historical urban walls: literature review and case of studies

**Citation:** Puppio, M. L., Sassu, M., Safabakhsh, A., Damage and restoration of historical urban walls: literature review and case of studies, *Frattura ed Integrità Strutturale*, 65 (2023) 194-207

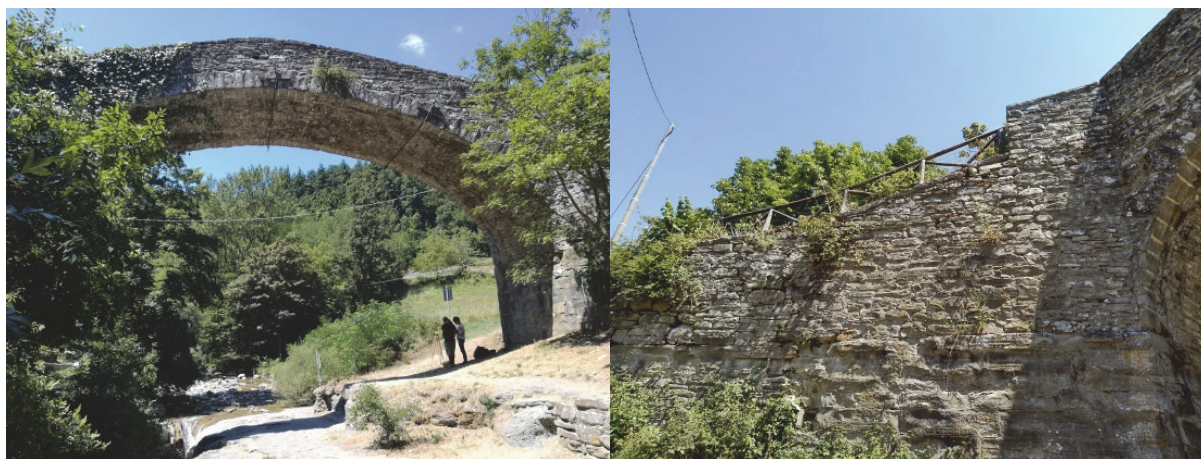
Figure 1: An example of infrastructure deterioration.

Exposure to damaging factors has affected the existing heritage artifacts worldwide. Natural hazards can impact heritage in various forms. Moreover, their consequence can be defined according to the aim of the study, which is, in civil engineering, the direct, indirect and intangible losses related to infrastructure, environment and society (Figure 1) [35]–[39].

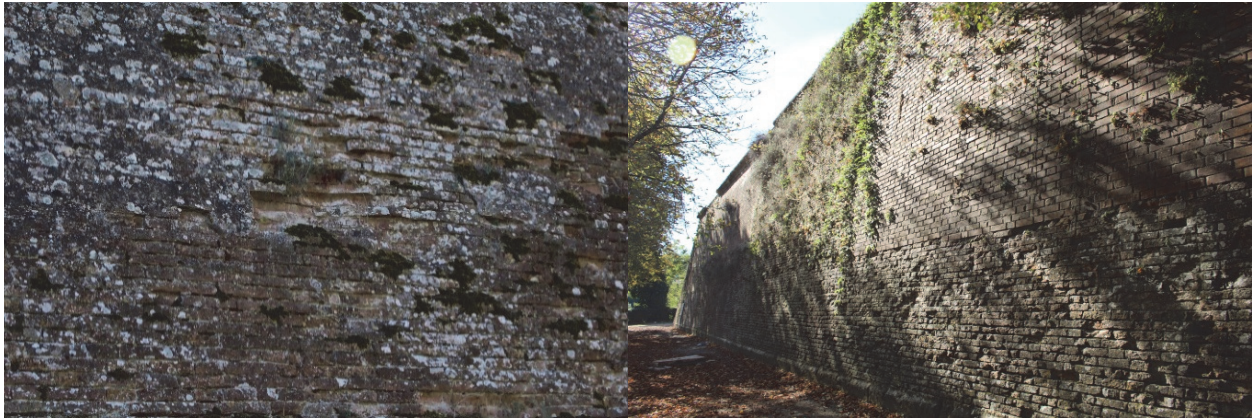
Figure 2 shows an example of degradation in masonry due to moisture. This can be easily detected because of the vegetation and the variation of the color of the external face of the walls. This is evidenced by the well-known case of the collapse of *Lungrano Torrigiani* in Florence in 2016 (

Figure 2: Examples of degradation due to moisture

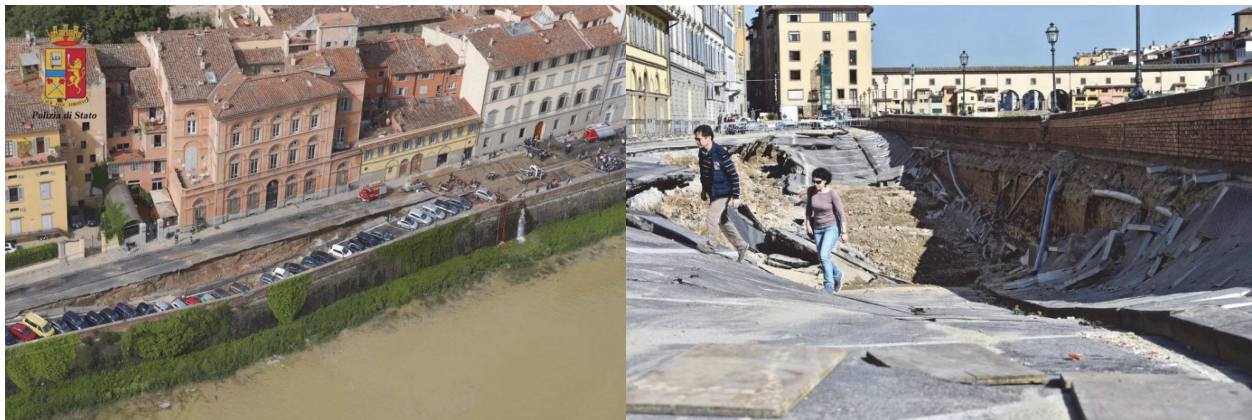
Figure 3). The abundant presence of vegetation along the embankment denotes a copious presence of moisture in the period before the collapse.

Figure 3: Collapse of Lungarno Torrigiani in Florence (25<sup>th</sup> May 2016) as an example of moisture related failure.

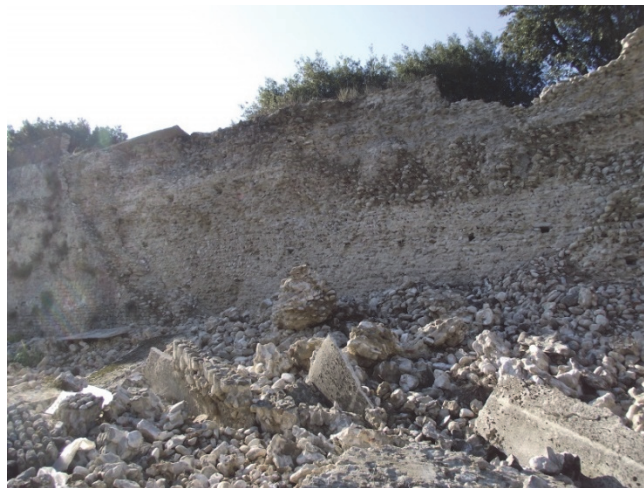
Figure 5: Collapsed portion of the wall, Pistoia

was damaged due to poor quality of the materials. As a matter of fact, the wall was constructed using river pebbles (limestone rocks, from the Brana river) and filled without proper connection between internal and external wythes. The thickness of the collapsed portion was about 1.6 meters, and 11 meters high (which is significant relative to the thickness). The results showed that significant height-to-thickness ratio and inappropriate materials were the effective factors in this collapse. Moreover, the existence of a previous riverbed and the extreme rainfalls contributed to the collapse.

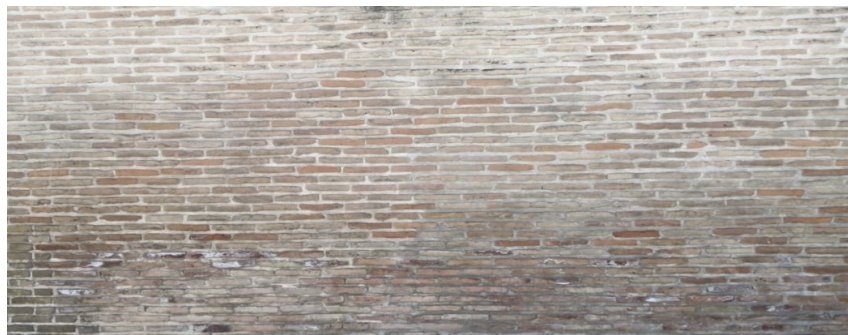
Figure 7: Migration of calcium sulphate in the wall, Ghiassieh school, Iran.

Ghiassieh School, a historical Timurid school founded in the 9<sup>th</sup> century, is located in northeastern Iran. The walls were constructed of rising masonry bricks and gypsum mortar. A typical feature is the presence of decorative tiles. The analysis showed that material deterioration was caused by salt crystallization, as well as stresses caused by moisture, wind erosion and thermal effects (Figure 7): this phenomenon is shown throughout the variation of colors of the façade, joined with measurement of ettringite contains.

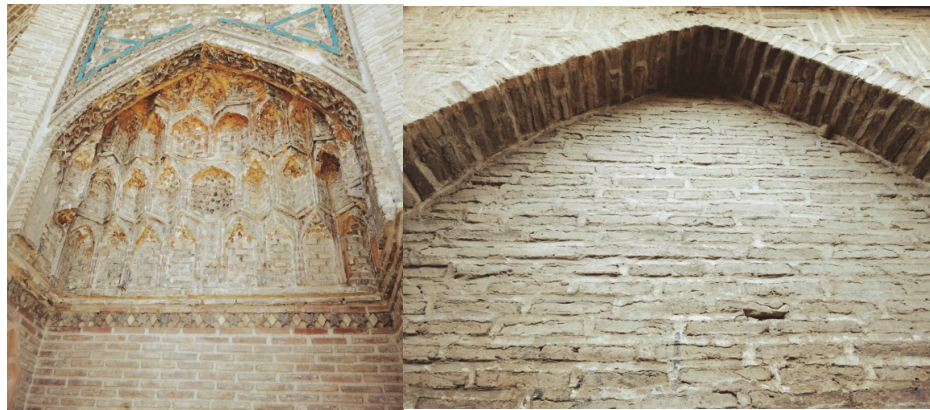
Firstly, severe moisture damage was surveyed in the pillars and portico of the structure which could cause collapse of ornaments, brick masonry and ceramic tiles, and moisture ingress in bricks. A few critical problems are illustrated in Figure 8.

Figure 8: Entrance in the Varamin mosque, Iran
