Summary Data for Cross-Shore Transects (Winter 2016-Summer 2020) - Humboldt Coastal Resiliency Project and Climate Ready Project

HUMBOLDT COASTAL RESILIENCY PROJECT
AND
CLIMATE READY PROJECT

SUMMARY DATA FOR CROSS-SHORE TRANSECTS
WINTER 2016-SUMMER 2020

Andrea Pickart and Candace Reynolds, U.S. Fish and Wildlife Service,
and Ian Walker, U.C. Santa Barbara

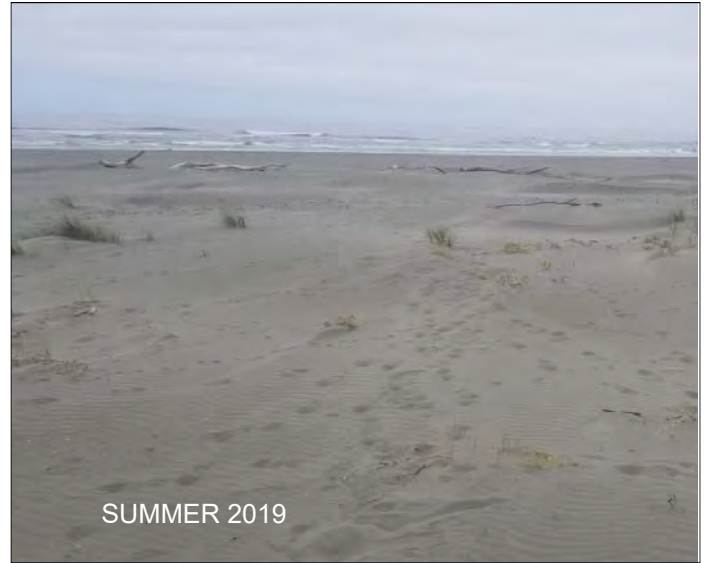
Little River Transect 5

Photos taken at 224 m from the crest of the incipient foredune show deposition and expansion of vegetation.

Notes: Similar to Transect 4, Transect 5 (located in the unrestored portion of Little River State Beach) is characterized by a broad *Ammophila* backshore/incipient foredune that forms transverse dunes during summers. The incipient foredune experienced up to 1 m of deposition between summer 2016 and summer 2020 (see photos below). There is an established, two-peaked *Ammophila* foredune separated from a landward relict foredune by a foredune swale, and a deflation plain separates these from an older, landward, relict foredune at approximately 60 m. Overall, there was net deposition on the backshore and incipient foredune over the course of the study, while the backdune remained stable.

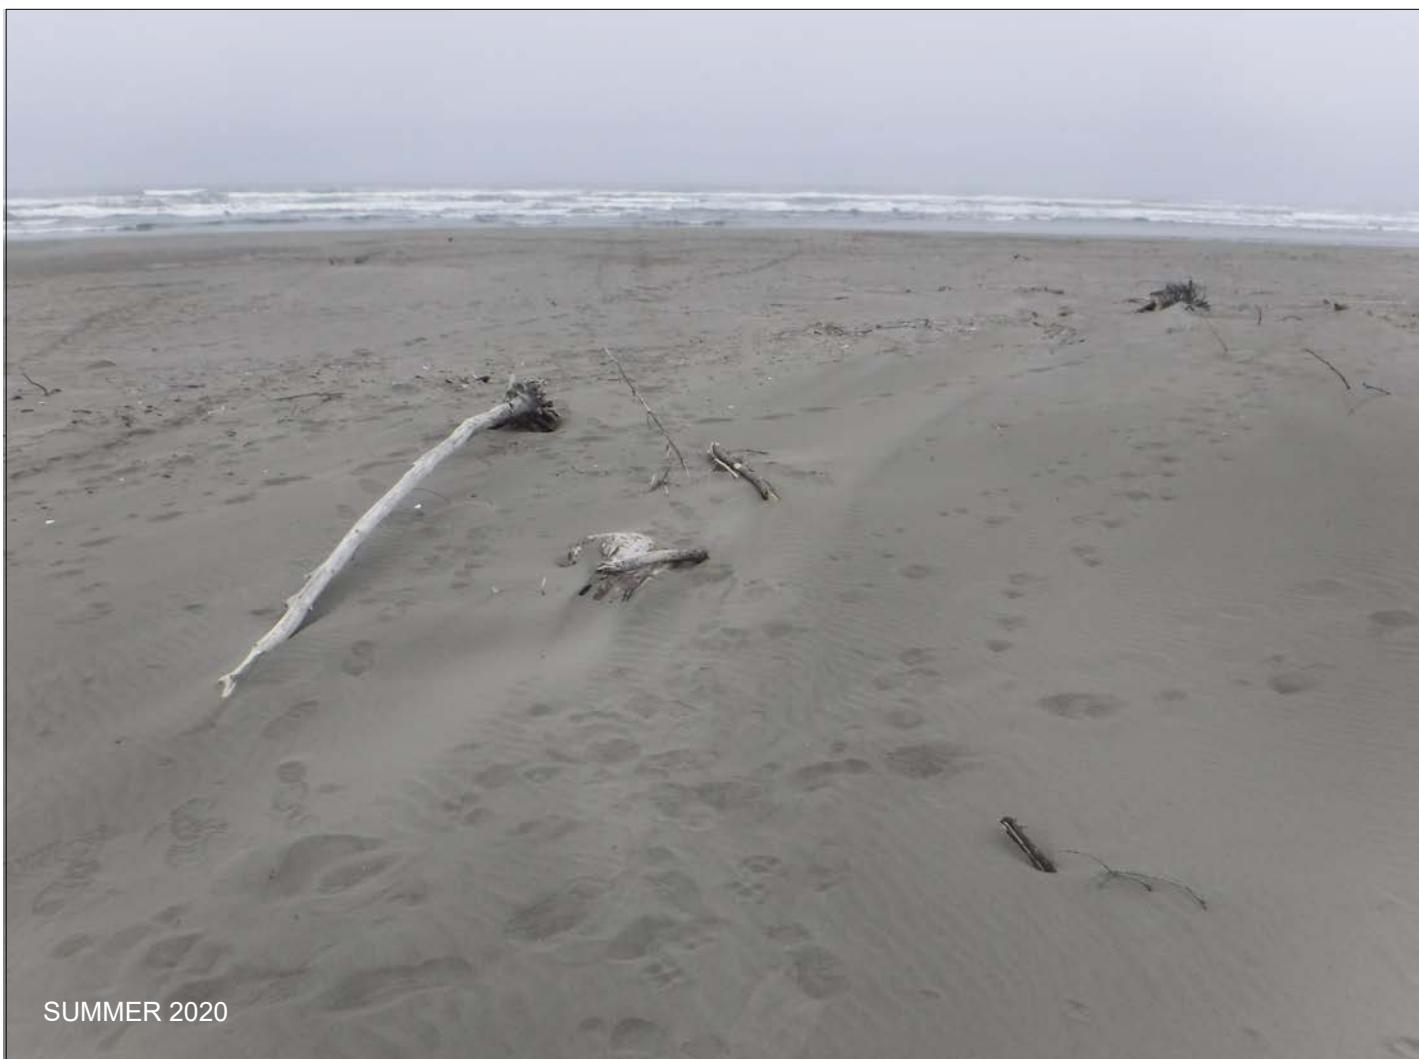
Clam Beach T8 View northwest at 58 m (Incipient Foredune)

Notes: This transect is located north of the mouth of the Mad River and represents a dynamic area. The incipient foredune present at the start of the surveys was completely eroded when the river migrated northward, with a smaller incipient foredune forming behind it at 42 m. Over the course of the study the incipient foredune was removed and a new one began to form 40 m eastward.
