This strangely beautiful solitude: an archaeological and historical study of Uffington House, 40MO145, Rugby, Tennessee

Avery, Paul Gordon, "This strangely beautiful solitude: an archaeological and historical study of Uffington House, 40MO145, Rugby, Tennessee. " Master's Thesis, University of Tennessee, 2001.
https://trace.tennessee.edu/utk_gradthes/9558

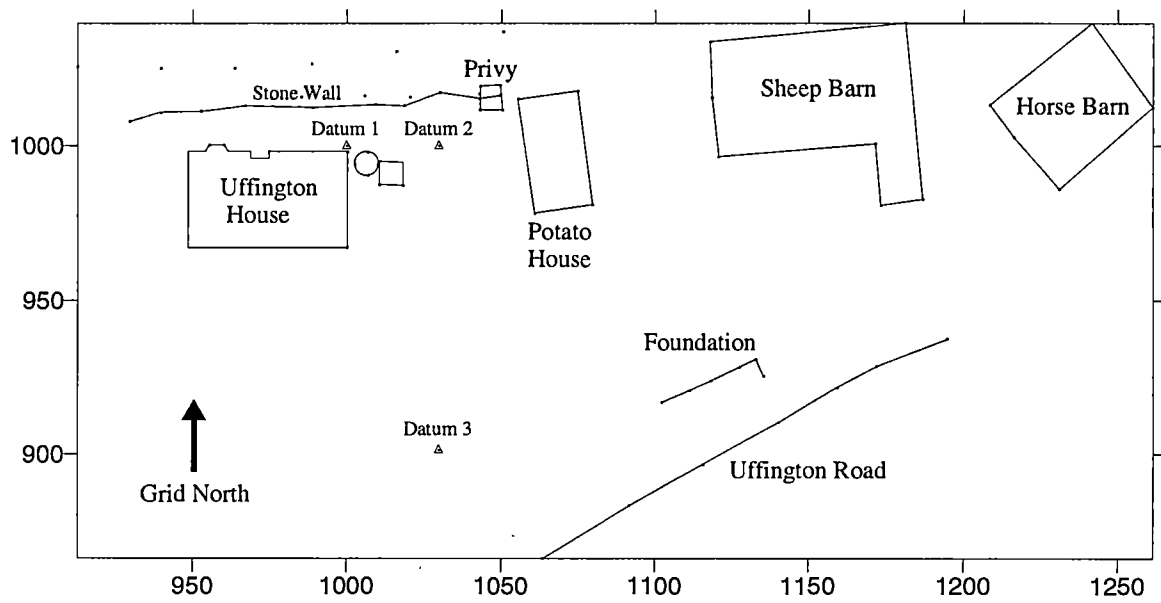
Figure 4. 40MO145 Overall site plan.

The Uffington House site currently consists of the dwelling house, a potato house, sheep barn, horse barn and chicken coop (Figure 4). A large brick cistern and concrete pad for a pump house are also associated with the house. An east-west dry-laid sandstone retaining wall runs parallel to and north of the house. At the east-end of this wall is the foundation for a privy. While the Uffington property encompasses approximately 3 acres, the structures are clustered fairly close together. The property

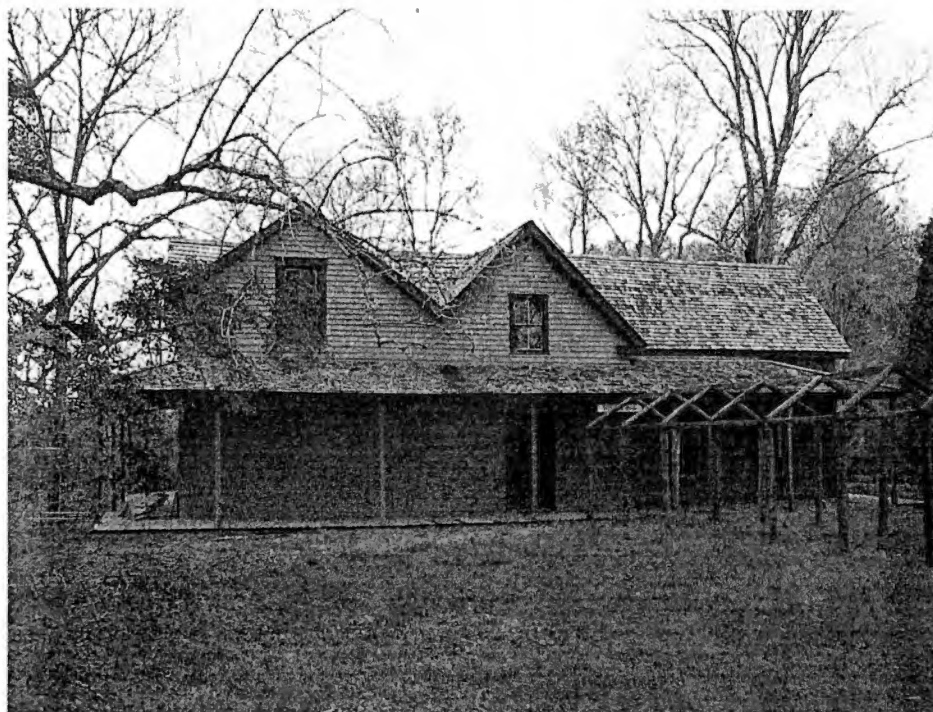
Figure 5. Uffington House, 2001.

The house rests on a continuous foundation of uncut stone. The stone is sandstone, which is readily available naturally, and is mortared in place. A small cellar is present beneath the kitchen in the rear side-gable, with a brick floor and plaster walls. The cellar does not communicate directly with the interior of the house.

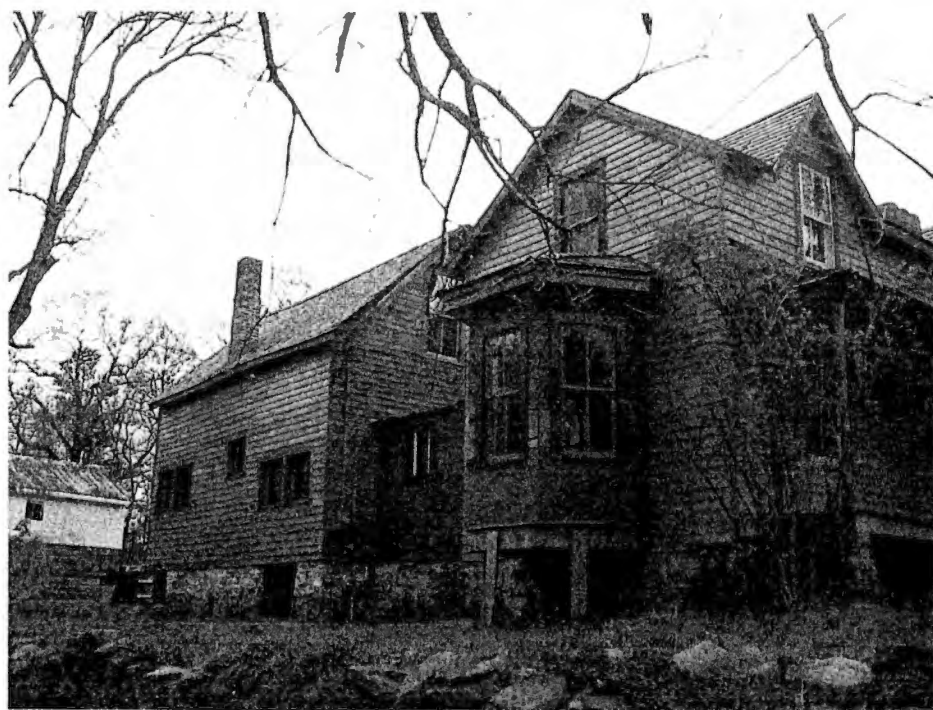
Figure 6. Rear of Uffington House, 2001.

The exterior walls are clad in beveled clapboards over the entire structure. The roof has recently been resurfaced with cedar shakes and copper flashing, as it was originally. One of the most unusual aspects of Uffington is the roofline. The pitch of the roof of the two front gables is different as is that of the two side gables. Again, this reflects the piecemeal manner in which the house was constructed.

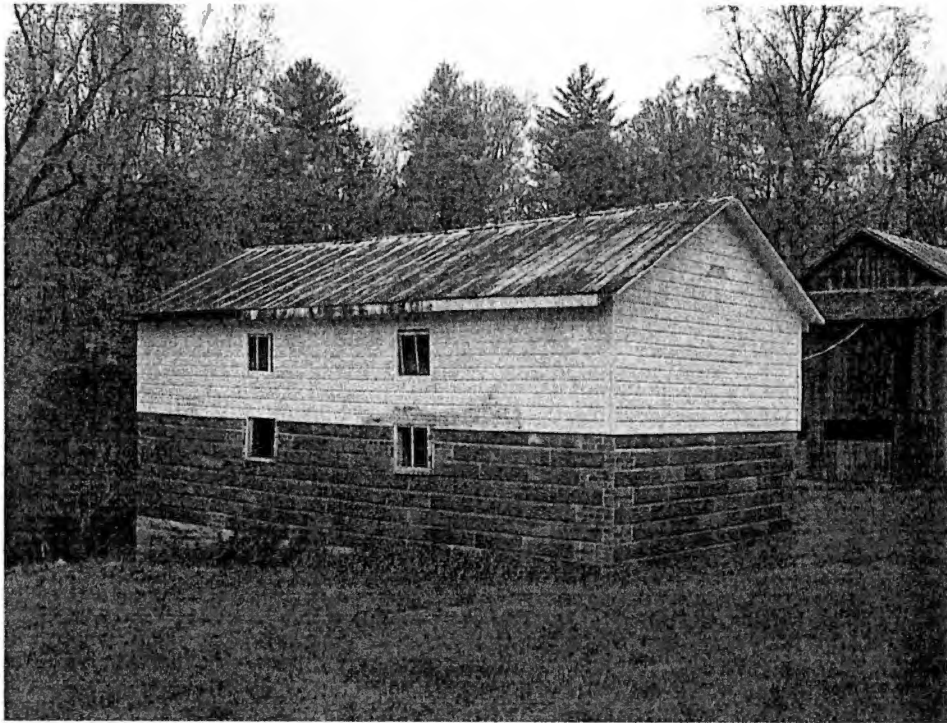
Figure 7. Potato House, facing northeast.

Potato House. The potato house (Figure 7), constructed in the late-1930s, lies east of the main house. It has 1-1/2 stories and is constructed on a heavy, natural sandstone foundation, which is dug into the bank on the south end of the building. The walls of the lower story are constructed of ceramic chimney flues, which are filled with sawdust (Loren Lawhorn 2001, Pers. Comm.) and laid in stretcher courses with brick corners. The flues are marked "SOClay" for the Southern Clay Manufacturing Company located in nearby Robbins, Tennessee (See Chapter 4 for discussion of Southern Clay). The upper walls are frame, with wooden shiplap siding. The gable roof is covered in standing-seam tin sheets. The door into the ground floor is located on the east-elevation at the southeastern corner of the structure. Another small door is located directly above the main door on the upper story (Figure 8). All of the windows are two-pane casement types, with two for the ground floor on the west elevation and two each on the east and west elevations for the upper floor.

The corners were constructed using what appears to be a decorative machine-made brick. The ends of each brick are cut to point and smoothed, while the sides exhibit deep machine marks. These bricks are also used as spacers between some of the flues. Paver bricks have been utilized in three areas of the potato house to close

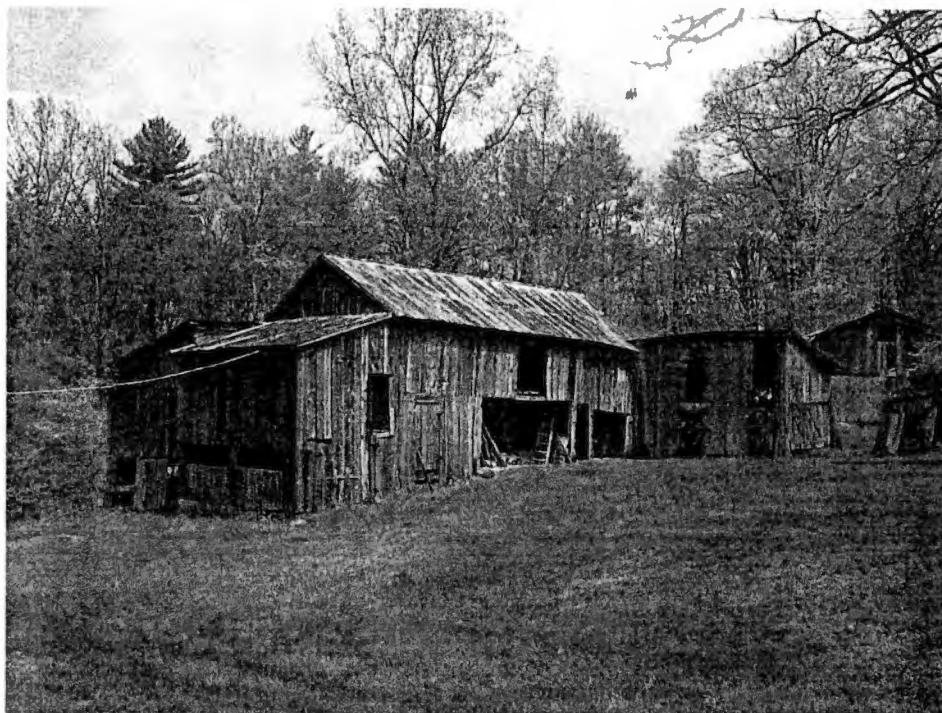
Figure 9. Sheep Barn, facing northeast.

Sheep Barn. The sheep barn (Figure 9) is located west of the potato house. It is constructed of wood pole framing on a stone foundation that is continuous in places and piers in others. The sides are clad in wide circular-sawn boards without battens. The barn appears to have begun as a gable-roofed, three-pen structure, which is now the central portion. At least three additions have been added to bring it to its current form. The central portion has three-pens and a loft under a gable-roof covered with raised-seam tin sheets. A small addition, approximately the same width as the original barn, has been added to the west end. It does have a loft under a shed roof, but it is not as tall as the original gable. Another addition forms an "ell" on the eastern end of the barn. It also has a shed roof over a loft shorter than the original structure. Finally, a shed-roof addition with a loft runs the length of the northern side of the barn. The barn is currently used as storage for a wide variety of lumber and architectural debris.

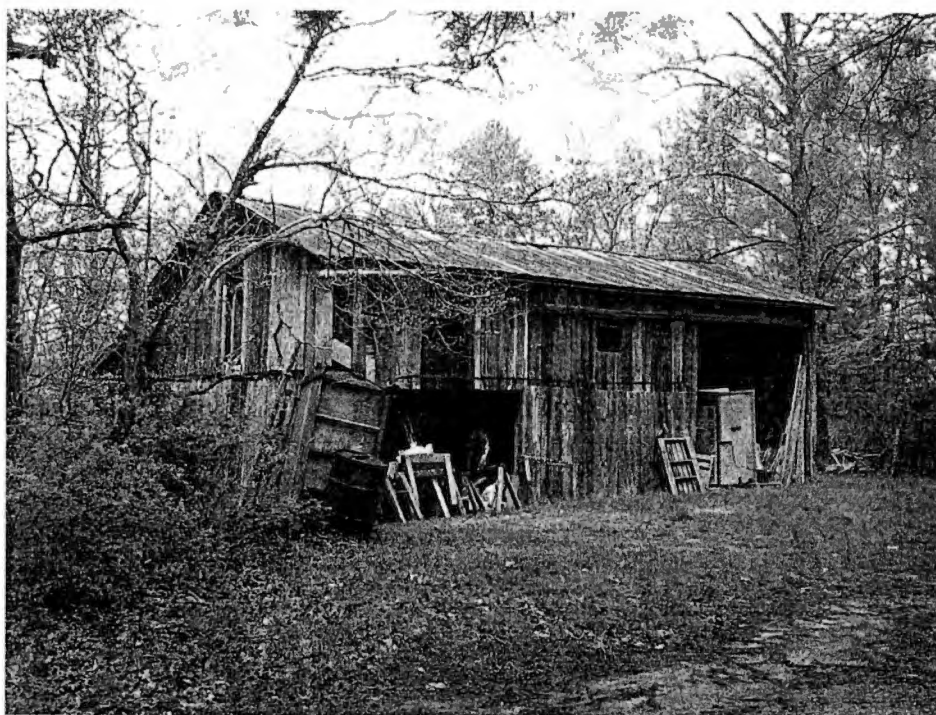
Figure 10. Horse Barn, facing north.

Horse Barn. The horse barn (Figure 10) is located east of the sheep barn and is the furthest structure from the main house. It is a large gable-roofed structure with an open shed-roofed addition along the north edge. The entire roof is covered by standing seam tin sheets. The siding is vertical circular-sawn boards without battens. Interestingly the post framing is of hand-hewn timbers, which have cut nails in them. The construction date of this barn is likely later than these materials, which would indicate that they were recycled for this purpose. The origin of these posts is

unknown. The main barn is divided roughly into thirds, with the western and center portions having a second floor. The stairs to this floor lead from the eastern end of the barn. This barn is also used for storage at this time.

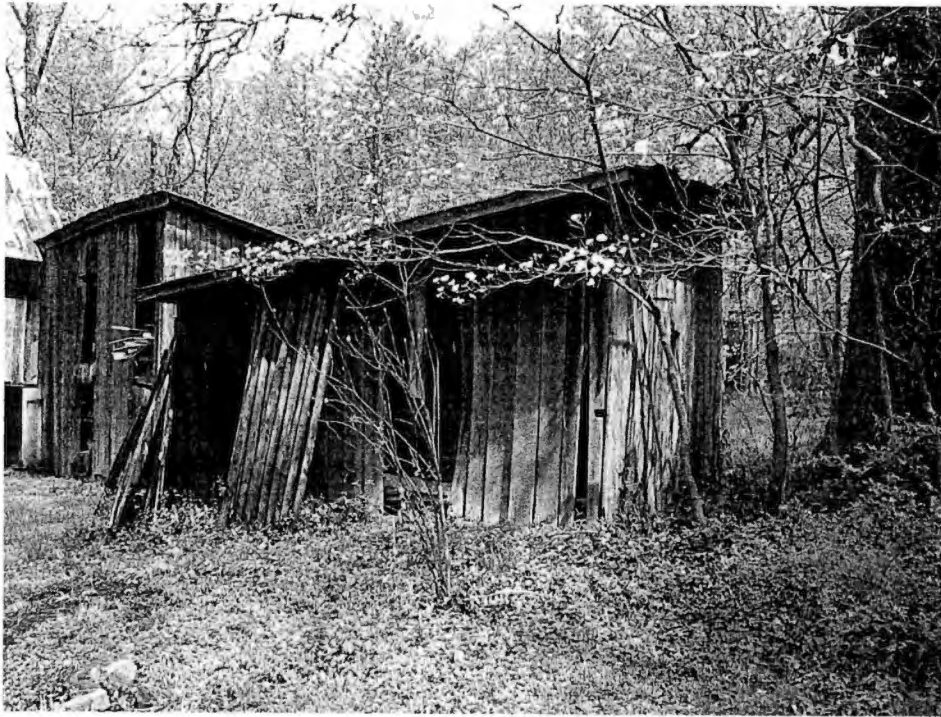
Figure 11. Chicken Coop, facing east.

Chicken Coop. A small (10-feet by 14-feet) rectangular chicken coop (Figure 11) lies south of the sheep barn along Uffington Road. It is of simple pole frame construction with rough board siding and a shed roof covered in sheet tin. It rests on sandstone piers, on one end of what may be an earlier foundation. The exposed portion of this foundation consists of sandstone rocks set in the ground in a rectangular pattern, with a pile of sandstone and brick rubble covering the center. The coop's placement is unusual, in that the higher portion of the roof, which is generally the front of a structure, faces the road and not the farm yard. A board and batten door, located on the front, has been nailed shut, while the back is open. Recycled materials were used in the construction of this building. It is currently full of lumber and is in very poor condition.

A 10-foot by 14-foot shed, located south of the sheep barn, is likely of Brooks origin. It is interesting in that it rests on a foundation of stone piers, which are in turn resting on what appears to be one end of another stone foundation. This foundation

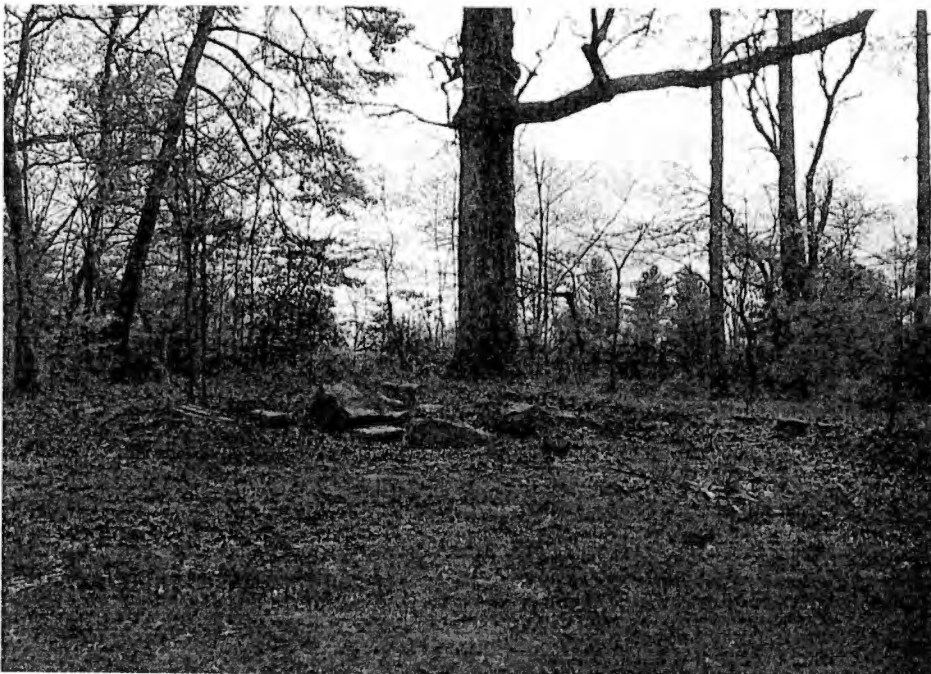
Figure 12. Foundation remains along Uffington Road, facing south.

Located to the northeast of the house, near Uffington Road, are the remains of a stone and brick foundation that was once part of a larger chicken coop (Figure 12). These remains lie in a brushy area near a row of large trees that parallel Uffington Road on the southern edge of the property. The foundation consists of some *in situ* remains and a seemingly random pile of stone and masonry rubble. A pump for a drilled well is located nearby to the west.

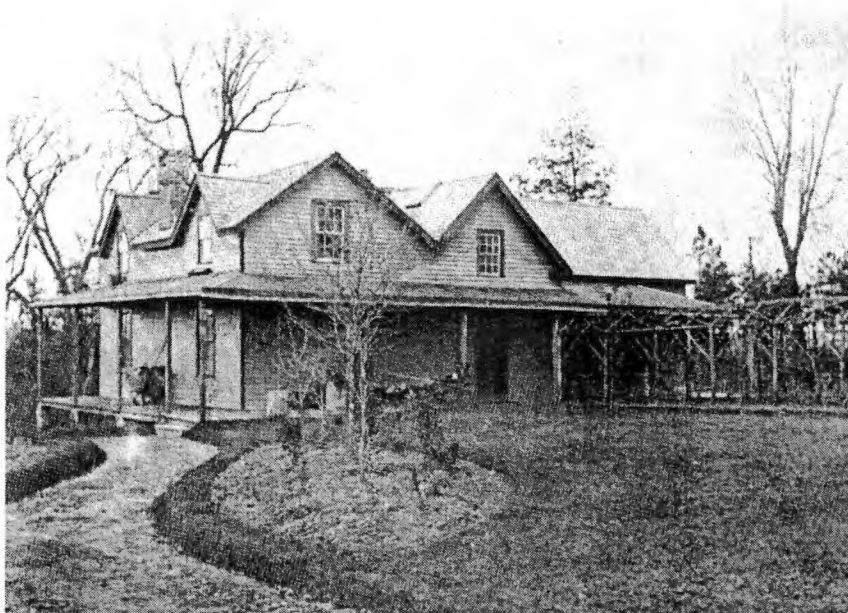
Figure 19. Uffington House, ca. 1882 (On File, Historic Rugby Archives).

yesterday” (E. Hughes 1976: 24). Emily’s room was located above the new drawing room toward the front of the house (Figure 19). By February, they were unpacking the last of their things and getting settled in the new space (E. Hughes 1976: 29).

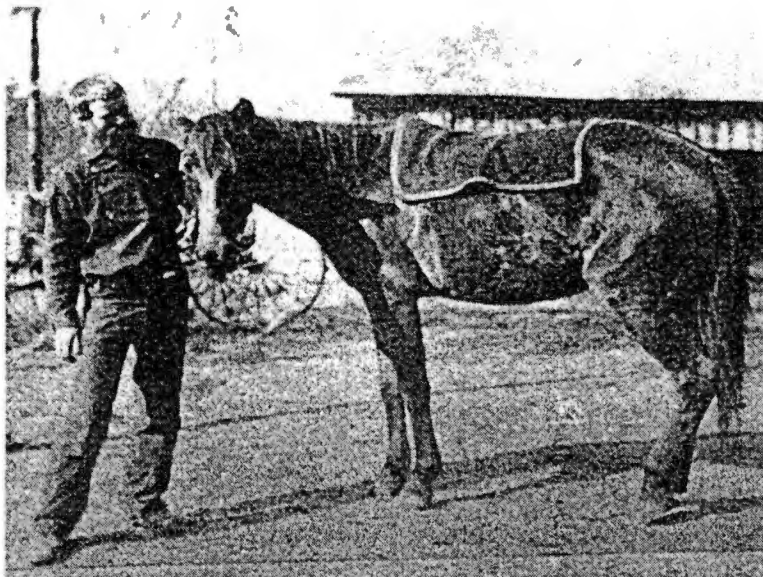
Figure 20. Harry Hughes in front of a barn presumed to be on the Uffington property, 1887 (E. Hughes 1976).

A photograph of Harry Hughes (Figure 20) in front of a barn taken by Emily sometime in 1887 (E. Hughes 1976: 70) adds to the confusion. This structure, which is assumed to be on the Uffington property, is not the same building that Mrs. Taylor painted. It has what appears to be a central drive through, or at least a large central barn door, and has no cross-gable or dormer. No other barn is listed in the sale notice for the property, but it is likely that the Hughes ladies would have needed such a barn for their blossoming dairy. Judging by the lay of the land, it is possible that this structure stood where the extant sheep barn is located, although there is no documentary evidence of this. If Emerick (1995) is correct, and Emily's stable and fowl house were separate, this could be the stable, possibly combined with the carriage house. It seems more likely, however, that this structure was a barn associated with the operation of the dairy.

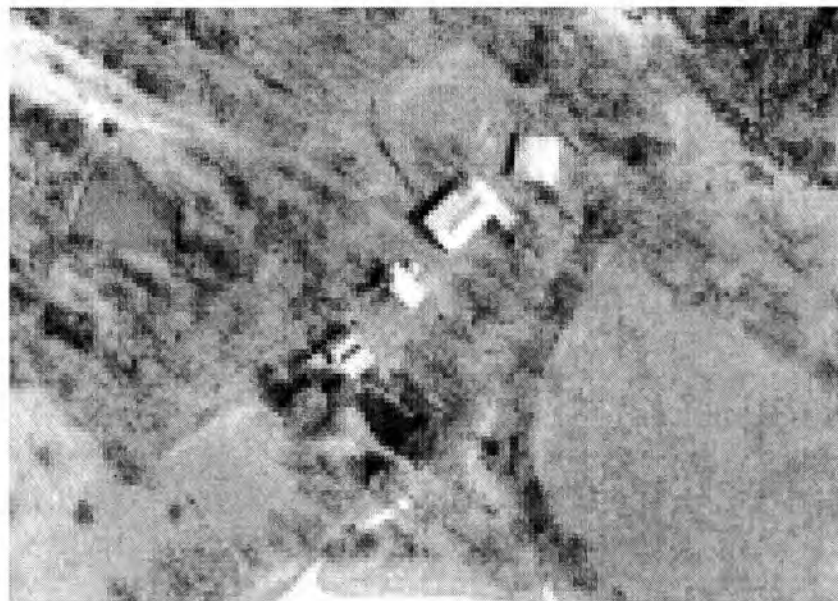
Figure 22. 1978 aerial photograph of the Uffington property (On File, Historic Rugby Archives).

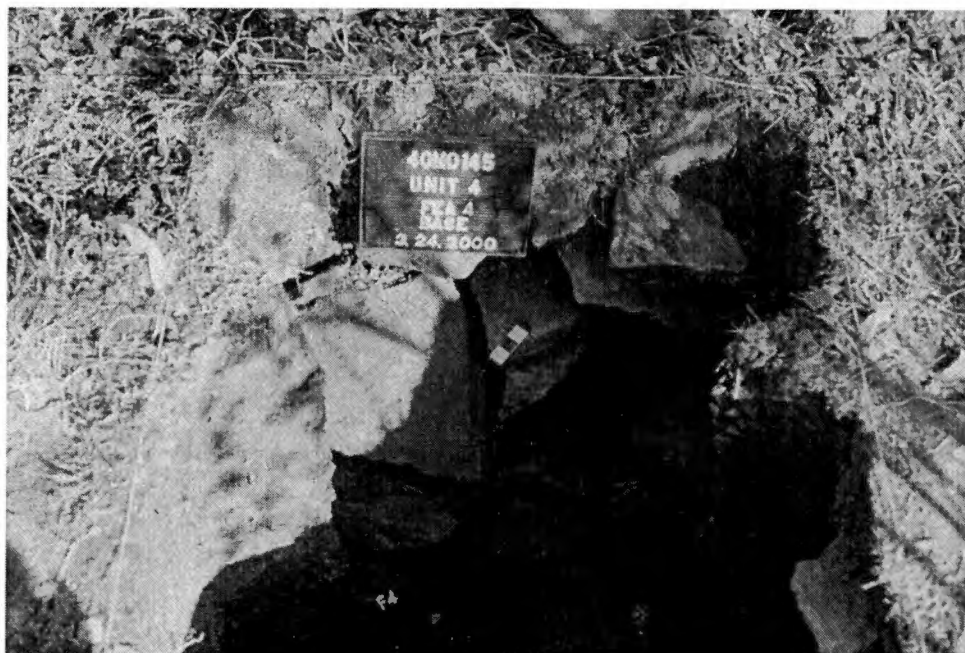
Figure 27. Unit 4.

Unit 4. Unit 4 was a 1.5 feet by 3 feet rectangle north of and adjacent to Unit 3, approximately .5 feet from the stone wall. This unit was intended as a quick way to determine the width of Feature 4. At the base of Level 1, large rocks began to impede excavation (Figure 27). These rocks appeared to be the rear margin of the existing wall or an older buried wall. No architectural material was recovered from Feature 4. Unit 4 was closed out at a depth of approximately 2.5 feet below surface.

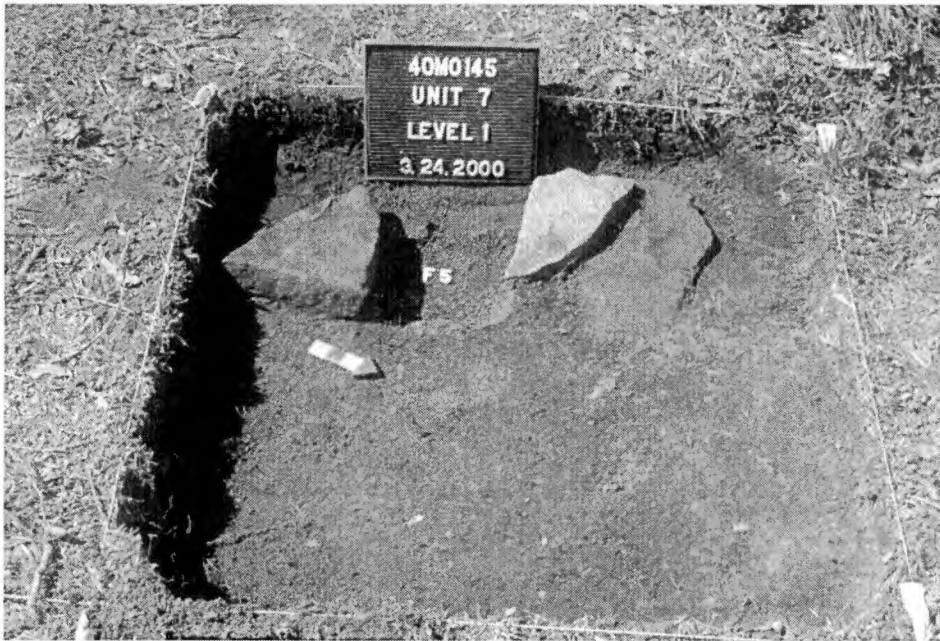
Figure 29. Feature 5.

Feature 5. Feature 5 was a brick drain capped by sandstone located just below the humus (Figure 29). It was constructed in a builder’s trench and associated with a layer of sandy, yellow clay to the north. The bricks used are handmade soakers, likely recycled for this purpose, laid in stretcher rows. The drain was located in the western half of the unit and oriented north-south and with the slope of the land. This feature lines up almost exactly with the drain pipes discovered in Feature 3, Unit 1. It appears that they both may be part of some drainage system that once sat on the ground surface. Exactly what, if anything, these features were associated with is unclear.

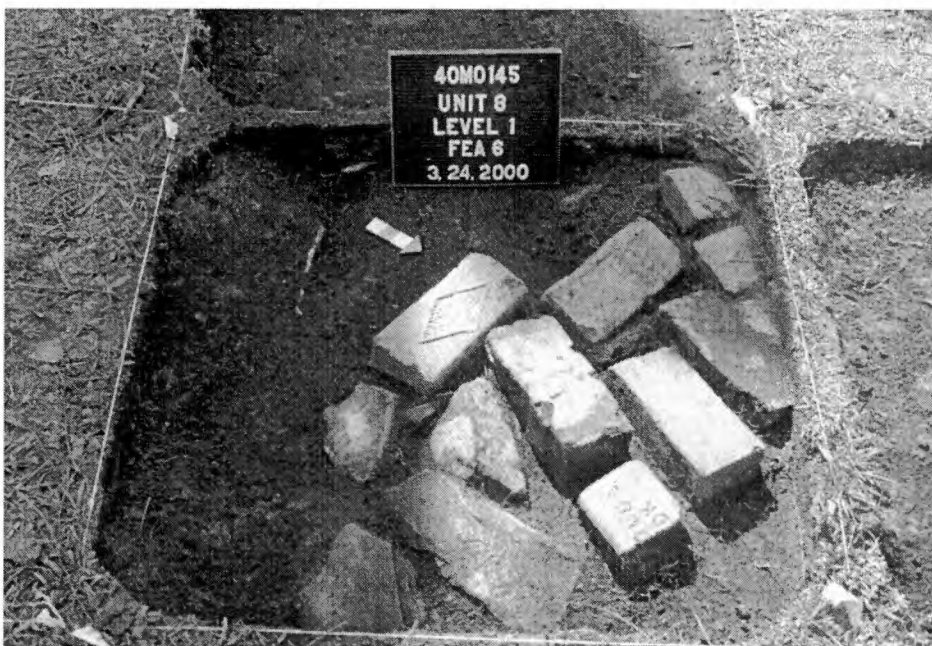
Figure 30. Feature 6.

Feature 6. Feature 6 was a brick walkway detected just below the surface of Unit 8 by probing (Figure 30). The bricks are machine-made pavers, including three made locally by the Southern Clay Manufacturing Company and one Reynolds Block (See Chapter 4 for a discussion of Southern Clay). Large sandstone blocks were also associated with the walk, which appears to have rested on the original ground surface. Domestic debris, including ceramics and container glass, was recovered from the area around the feature along with architectural material. While there is no direct

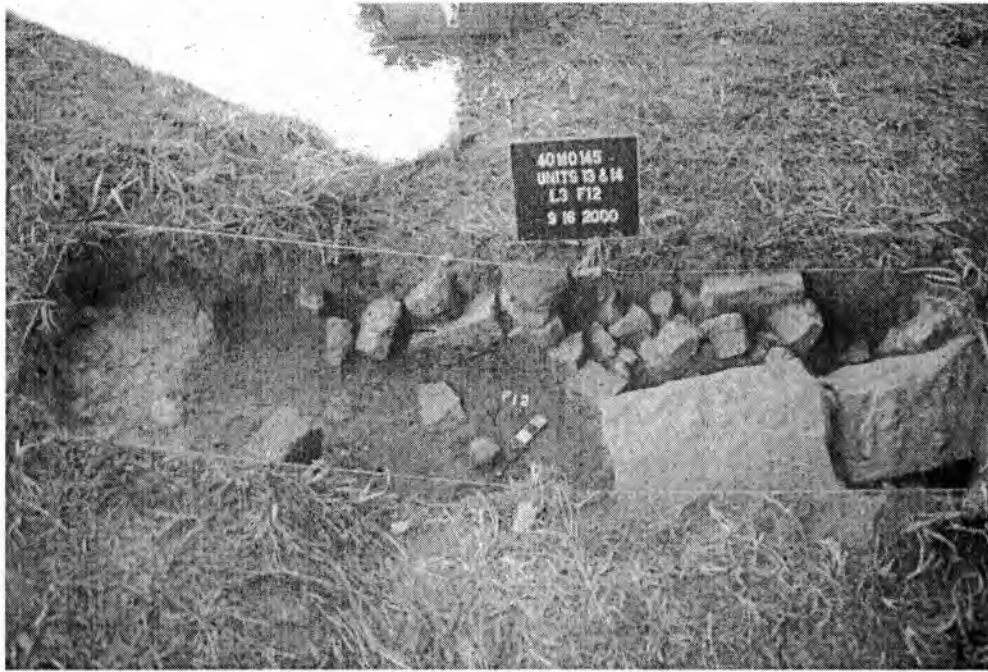
Figure 35. Feature 12.

Unit 13. Unit 13 was located east of and adjacent to Unit 12 parallel to the northern edge of the depression. It was located here in order to examine this margin of the depression. The soil in Level 1 was a fine, dark brown, silty loam containing coal and cinders. Just below the surface, Feature 12 (Figure 35), a concentration of large sandstone rocks and brick, was encountered. The rocks covered the majority of the unit, but the remainder was taken down to .6-foot where possible. The soil remained the same to this depth, where further excavation became impossible due to the rocks. This feature appears to be rubble from the destruction of the down-slope wall of the structure. Mostly architectural debris was associated with Feature 12, but a small amount of domestic material was also recovered.

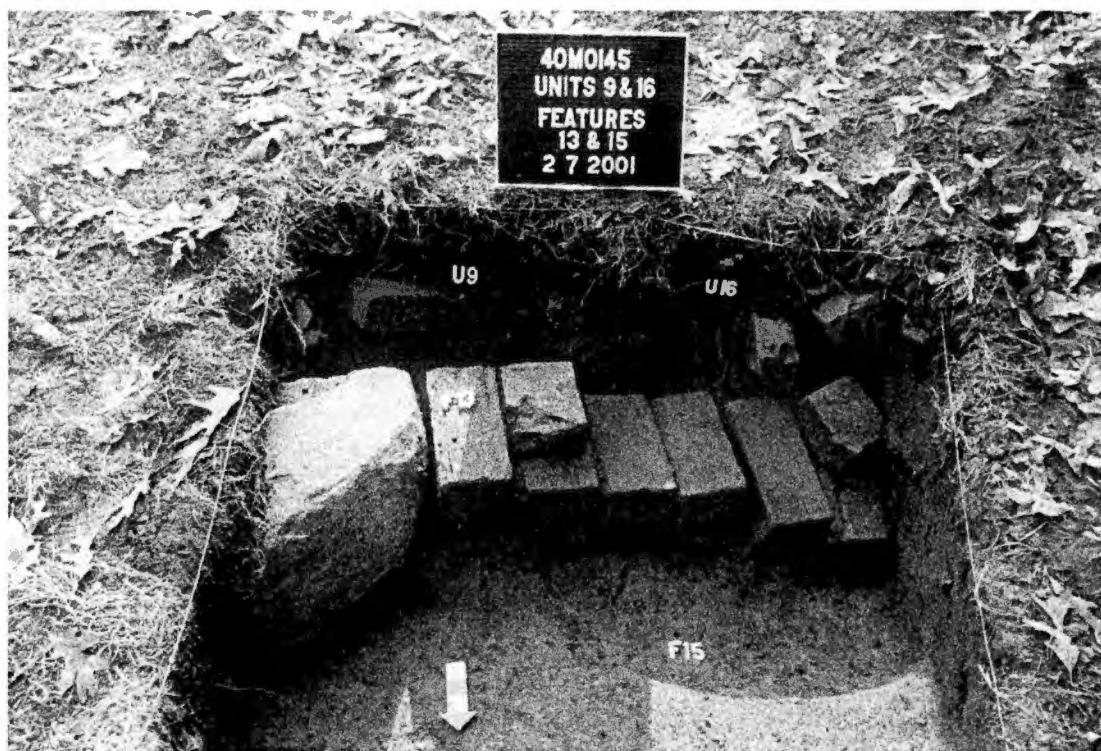
Figure 38. Features 13 and 15.

Unit 16. Unit 16 was located west of and adjacent to Unit 9 in order to further expose Feature 13, the brick and stone foundation (Figure 38). The stratigraphy was identical to that of Unit 9, with similar artifacts recovered. Another large sandstone block was exposed in the western wall of the unit, approximately 4-feet from the

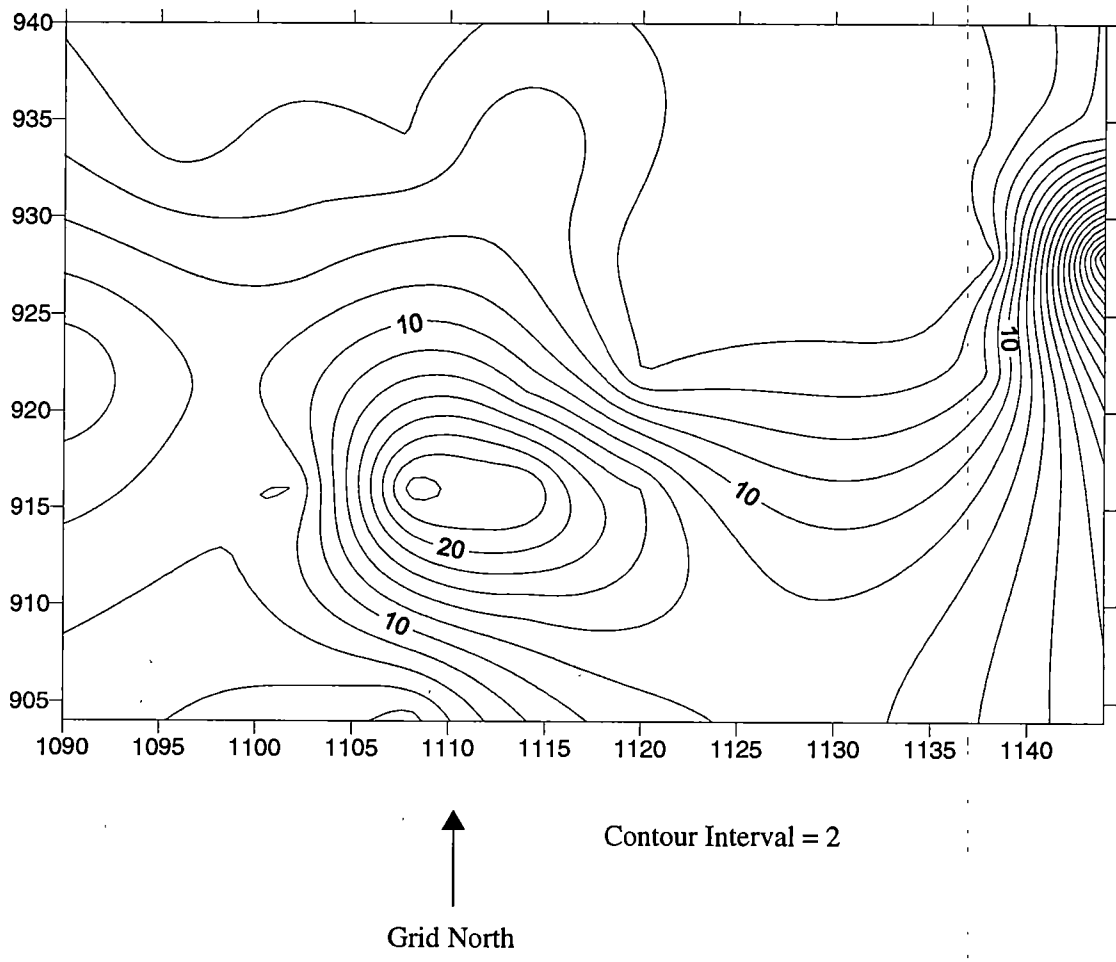
Figure 41. SURFER plot of the distribution of all bricks from Area II.

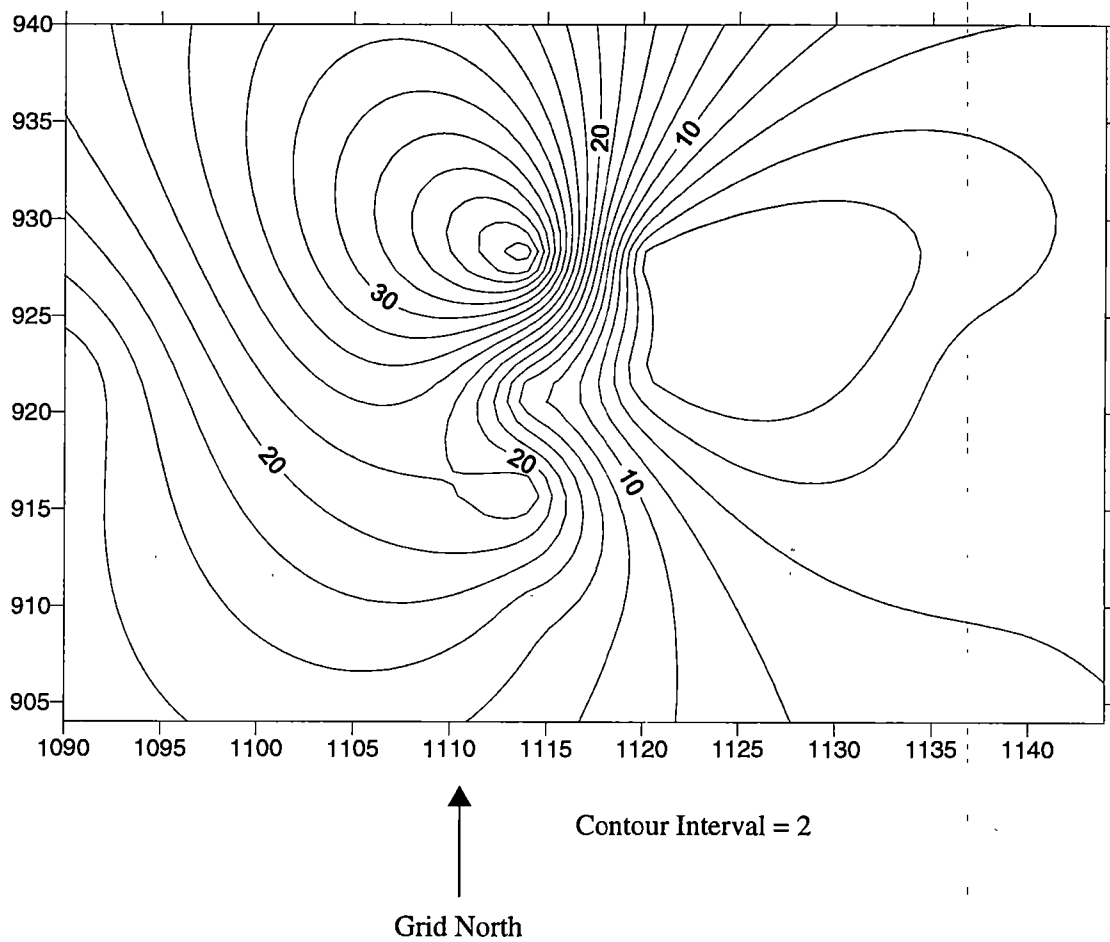
Figure 42. SURFER plot of the distribution of hand-made bricks from Area II.
