Residual Strength after Fatigue of Unidirectional and Cross-Ply Metal Matrix Composites at Elevated Temperature

THESIS

Sen-Tzer Chiou, Major, R. O. C., ARMY

AFIT / GAE / ENY / 96 J-2

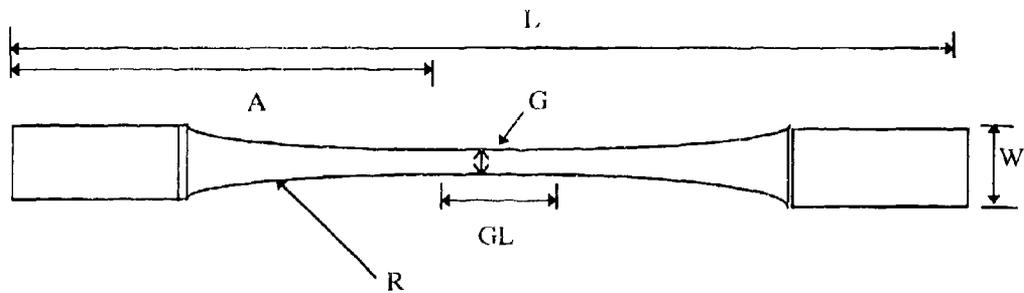
A sketch of the unidirectional specimens as shown in Figure 1. The cross-ply specimens were cut into rectangular coupons with the dimensions as shown in Figure 2.

$L = 15.2 \text{ cm}$	$A = 6.97 \text{ cm}$
$GL = 1.27 \text{ cm}$	$R = 116 \text{ cm}$
$W = 0.9 \text{ cm}$	$G = 0.18 \text{ cm}$

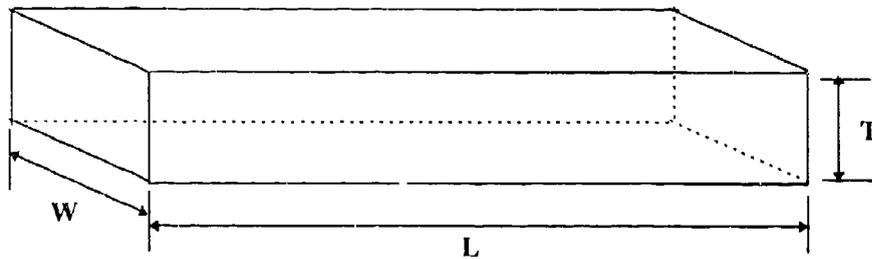
Figure 2. The Geometry of Cross-Ply Specimens

L: 15.2cm(Length),
 W: 0.7cm(Width),
 T : 0.20cm(Thickness)

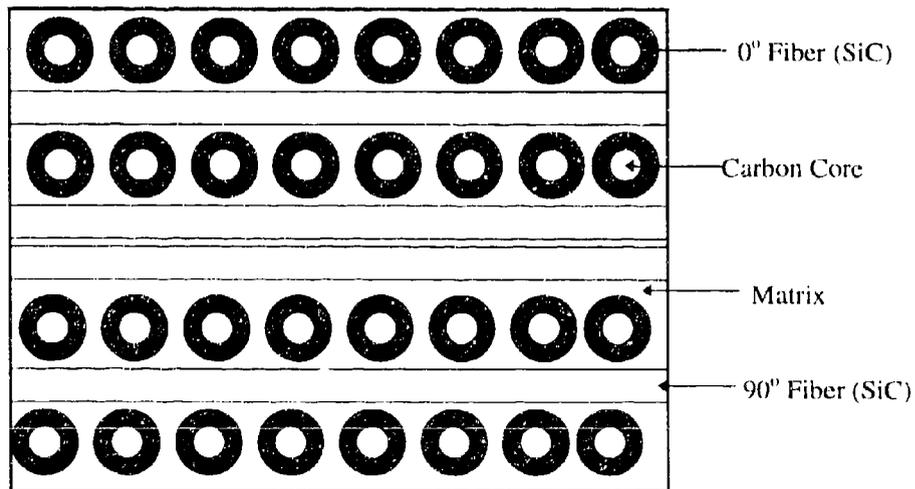
Figure 3. Side View of Cross-Ply Laminate

A pictorial view of the cross-ply is demonstrated in Figure 3. The average curvature of test specimens was 1160 mm (45.7 in.). All specimens were machined using a diamond encrusted blade and then wrapped in titanium foil and heat treated at 700°C for 24 hours in an argon atmosphere to produce a stabilized matrix microstructure by precipitating out the α phase (i.e., stabilize the microstructure of the matrix material). This heat treatment has also been shown to reduce the residual stress produced during fabrication [1]. The as-received titanium alloy is a metastable, beta (β) phase alloy.

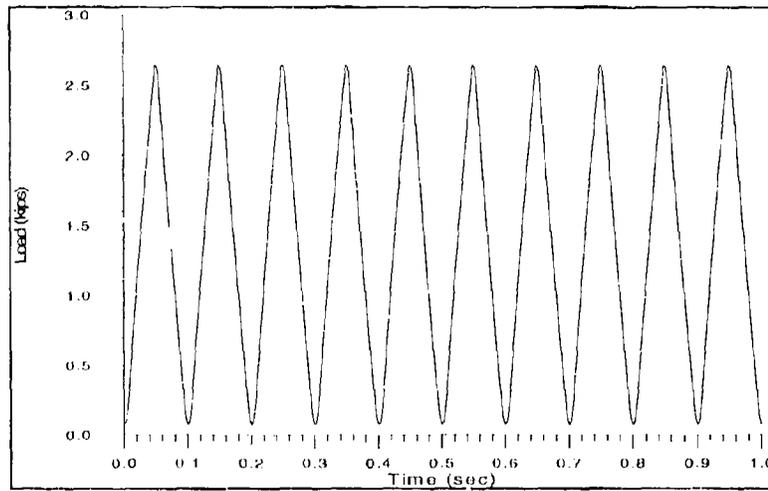
Figure 5. Load Time History for Unidirectional Laminates, Frequency (f) =10Hz, R=0.05, σ_{max} =900MPa, at 427°C

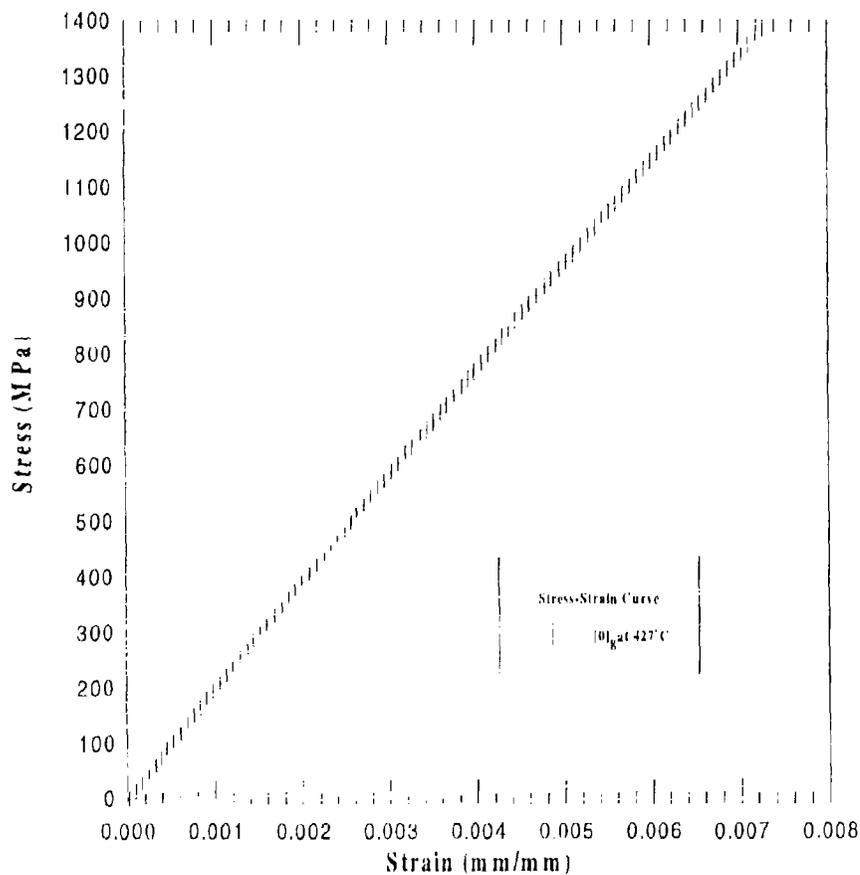
Figure 8 and 9 illustrate the stress strain response for the unidirectional laminate under the monotonic loading and cyclic fatigue loading. From Figure 8, it shows that the linear characteristics behavior occurred on these MMCs. Also, for the fatigue loading case, as the applied cycle numbers increases, the permanent strain increases and the modulus of the specimen decreases until failure.

Figure 8. Stress-Strain Response for $[0]_8$ Laminates at 427°C , with a Stress Rate of 15 MPa/s (Monotonic Test)

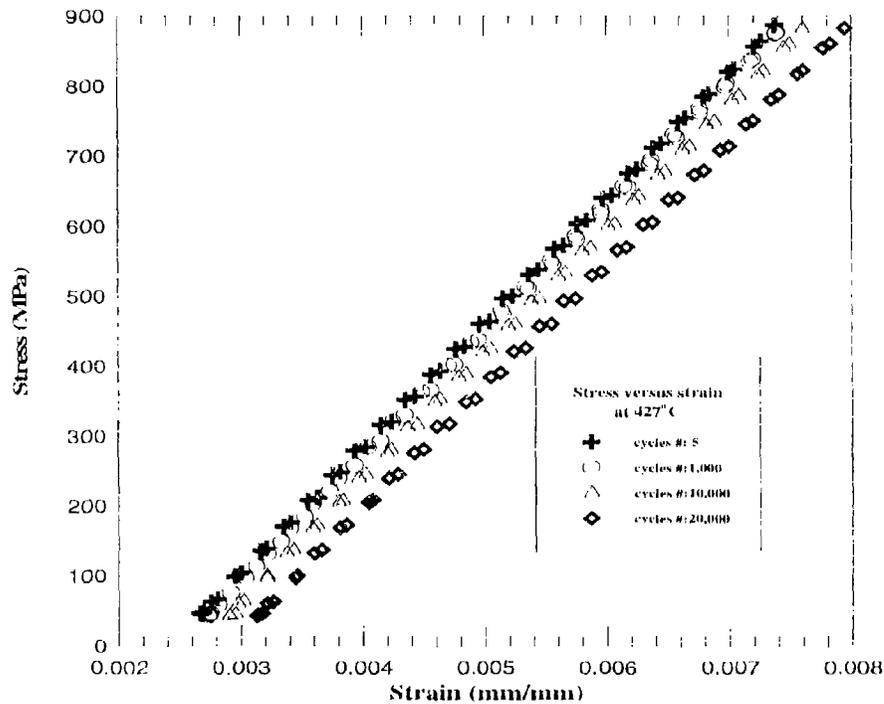
Figure 9. Stress-Strain Response for $[0]_R$ Laminates Fatigue Test at 427°C;
 $\sigma_{\max} = 900$ MPa, $R=0.05$, $f=10$ Hz Conditions

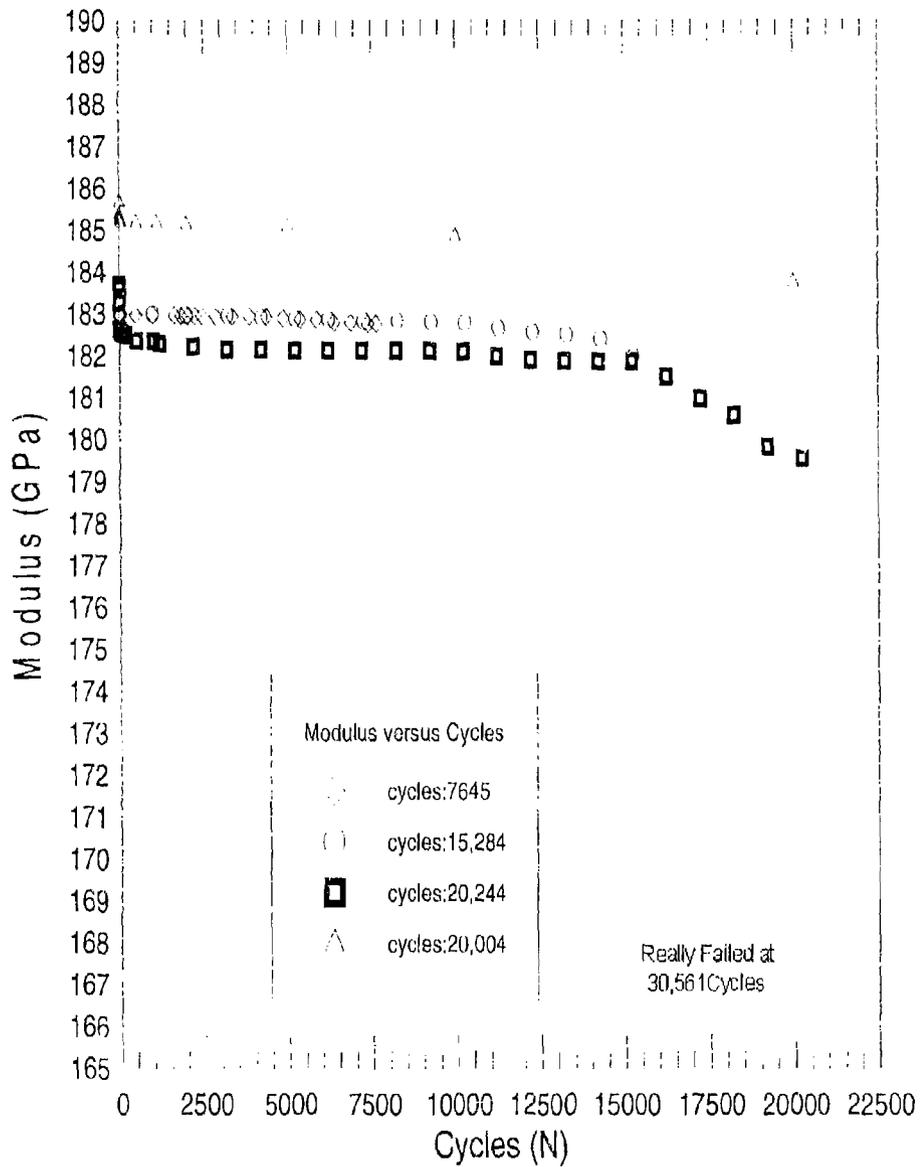
A common consequence of fatigue in composite is a reduction in stiffness which begins very early in the fatigue life. The modulus versus cycles, and normalized modulus versus normalized cycles diagrams are shown in Figures 10 and 11, respectively. The modulus drop is shown to be approximately 3 % over the fatigue life. The normalized modulus is defined as the measured modulus during the fatigue test divided by the initial modulus of the undamaged specimen (i.e., E/E_i). In the same way, the normalized cycle is the measured cycles divided by the fatigue life (i.e., N/N_f).

Figure 10. Modulus Cycles Relationship for $[0]_s$ Laminates under 427°C ,
 $\sigma_{\text{max}}=900\text{ MPa}$, $R=0.05$, $f=10\text{ Hz}$ Conditions

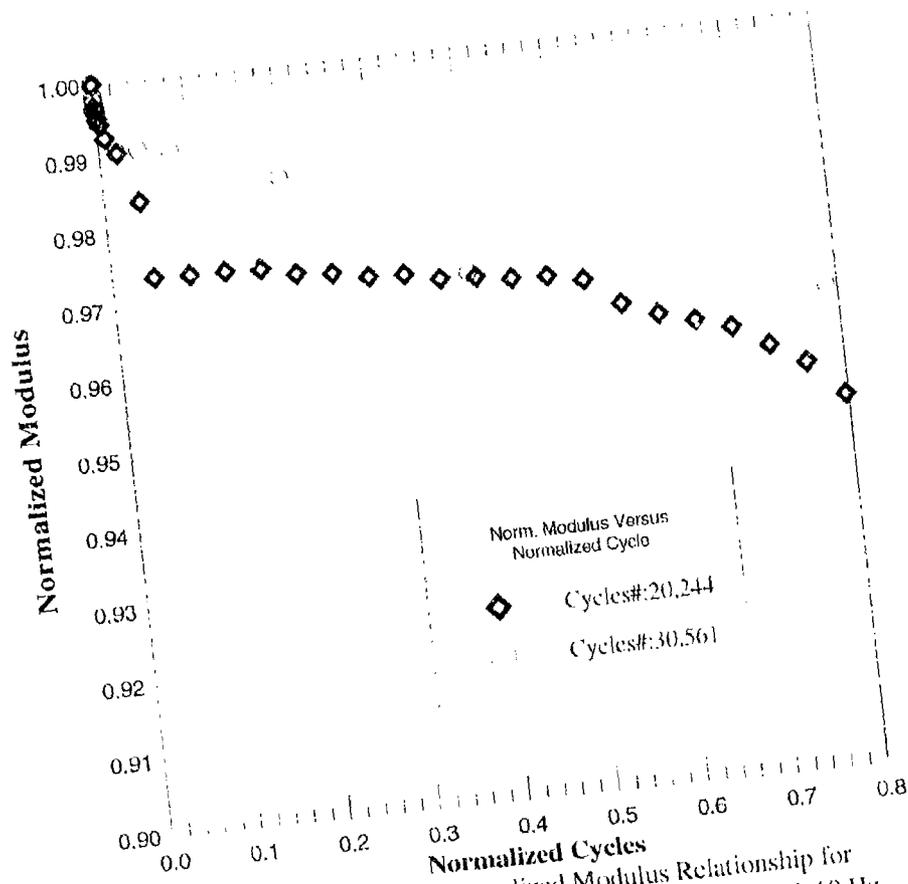
Figure 11. Normalized Cycles vs Normalized Modulus Relationship for $[0]_8$ Laminates under 427°C , $\sigma_{\text{max}}=900\text{ MPa}$, $R=0.05$, $f=10\text{ Hz}$

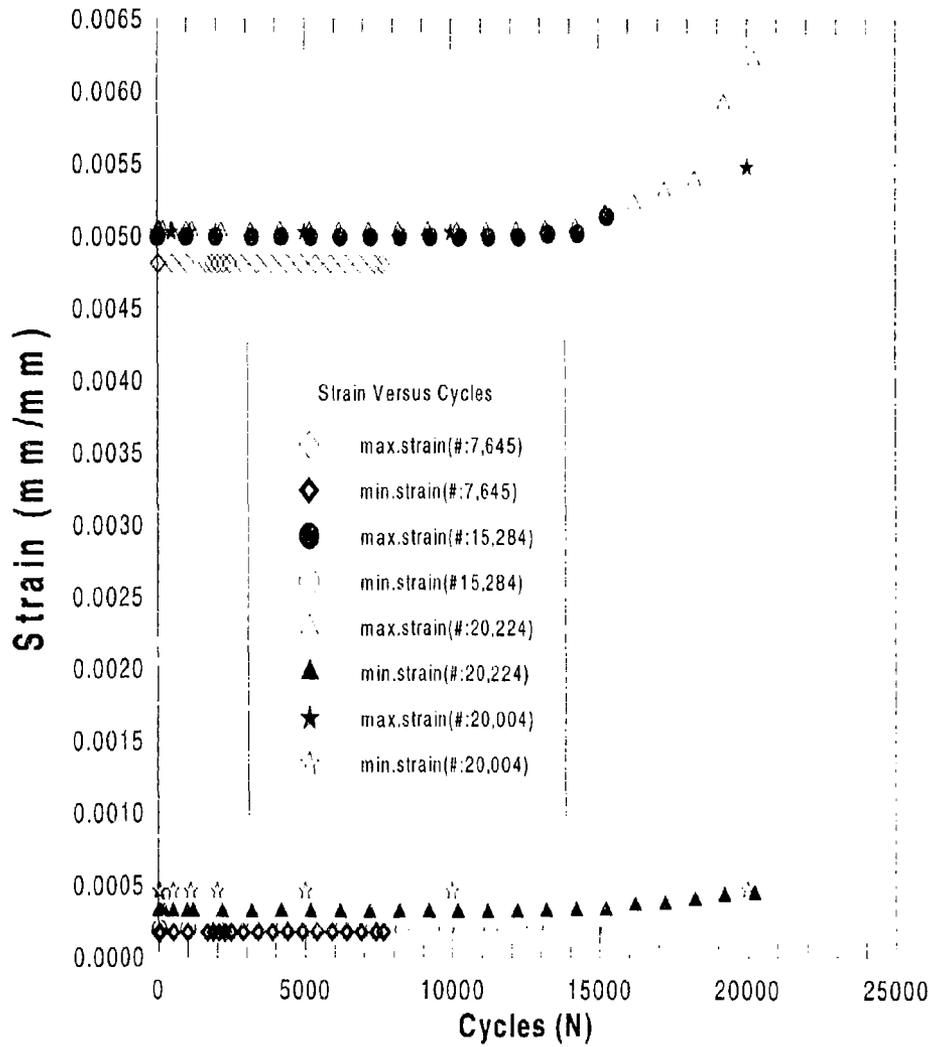
The strain and cycles response for $[0]_8$ laminates are shown in Figure 12. From these plots, it is apparent that the strain does not change very much before two thirds of the fatigue life (i.e., $2/3 N_f$). They also show that the strain suddenly increased just prior to specimen failure.

Figure 12. Comparisons for the $[0]_8$ Laminates Fatigue Tests at $\sigma_{max} \approx 900$ MPa, $R=0.05$, $f=10$ Hz, 427° C Conditions

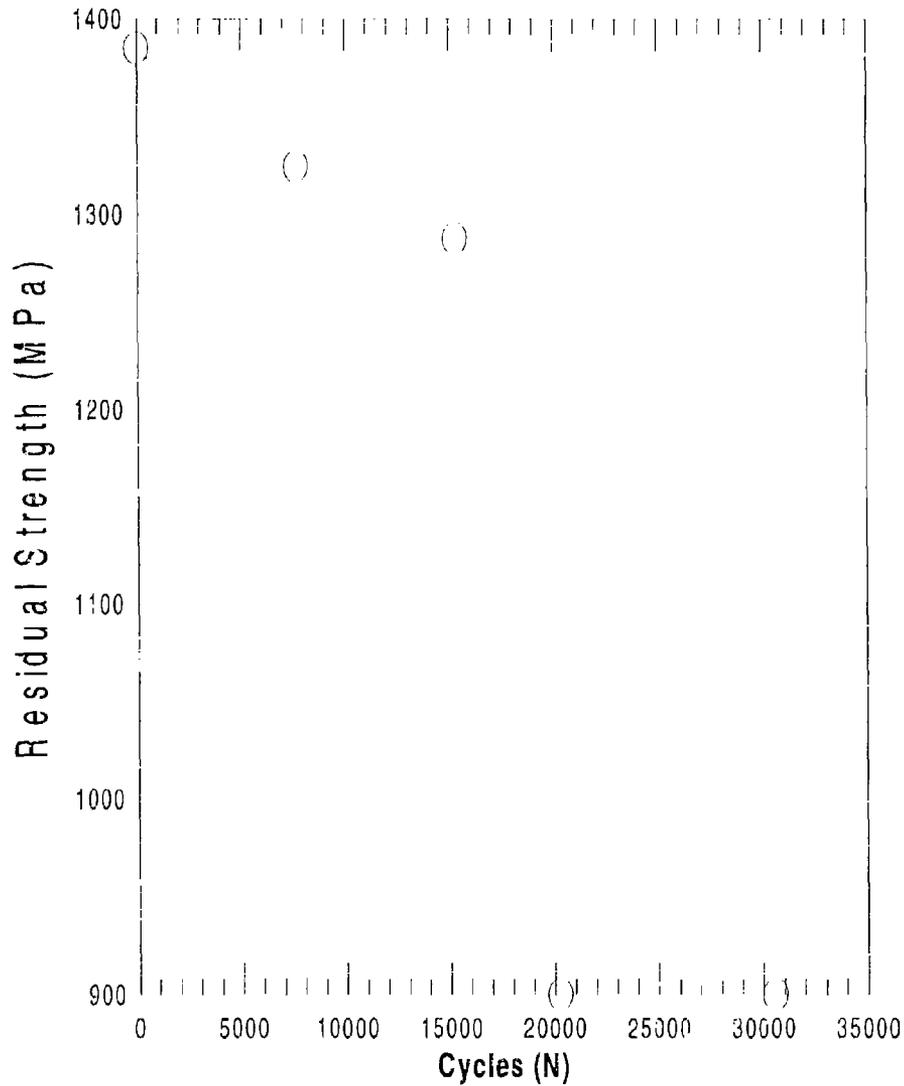
cycles, however, this decrease is very small. Rather than a gradual decrease over the life, the strength of the specimens exhibited more of a catastrophic or critical drop in strength near the end of the life.

Figure 13. Residual Strength & Cycles Relationship for $[0]_6$ Laminate at 427°C , $R=0.05$, $\sigma_{\text{max}}=900$ MPa, $f=10$ Hz Conditions

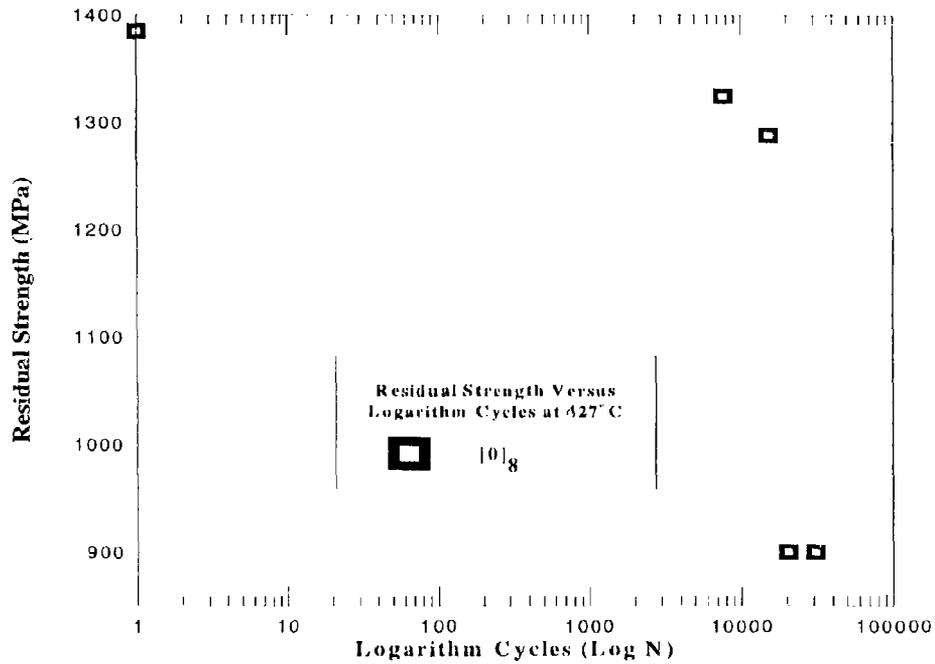
Figure 14. Residual Strength vs Logarithm Cycles Relationship for $[0]_8$ Laminates at 427°C , $R=0.05$, $\sigma_{\max}=900$ MPa, $f=10$ Hz

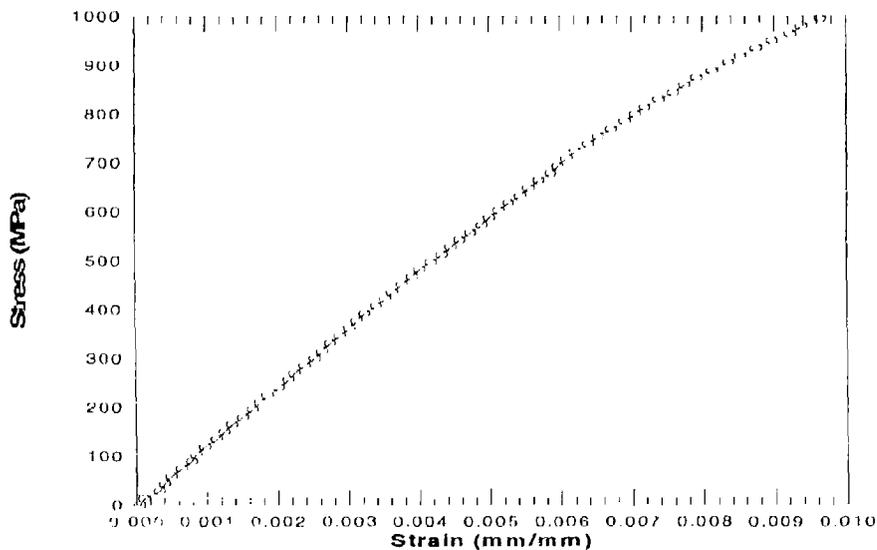
The stress strain curve for static loading is shown in Figure 15. It presents the slightly nonlinear characteristics.

Figure 15. Stress Strain Response for $[0/90]_{2s}$ at 427°C, Stress Rate=15 MPa/s (Static Loading)

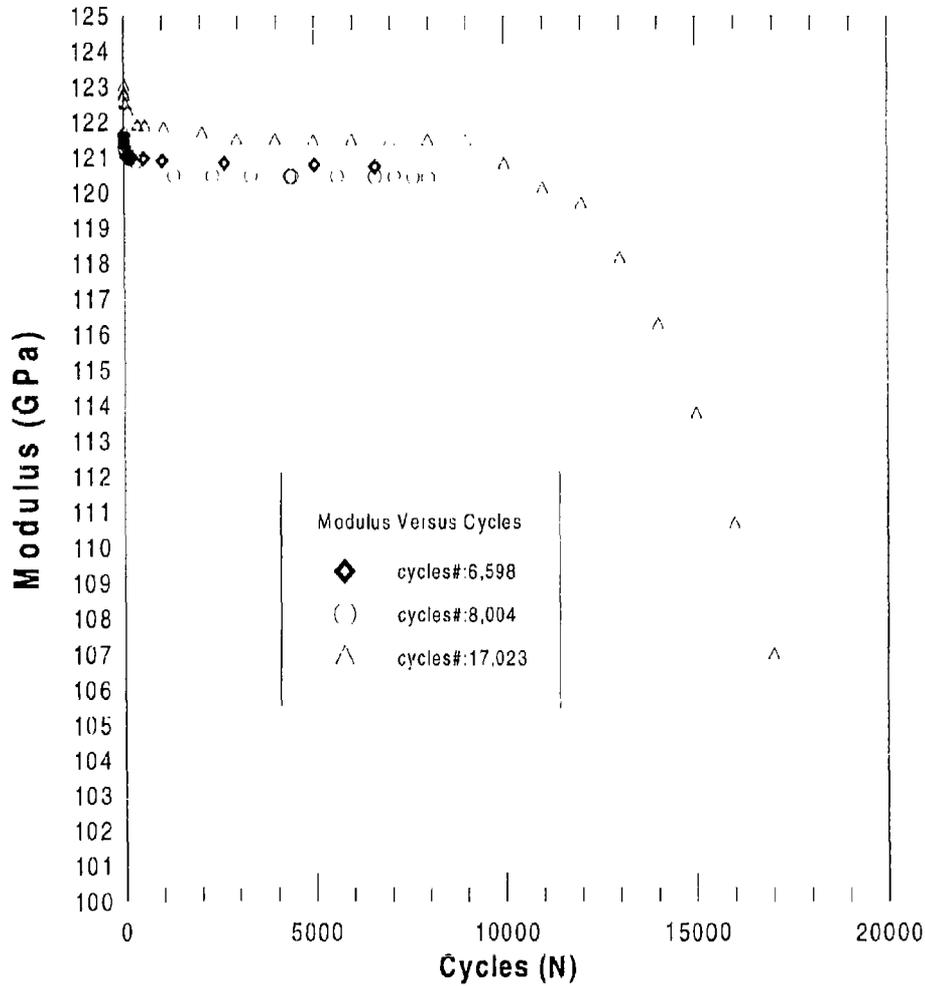
The modulus vs cycles relationships are demonstrated in Figures 16 and 17. At the beginning of the fatigue test, the modulus decreased slightly, followed by little or no change with increasing cycles until approximately two thirds of the fatigue life, where it continued to drop with increasing cycles.

Figure 16. Modulus Cycles Response for $[0/90]_{2s}$ under Cyclic Loading at $\sigma_{max} = 450$ MPa, $R=0.05$, $f=10$ Hz, 427° C

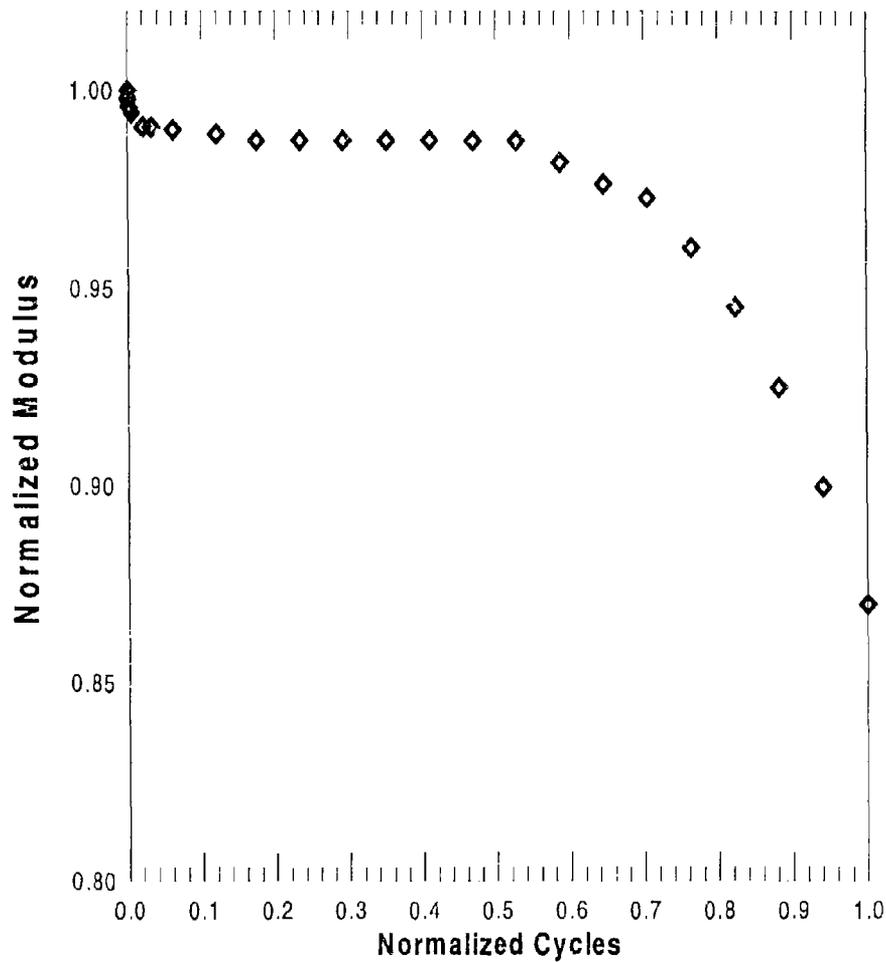
Figure 17. Normalized Modulus vs Normalized Cycles Response for $[0/90]_{2s}$ under Cyclic Loading at $\sigma_{\max} = 450$ MPa, $R=0.05$, $f=10$ Hz, 427° C

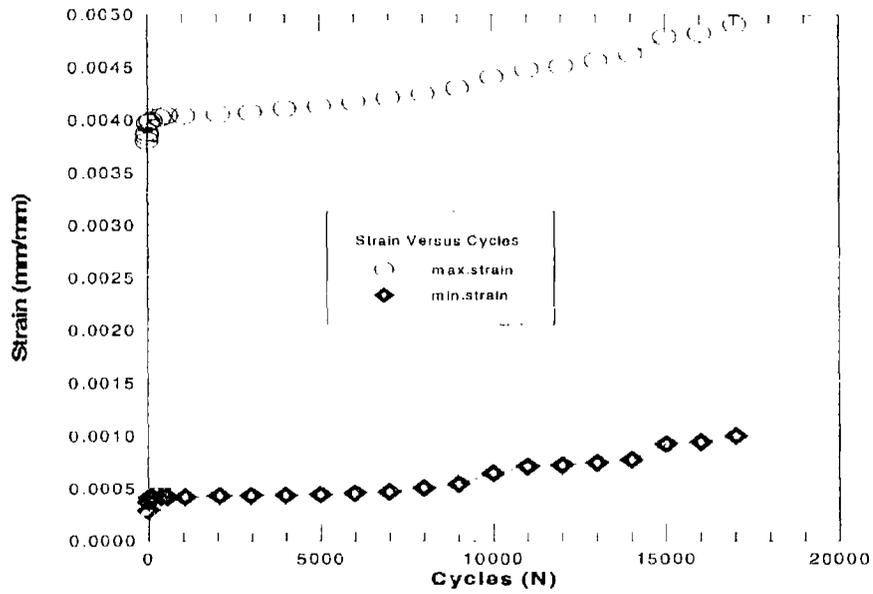
The strain vs cycles are shown in Figures 18 and 19. As it can be seen in these figures, there was a rapid increase in strain over the first few cycles. This may be attributed to viscoplastic deformation of the matrix and was a very short-lived effect. This was followed by a plateau region with a very slow increase in strain to failure.

Figure 18. Max. & Min. Strain vs Cycles for Fatigue Test at $\sigma_{max} = 450$ MPa, $R=0.05$, $f=10$ Hz, 427° C

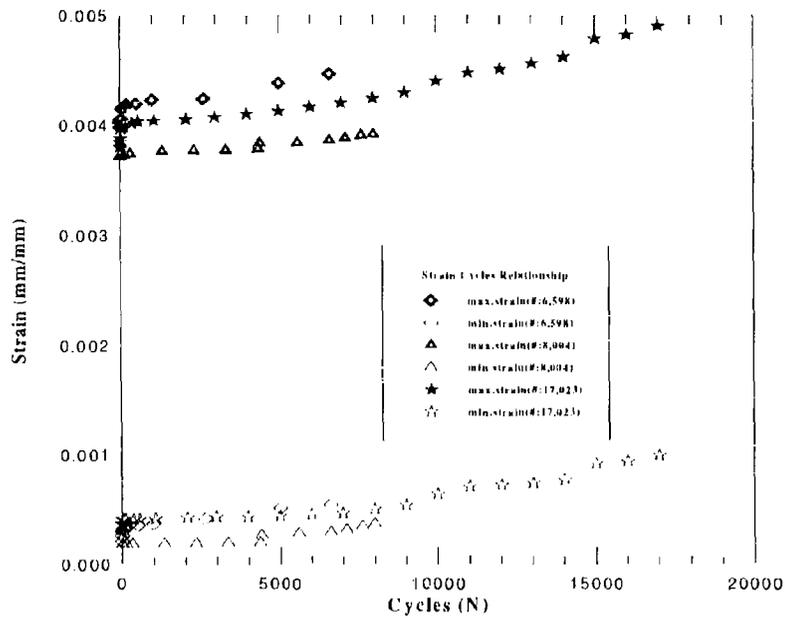
Figure 19. Strain vs Cycles for Fatigue and Residual Strength Tests at $\sigma_{max} = 450$ MPa, $R=0.05$, $f=10$ Hz, 427° C

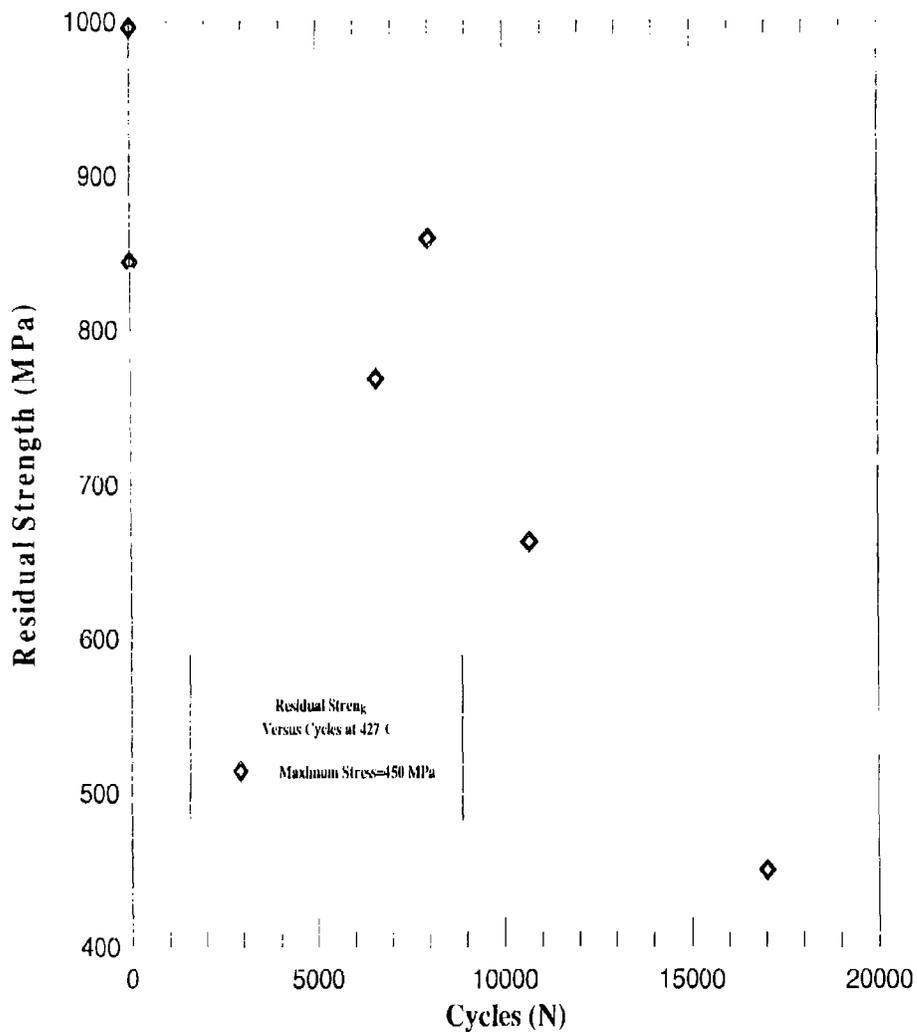
The residual strength results of the cross-ply for the specimens fatigued to 450 MPa maximum stress are shown in Figures 20-21, and Table 4.

Figure 20. Residual Strength vs Cycles for $[0/90]_{2s}$ Laminates at 427° C, $R=0.05$, $f=10$ Hz, $\sigma_{max}=450$ MPa

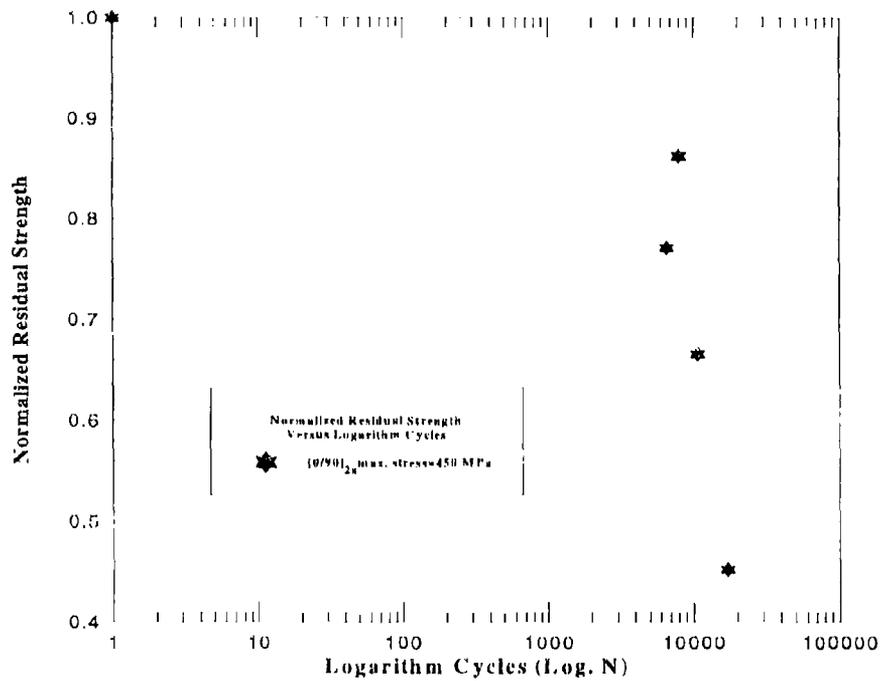
Figure 21. Normalized Residual Strength vs Logarithm Cycles for [0/90]_{2s} Laminates at 427°C, R=0.05, f=10Hz, σ_{max} =450 MPa

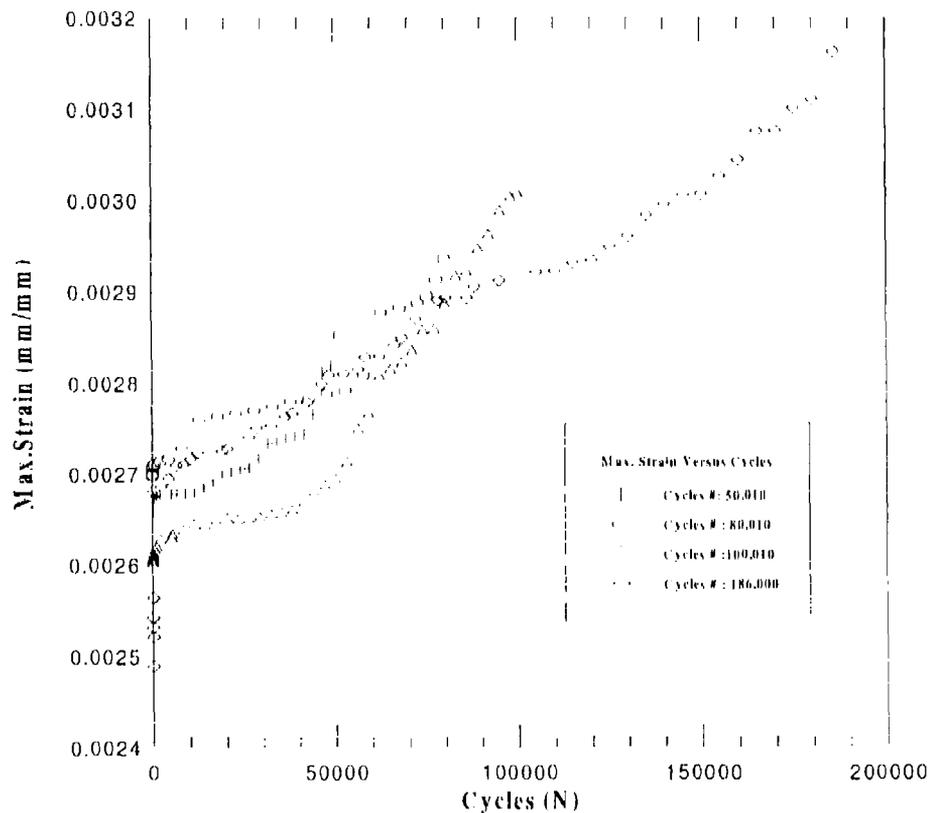
The maximum strain vs cycles relationships were shown in Figure 22. The strain increased with the increasing cycles.

Figure 22. Max. Strain vs Cycles for $[0/90]_2$ Laminates at 427°C , $R=0.05$, $f=5$ Hz, $\sigma_{\max}=300$ MPa

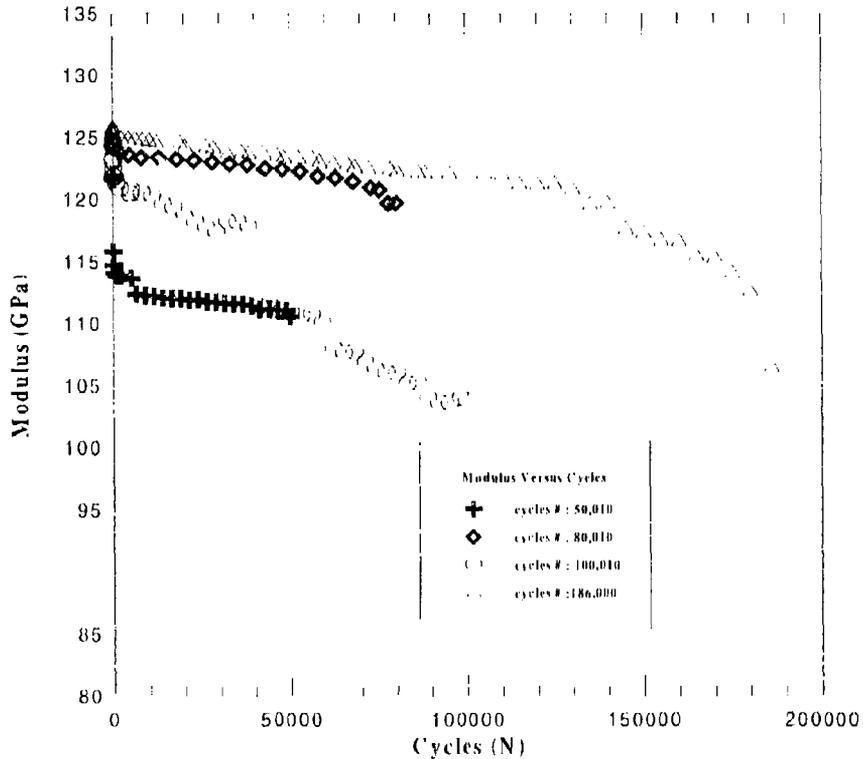
Figure 23 shows the modulus and cycles relationship for these fatigue tests. Also, from these plots, the modulus was found to decrease slowly with cycles in an almost linear fashion until approximately two-thirds of the fatigue life of the first fatigued specimen at which point the modulus dropped more rapidly.

Figure 23. Modulus vs Cycles for $[0/90]_{2s}$ Laminates at 427°C , $R=0.05$, $f=5\text{ Hz}$, $\sigma_{\text{max}}=300\text{ MPa}$

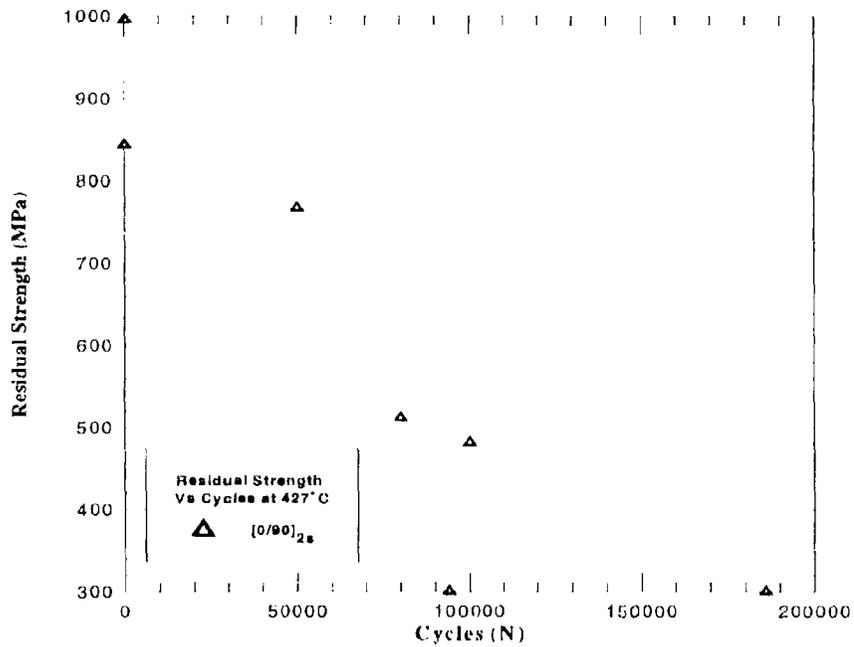
The residual strength results after different percentages of fatigue life are shown in Figures 24 and 25, and Table 5. These specimens were loaded at a constant stress rate of 15 MPa/s . Two specimens failed before the residual strength could be obtained.

Figure 24. Residual Strength vs Cycles for $[0/90]_{2s}$ Laminates at 427°C , $f=5\text{ Hz}$, $R=0.05$ with a Stress Rate of 15 MPa/s

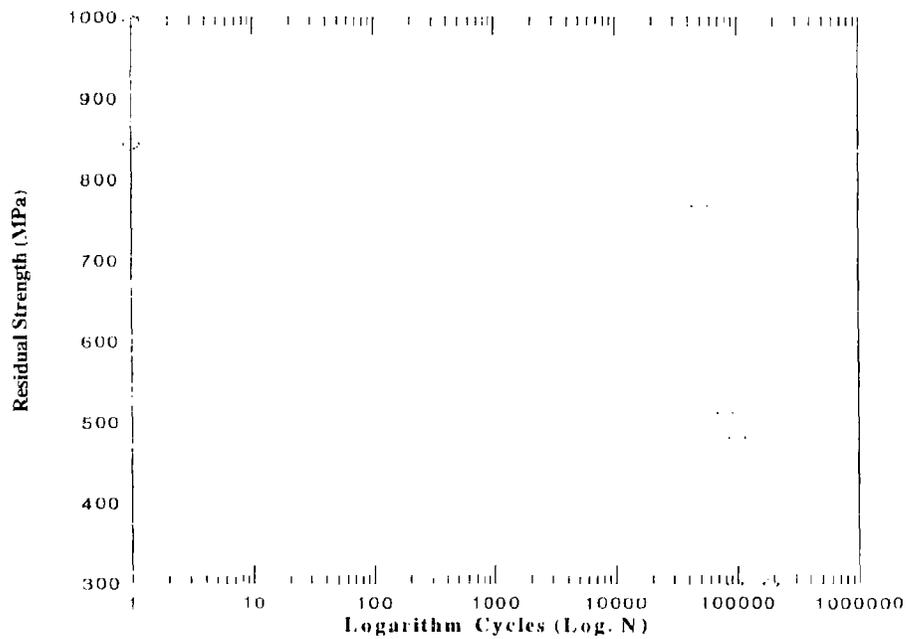
Figure 25. Residual Strength vs Logarithm Cycles for $[0/90]_{2s}$ Laminate under 427°C , $\sigma_{\text{max}}=300\text{ MPa}$

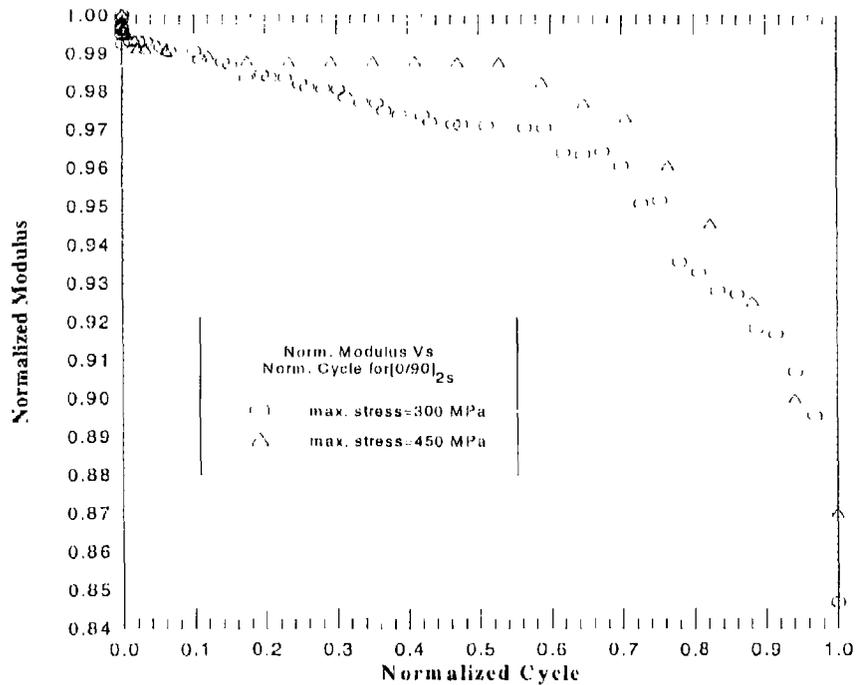
The comparisons of the cross-ply laminates at different stress level are shown in Figures 26 and 27, and Table 6. Although the fatigue tests were applied at different frequency, the results were very similar for the response of modulus vs cycles and strain vs cycles. In both instances, the modulus didn't change much before two-thirds of the fatigue life or until near the end of the fatigue life; whereas, the strain for [0/90]_{2s} laminates increased gradually with the increasing cycles until near the end of the fatigue life when it increased suddenly.

Figure 26. Normalized Modulus vs Normalized Cycle for [0/90]_{2s} Laminates, at 427°C, f₃₀₀=5 Hz, f₄₅₀=10 Hz

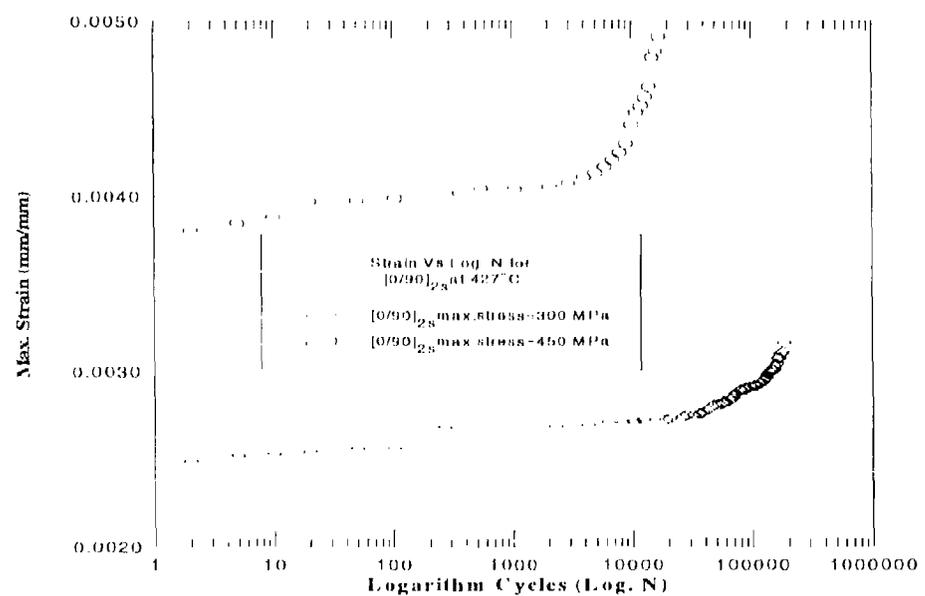
Figure 27. Maximum Strain vs Logarithm Cycle for [0/90]_{2s} Laminates, at 427°C, f₃₀₀=5 Hz, f₄₅₀=10 Hz

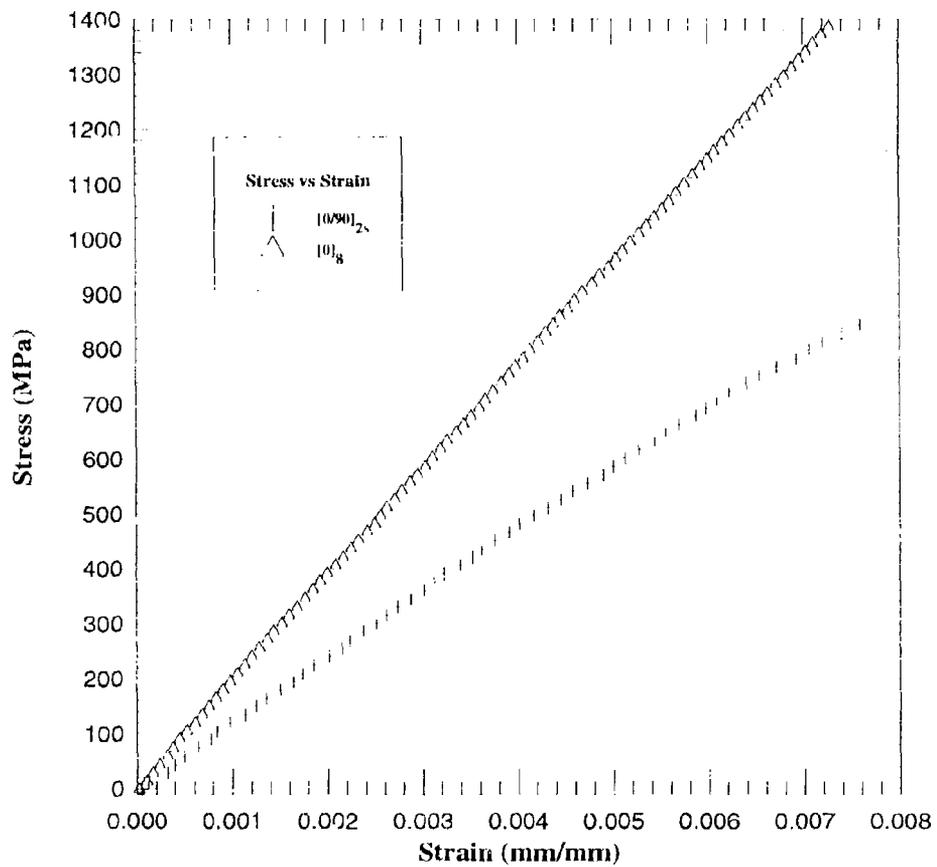
Figure 28 shows that the modulus of the unidirectional specimen was higher than the cross-ply laminates as is expected.

Figure 28. Stress-Strain Relationship of $[0]_8$ and $[0/90]_{2s}$ at 427°C

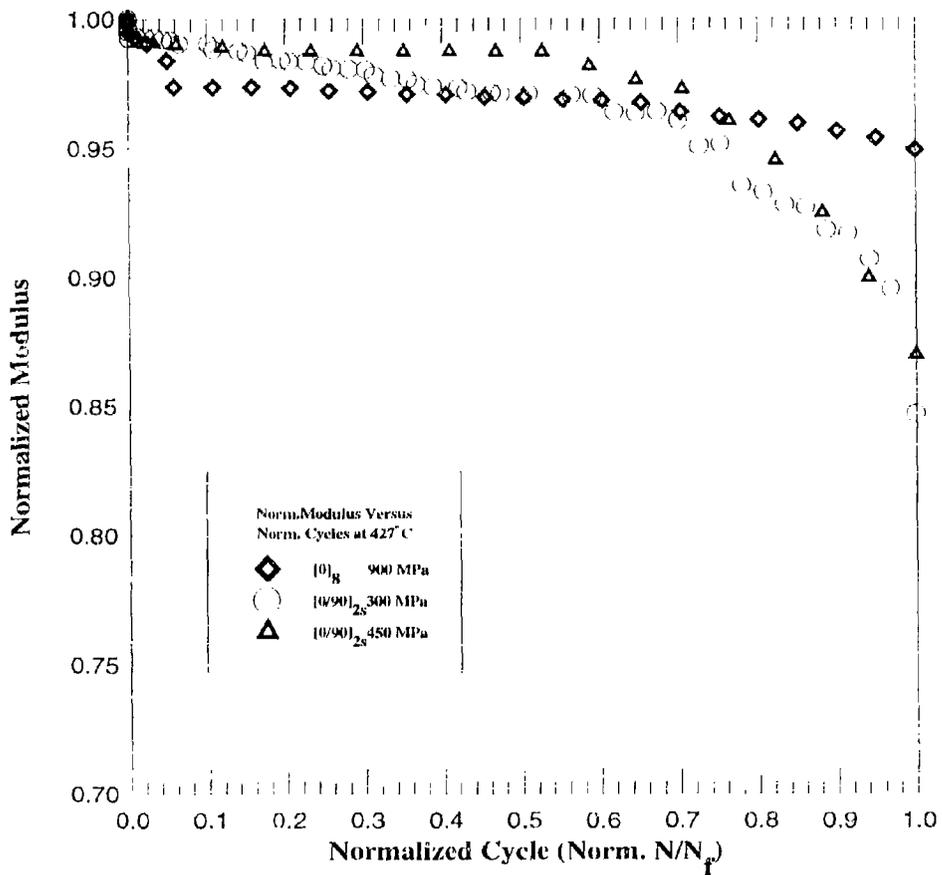
Figure 29 displays the normalized modulus and normalized cycles relationships for the unidirectional laminates and cross-ply laminates. As expected, cross-ply laminate showed more degradation in modulus than the unidirectional laminate.

Figure 29. Normalized Modulus vs Normalized Cycles for [0]₈ & [0/90]_{2s} Laminates Fatigue Tests at 427°C, R=0.05, f=10 Hz(5Hz), σ_{max} =900, 450, 300 MPa Conditions

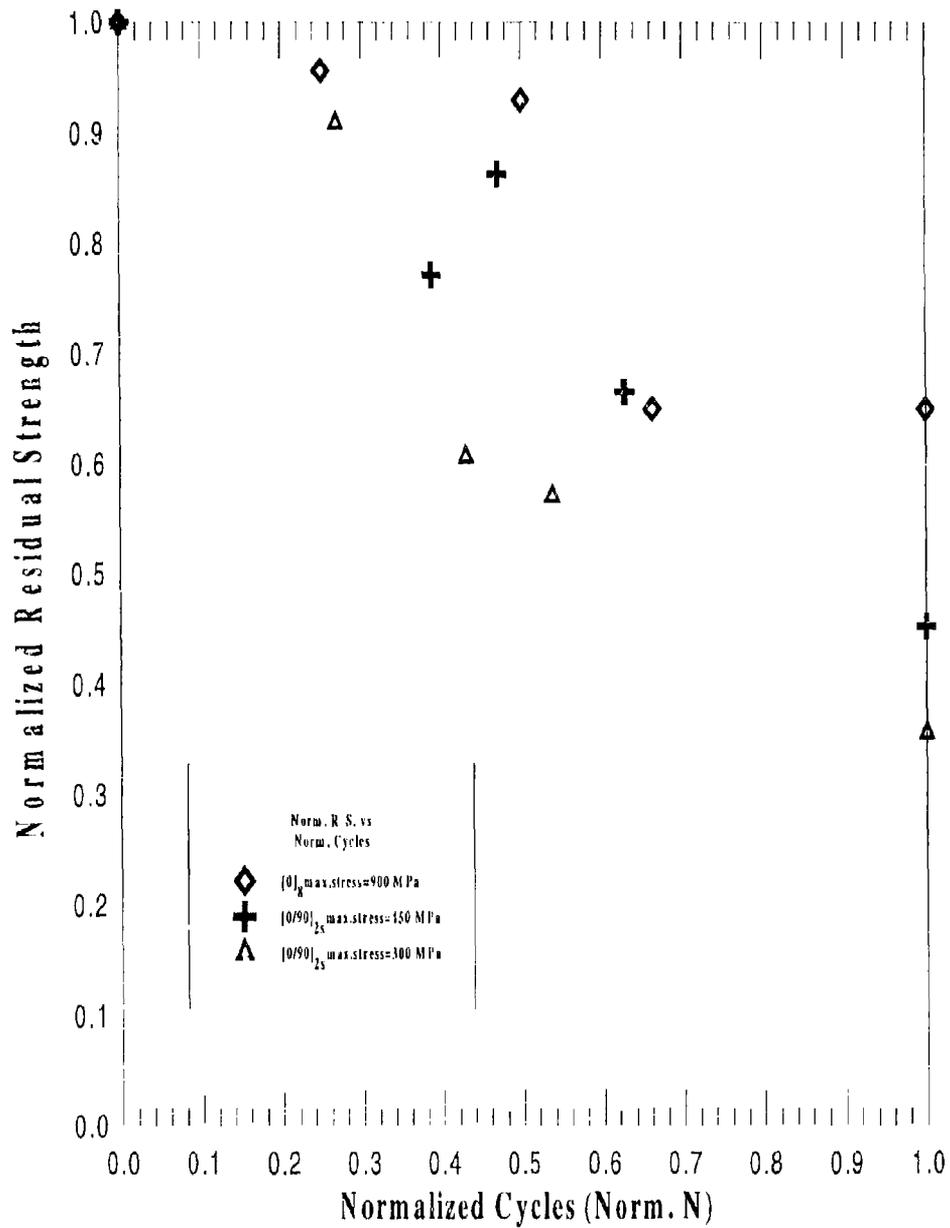
The normalized residual strength vs normalized cycles is shown in Figure 30. The same general trend is observed in all tests as the residual strength drops rapidly near the end of the fatigue life. Also, a scatter in the specimen fatigue life of approximately a factor of two is observed. The comparisons of unidirectional, [0]₈, and cross-ply, [0/90]_{2s} laminate tests including static, fatigue, and residual strength results are shown in Table 7.

Figure 30. Normalized Residual Strength vs Normalized Cycles for [0]₈, & [0/90]_{2s} Laminates at 427°C, R=0.05, f=10 Hz(5Hz), σ_{max} =900, 450, 300 MPa

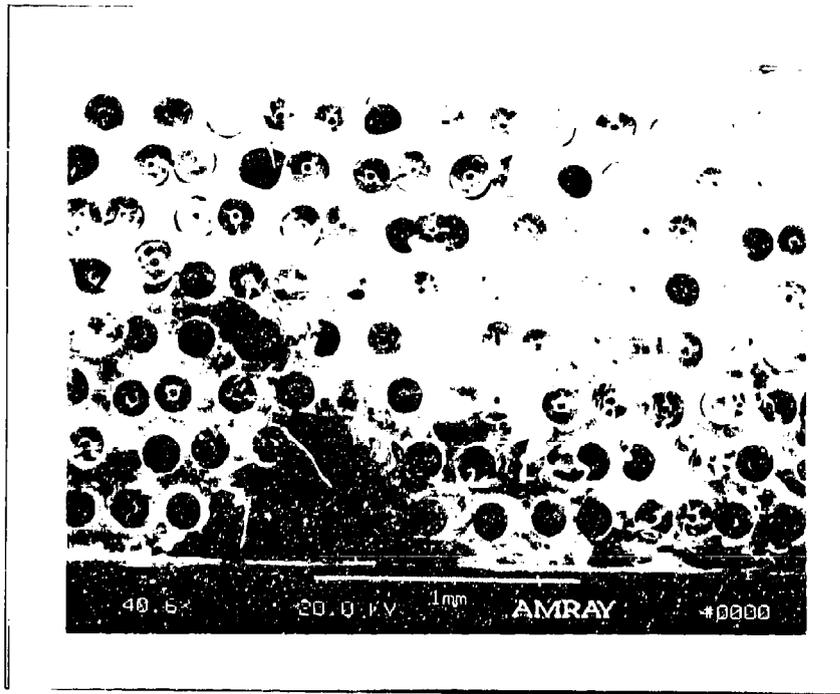
The typical distribution of the fibers within the metal matrix composite are shown in figure 31. The fiber volume fraction was approximately 0.35.

Figure 31. Fiber Distribution within the Laminate

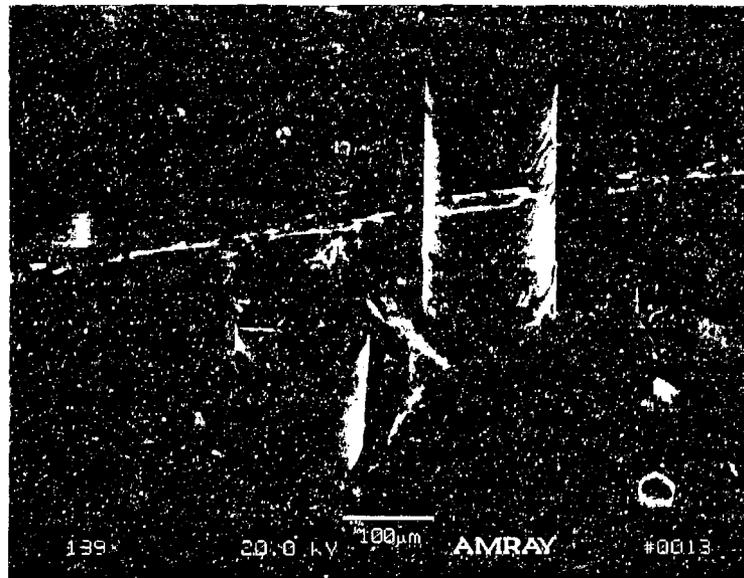
Fracture analysis indicated interface debonding between fiber and the matrix during the tensile testing as the matrix exhibited plastic "necking" between the fibers as shown in Figure 32. Also, it is found that the degradation or the fracture of the fiber coating layer occurred during fatigue.

Figure 32 Matrix Plastic Necking between Fibers

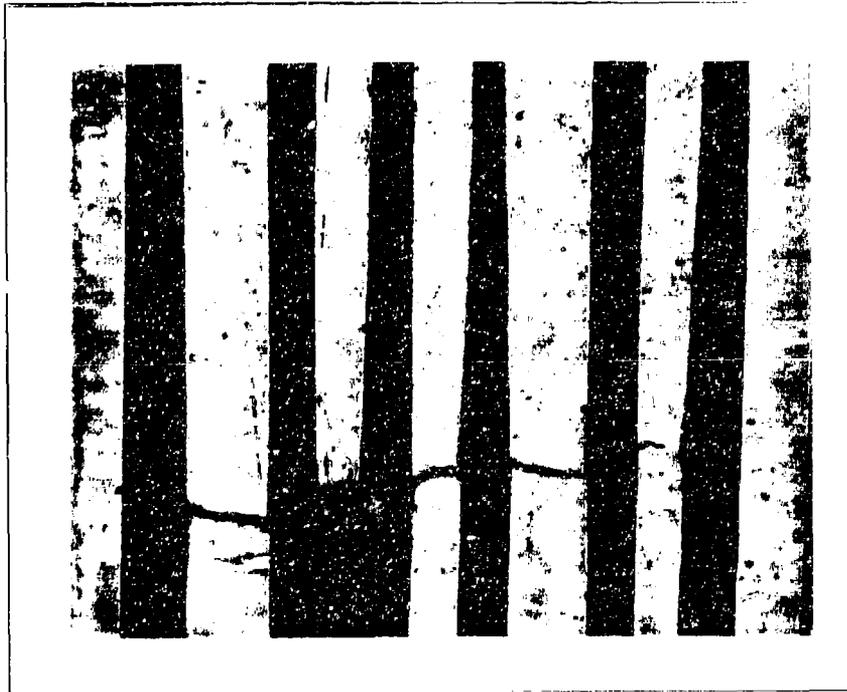
Figure 36 shows the first layer of fibers from the surface of the specimen. Several matrix cracks were observed. In addition to matrix cracking, there was also the debonding of the fiber-matrix interface. This phenomena explained the reduction in stiffness during the fatigue tests.

Figure 36. Fracture Surface Dominated by Matrix Failure Mode
