Residual Strength after Fatigue of Unidirectional and Cross-Ply Metal Matrix Composites at Elevated Temperature

THESIS

Sen-Tzer Chiou, Major, R. O. C., ARMY

AFIT / GAE / ENY / 96 J-2

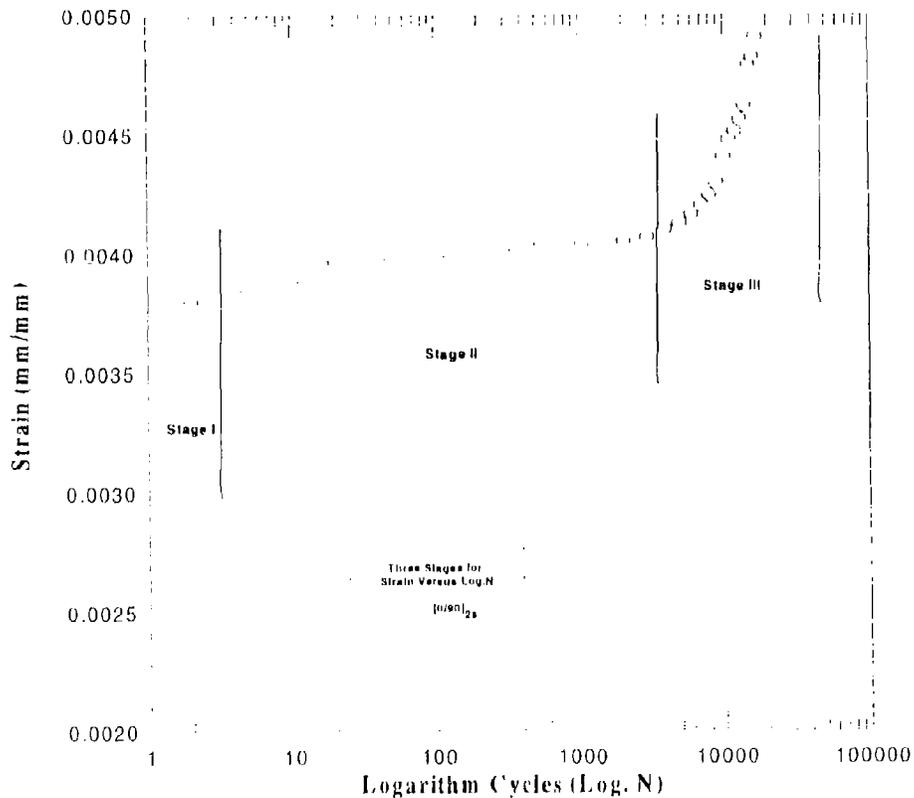
During the fatigue of the cross-ply specimens, three stages of behavior were observed (as could be seen in Fig. 37). Strain in the stage I rapidly increased within the first few cycles due to plastic deformation. In the stage II, the strain increased steadily with fatigue cycles indicating a fatigue crack started to initiate and propagate. In stage III, the strain increased rapidly until composite failure, indicating the matrix crack was near its critical length and/or fiber failure was occurring. Also, due to the transverse plies in the cross-ply, the fatigue cracks in the unidirectional specimen were more difficult to initiate than in the cross-ply.

Figure 37. Three Stages for the Strain Cycles Response under Fatigue Test

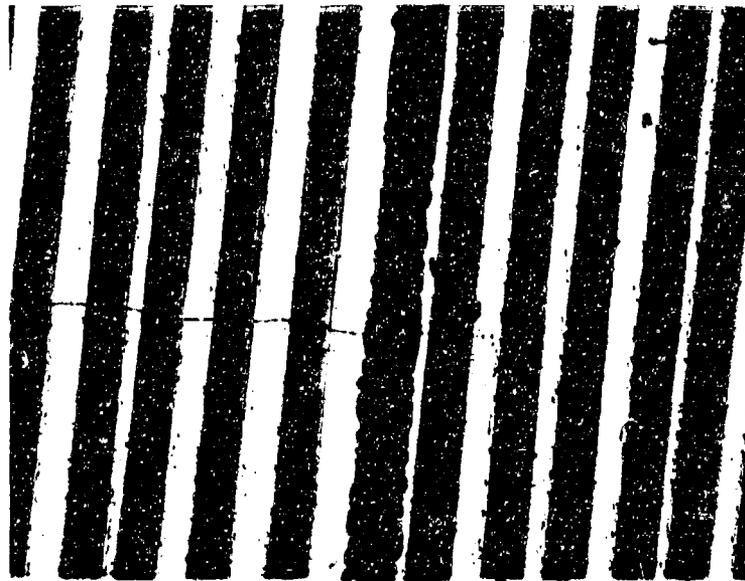
Figure 40. Cracks Propagated Transverse to the Loading Direction

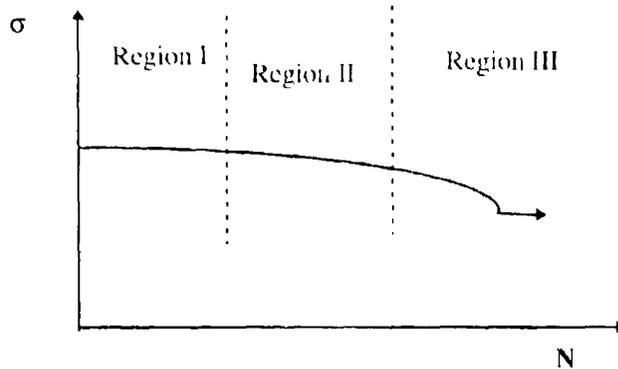
Figure 48. Three Regions Response for Fatigue

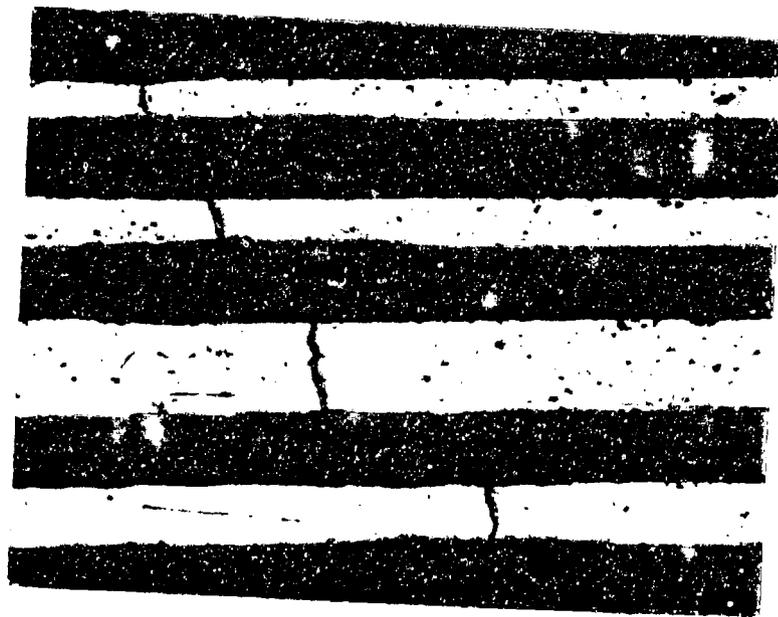
Figure 49. Matrix Cracks Throughout the Width

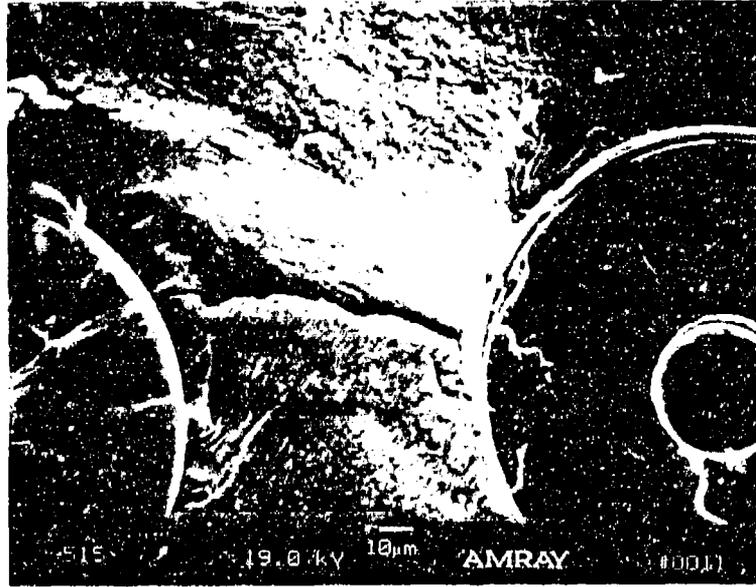
Figure 54. Matrix Failure between Fibers

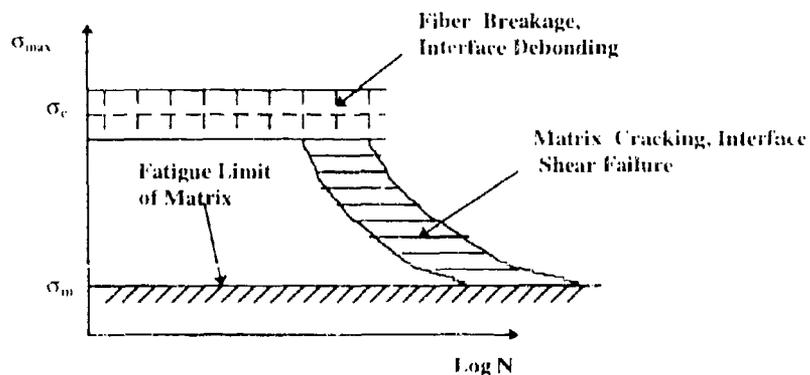
Figure 61. Three Fatigue failure modes for [0]_s under Load Parallel to Fibers

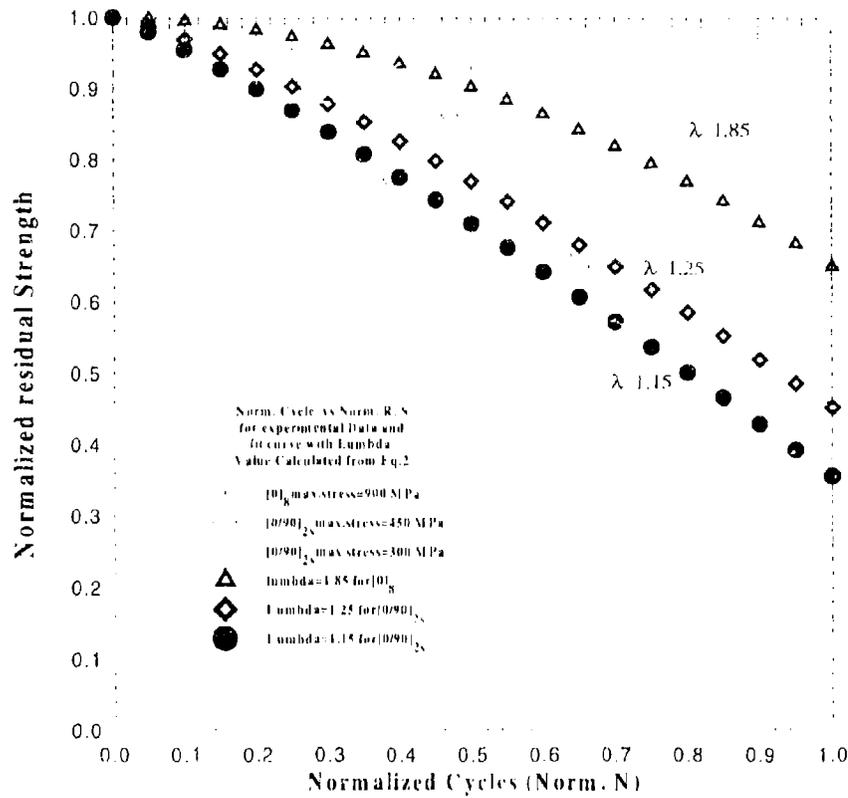
Figure 62. The Fit λ Values for $[0]_S$ & $[0/90]_S$, Calculated by Eq.2
