Lessons Learned During Testing Through Commissioning of the joint Brazil-US SPORT Mission

ABSTRACT

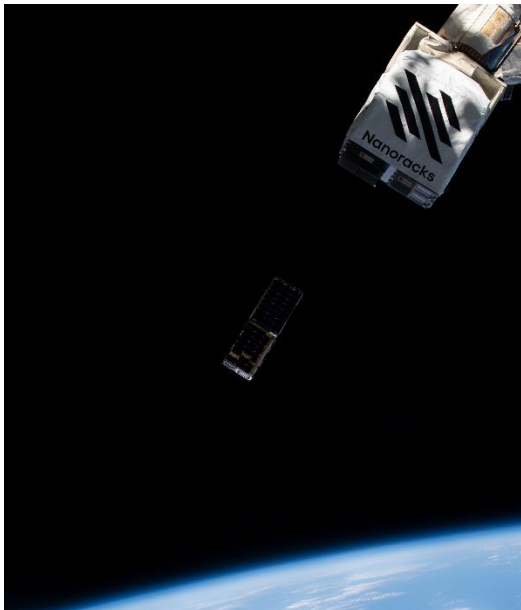
Figure 1: SPORT Jettison from ISS.

SPORT was launched as part of the CRS-26 resupply mission to the International Space Station (ISS) from Kennedy Space Center on November 26th, 2022. The docking of the Dragon Capsule occurred on the next day on the ISS, November 27th and then SPORT waited on ISS until December 29th, when it was inserted into its final orbit and operations started.

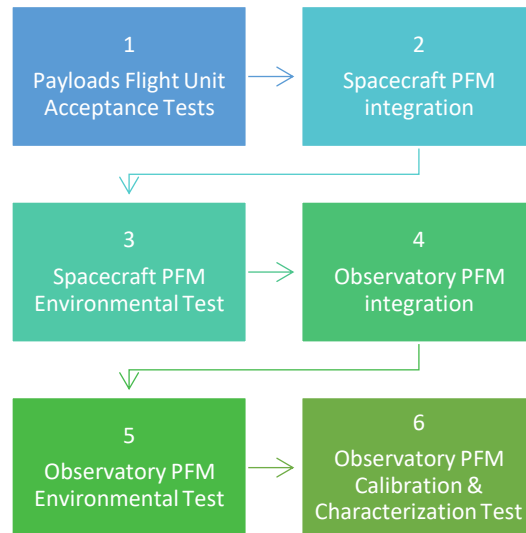
Figure 3: SPORT PFM simplified AIT block diagram.

Satellite Assembly, Integration, and Test (AIT) is a critical phase in the development and deployment of a satellite. It involves the physical construction, integration, and comprehensive testing of all the subsystems and components to ensure the satellite's proper functionality and readiness for launch. Figure 3 describes the simplified AIT process for SPORT Proto Flight Unit.

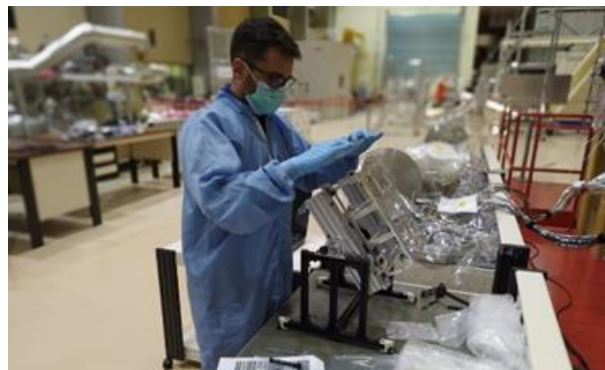
Figure 4: SPORT structure pre-integration tests. Mechanicals parts only.

Mechanical Integration: The satellite's structure is assembled by integrating various structural elements, such as panels, brackets, and frames. Mechanical integration ensures that all components are securely connected, aligned, and can withstand the mechanical stresses during launch and in space. Figure 4 shows the team performing pre-integration tests of the structure to be sure all parts could be integrated as designed. This pre-integration test was performed in all structural units upon acceptance, so at least four structural integrations were performed by the team.

- The quantity of fastening screws for the SPORT's tabs was not sufficient to withstand the vibration levels. We increased the number of fastenings, and the problem could be solved.

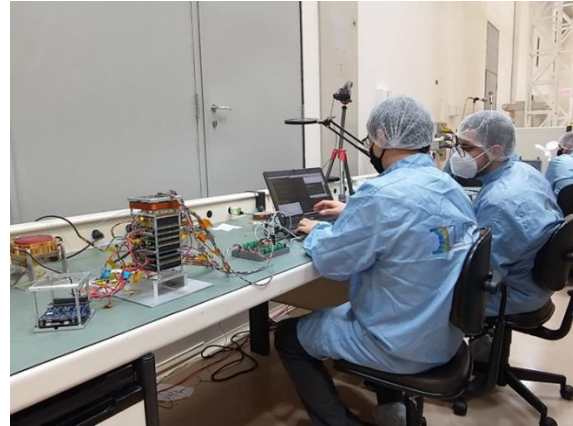
Figure 7: PFM Integration and intermediary functional tests.

System Integration: Once individual subsystems are tested and verified, they are integrated into the overall satellite system. This includes integrating the payload with the bus and verifying their interaction and performance as a unified system. After each step of the assembly and integration process, intermediary functional tests were carried out to be sure that the system was still working as designed. Figure 7 shows the team testing the integration of the Electrical Power Subsystem (EPS) and the main core of the spacecraft.

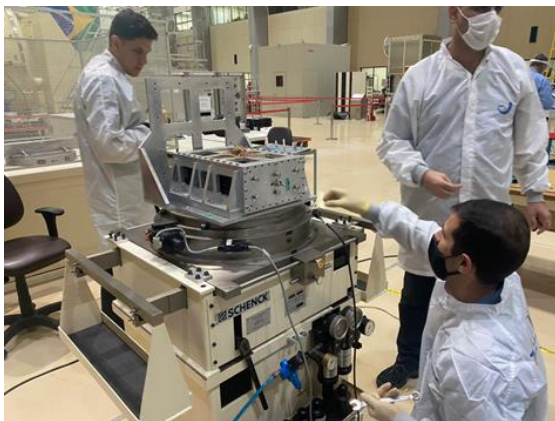
Figure 10: SPORT PFM During Mass Properties Tests.

Final Checks and Preparations: Before the satellite is prepared for launch, a final set of checks is performed to ensure all systems are functioning correctly. These checks include system-level functional tests, electromagnetic compatibility testing, and final verification of all mechanical and electrical connections. At this phase the misalignment between the Ion Velocity Meter (IVM) and the spacecraft star tracker was measured to assure the correct attitude pointing knowledge to the payload. As required for the launch provider's Safety Review documentation, physical properties of the observatory such as mass, center of mass and momentum of inertia were measured. Figure 10 External measurements and weight were also recorded as part of the project verification database.

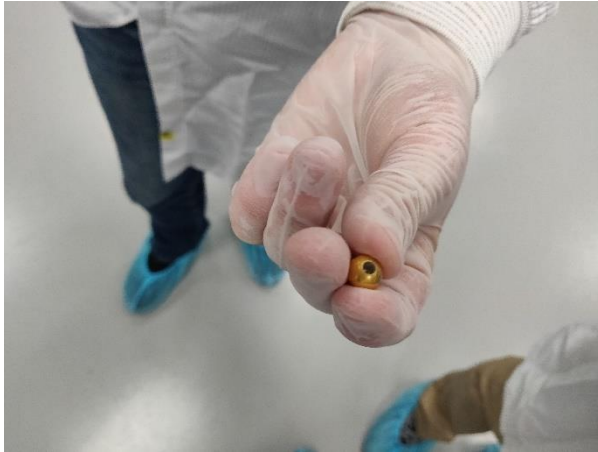
Figure 18: E-field broken sensor.

Finalized the unpacking, the team could see the broken piece of the probe, as shown in Figure 18. Further inspection showed that no damage occurred to the solar panels. The springs of the hinges of the booms were damaged but spare parts were available for exchange. Functional tests, as far as they could be tested, showed expected behavior, so it was determined that only the E-field probe was broken.

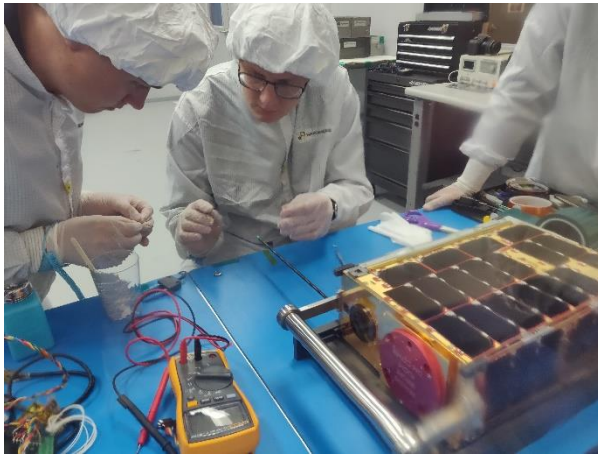
Figure 19: USU team during probe repair.

The USU team analyzed, and the repair could be easier than the first plan, so they started while ITA team was helping in the procedure. After the repair the probe should stay for as long as possible curing, so the ITA team performed other activities in the flight unit, such as more functional tests and final software configuration of the observatory.

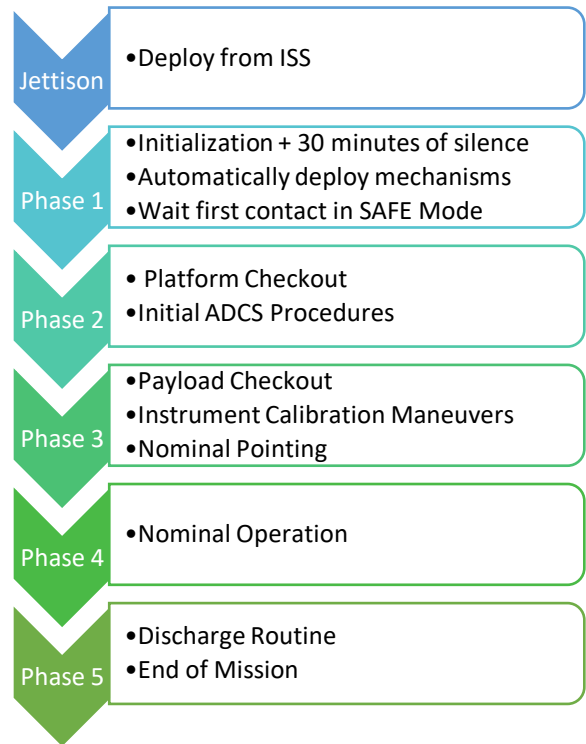
Figure 21: Planned Concept of Operation.
