## **Defect Prognostics Models for Spall Growth in Railroad Bearing Rolling Elements**

**JRC2018-6214**

**DEFECT PROGNOSTICS MODELS FOR SPALL GROWTH IN  
RAILROAD BEARING ROLLING ELEMENTS**

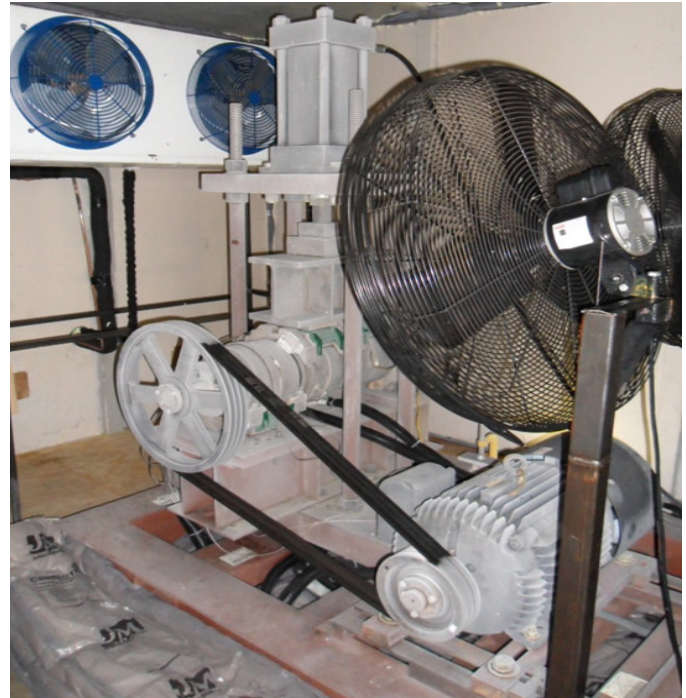
Figure 2. Older design of the four-bearing tester housed within the environmental chamber showing tester at -40°C

The four-bearing dynamic test rigs (Figure 2 and Figure 3) can accommodate four Class K (6½"×9") or four Class F (6½"×12") tapered-roller bearings mounted onto a test axle. The hydraulic cylinders on these testers are capable of applying various load conditions ranging from 0 to 175% of full load. A fully-loaded railcar or 100% load corresponds to an applied load of 153 kN or 34.4 kips per bearing. An empty railcar corresponds to 17% load which translates to an applied load of 26 kN or 5.85 kips. These four bearing testers feature a 22.3 kW (30 hp) motor that can produce variable bearing rotational speeds that simulate train traveling velocities ranging anywhere from 8 to 137 km/h (5 to 85 mph). To simulate the convection cooling that bearings experience in service which is generated by the air flow passing

across the bearing cup, two industrial strength fans were used to produce an airstream traveling across the bearings at an average speed of 18 km/h (11.2 mph). The environmental chamber that houses the four-bearing tester can mimic ambient conditions as low as -40°C (-40°F) and as high as 65.6°C (150°F).

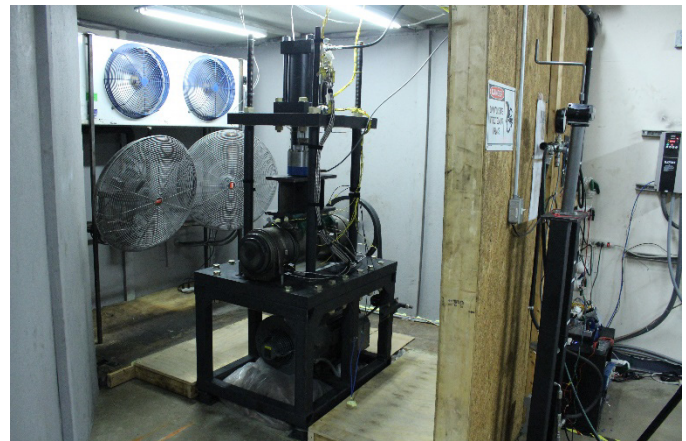
Figure 3. New design of the four-bearing dynamic tester housed within the environmental chamber

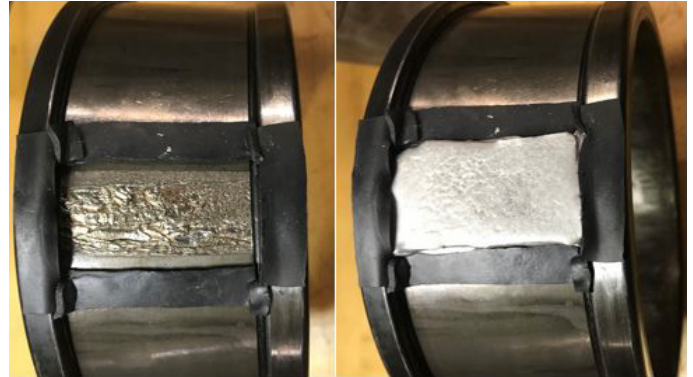
Figure 5. Casting procedure using Bismuth; (left) spalled surface outlined with tacky tape; (right) Bismuth alloy cast

The data used in this study were acquired from spalls located on the inner rings (cones) of bearings, also referred to as cone spalls. As for the bearing cones that spalled during the laboratory service life testing, once the defect was detected through vibration analysis performed on the acquired accelerometer data, the test was stopped, and the bearing was pressed off, disassembled, cleaned out, and a thorough inspection was carried out. In order to track and maintain accurate records of the spall growth size and to ensure detailed measurements of the spalled area while still allowing testing of the bearing to resume, a casting was made of the spall using low-melting, zero-shrinkage bismuth alloy. Tacky tape is applied around the edges of the defect area to create a mold border for the molten alloy, which melts at 80°C (176°F). The molten bismuth alloy is then poured into the cavity to obtain a casting of the spalled region. This process is pictured in Figure 5.

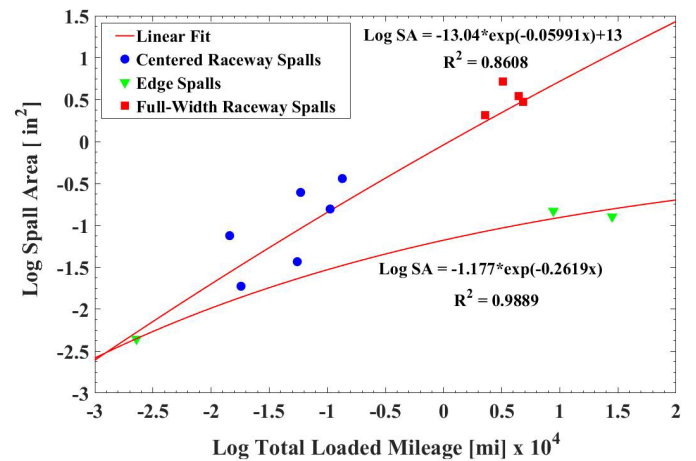
Figure 9. Log spall area as a function of the Log total loaded mileage of operation

Note that the experimental results summarized in Figure 8 and Figure 9 reflect total mileage under full-load operation only. However, these bearings also ran for some period of time under loads that simulate an empty railcar as part of other ongoing projects. The empty railcar operation mileage is included in the analysis results presented in Figure 10.

In Figure 8, spall area is plotted against the total miles of operation from all previous experiments since the spall was first detected. It is evident that the spall size growth model for spalls located in the middle region of the cone raceway (D) as well as those which span the entire width of the cone raceway (C) will tend to follow one general curve, whereas, spalls located on the edges of the cone raceway (A-B) will follow a much slower growth model. Note that Figure 9 presents the same experimental data used to generate Figure 8 but on a log-log scale. In both figures, the x-value in the provided correlations is in ten-thousands of miles of operation.
