## **Development of Prognostic Techniques for Surface Defect Growth in Railroad Bearing Rolling Elements**

**JRC2017-2262**

**DEVELOPMENT OF PROGNOSTIC TECHNIQUES FOR SURFACE DEFECT  
GROWTH IN RAILROAD BEARING ROLLING ELEMENTS**

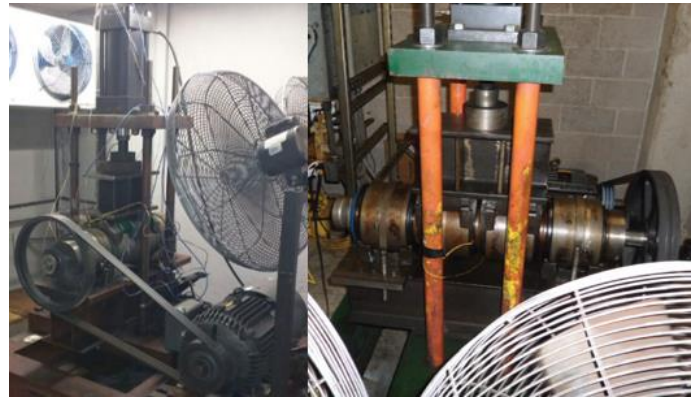
Figure 2. Four bearing testers at UTRGV's UTCRS

The experiments were performed utilizing two types of dynamic testers available at UTRGV's University Transportation Center for Railway Safety (UTCRS). Pictures of the four bearing and single bearing testers are provided in Figure 2 and Figure 3, respectively. Both tester types are equipped with hydraulic load cylinders to simulate various loading conditions of a bearing in field service. Bearings, which spalled in the laboratory, were generally being run on the four bearing testers, and many of the field-initiated spalls were also grown on both bearing testers. Much of the most recent data was obtained by running bearings on the single bearing tester.

The four bearing tester is capable of running four Class K or Class F bearings simultaneously. Testers include instrumentation for monitoring temperature and vibration of all bearings during operation, although that data is not used in this study. All bearings tested in this study were subjected to loads simulating a fully-loaded railcar which corresponds to a load of 153,000 N (34,400 lb) per bearing.

The four bearing tester permits the testing of multiple bearings in long duration experiments such as those performed for service life testing and qualification of bearing steel. The single bearing tester (SBT) is designed and built by the UTCRS research team for short duration testing where a railroad bearing

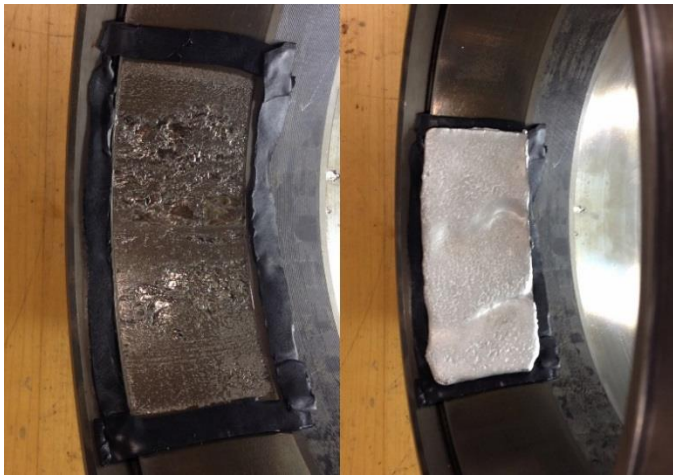
Figure 4. Bismuth casting procedure. Spalled surface with tacky tape (left); Bismuth alloy cast in place (right).

All data used in this study was collected from spalls on the outer bearing ring, also referred to as cup spalls. For bearings that spalled in the laboratory, once a defect was detected through vibration analysis of the acquired accelerometer data, the test was stopped and the bearing pressed off, disassembled, and cleaned for inspection. To permit detailed measurement of the spall while allowing continued testing of the bearing, a casting was made of the spall using a low-melting, zero-shrinkage bismuth alloy. Tacky tape was applied to the raceway to create a mold border around the defect and then molten alloy (80°C/176°F) was poured into the cavity to obtain a casting as pictured in Figure 4.

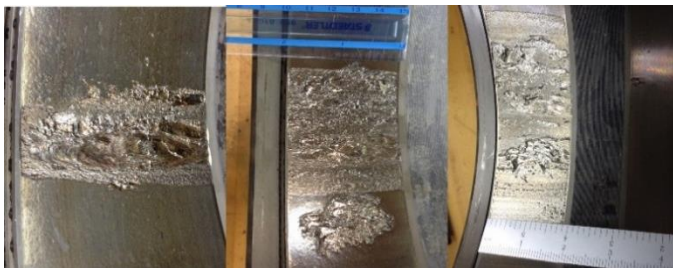
Figure 5. Spall growth in a bearing outer ring (cup) under continued operation (increasing mileage left to right).

Once the casting was hardened and removed, the borders of the casting up to the spall impression were painted and the casting photographed. Images were then post-processed in MatLab™ to enhance the contrast. The enhanced image was imported into Image-Pro®Plus where measurements of area and other geometric parameters were performed. After castings were obtained, the bearings were remounted on the tester and run under load with periodic removal for measurement. Continued operation resulted in additional growth in the spall area and change in the spall aspect ratios and other parameters as depicted in Figure 5.

Spalls typically grow lengthwise on the bearing cup until they reach the rib of the bearing at which point the spall will grow along the raceway, as can be observed in Figure 5. Spall growth rates were calculated in terms of change in spall area per mile of loaded operation and are plotted in Figure 6. In general, there is no clear trend in the early stages of spall development as seen in Figure 7. This lack of trend is to be expected since spall formation is random both in location and in spall size.

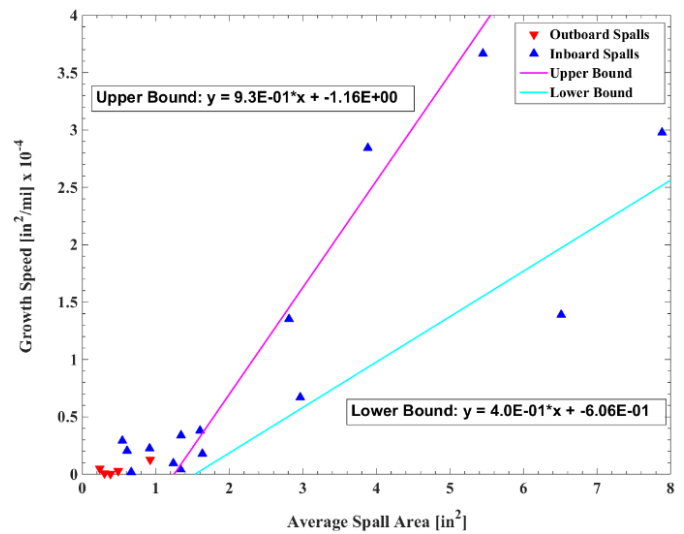
Figure 6. Growth speed correlation with spall area

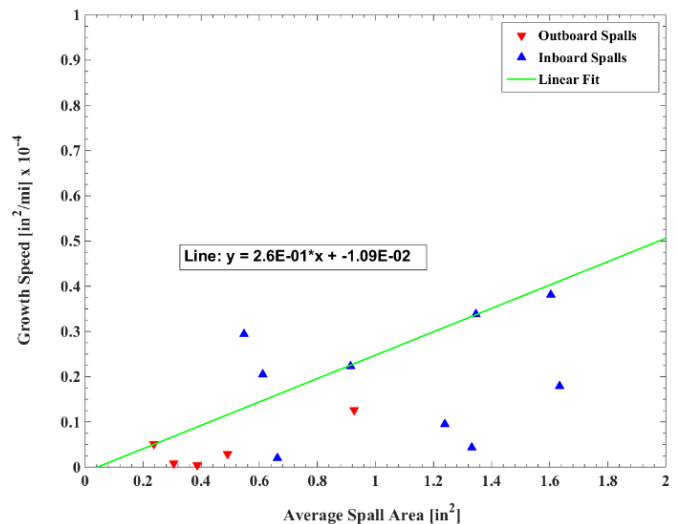
Figure 7. Growth speed of spalls less than 2 in<sup>2</sup> (13 cm<sup>2</sup>)

Note that after spall areas exceed approximately 2 in<sup>2</sup> (13 cm<sup>2</sup>), the rate of growth increases dramatically. The upper and lower bounds have slopes differing by a factor of 2.3. The presence of at least two modes of growth is not surprising as a change in mode is expected as the spall size approaches the diameter of the bearing rollers. When rollers can drop into the spall completely, they can be expected to induce a stress state and propagate damage differently than when they are kept above the floor of the spall by the shoulders of the defect, as illustrated in Figure 8. Once vibration excitation is triggered by any external source, it causes the rollers to vibrate, increasing the possibility for rollers to misalign upon entering the loaded zone of the bearing (top hemisphere). The latter results in enhanced frictional heating and roller deformation that generates significant amounts of heat and abrupt temperature fluctuations. Longitudinal spalls also initiate at the center of the roller (i.e. roller crown) and grow outward towards the ends of the tapered roller. The roller crown is the point of maximum stress when the roller misaligns during bearing operation [7].

Inspecting spall growth data from both inboard and outboard bearing cup raceways, it does not seem that spall location is significantly affecting the growth rates, as demonstrated in Figure 7.

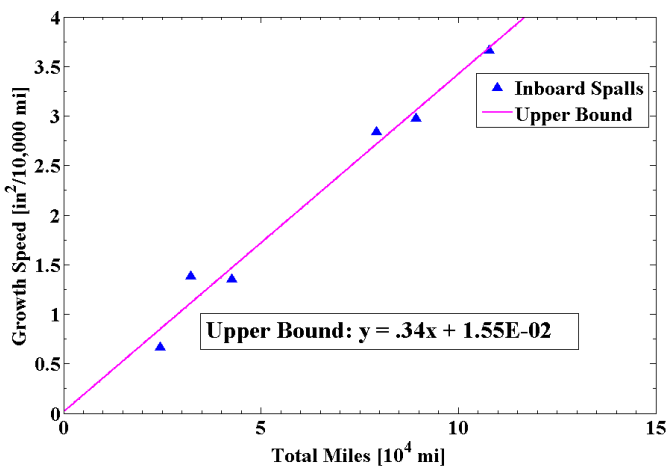
Figure 9. Spall growth rates versus total simulated miles of operation for spalls larger than 2 in<sup>2</sup> (13 cm<sup>2</sup>)

To this point, it has been assumed that only miles run under full-load produce significant spall growth. The final figure presented in this study has spall growth speeds plotted against total miles operated, including miles simulating an unloaded (i.e. empty) railcar or 17% of bearing rated capacity. Figure 9 shows that spalls larger than 2 in<sup>2</sup> now appear to fall along a single bound while those below 2 in<sup>2</sup> show no pattern in their response.

The data presented in Figure 9 are potentially an extremely useful finding. Should the addition of more spall growth data continue to exhibit this behavior, then this correlation provides a sound basis for a worst-case model for spall growth. Spalls greater than 2 in<sup>2</sup> (13 cm<sup>2</sup>) will grow according to a simple rule as a linear function of miles of operation, independent of the load status of the car. Below this threshold, growth does not appear to show any clear pattern of behavior, but spalls that small do not generally pose an immediate threat to bearing health.
