Periprosthetic acetabular bone loss using a constrained acetabular component

Case Report

Hiroshi Ito, MD; and Takeo Matsuno, MD

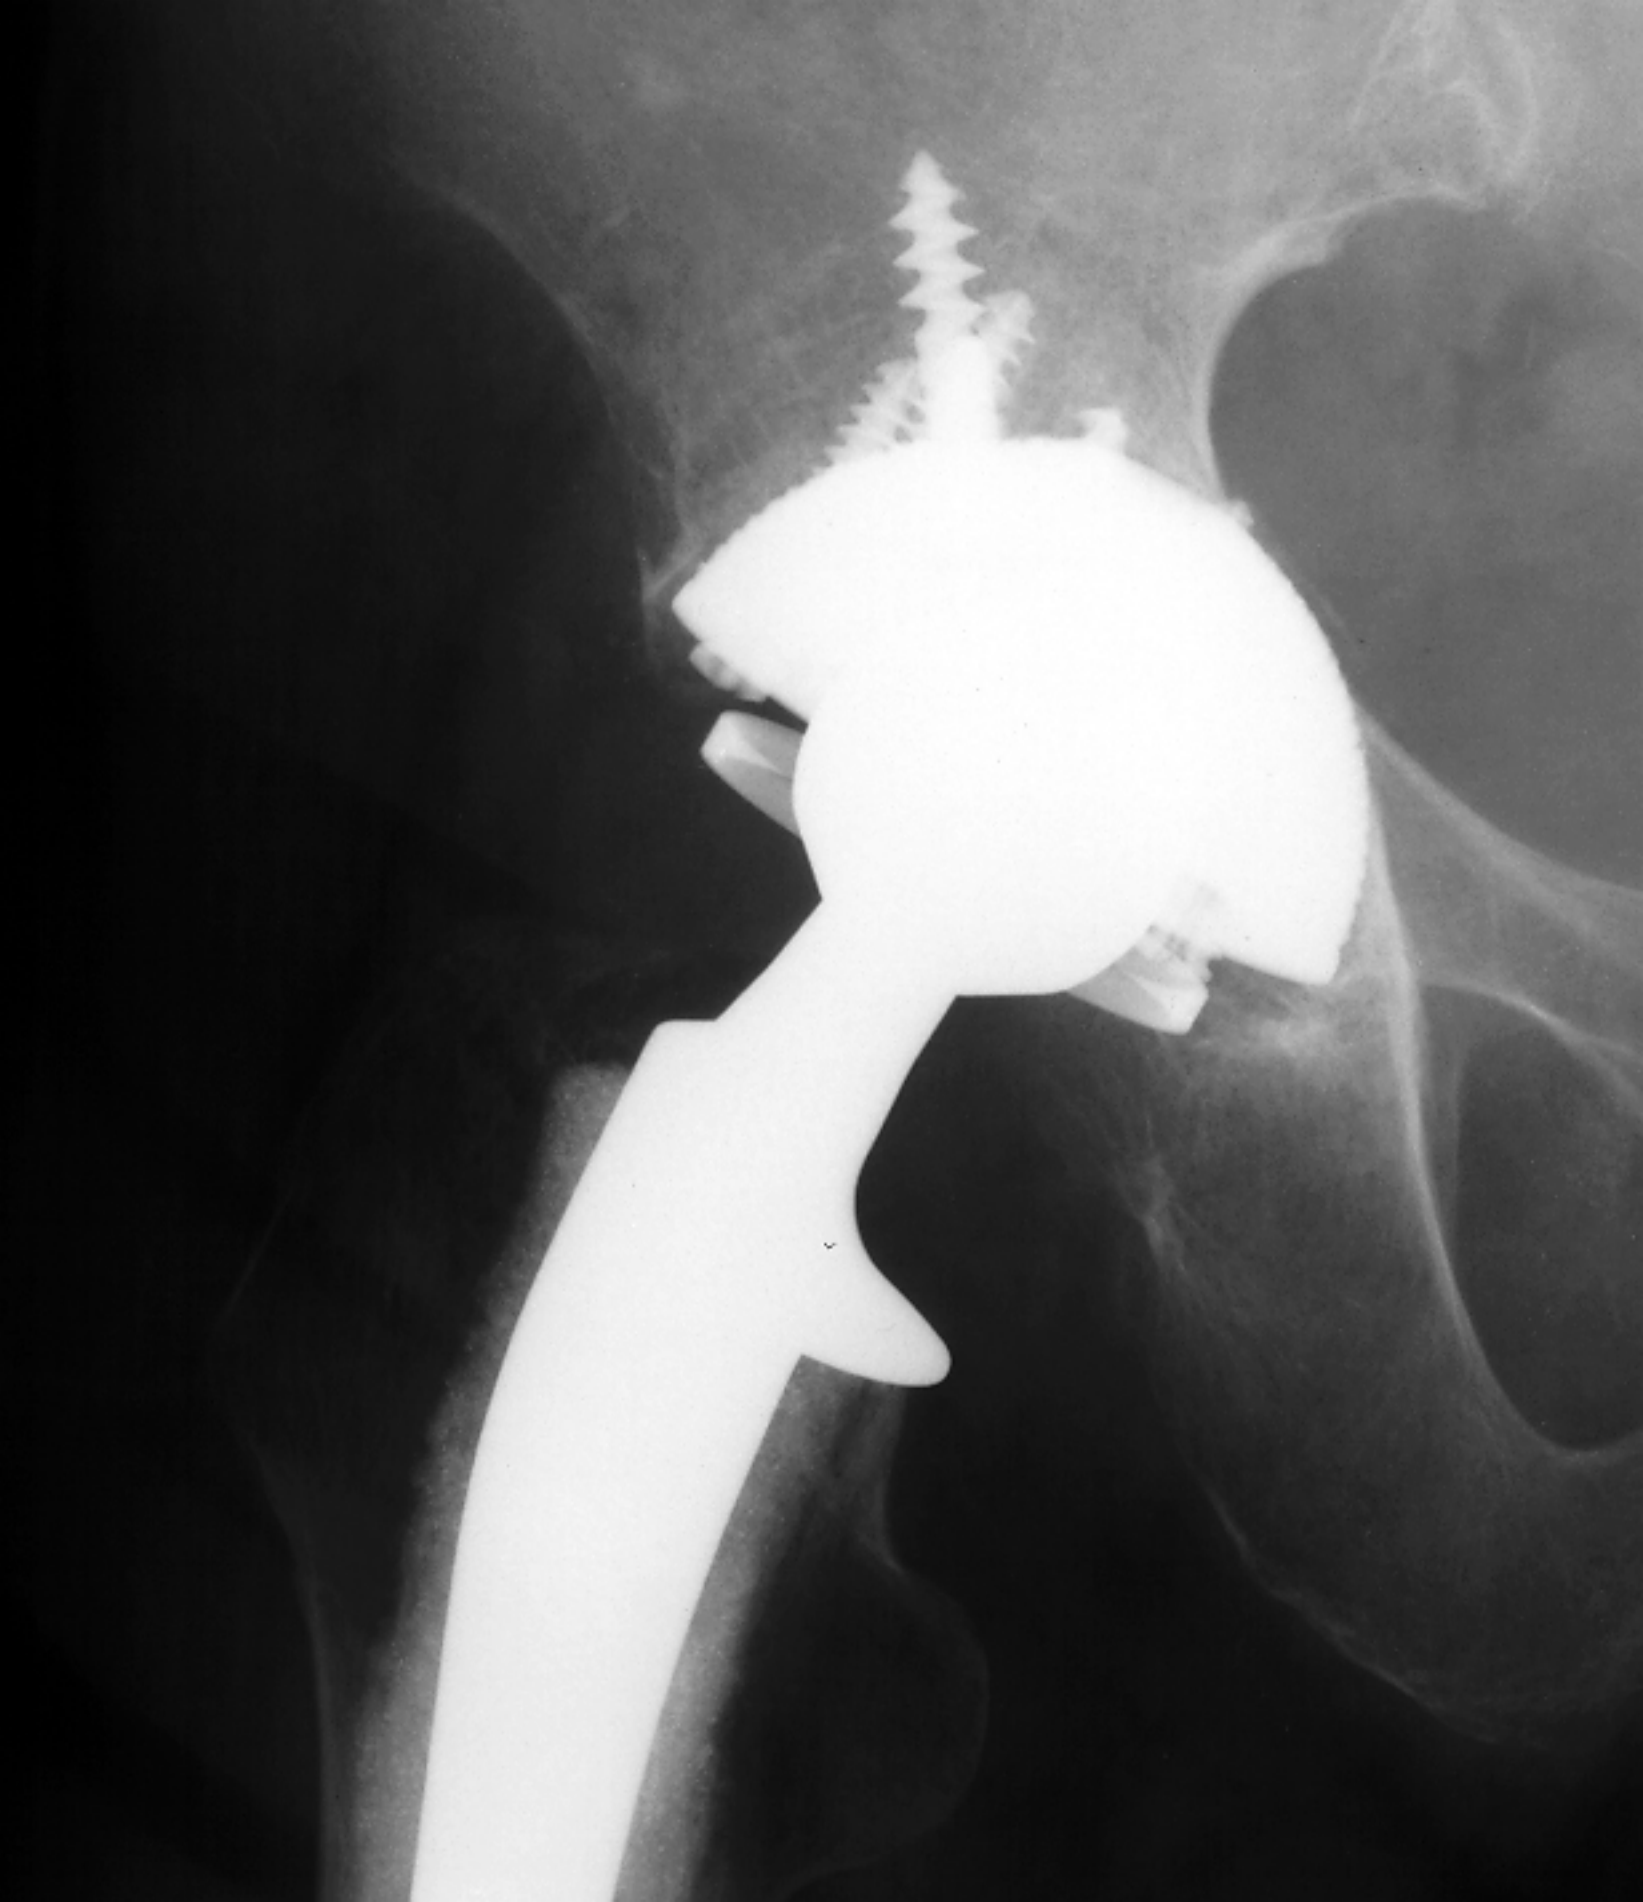
A Early postoperative radiograph.

Case 1 A 63-year-old woman with rheumatoid arthritis underwent total hip arthroplasty of the right hip through a posterolateral approach without trochanteric osteotomy. A 50-mm Harris-Galante Porous II cup and a non-constrained liner (Zimmer, Warsaw, IN, USA) were inserted without cement and a Harris precoat plus stem (Zimmer) was inserted with cement. The patient had a posterior dislocation 6 days postoperatively which had occurred after marked flexion with the hip in adduction. The patient subsequently had 6 additional episodes of posterior-superior dislocation. Each dislocation occurred after the hip had been placed in marked flexion with adduction. Revision surgery was performed 10 months after index surgery. The Harris-Galante Porous II cup was removed and a 54-mm S-ROM ZTT II acetabular cup (DePuy / Johnson & Johnson, Warsaw, IN, USA) was inserted in a position of 15° anteversion 35° abduction without cement. Three dome screws were inserted for augmentation of the cup. A constrained polyethylene liner was placed and 4 peripheral bone-screws were inserted. The well-fixed femoral stem was left in place. A new femoral head was fit into the liner with a reinforcing ring (Fig. 1A). Fourteen months after revision, the patient

Fig. 1 Case 1: Anteroposterior radiographs of the right hip of a 63-year-old woman with rheumatoid arthritis.

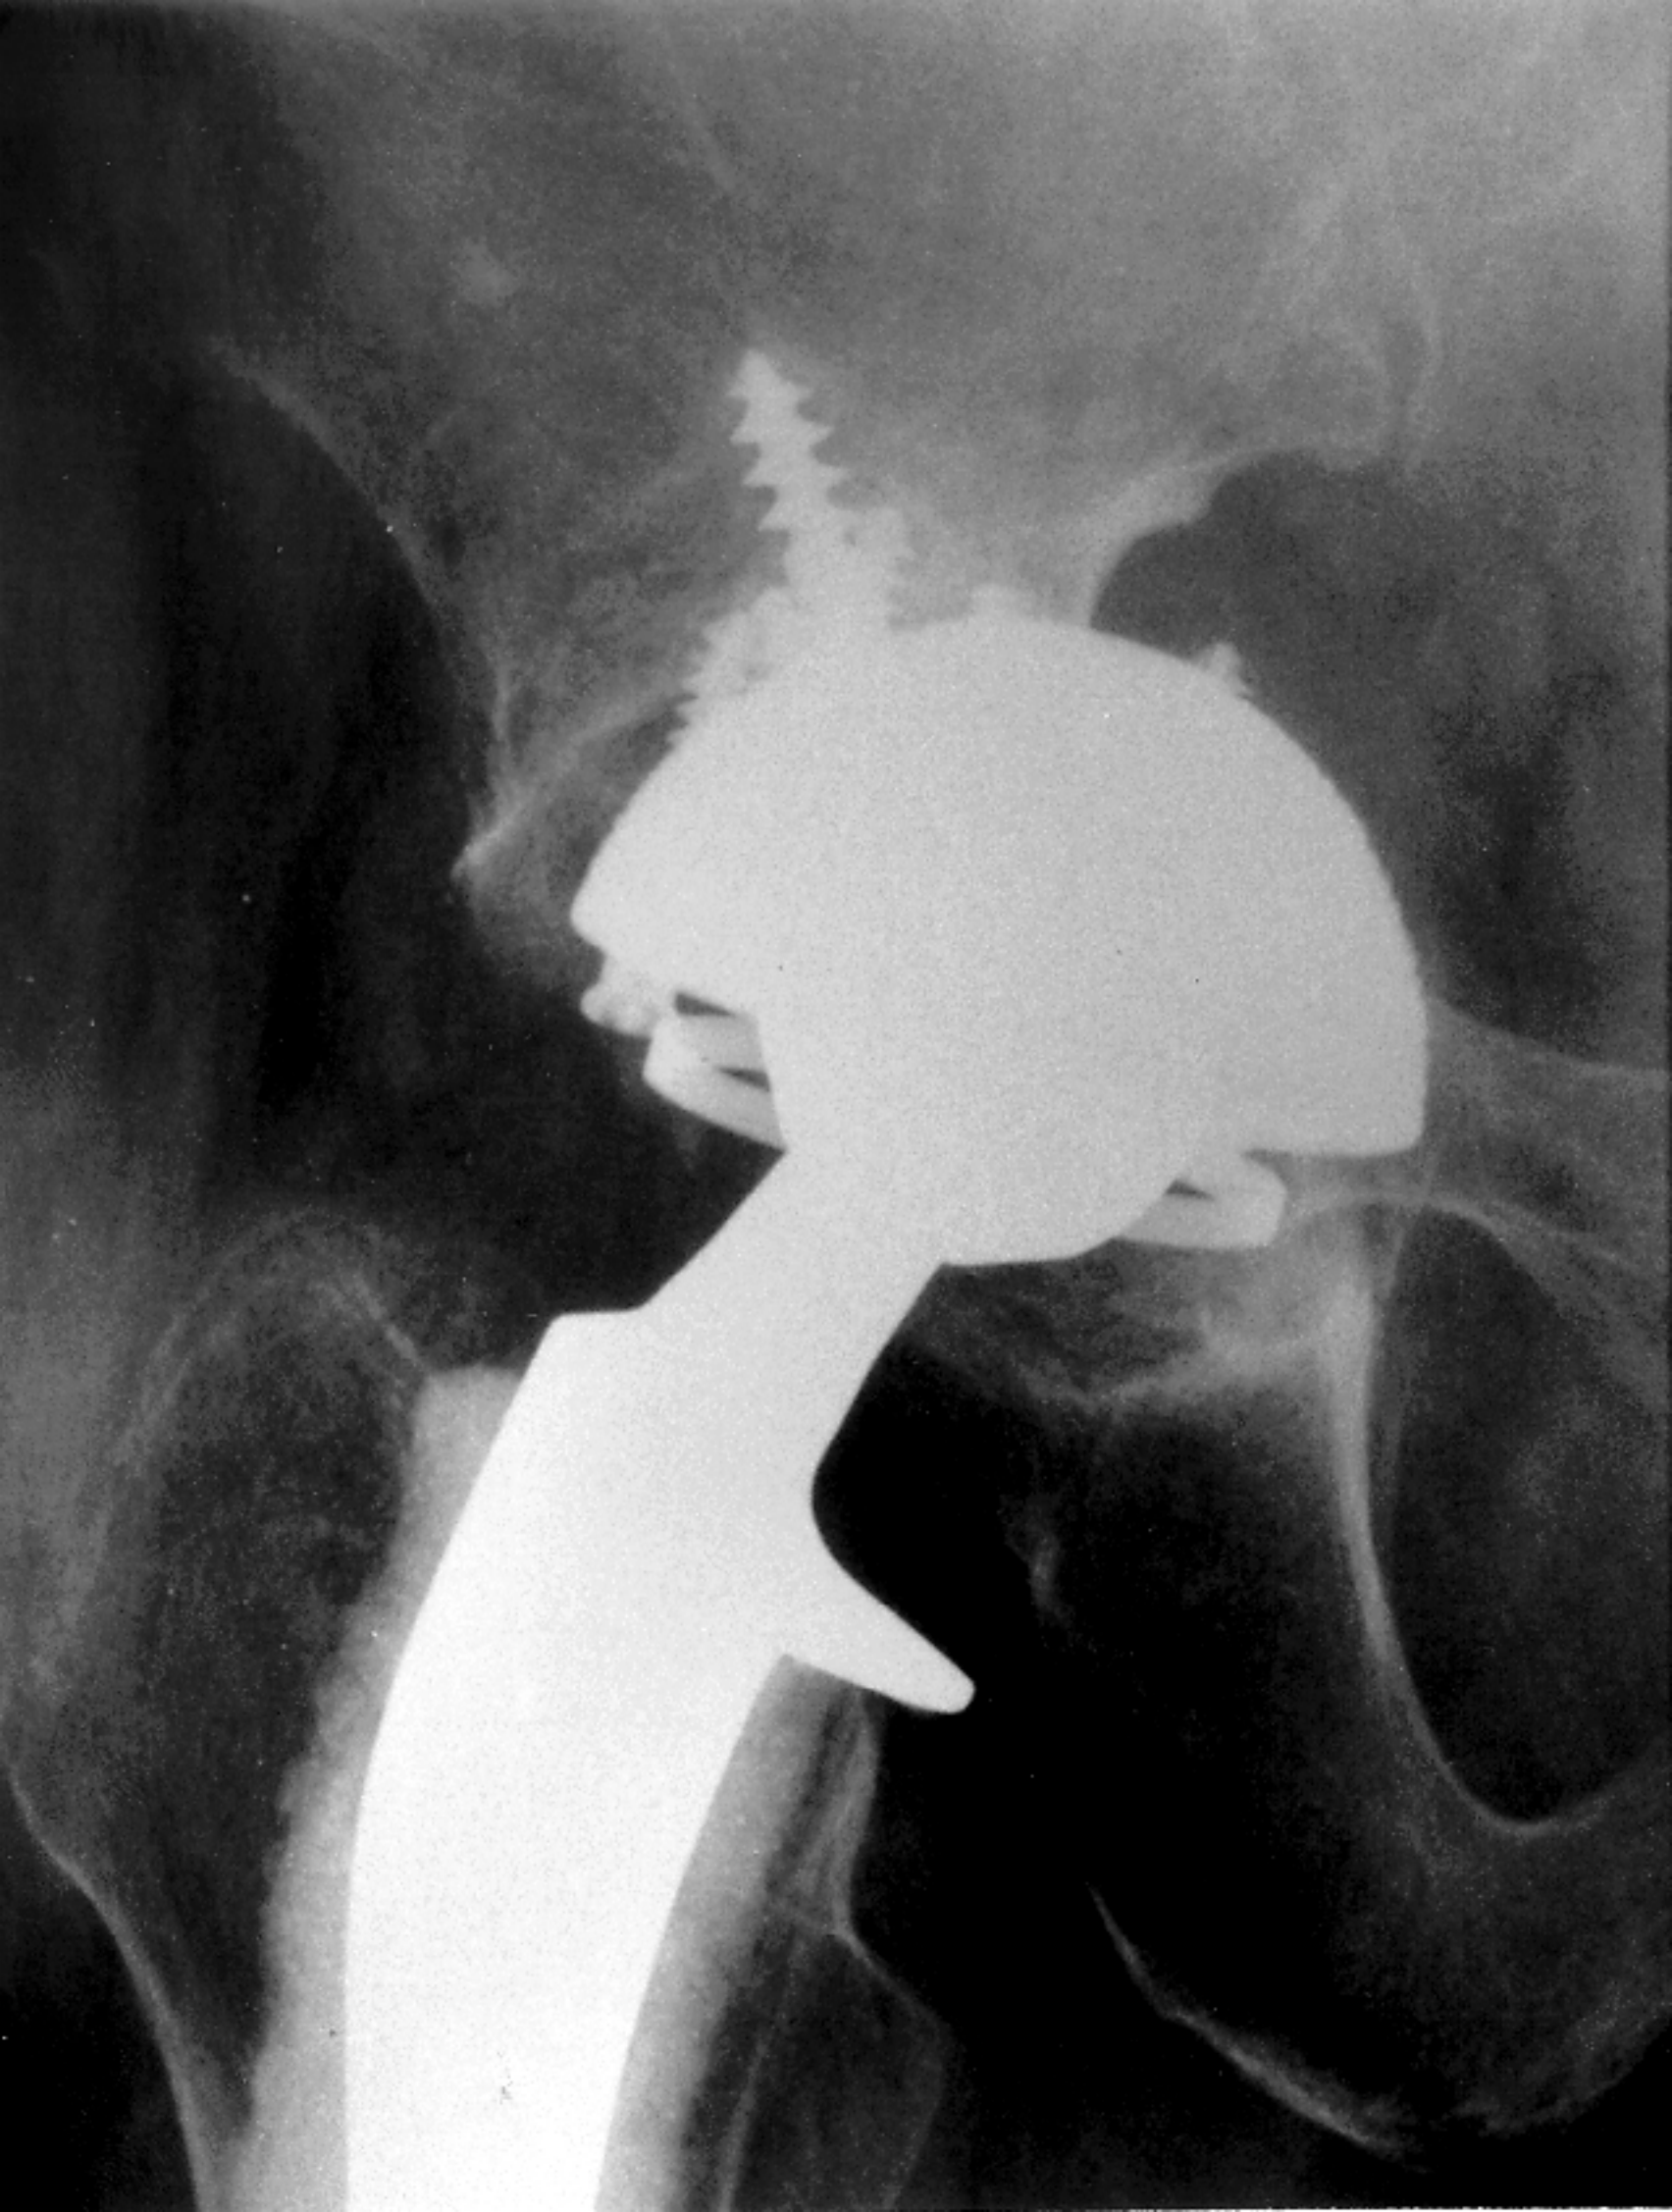
B Radiograph obtained 14 months postoperatively.

complained of slight hip pain without any preceding traumatic event. A radiograph demonstrated proximal and medial migration of the acetabular component and acetabular bone destruction (Fig. 1B). A radiograph obtained 24 months after revision surgery demonstrated progression of the acetabular component migration and bone destruction (Fig. 1C). A second revision surgery was performed. Apparently, there was no obvious loosening of the acetabular cup. Medial and superior bone defect of the acetabulum without any signs of infection was observed. The acetabular component and the femoral head were removed and a 58-mm Harris-Galante Porous II cup was inserted without cement. Five bone-screws and a non-constrained elevated liner were inserted. A new femoral head was placed into the neck taper. Intraoperative assessment of hip movement indicated that the hip did not dislocate in a position of 70° flexion and 45° internal rotation, which was evaluated as providing acceptable stability. The patient wore bracing to prevent excessive flexion and adduction for 4 months postoperatively. At the most recent follow-up 26 months postoperatively, the patient was able to walk using a cane without hip pain and had no symptoms that would suggest recurrent subluxation or dislocation. Serial radiographs have not demonstrated any signs of cup migration.

bone-prosthesis interface lead to gradual component migration, resulting in periprosthetic acetabular bone loss. The photos of case 1 and 2 were almost identical. The main reason for this failure might be increased bone-implant interfacial stress caused by impingement between the prosthetic femoral neck and the polyethylene liner. Sufficient initial and continuous stability of the constrained acetabular component may be difficult to achieve compared to that of the non-constrained acetabular component because of increased bone-implant interfacial stress. The manufacturer recommends using at least 4 peripheral screws to achieve initial stability when using the S-ROM constrained acetabular component. The present failures suggest that continuous stability of the constrained acetabular component was difficult to achieve even after the initial stability had been obtained. The acetabular cancellous bone in these 2 patients was osteoporotic due to rheumatoid arthritis and advanced age. The increased bone-implant interfacial stress continued and the sharp ends of the screws with a metal shell gradually plowed up the periprosthetic acetabular bone. The present failures suggest that a constrained acetabular component can migrate without apparent fixation loss especially in patients with osteoporotic bone. This complication usually occurs within the first 2 years postoperatively. These gradual migrations of the acetabular component might have resulted in subluxation or dislocation if we had used a non-constrained component.
