Top-down cracking in Italian motorway pavements: a case study

## Top-down cracking in Italian motorway pavements: a case study

### Abstract

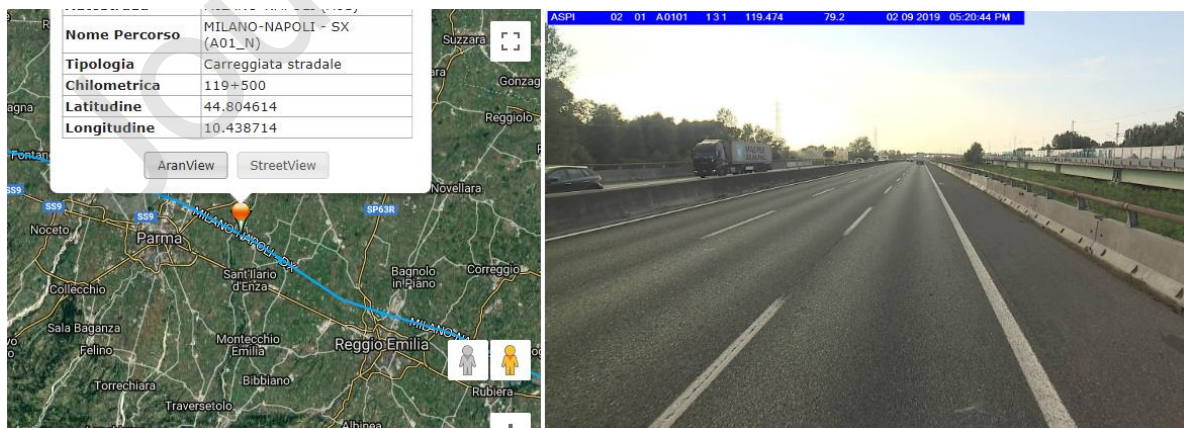
Figure 2 – Example of ARAN View output from Autostrade Google Earth software

The trial network was visually surveyed using Autostrade Google Earth software, which provides various information about the motorway network managed by Autostrade per l'Italia S.p.A., including pavement conditions, geometric characteristics, accident data, etc. Specifically, the ARAN View output images were considered, where ARAN is an acronym that stands for *Automatic Road Analyzer*, which is an equipment used to monitor the regularity of the pavement surface through the *international roughness index* (IRI). In fact, during pavement monitoring, ARAN equipment acquires frames of the pavement with a pitch of about 5 m through a georeferenced camera. The analysed images dated back to the year 2019 and an example is shown in Figure 2. It should be pointed out that the visual analysis of the images was necessary because an automatic image analysis would not have allowed to effectively distinguish TDC and other longitudinal cracks. The definition of specific identification criteria (see Section 3.1) allowed to minimize subjectivity in the image analysis.

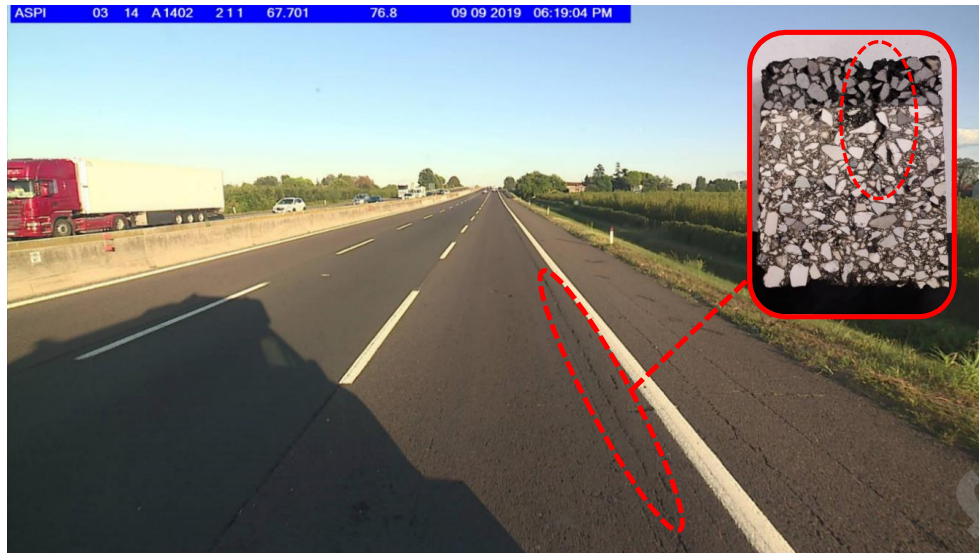
Figure 4 – Example of TDC

- A top-down crack appears rectilinear at a global observation scale, whereas – as compared to the other types of longitudinal cracks observed on the trial network – it presents a more irregular pattern at a small observation scale, following the edge of coarser aggregate particles;
- In advanced distress stages, TDC can be recognized by the peculiar presence of sister cracks and/or longitudinal cracks connected by multiple transverse cracks. For this reason, it is unlikely that a single top-down crack reaches lengths greater than 100 m (as an order of magnitude);
- In addition, for control purposes, it is recommended that cores taken from pavement areas affected by TDC have a diameter of at least 150 mm, because smaller diameters may not allow to properly identify the crack due to the material loss caused by coring operations.

Figure 4 shows an example of TDC, confirmed by the extraction of a core presenting a crack initiated at the pavement surface and propagated downwards. As can be seen from the figure, in order to better analyse the crack, the core was cut vertically perpendicular to the wheelpath direction.

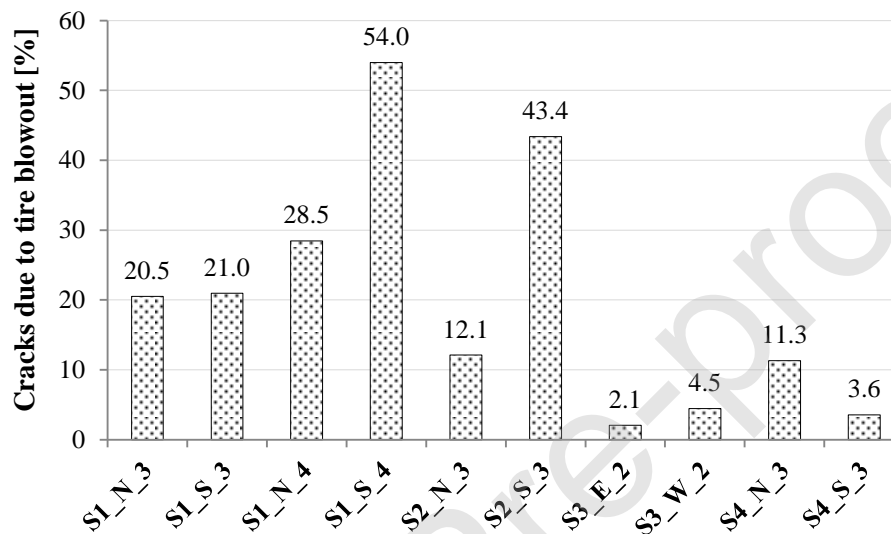
Figure 11 – Amount of cracks due to tire blowout

In addition, during the analysis of the ARAN View images from Autostrade Google Earth software, a remarkable diffusion of cracks due to tire blowout was observed. Therefore, their concentration on the slow traffic lane of each section was quantified as follows:

Where  $l_{TBC}$  is the cumulated length of cracks due to tire blowout on the slow traffic lane and  $l_0$  is the length of the analysed section. As can be noted from the comparison between Figure 11 and Figure 7, surprisingly the concentration of cracks due to heavy vehicles tire blowout was even higher than TDC (in some cases, up to 40-50%). This finding highlights once again the importance of defining specific identification criteria which allow to distinguish between TDC and other types of longitudinal cracks in the perspective of pavement maintenance/rehabilitation (i.e. in a PMS).

- Surprisingly, the concentration of cracks due to heavy vehicles tire blowout is even higher than TDC (in some cases, up to 40-50% of the slow traffic lane), further highlighting the importance of the developed identification criteria.
