Reliability of dynamic identification techniques connected to structural monitoring of monumental buildings

SUMMARY

KEY WORDS: structural health monitoring; monumental masonry buildings; dynamic identification reliability; damage detection; boundary conditions

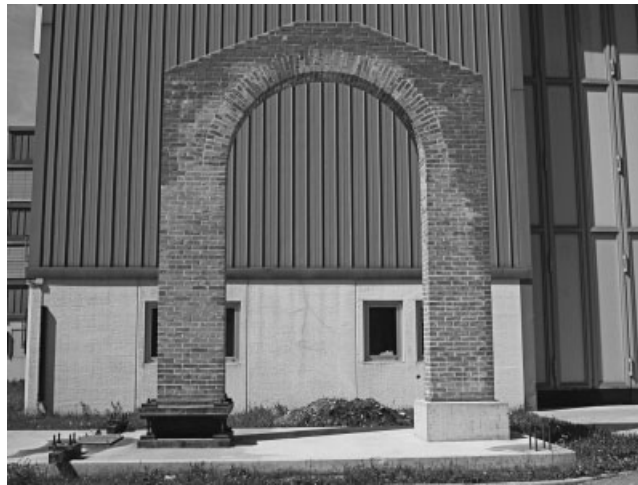
Figure 14. Wet arch due to rain.

Another parameter that could influence the variability of a dynamical identification is the water absorbed by the structure. Bricks are very porous material and a significant amount of water absorbed can lead to a not negligible increase in structural masses. In this case, the water absorbed by the bricks is due to the fact that the arch was subject to intense rain for several days. Even if a deep inspection of this phenomenon was not possible for test timing reasons, we noticed that the peak values of the ‘wet’ arch were slightly lower than those obtained with under ‘dry’ conditions, confirming the hypothesis (Figure 14).

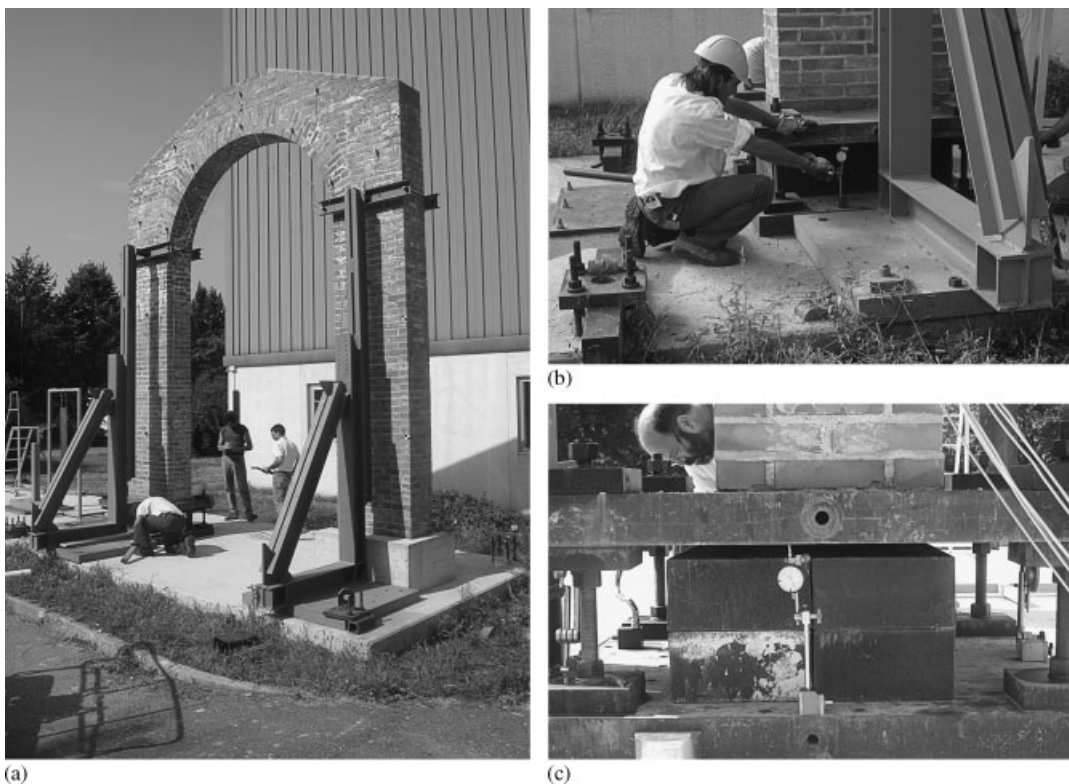
Figure 17. Settlement: (a) provisional structure and (b) and (c) lowering operations.

placed in the vicinity of the arch (but not in contact with it) in order to permit safe operations without changing the dynamic properties of the test structure (Figure 17(a–c)).

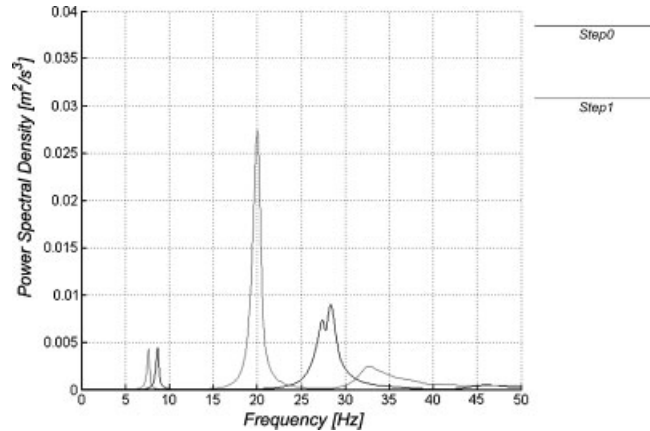
Figure 21. Comparison of in-plane PSD for *Step0* and *Step1*.

A comparison between the PSD curves of two representative tests, one for *Step0* (undamaged structure) and the other for *Step1* (5 mm settlement) clearly shows that the natural frequencies have lowered as a consequence of the inserted damage in the arch (Figure 21).
