The large tsunami of 26 December 2004: Field observations and eyewitness accounts from Sri Lanka, Maldives Is. and Thailand

Key words: Sumatra earthquake, Indian Ocean tsunami, field observations, eyewitness accounts, Sri Lanka, Maldives Is., Thailand.

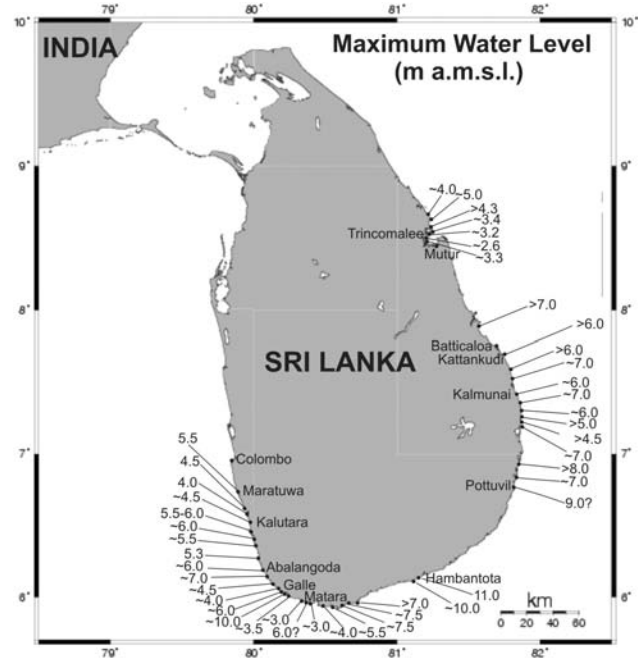
Fig. 3. Geographical distribution of the maximum water level, h (in m), measured in Sri Lanka.

Lanka, maximum water level was estimated to range from 2.6 m to 11 m (Fig. 3). The highest values measured are concentrated in the south part of the island from Ambalangoda in southwest to Pottuvil in southeast and particularly in Hambantota ($h = 11$ m) and near Galle ($h \sim 10$ m) (Fig. 3). Values of h ranging from 4.5 m to 9 m were measured in the east coast from Pottuvil to around Batticaloa. Sets of relatively low values were observed in the northeast part around Trincomalee (h ranges from 2.6 to 5.0 m) and in the west coast from Moratuwa to Ambalangoda (h ranges from 4.0 m to 5.0 m). The inundation, D , ranged from about 50 m to 500 m, while maximum inundation, d , is equal to at

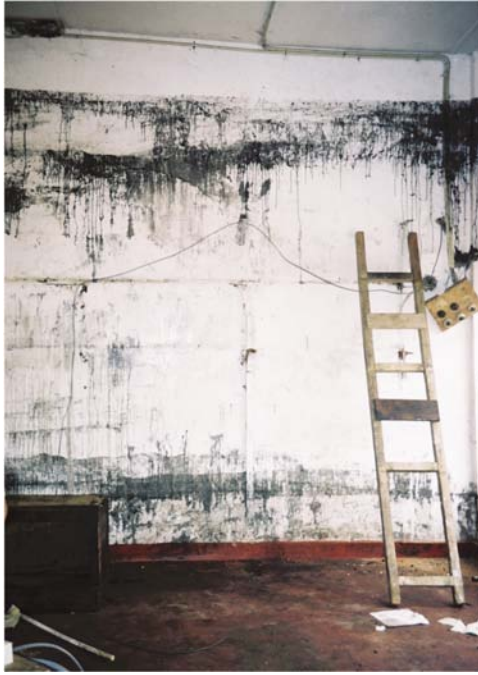
Fig. 4. Characteristic indoor sea sand mark left behind by the tsunami in the coastal zone of downtown Hambantota, south Sri Lanka. This is one of the locations where the maximum water level of $h \sim 11$ m was measured.

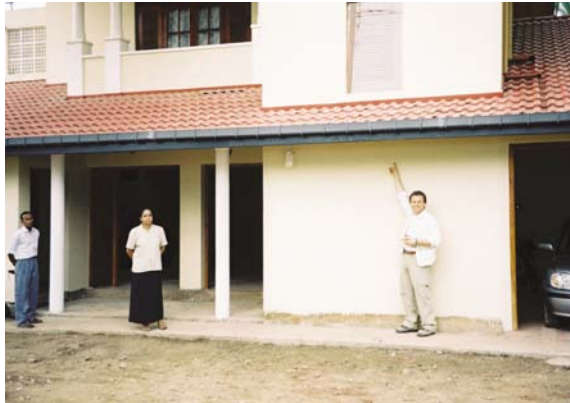
Fig. 5. Two-storey RC house that resisted very well the tsunami attack at distance of ~ 80 m from the shoreline of Paralyia, southwest Sri Lanka. Only little damage was caused in doors and windows. Water mark was left on wall.

Figures 5 and 6 show a characteristic example of one nRC and one RC building situated at exactly the same spot of observation at a distance of about 80 m from the shoreline of Paralyia, southwest Sri Lanka: the nRC building was completely demolished by the tsunami, while the RC one resisted very well and only minor damage was noted on it.

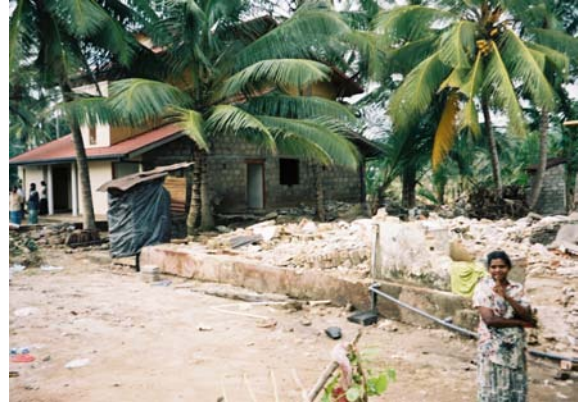
Fig. 6. Non-RC brick-work house completely demolished by the tsunami in Paralyia, southwest Sri Lanka. In the left-hand side the RC house (Fig. 5) makes strong contrast.

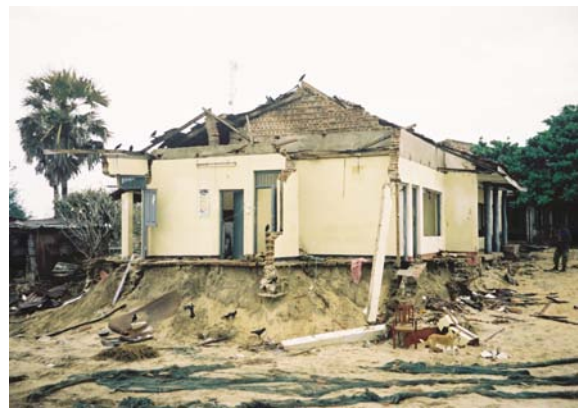
Fig. 7. The soil erosional action of the tsunami caused the sea-facing side of the non-RC building to collapse (~ 120 m from beach, near Karativu, east Sri Lanka).

The tsunami erosional action in soil was a factor of destruction in buildings and infrastructure. Buildings with eroded foundations typically tilted, and because of this were damaged or even were collapsed (Fig. 7). Along railways erosion caused the embankment either to collapse or to spread laterally (Fig. 8). Because of this the railway system along the coastal zones hit by the tsunami was destroyed in many localities. Tens of bridges were also destroyed because either of the hydrodynamic force of the wave or its erosional action at the base of the bridge or both (Fig. 10).

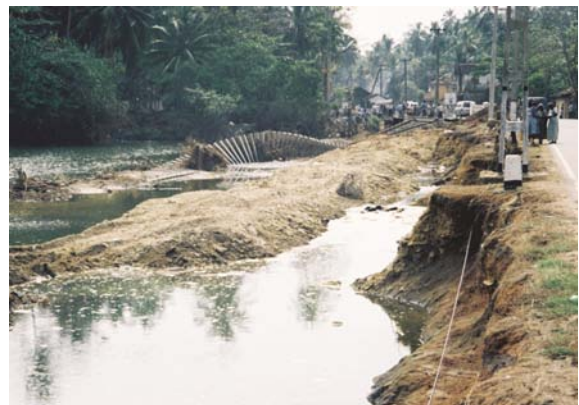
Fig. 8. Complete failure of railway due to lateral spreading and collapse of its embankment caused by the soil erosional action of the tsunami (Abalangoda, southwest Sri Lanka). The tsunami wave moved from the right-hand side to the left-hand side of the picture.

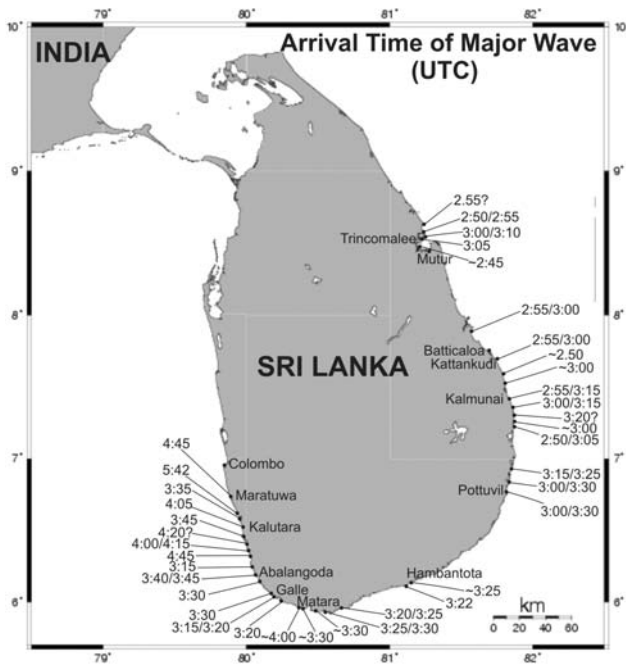
Fig. 9. Geographical distribution of the times of the major tsunami wave arrival in Sri Lanka according to eyewitness accounts.

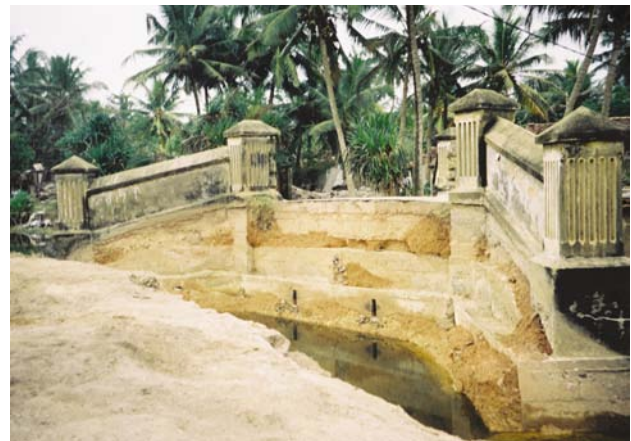
Fig. 10. The soil erosional action along with the force of the hydrodynamic flow of the tsunami caused collapse of one side of bridge (North Kalutara, southwest Sri Lanka).

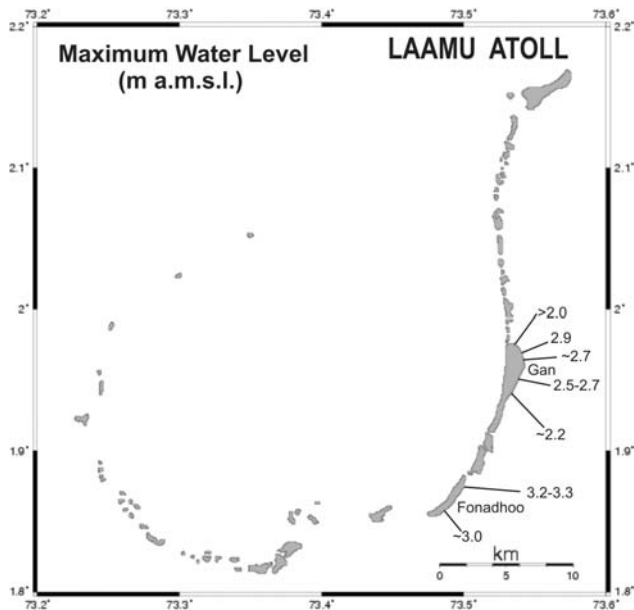
Fig. 11. Geographical distribution of the maximum water level, h (in m), measured in Laamu Atoll, Maldives.

In Maldives post-event field investigation was conducted on North Malé Atoll, South Malé Atoll and Laamu (Had-dummati) Atoll (Table 2). The maximum water level was estimated to range from 1.4 m to 3.3 m a.m.s.l. (Figs. 11 and

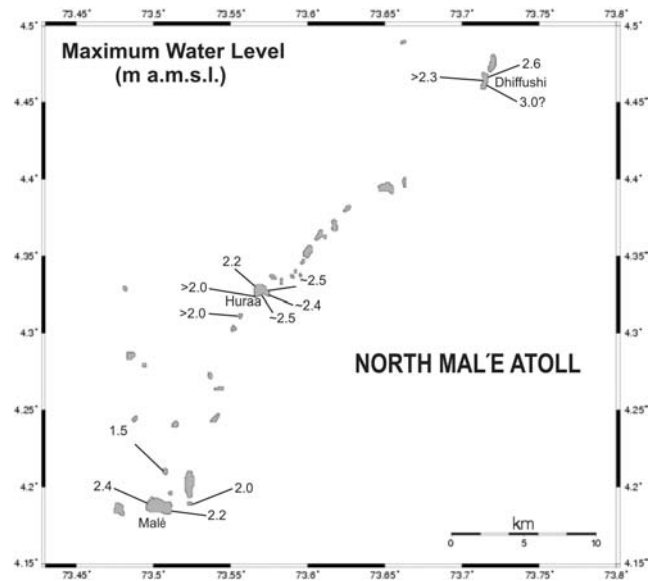
Fig. 12. Geographical distribution of the maximum water level, h (in m), measured in North Malé Atoll, Maldives.

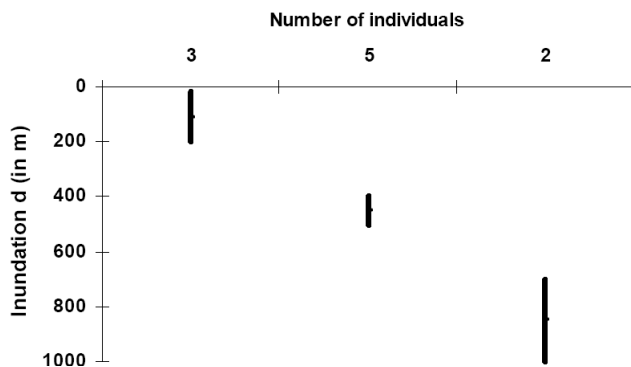
Fig. 16. Inundation, d , in Patong beach, Phuket island, Thailand, according to eyewitness accounts.

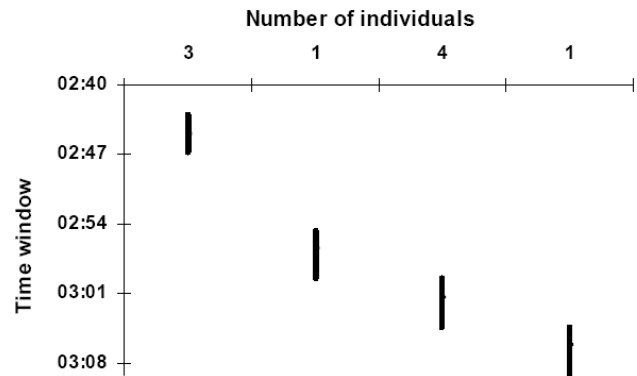
Fig. 17. Time windows (vertical bars) of reported tsunami occurrence in Patong beach, Phuket island, Thailand, according to eyewitness accounts.

In Patong beach, most people observed at least two waves. It is likely that the leading wave described in both Sri Lanka and Maldives was not observed in Patong beach. What people said is that the first sea motion was a retreat of more than 100 m. A few minutes later the strong wave arrived. Then, after another 5 or 10 min. one more wave attacked but less violently than the first one. Nearly all the interviewed persons reported that the tsunami inundation in the Patong beach varied from 150 m to at least 750 m (Fig. 16). One eyewitness reported inundation of only 20 m. As for the arrival time of the strong wave the eyewitnesses do not agree. However, most reports concentrated around 02:55 to 03:05 (09:55 to 10:05 local) which seems to be a reliable description (Fig. 17).
