# Validation of a measurement procedure for the assessment of the safety of buildings in urgent technical rescue operations

Maria Alicandro<sup>1</sup>, Giulio D'Emilia<sup>2</sup>, Donatella Dominici<sup>1</sup>, Antonella Gaspari<sup>3</sup>, Stefano Marsella<sup>4</sup>, Marcello Marzoli<sup>4</sup>, Emanuela Natale<sup>2</sup>, Sara Zollini<sup>1</sup>

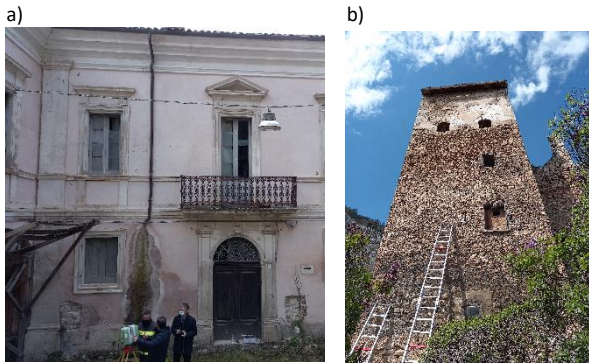
Figure 2. Monitored buildings: a) house; b) tower.

The test area is located in Fossa, a small village next to L'Aquila, in central Italy (Figure 1), hits by 2009 earthquake [15]. The area is a square surrounded by three buildings and a tower. Reference targets have been materialised on two buildings, while monitoring points have been located on the other buildings, the “house” and the “tower” in Figure 2.

These buildings have been chosen as test cases for the analyses, as they have different characteristics from the point of view of height, that implies different distance and inclination angle of the highest points with respect to the position of the measurement system, which is more or less halfway between the two buildings.

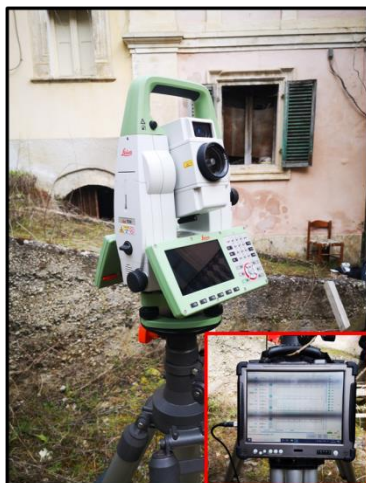
Figure 3. SafeR System used for the analysis.

The SafeR System has been used to perform the measurements. The SafeR System has been designed to estimate and monitoring any critical movements of structures and civil works. The operating modes and functions have been developed to make the system as suitable as possible for the emergency activities of the fire fighters. It is composed by (Figure 3):

- A total station Leica Geosystems (IPS), model TS16 Imaging, tool used extensively in monitoring activities by measuring azimuthal and zenithal angles and distances from the instrumental centre to the measured point with high precision. These measures (Polar

- Software SafeR, in order to manage the total station;
- a tablet PC, with the software installed on it, able to communicate with the Leica Total Station (TPS) both by wireless and with dedicated cabling.

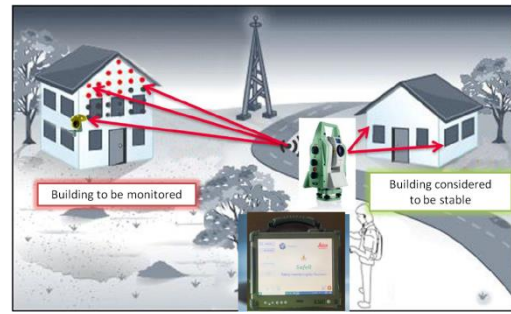
Figure 4. SafeR System operational scene [30].

The SafeR System is designed to provide spatial information (3D coordinates) of punctual points and the operational scene is schematised in Figure 4.

The points on the building considered to be stable are called reference points while the ones on the building to be monitored are called monitoring points. The SafeR System is positioned at the centre in order to have maximum visibility.

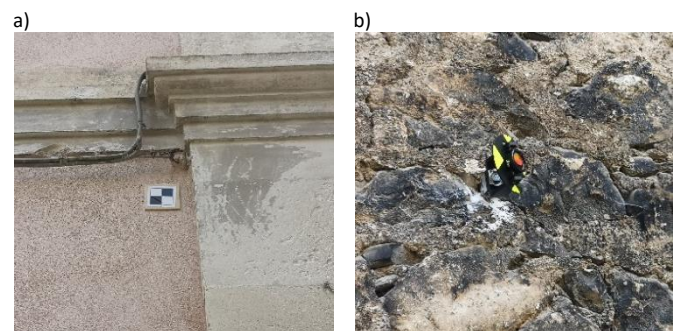
Figure 5. Targets used for monitoring and reference points, respectively: a) black/white target; b) prism.

Surveying by infrared ray needs a reflective target, the prism. Using the prism allows more accurate measurements and guarantees the achievement of greater distances.

At the reference points, prisms are used; at the monitoring points, white/black targets (Figure 5) are positioned using epoxy resins, to have reference positions, easily identifiable, on which to impose, in perspective, known displacements for the evaluation of the metrological characteristics of the instrument and to obtain useful information for the optimization of the procedure. The latter targets have reflectivity characteristics similar to those of a common building wall.

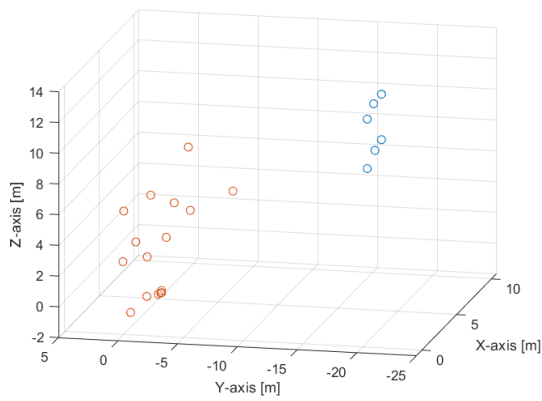
Figure 6. Point clouds acquired on the façades of the buildings: in red the points on the house; in blue the points on the tower.

A coordinate system has been defined with reference to the first building, the house, in such a way that the x-axis direction is obtained by projecting on the horizontal plane the points taken on the façade, the z-axis is vertical and its origin is on the horizontal plane at the height of the instrument, the y-axis enters the wall of the house. Figure 6 shows the point clouds acquired on the façades of the two buildings and the defined reference systems.

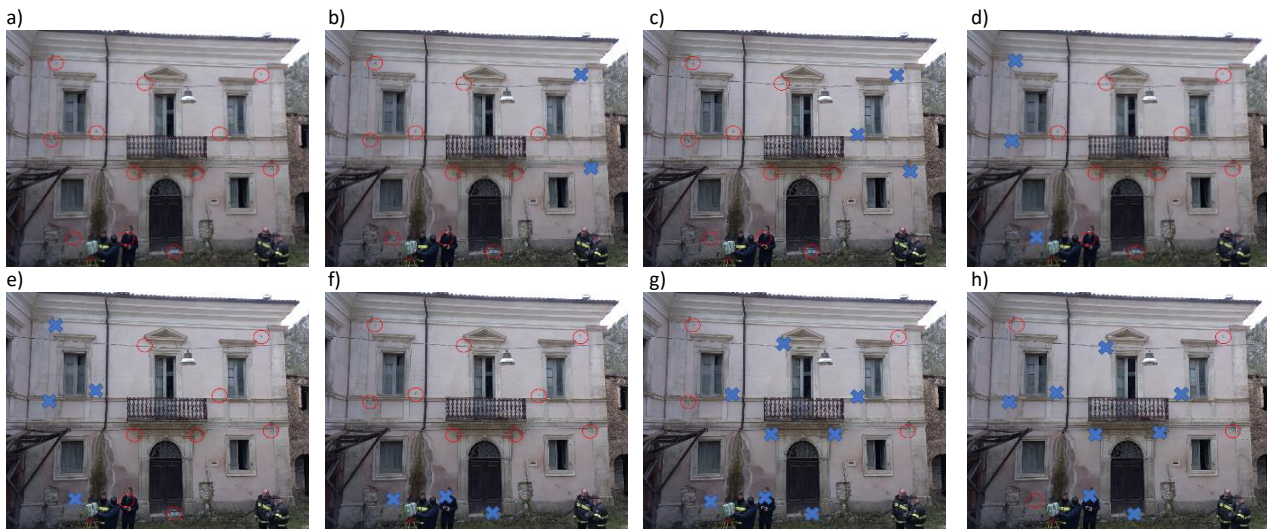
Figure 8. Configurations of measuring point for the house: a) "Ref" (reference); b) "Config 2"; c) "Config 3"; d) "Config 4"; e) "Config 5"; f) "Config 6"; g) "Config 7"; h) "Config 8".

3. The angle of inclination is calculated with reference to the configurations described in Figure 8 and Figure 9, that is:
  - excluding points along vertical lines from the analysis (configurations b, c, d and e for house; configurations b' and c' for tower)

- excluding the points along the lowest line, only in the case of house (configuration f)
  - considering only extreme points (configuration g and h for house; configuration d' for tower).

The least squares regression has been also performed for the configurations of Figure 8 and Figure 9, and the inclination differences with respect to the reference case have been calculated (Figure 12 and Figure 13).

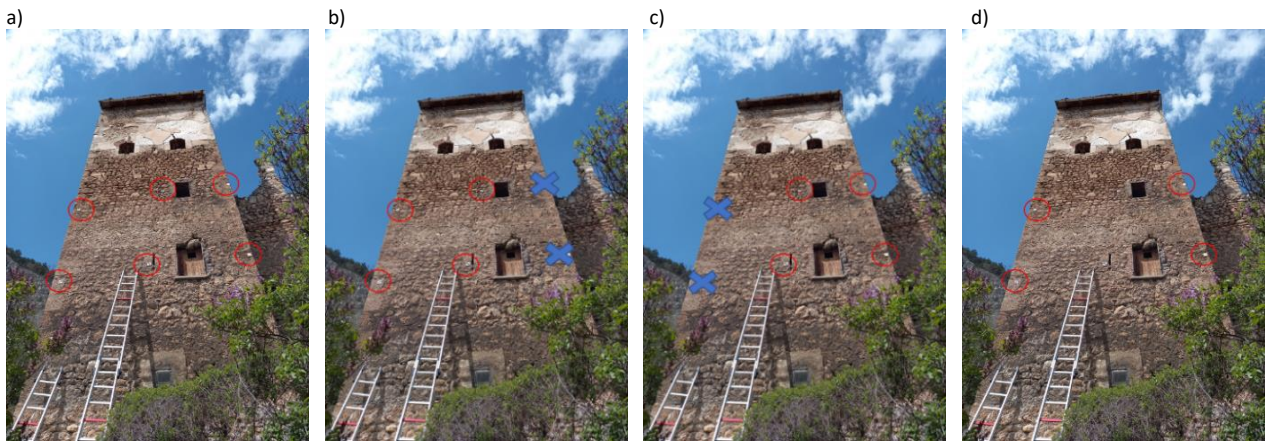
Figure 9. Configurations of measuring point for the tower: a) "Ref" (reference); b) "Config 2"; c) "Config 3"; d) "Config 4".

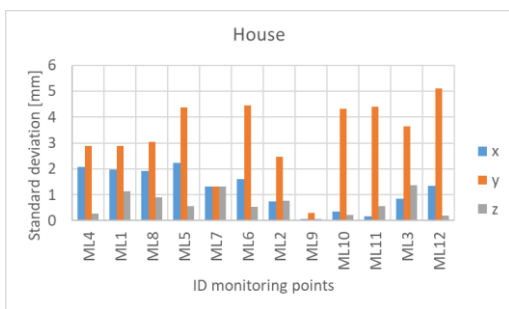
Figure 10. Standard deviation of the coordinates of the monitoring points for the house.

Figure 10 and Figure 11 show the calculated standard deviations for the monitoring points on the house and the tower: these values do not exceed 5 mm.

- It must be noticed that the standard deviation of the measurements is greater in some areas of the façade of the house, and this does not seem to be directly related to parameters such as distance and angle of positioning of the total station with respect to the building. This aspect will need to be explored in future work.

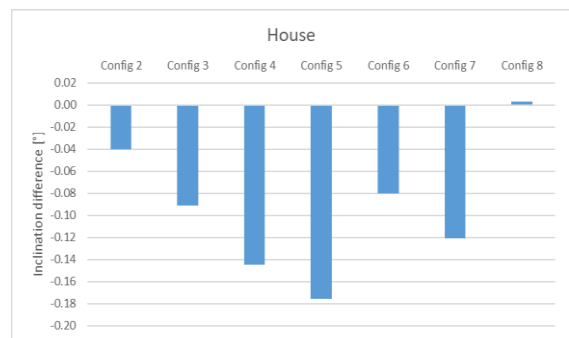
Figure 12. Inclination difference with respect to the reference for the house.

- For the house, variations in the angle of inclination up to  $0.18^\circ$ , compared to the reference case, may result, by changing the number of points chosen for processing; the displacements evaluated in the horizontal direction, at the height of the highest point, can reach about 20 mm.

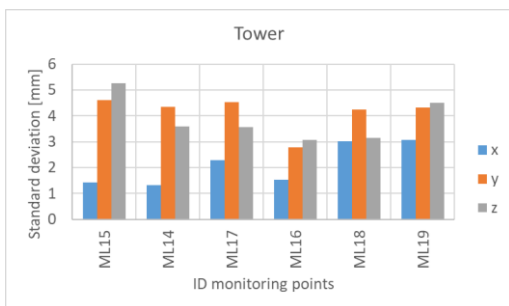
Figure 11. Standard deviation of the coordinates of the monitoring points for the tower.

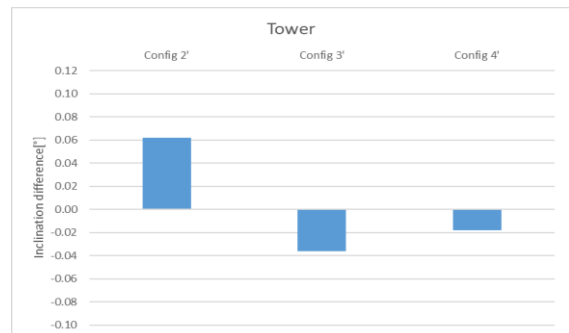
Figure 13. Inclination difference with respect to the reference for the tower.

- For the tower, variations in the angle of inclination up to  $0.062^\circ$ , compared to the reference case, may result, by changing the number of points chosen for processing; the displacements evaluated in the horizontal direction, at the height of the highest point, can reach about 25 mm.

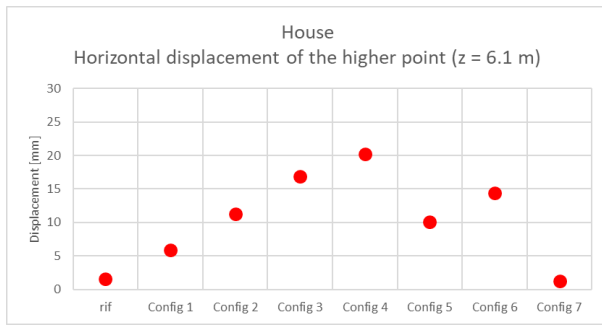
Figure 14. Horizontal displacement of the higher point for the house.

Furthermore, the displacement in the horizontal direction of the highest point in both the two buildings has been evaluated (Figure 14 and Figure 15). The following observations can be made:

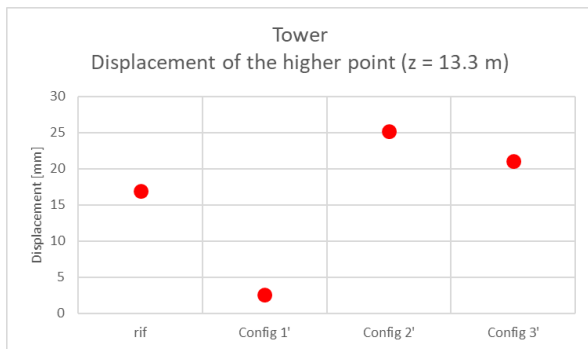
Figure 15. Horizontal displacement of the higher point for the tower.
