F. Benazzo
M. Mosconi
L. Piovani
G.S. Fossati
A. Sgarella

Abdominal cyst after early failure of polyethylene liner in total hip arthroplasty

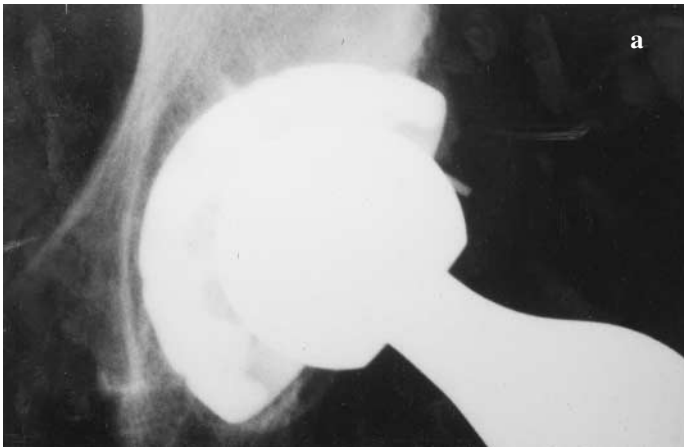
Six month later, the patient began to complain of left groin pain on walking and of abdominal discomfort, without any traumatic event. Three months later radiography showed a decreased thickness of the upper portion of the polyethylene (PE) liner. The ball head was not in line with the rotational center of the articulation due to the asymmetrical deterioration of the PE liner. Nevertheless, no osteolysis or radiolucency lines were detectable behind the metal back or around the stem (Fig. 1a,b).

Fig. 1 a Radiographic evidence of the upward shifting of the prosthetic 32-mm head, due to polyethylene wear. **b** No more bone resorption is visible around the components

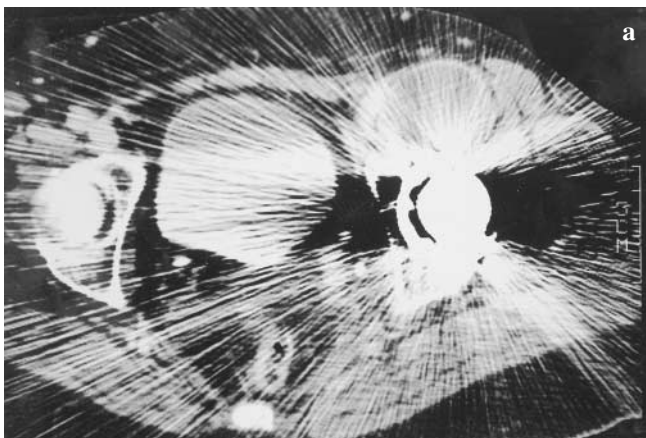
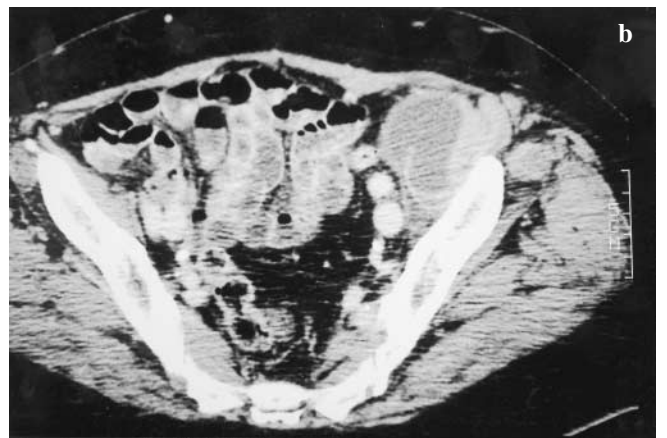
Fig. 2 CT demonstration of the cystic dilatation of the iliopsoas bursa (**a**) dissecting between muscles up to iliac crest (**b**)

The hip's passive range of motion remained complete but the patient limped due to the pain. Furthermore, clinical examination revealed a slightly painful swelling in the inguino-abdominal and inguinocrural regions. The swelling was investigated with computed tomography (CT) and with sonography. In August 1998, CT showed a wide retroperitoneal cystic body 5 cm in diameter,

enveloping the whole iliopsoas muscle along its iliac course from the lesser trochanter up to lumbosacral junction (Fig. 2a,b). With intravenously injected contrast medium, a moderate peripheral enhancement was observed.

In the second phase of the operation, the patient was turned face up, and a retroperitoneal approach with a parainguinal incision at the iliac fossa was performed. Once the abdominal wall was opened, the cyst was exposed, incised and drained, and then smoothly detached and completely excised. Drains were removed 24 hours after surgery and rehabilitation started immediately with full weight-bearing after 48 hours. The cultures of the fluid were also negative this time.

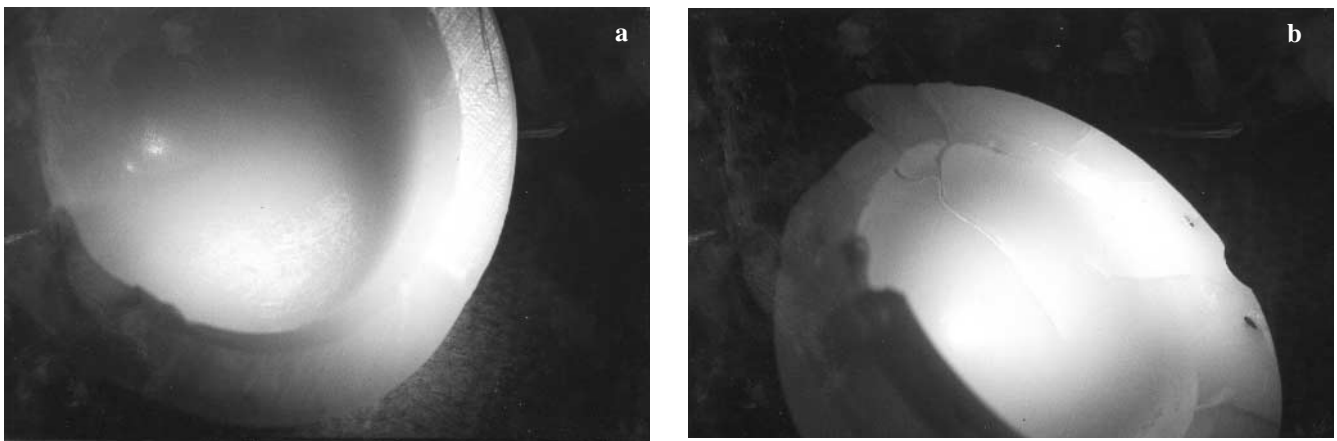
Fig. 3 **a** The huge wear of the liner is evident. **b** Cracks and fissures at the upper rim can be considered signs of a rupture of the liner

In October 1998, a two-step surgical revision was performed. In the first phase, with the same posterolateral approach of primary surgery, the hip was dislocated after complete removal of periprosthetic fibroid tissue; the head and the liner were removed. The insert was eccentrically worn out and fractured, and the inner surface was scratched (Fig. 3a,b). The metal back was firmly integrated, and the acetabular bone was inspected with a probe through the holes of the cup once the fibrous membrane filling them was removed; no abnormal softening was detected. The greater trochanter and the calcar showed no absorption around the cement mantle. In the lesser trochanter region, the "cul-de sac" of the cyst was emerging aside the iliopsoas tendon, but care was taken not to damage it, in order to avoid fluid spreading into the wound. A thicker liner and a 28 head were placed, the hip relocated, two drains placed and the wound closed.

Macroscopic analysis of the liner, performed also with magnifying lenses, confirmed excessive and asymmetrical wear of the PE liner, causing fractures and scratches on the loaded surface. No corresponding macroscopic alteration or scratches on the head were identified.

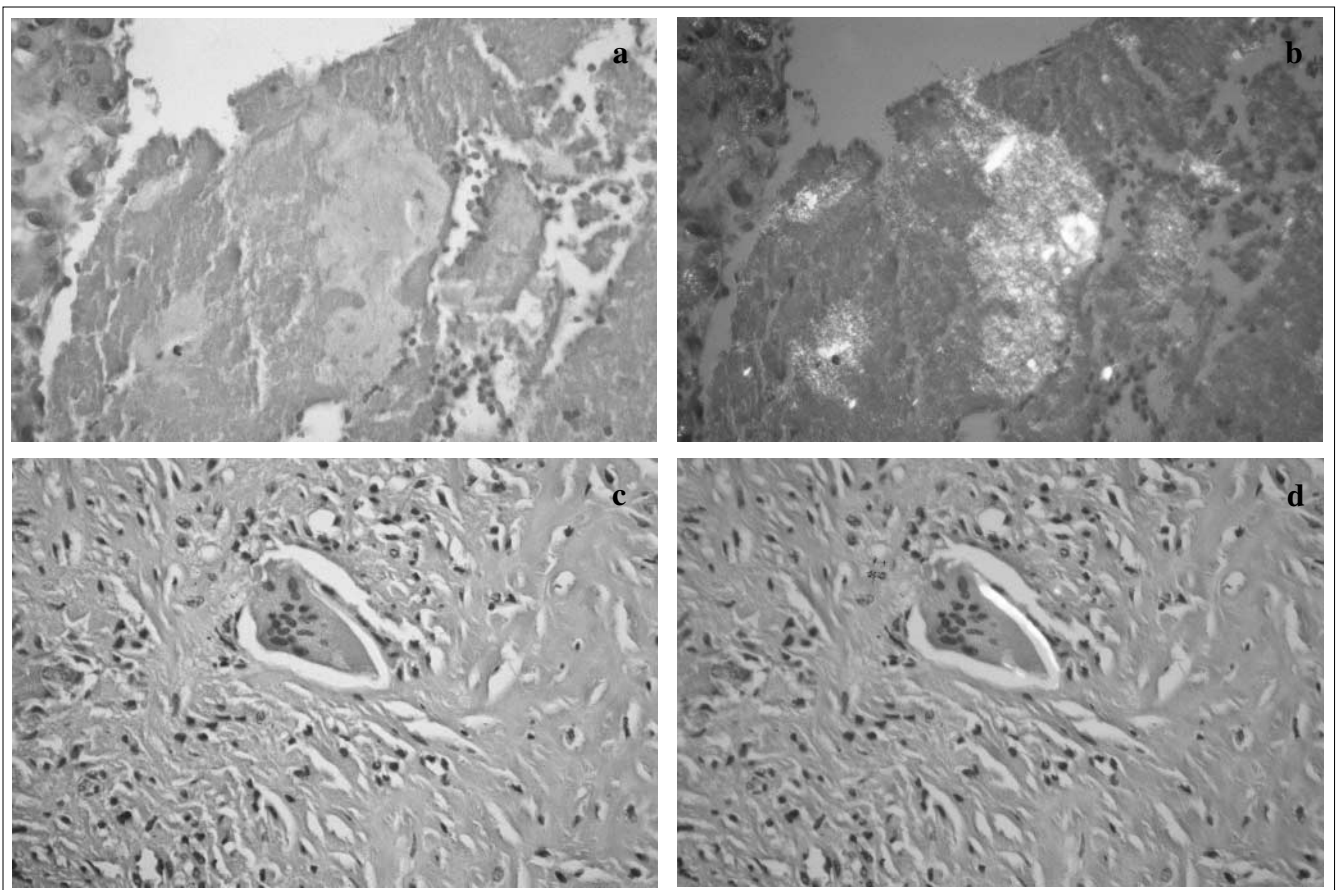
Fig. 4 Polarized light microscopy showed the presence of huge biriffringent debris (**a**, **b**), with the typical needle-like appearance within a macrophage (**c**, **d**)

(Levovist) also showed moderate peripheral vascularization. Under sonographic guidance, the cyst was punctured and 30 ml colloidal, dense material was evacuated. The culture was negative while microscopic observation under polarized light of the fresh unfixed material showed the presence of large birefringent debris.

Polarized light showed sparse, huge polyethylene debris surrounded by foreign-body granuloma and giant cell formation, and lack of inflammatory cells (Fig. 4). No evidence of metal debris or cement particles was found.

The absence of periprosthetic osteolysis may be ascribed to the large size of the polyethylene debris caused by insert cracking and/or rupture. These large particles of

debris promoted a reactive macrophage response with giant cell formation. This is a typical histological pattern in which there is no macrophage cytokine secretion, a key factor in osteoclastic activation. Macrophage and osteoclast activation is observed in presence of PE debris of small size (<4 µm) [6].
