Closure of the Failed Ash Dredge Cell at Kingston – The Engineering Challenge

Vernon J. Dotson, Jr.¹, Darrell E. Herron, PE², Alan F. Rauch, PhD, PE², and Michael J. Steele, PE²

ABSTRACT

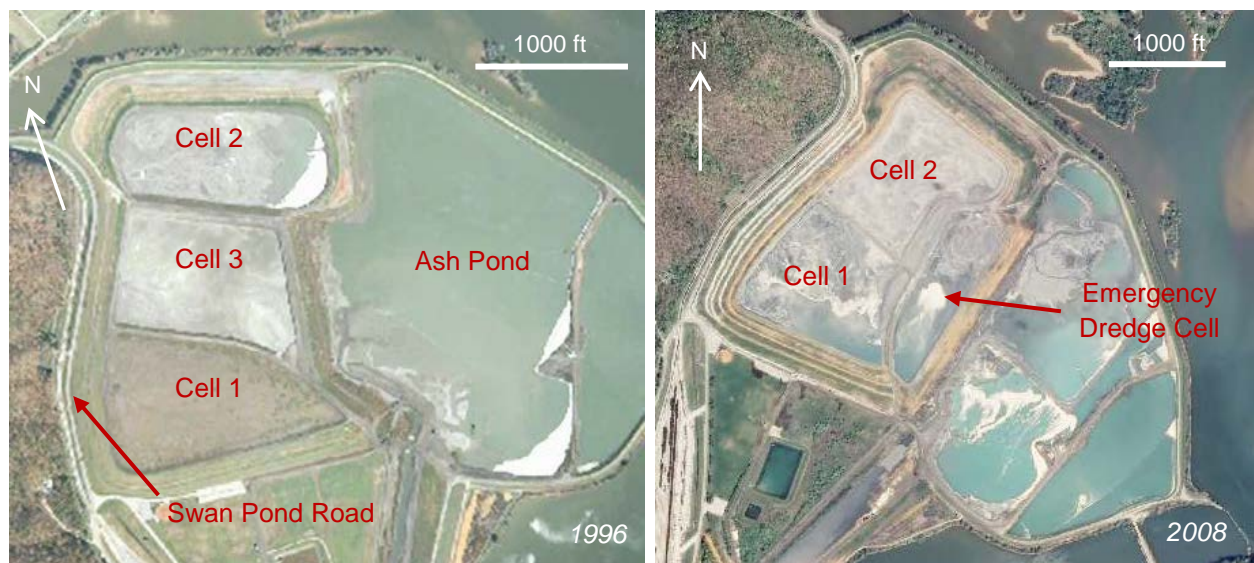
Figure 2. Aerial imagery of the ash pond facilities in 1996 and 2008.

The former ash pond complex was established by constructing earthen dikes across the adjacent, shallow embayment of the Emory River, thereby separating the disposal area from Watts Bar Reservoir. Ash was sluiced to the ash pond until 1984, when TVA began building elevated “dredge cells” to increase storage capacity. Ash slurry was hydraulically dredged from the ash pond and pumped alternately to three cells located on the western side of the ash pond complex (Figure 2). Dredging operations continued over the next 19 years, with the dredge cells being successively raised in steps with upstream dikes. Cells 2 and 3 were eventually combined into a single cell.

In 2003, a superficial slip occurred in the dikes along Swan Pond Road, and dredging operations into Cells 1 and 2 were suspended. An Emergency Dredge Cell (Figure 2) was constructed and became the primary disposal cell used over the next few years. Late in 2005, Cell 1 was returned to service. Another localized, shallow slip occurred in the western dikes in November of 2006. While slope repairs were implemented, all material was again dredged into the Emergency Dredge Cell. Operations in Cells 1 and 2 were then continued until the 2008 failure.

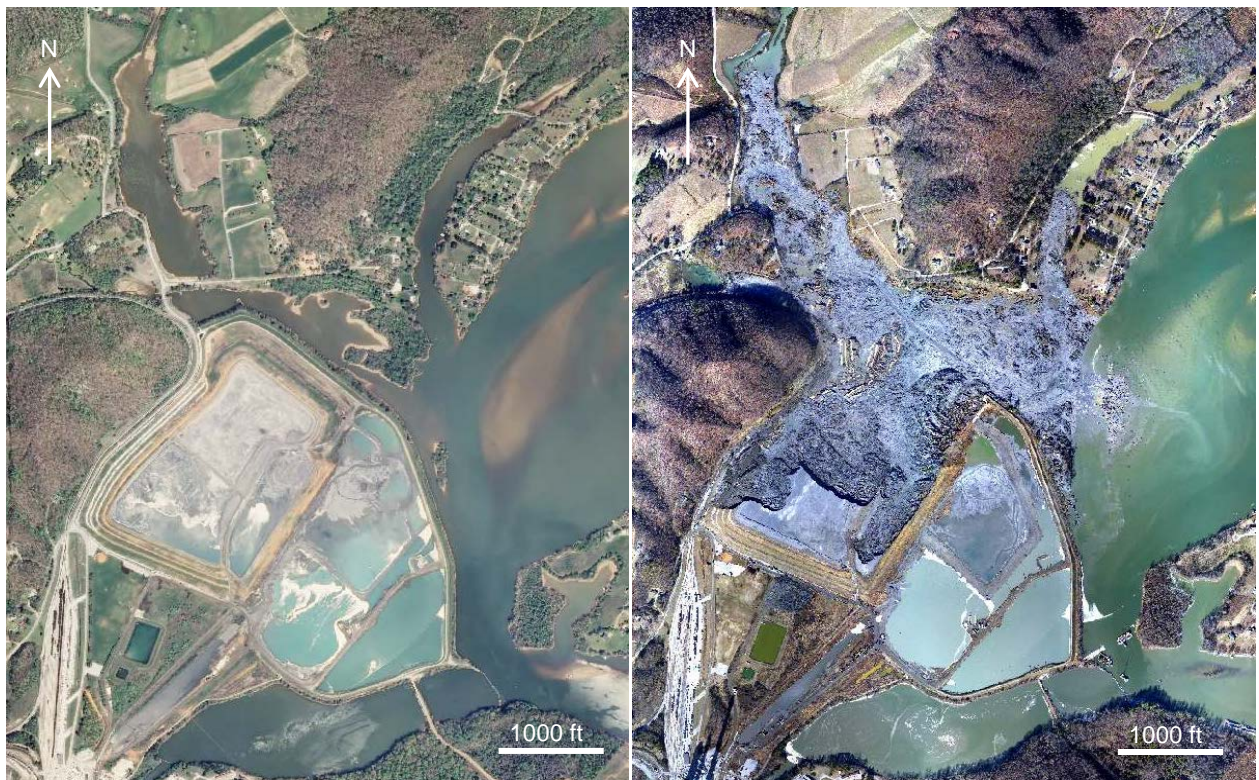
Figure 3. Comparison of aerial imagery before and after the 2008 failure.

The Kingston dredge cell failed in the early morning hours of December 22, 2008. At the time of the failure, the crest of the facility was approximately 60 feet higher than Swan Pond Road, and 78 feet above Watts Bar Reservoir. The breach began in the northern

corner of the site, with retrogressive slope failures that eventually involved most of the dredge cell. About 5.4 million cubic yards of liquefied ash slurry ran out several thousand feet to the north and east, filling the adjacent lake embayments. Figure 3 compares the site before and after the failure. The public highway and railroad along the western side of the site were devastated, and the Emory River channel was filled with ash. The dikes around the ash pond on the eastern half of the site held, although one corner at the northern end was cracked where impacted by the ash flow.

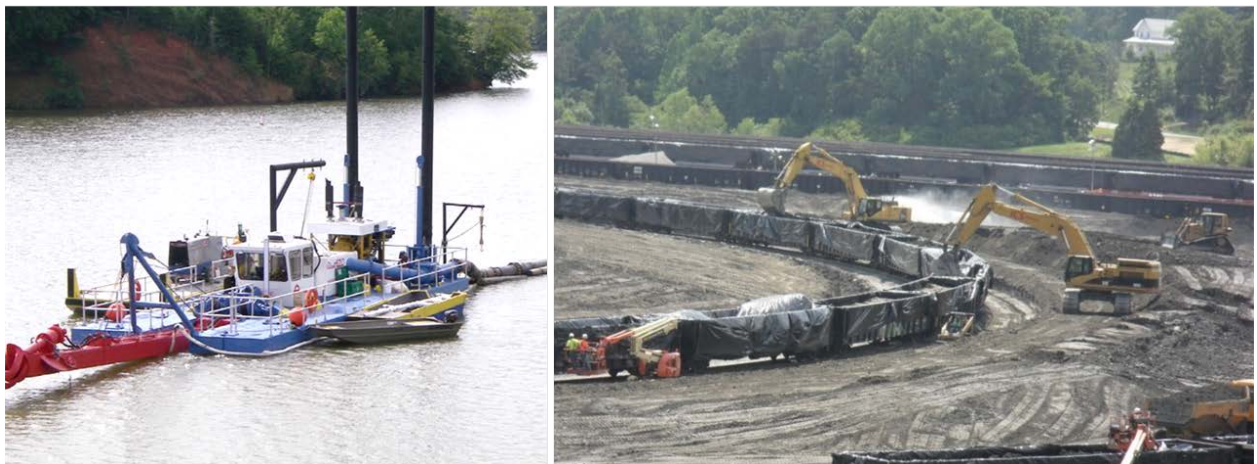
Figure 4. Dredging and load-out to railcars during Time-Critical ash removal.

Ash was removed from the river by mechanical and hydraulic dredging (Figure 4). Commencing in January 2009, dredging operations continued around the clock, typically seven days per week. The materials removed included ash, displaced soils, and sandy river bottom sediments. Processing areas were established to de-water and condition the materials prior to off-site shipment. Dredge water was circulated through sluice trenches excavated in the area immediately south of the ash pond, and the ash pond was used to further remove suspended solids prior to discharge of water back to the river. The recovered ash was dipped out of the sluice trench, moved, turned, and stacked multiple times to promote drainage and evaporation, until the water content was low enough for shipment.

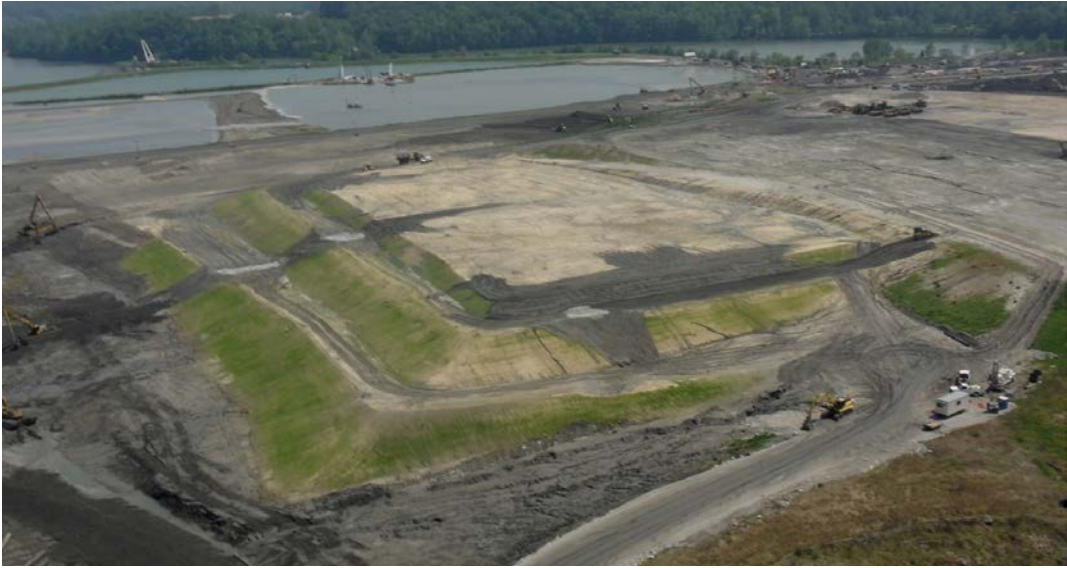
Figure 6. Aerial view of the completed test embankment.

With no warning at the surface, excess pore pressures generated by embankment stacking can trigger undrained failures in the underlying foundation ash. A test embankment program was completed during Phase 1 of the recovery, to demonstrate how instrumentation and engineering evaluation could be used to monitor the effects of loading on the deeper ash deposits. About 250,000 cubic yards of conditioned ash were stacked within the footprint of the failed cell (Figure 6), with extensive instrumentation and a well-defined monitoring program. The success of the test embankment program helped to allay concerns that new stacking would trigger another failure.

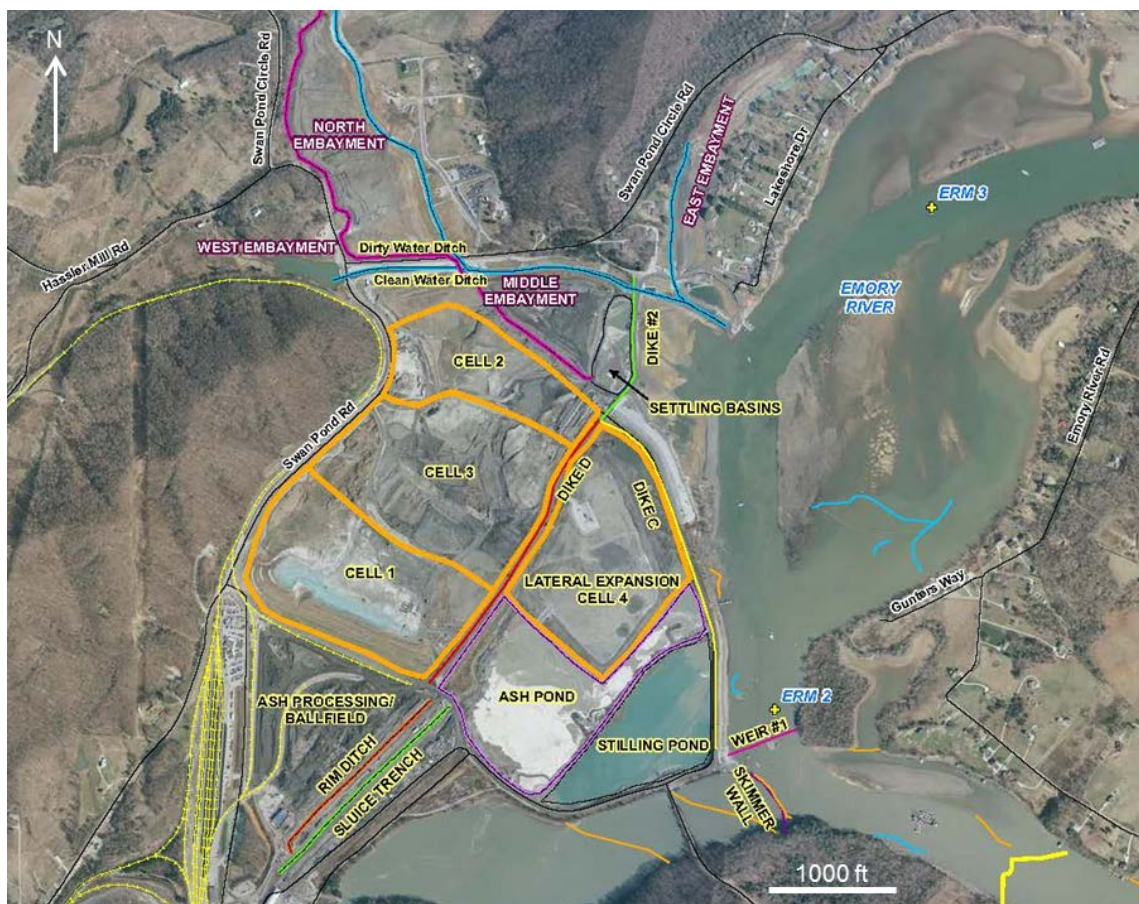
Figure 7. Primary site features at the Kingston Recovery Project.

During construction and prior to final regulatory release of the site, the storm water runoff is collected using a series of transverse ditches that discharge into armored flumes and drainage structures. To meet environmental regulations, runoff is conveyed to either the existing Stilling Pond or to the temporary settling basin in the Middle Embayment (Figure 7). Storm water routing had to be continually modified during construction, to accommodate both ash stacking and perimeter construction. Furthermore, when the power plant was converted to dry ash handling, production flows to the Ash Pond complex were greatly reduced. Drainage along the south side of the Ash Pond was then modified with the installation of pipes, to create needed spaced for perimeter construction.

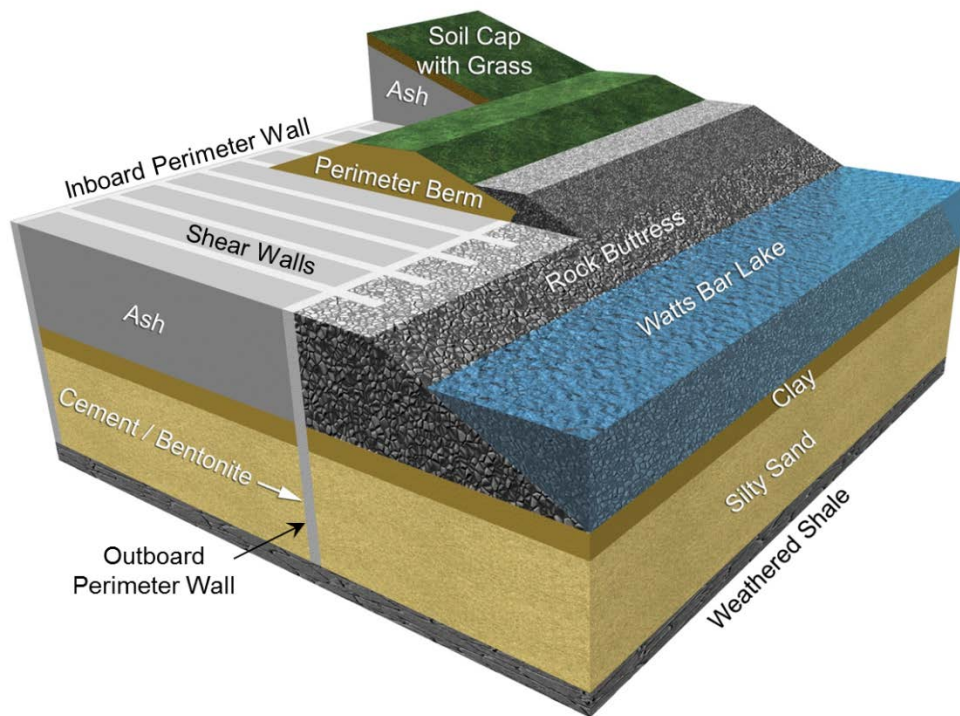
Figure 8. Rendering of the stabilized perimeter built around the Kingston ash landfill.

The landfill perimeter was designed to provide stability in an earthquake, and contain the stored ash with extensive liquefaction. The engineering design of this system is described by Rauch et al. (2013). The perimeter is comprised of an earthen berm built atop a grid of buried retaining walls, as depicted in Figure 8. Evenly spaced shear walls are oriented perpendicular to the landfill perimeter; in an earthquake, the shear walls will transfer the outward lateral thrust from the landfill to the underlying bedrock. Depending on the location, some segments include circumferential, perimeter walls on the inboard and/or outboard ends of the shear walls. The perimeter walls prevent liquefied ash and sand from pushing out between the shear walls. All of the foundation walls are socketed into shale, with a required bedrock embedment between 1.8 and 6.9 feet, depending on the location. The stabilized width varies between 50 and 100 feet, the shear walls are spaced between 14.6 and 20.4 feet apart, and the wall depths vary between about 40 and 70 feet.

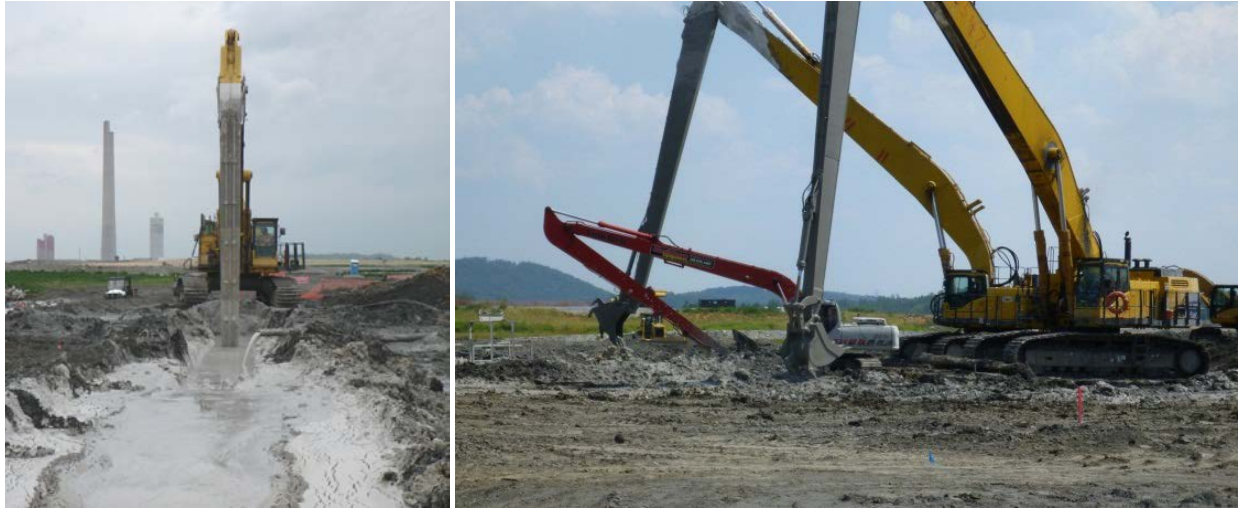
Figure 9. Slurry wall construction for the stabilized perimeter.

The original design concept assumed the walls would be built with deep mixing, where augers are used to mix cement with the in-situ soils. However, the bid package encouraged and allowed for contractors to propose alternate means of construction. The selected bidder (Geo-Con) proposed slurry trench methods to build the walls, and is using high capacity, long-reach, hydraulic excavators to dig trenches supported with slurry (Figure 9). Ripper teeth, installed on the back of the excavator bucket, are used to dig the bedrock sockets. The trench slurry is a mix of blast furnace slag cement and hydrated bentonite (cement-bentonite) that hardens over time after excavation is complete. The required unconfined strength of this material is 200 to 265 psi, depending on the perimeter section. The project team elected to construct four-foot thick walls, and the design allows for varying the shear wall spacing to achieve the specified treatment ratio. To stabilize the entire two-mile perimeter of the landfill, about 520,000 cubic yards of slurry walls will be required. Figure 10 shows an area where the completed walls have been excavated, along the edge of the restored lake.

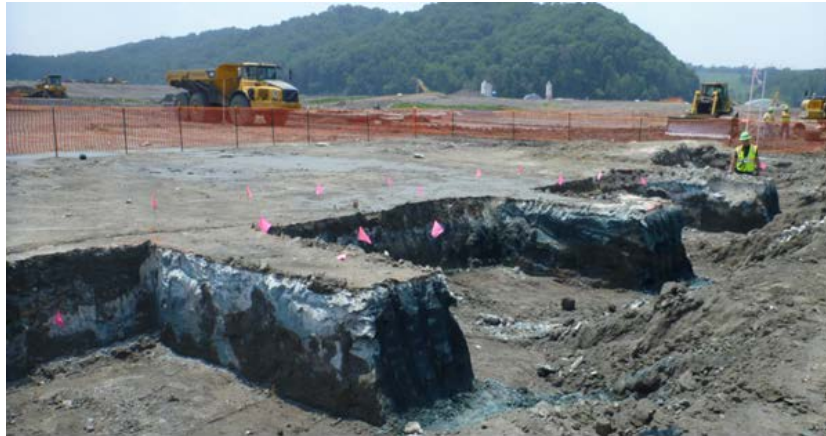
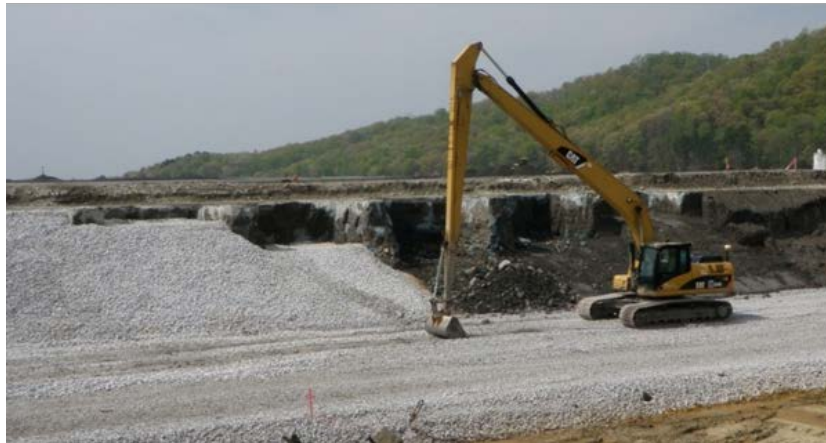
Figure 10. Excavation of ash between completed slurry walls and placement of the rock berm along the restored lake shoreline.

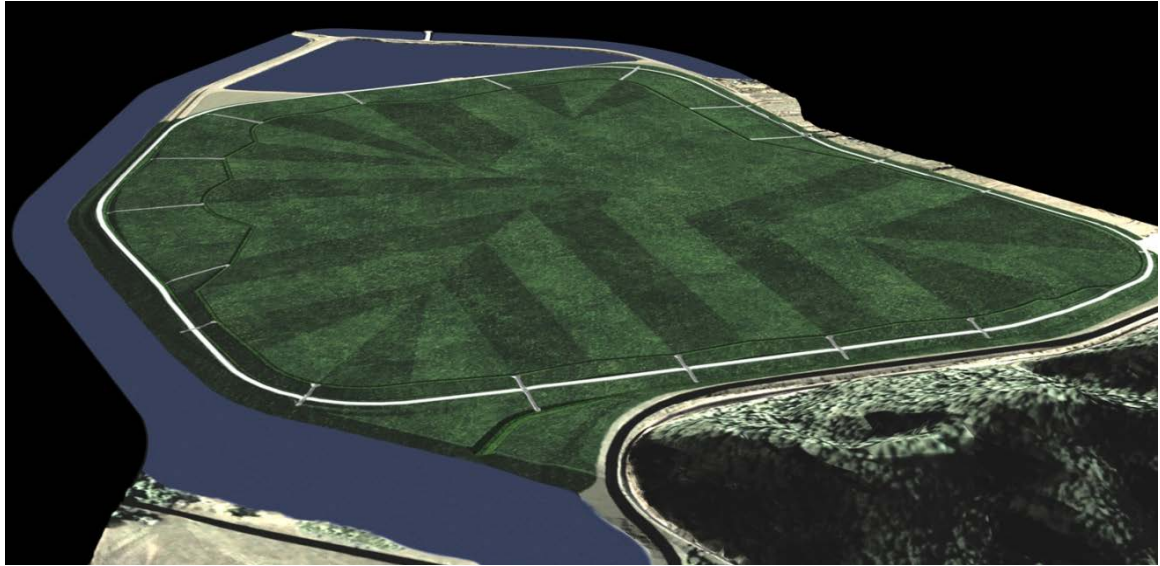
Figure 11. Final closure geometry for the Kingston ash landfill.

Given the large area and restricted crest height, the cap will be relatively flat across the top (Figure 11). To improve drainage, a serrated surface was developed with two percent cross slopes and a one percent drainage gradient towards the out slope. These serrations will collect runoff and convey it to flumes that will discharge to ditches, piping systems, or directly to the river.

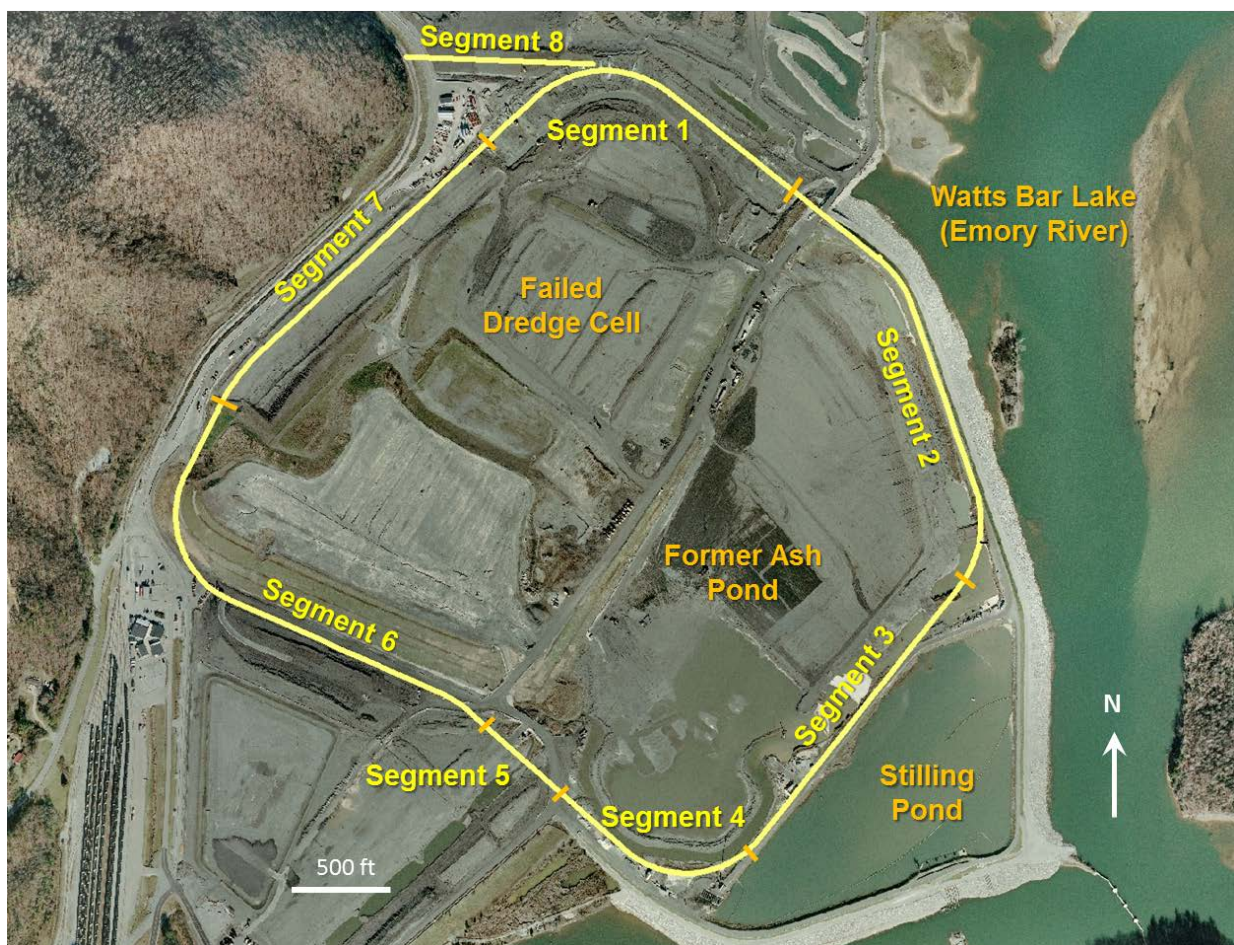
Figure 12. Delineation of design segments for perimeter stabilization.

The designated design packages provide for phased and concurrent construction of the primary landfill components, including the ash embankment, perimeter foundation improvements, and final cover. Figure 5 represents a cross-section of the closed configuration, and illustrates how these components tie together. The project was divided into three ash stacking designs, eight perimeter design segments (Figure 12), and four design packages for final cover. Each package consists of stand-alone drawings, specifications, engineering calculations, and other supporting documentation.

The design schedule is compressed to support recovery project milestones. To accelerate the design and review process, some of the later design sections were combined. For example, perimeter Segments 3 and 4 are contained within one combined design package.
