**Experimental investigations and non-linear numerical analyses
of skewed one-way prestressed concrete bridge decks**

Volume 1 : Experimental Investigations

**Thesis submitted in accordance with the requirements of
the University of Liverpool for the degree of**

Michael D Cope

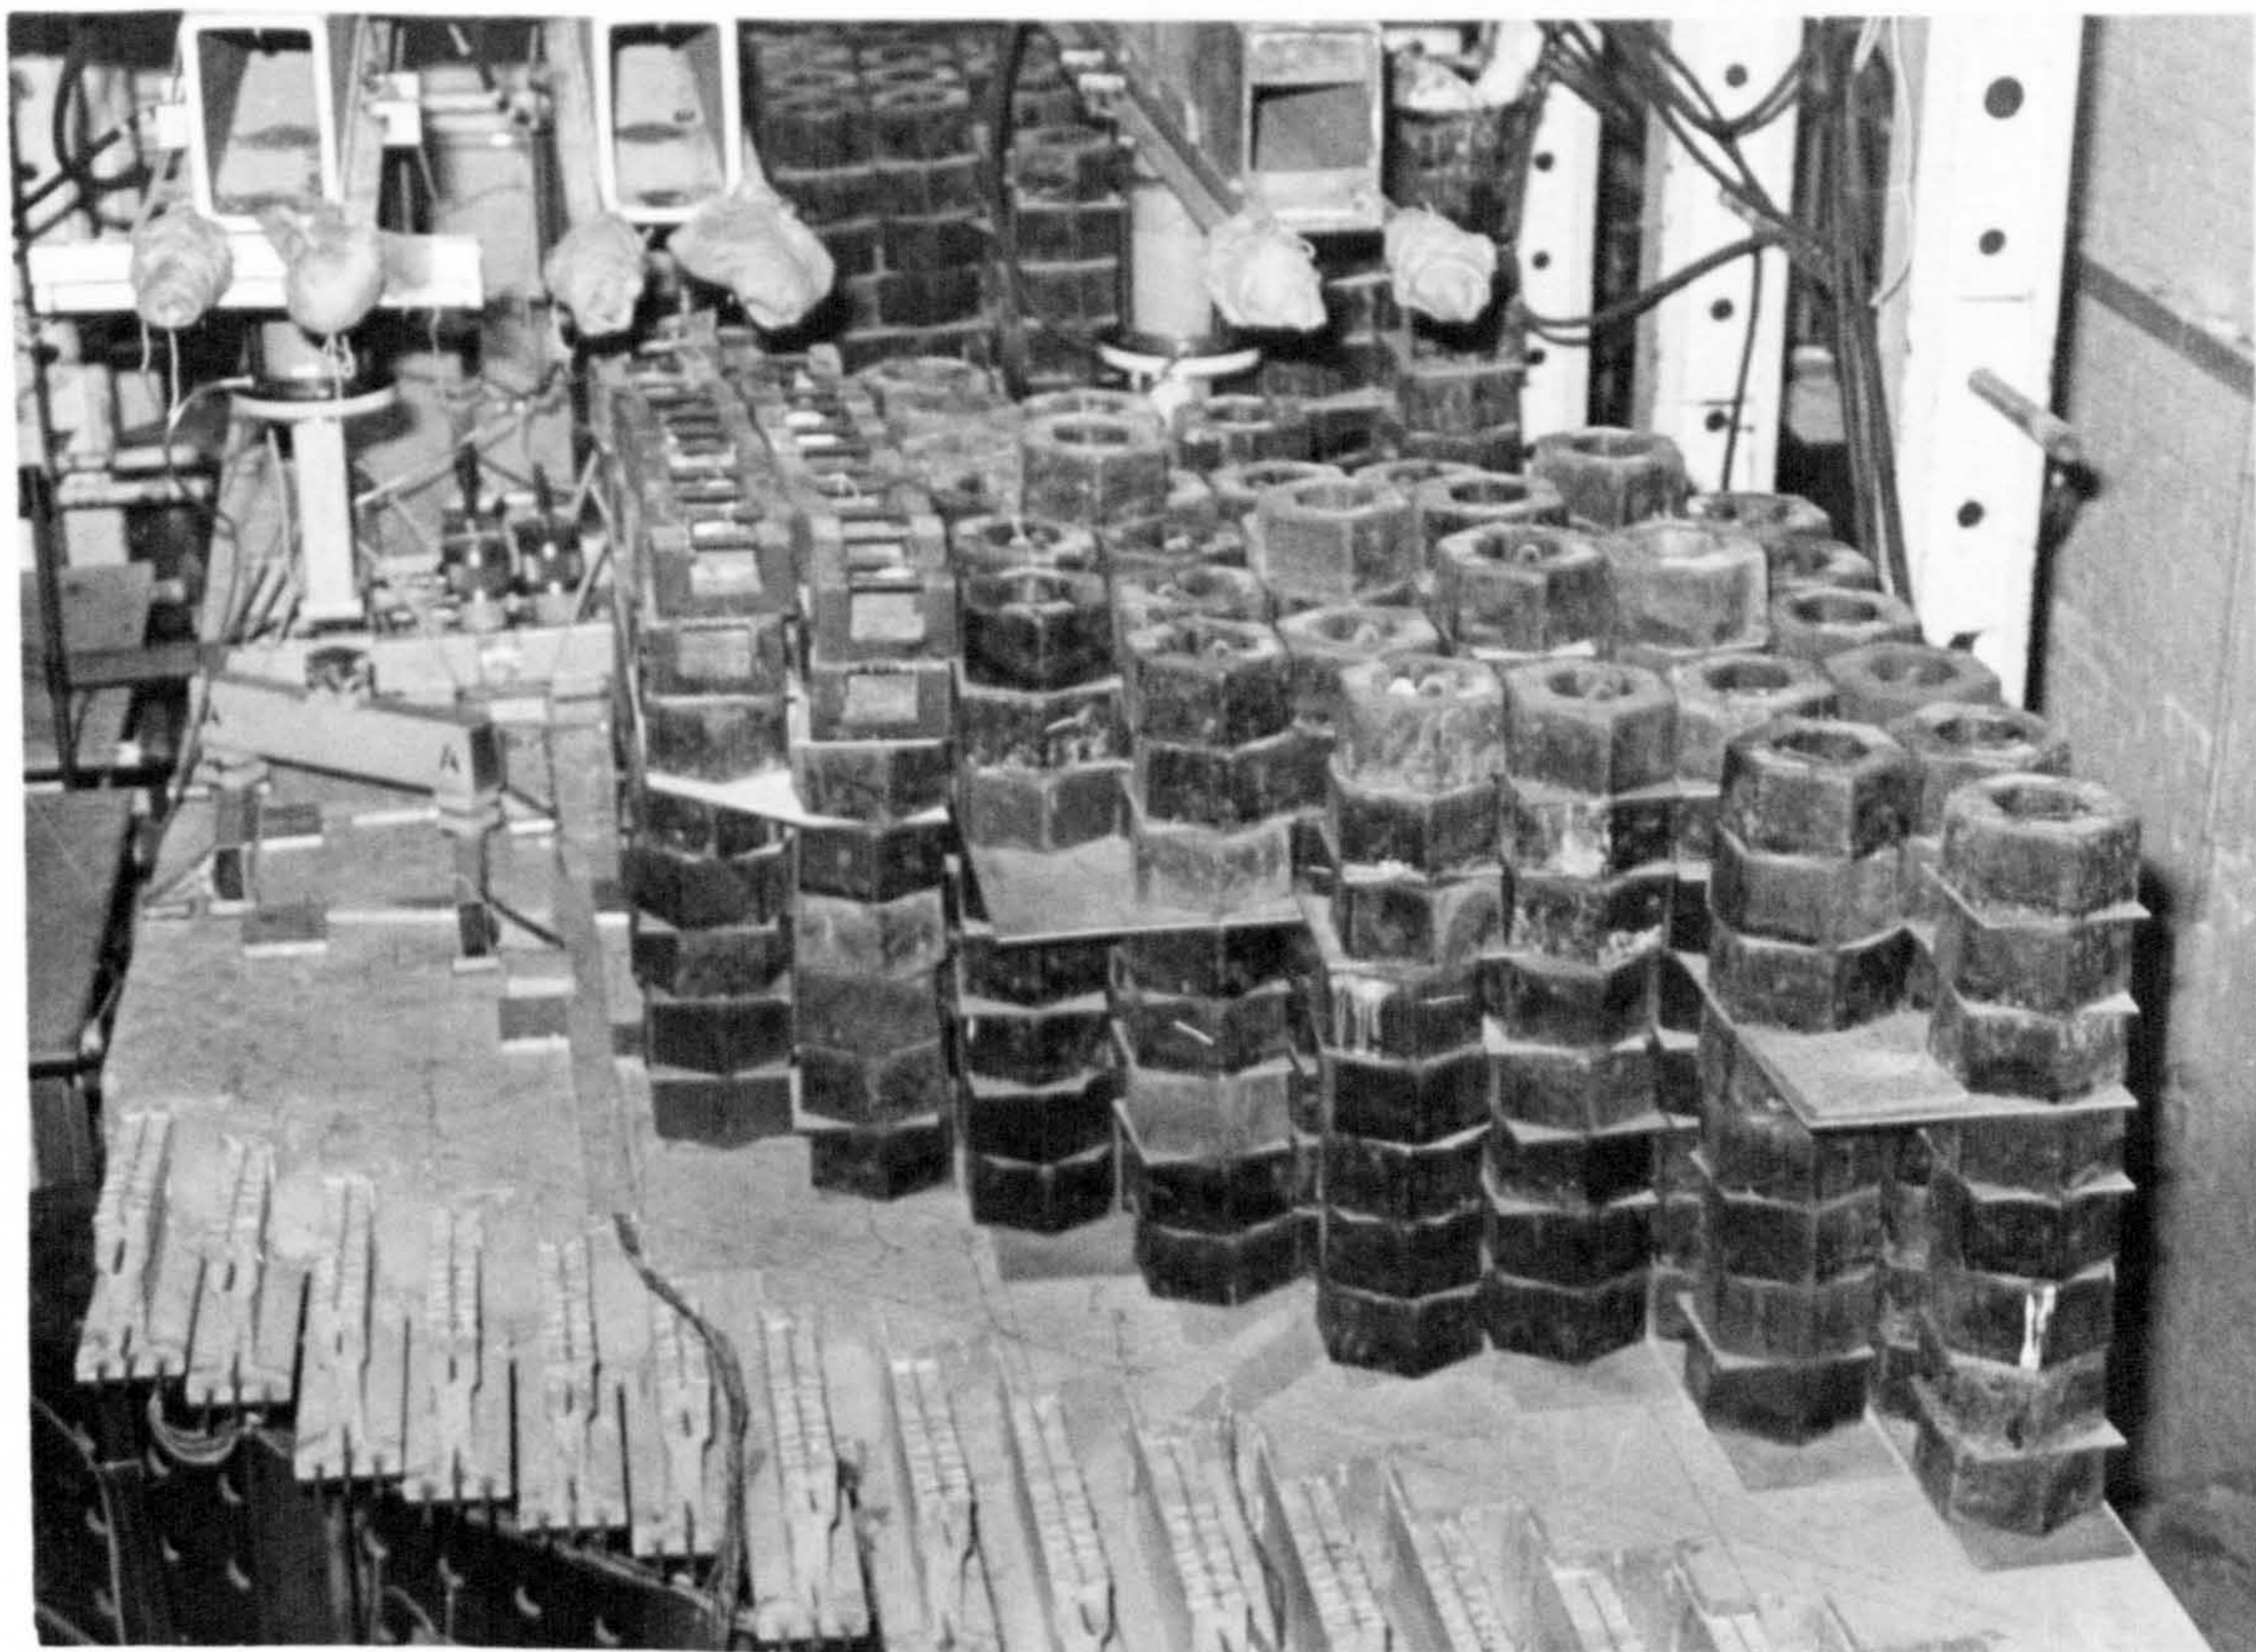
PLATE 7.1 GENERAL VIEWS OF MODEL 2 DURING TESTING

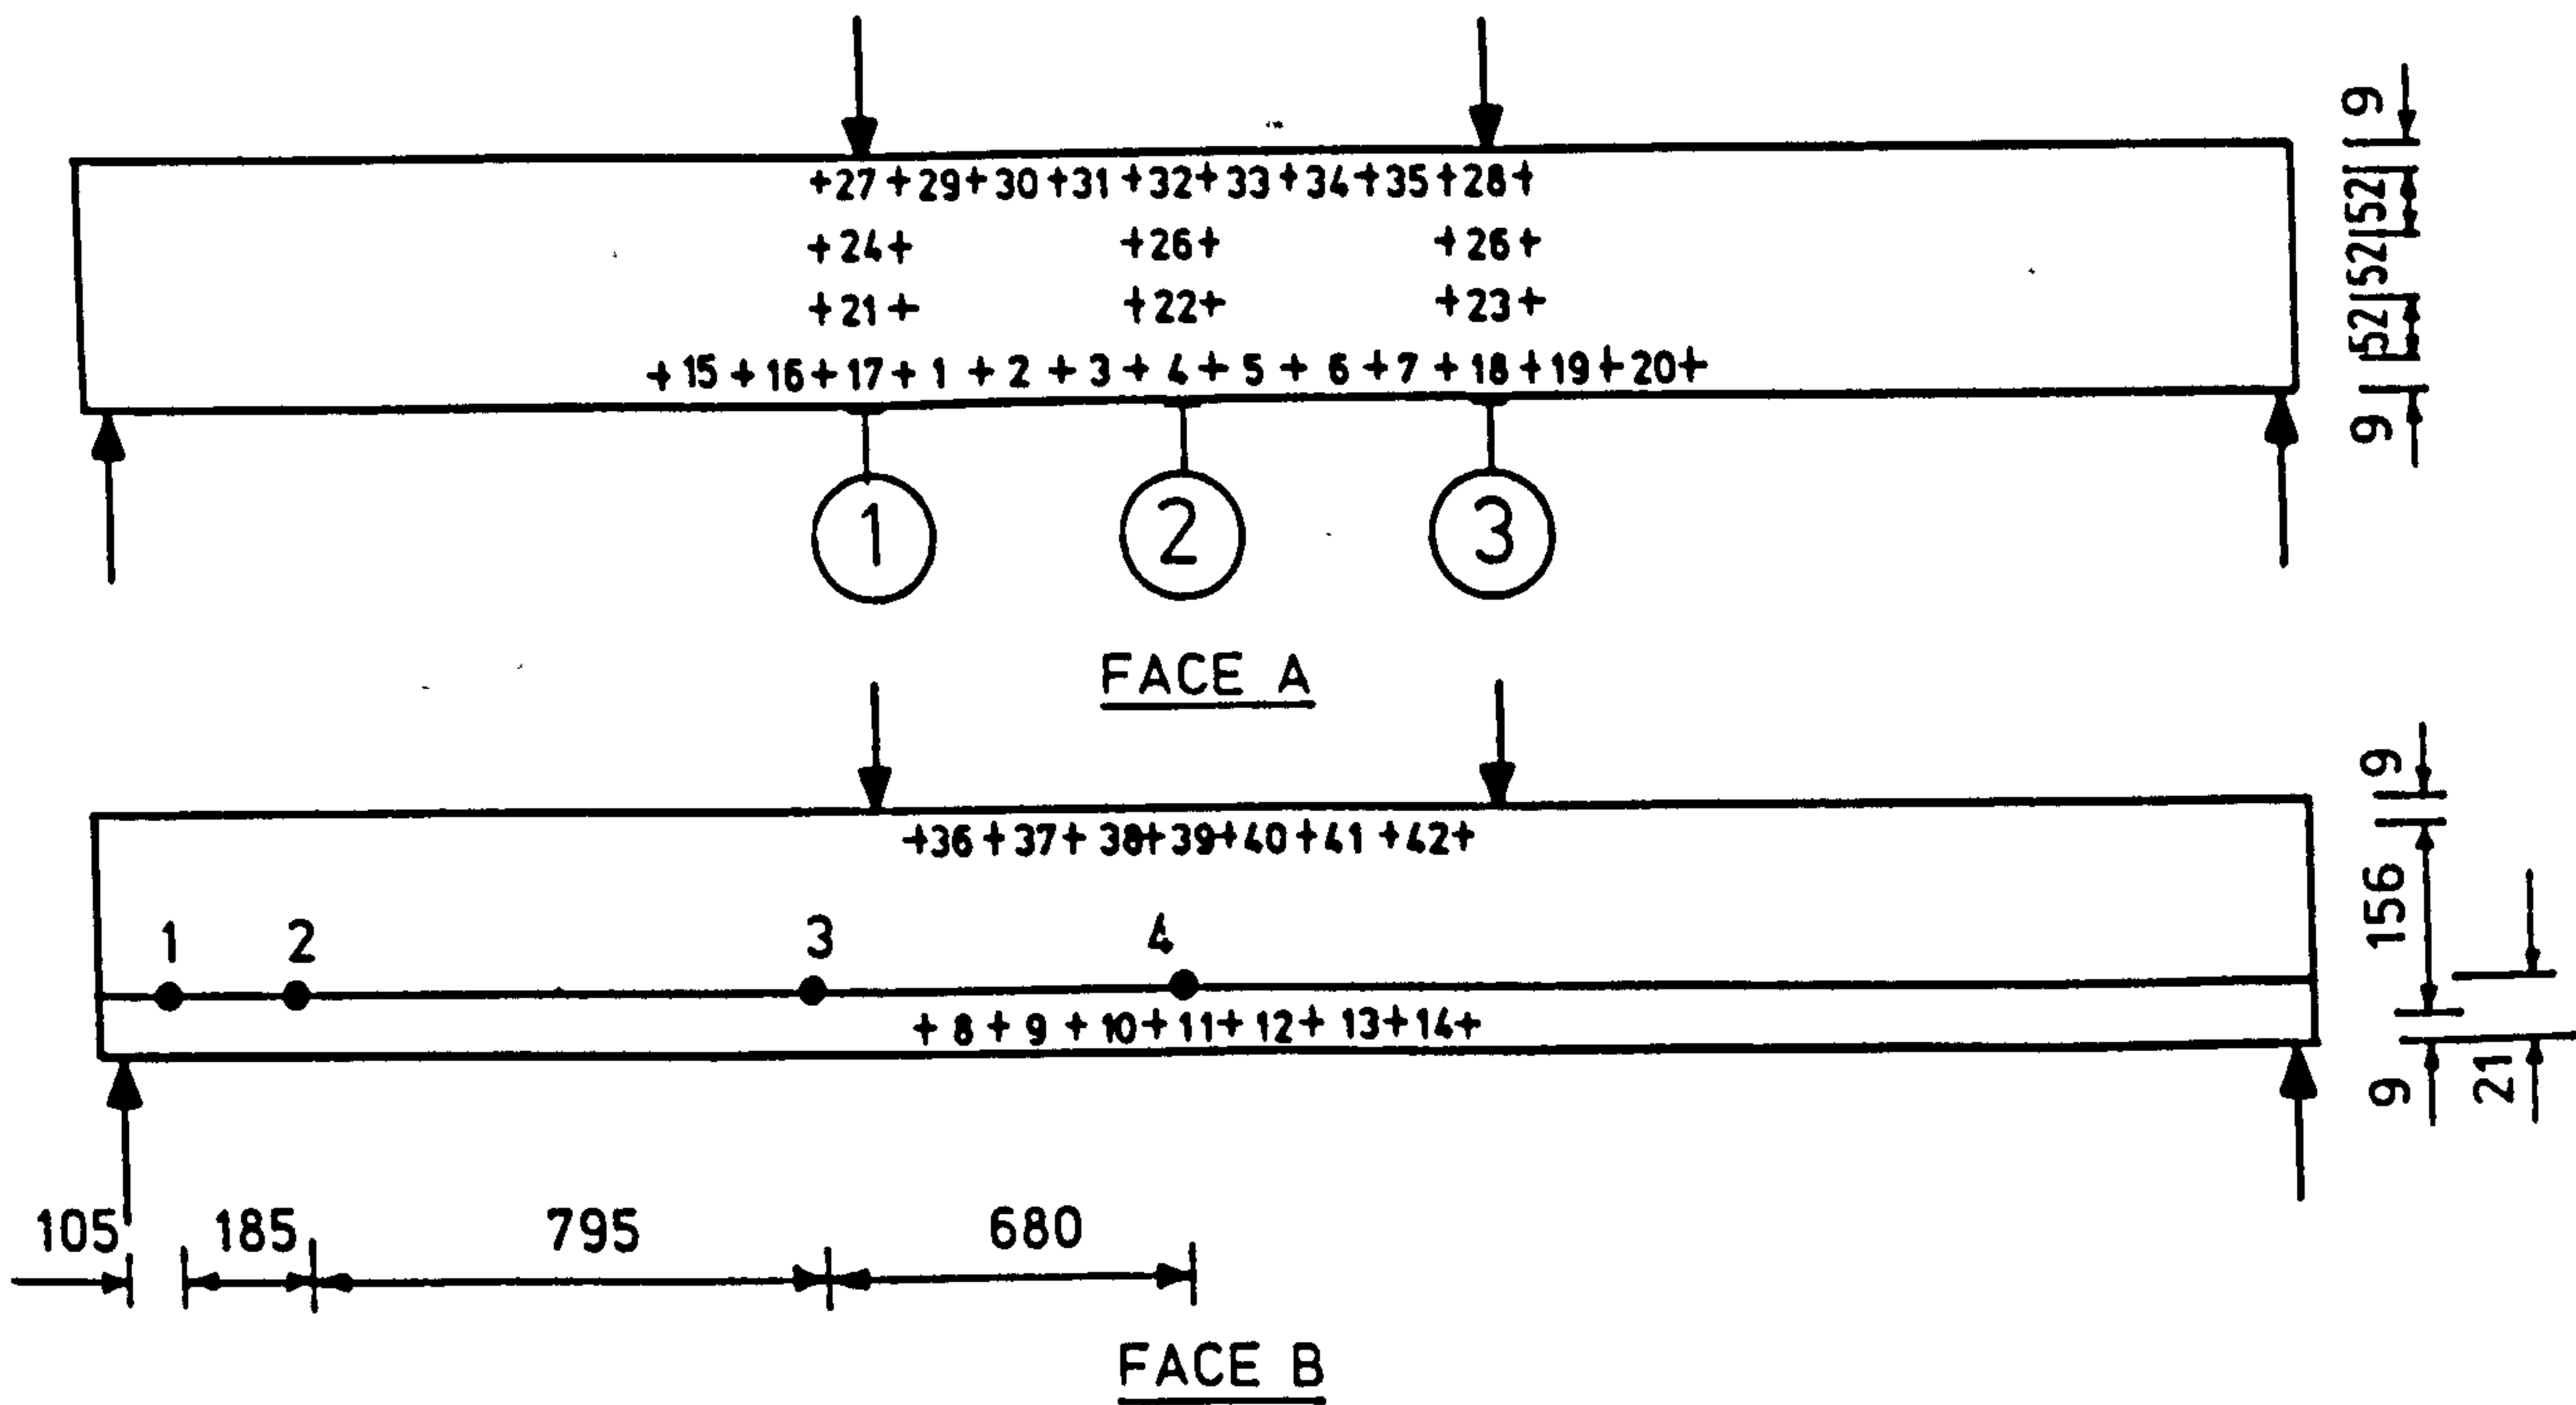
FIG. 2. TRANSDUCER AND DE-MEC POINT LOCATIONS FOR NEW BEAM

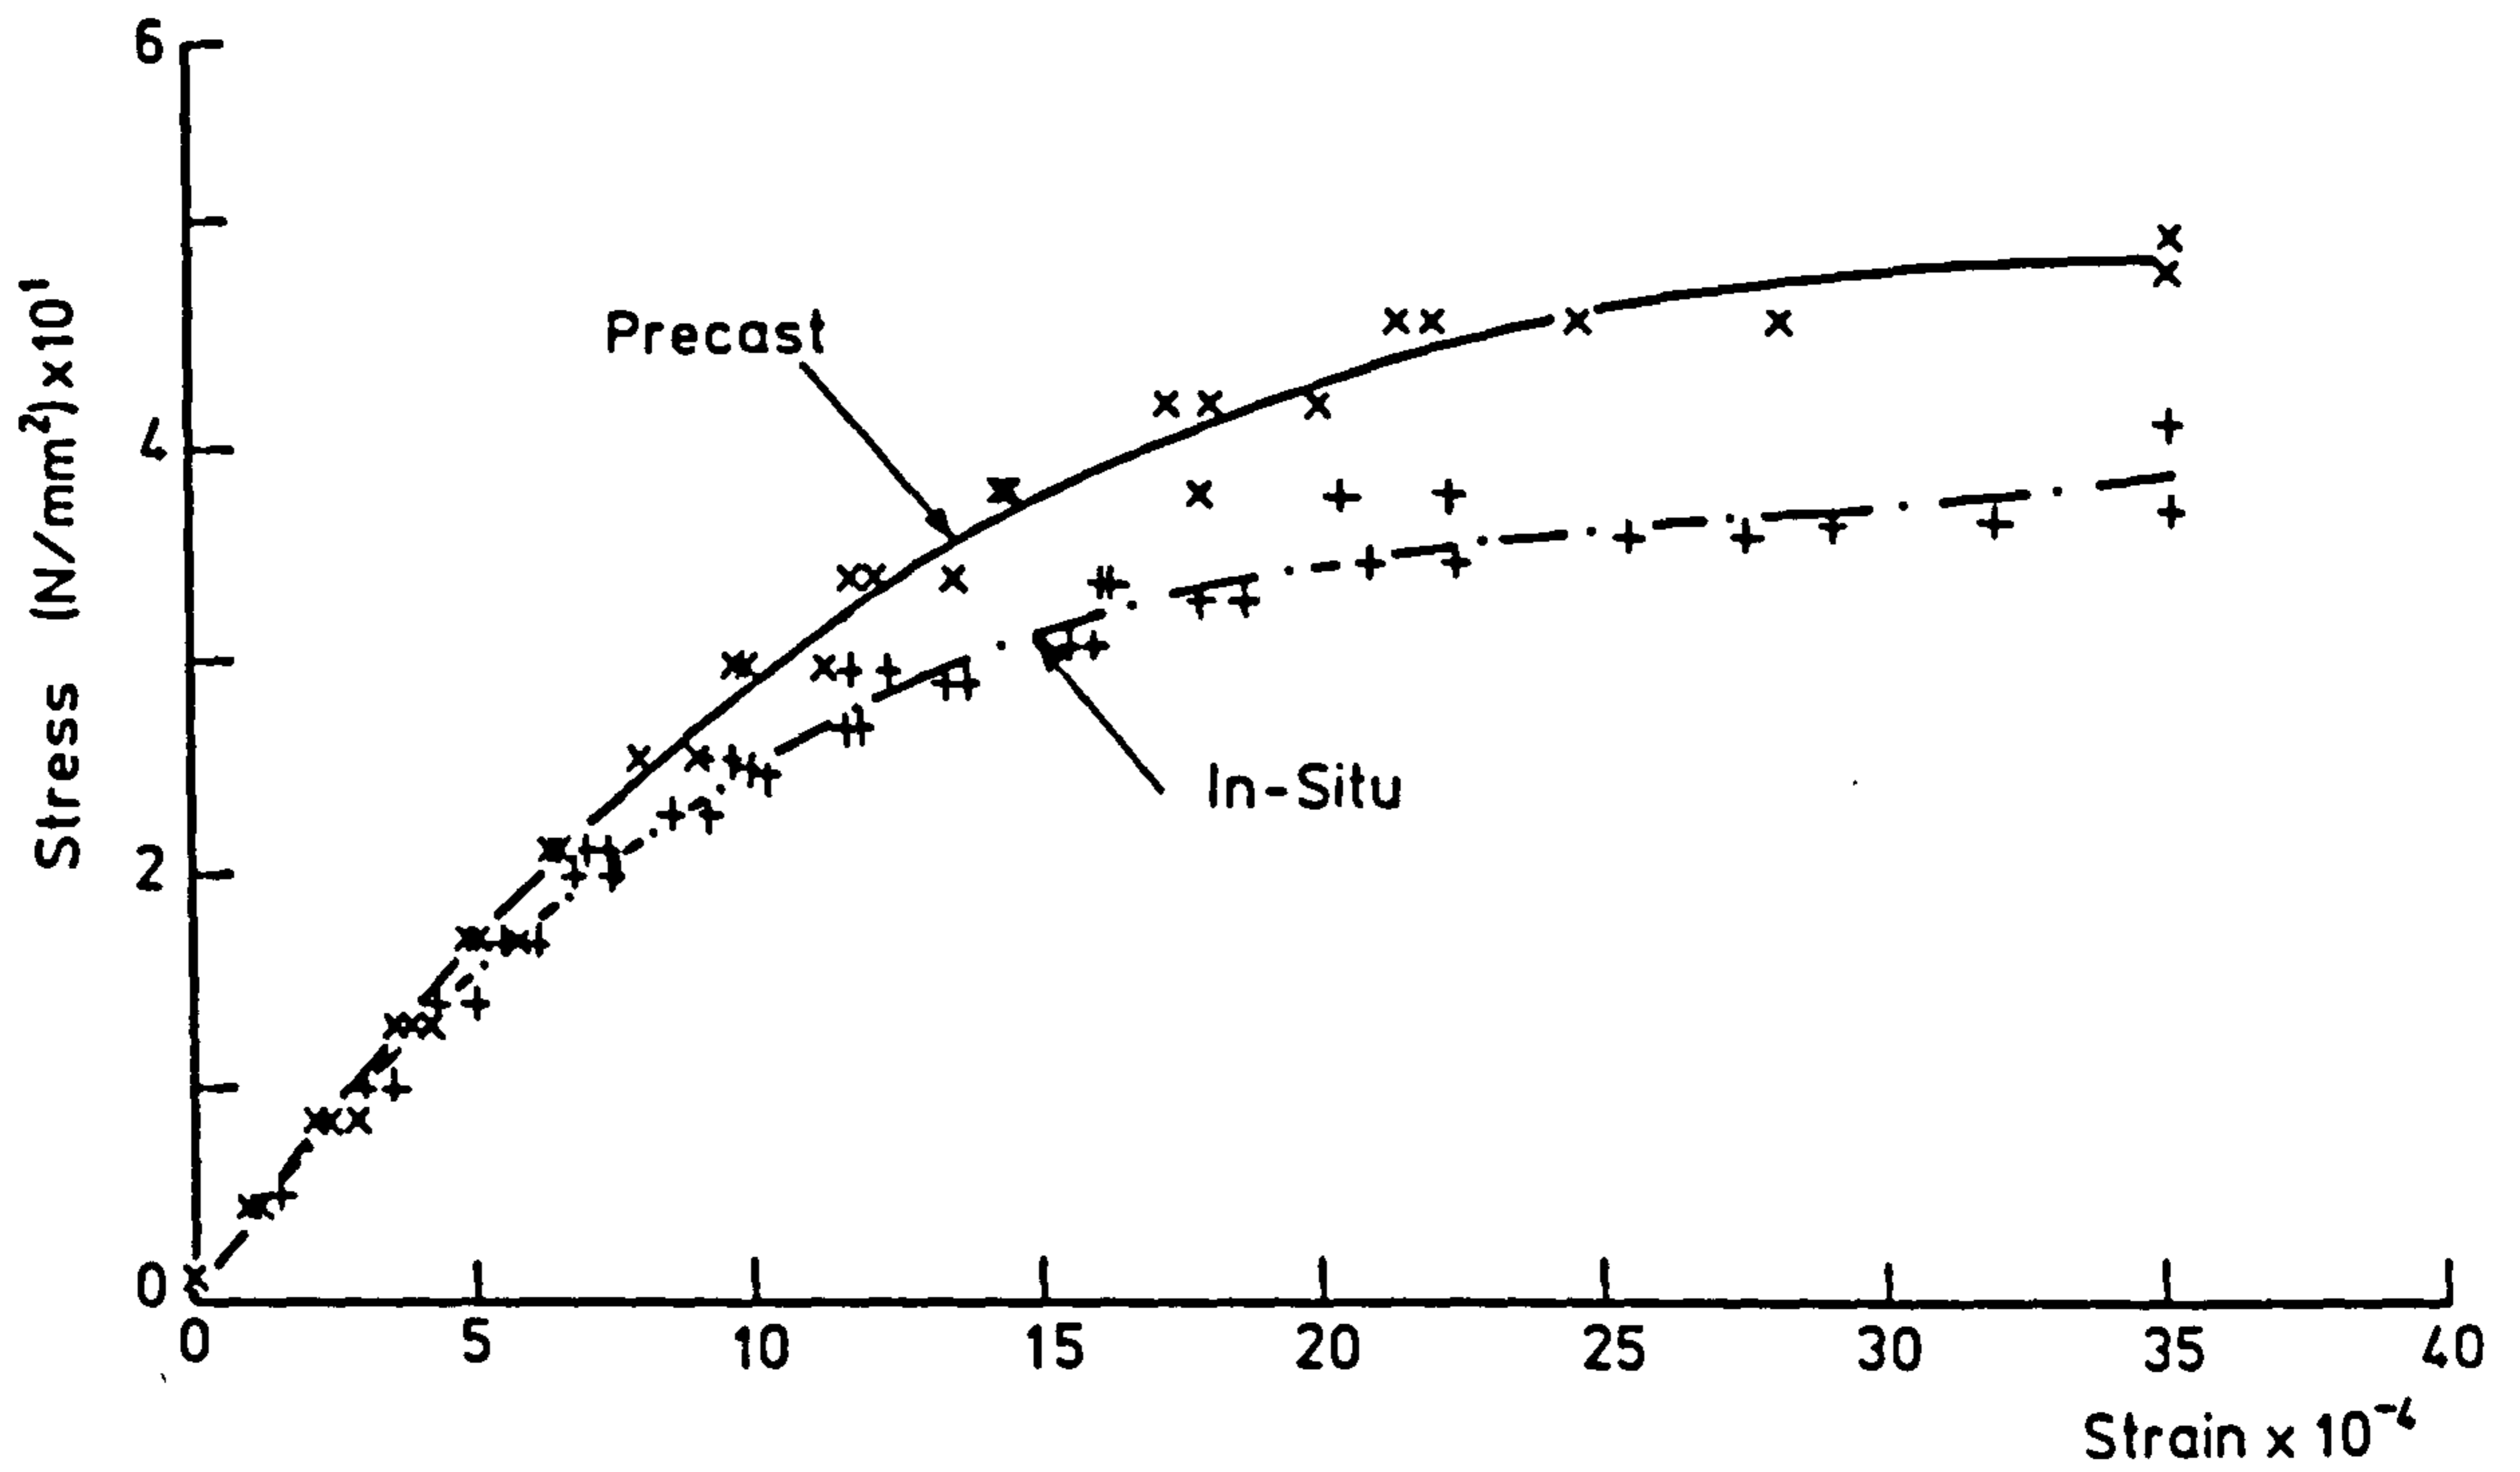
FIG. 3. CONCRETE STRESS-STRAIN DIAGRAM

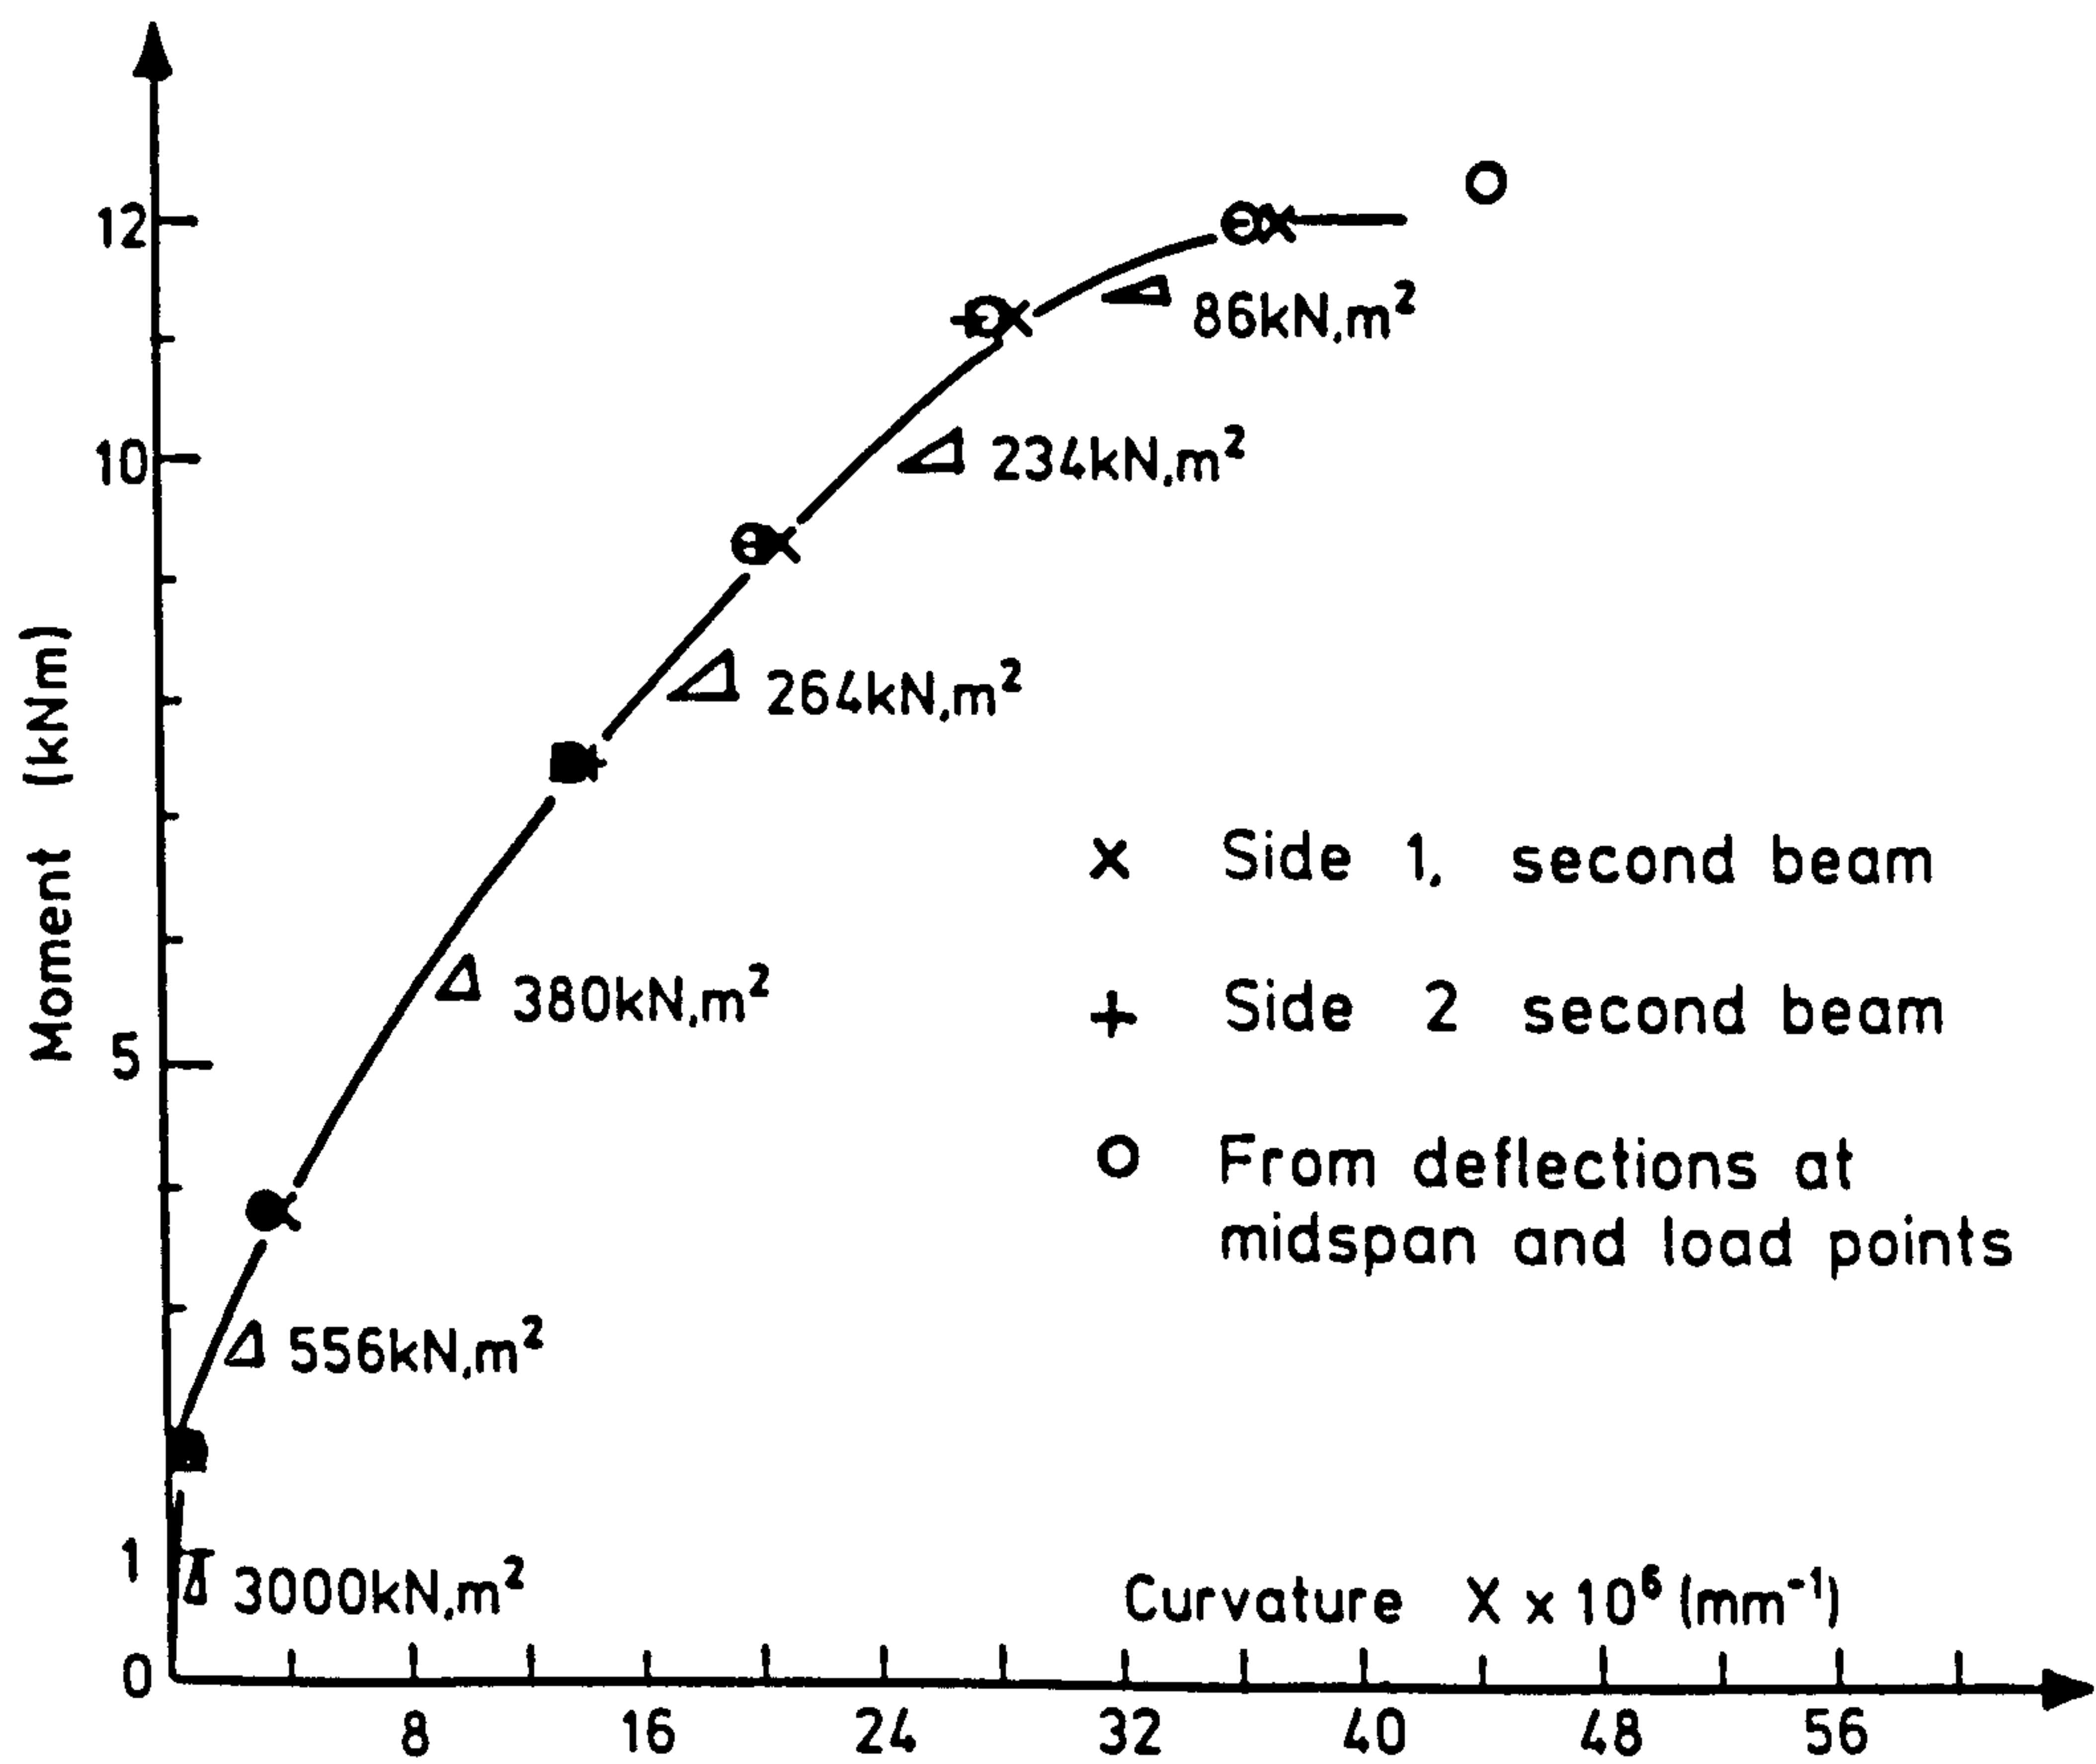
**FIG. 2. MOMENT CURVATURE OF TRANSVERSE SECTION
BASED ON STRAINS AVERAGED OVER 1200 mm
AND DEFLECTIONS.**

Incremental average values of flexural stiffness are shown on Fig. 2. The calculated value for an elastic, cracked section is 435 kNm². It can be seen that the calculated value gives a reasonable prediction of

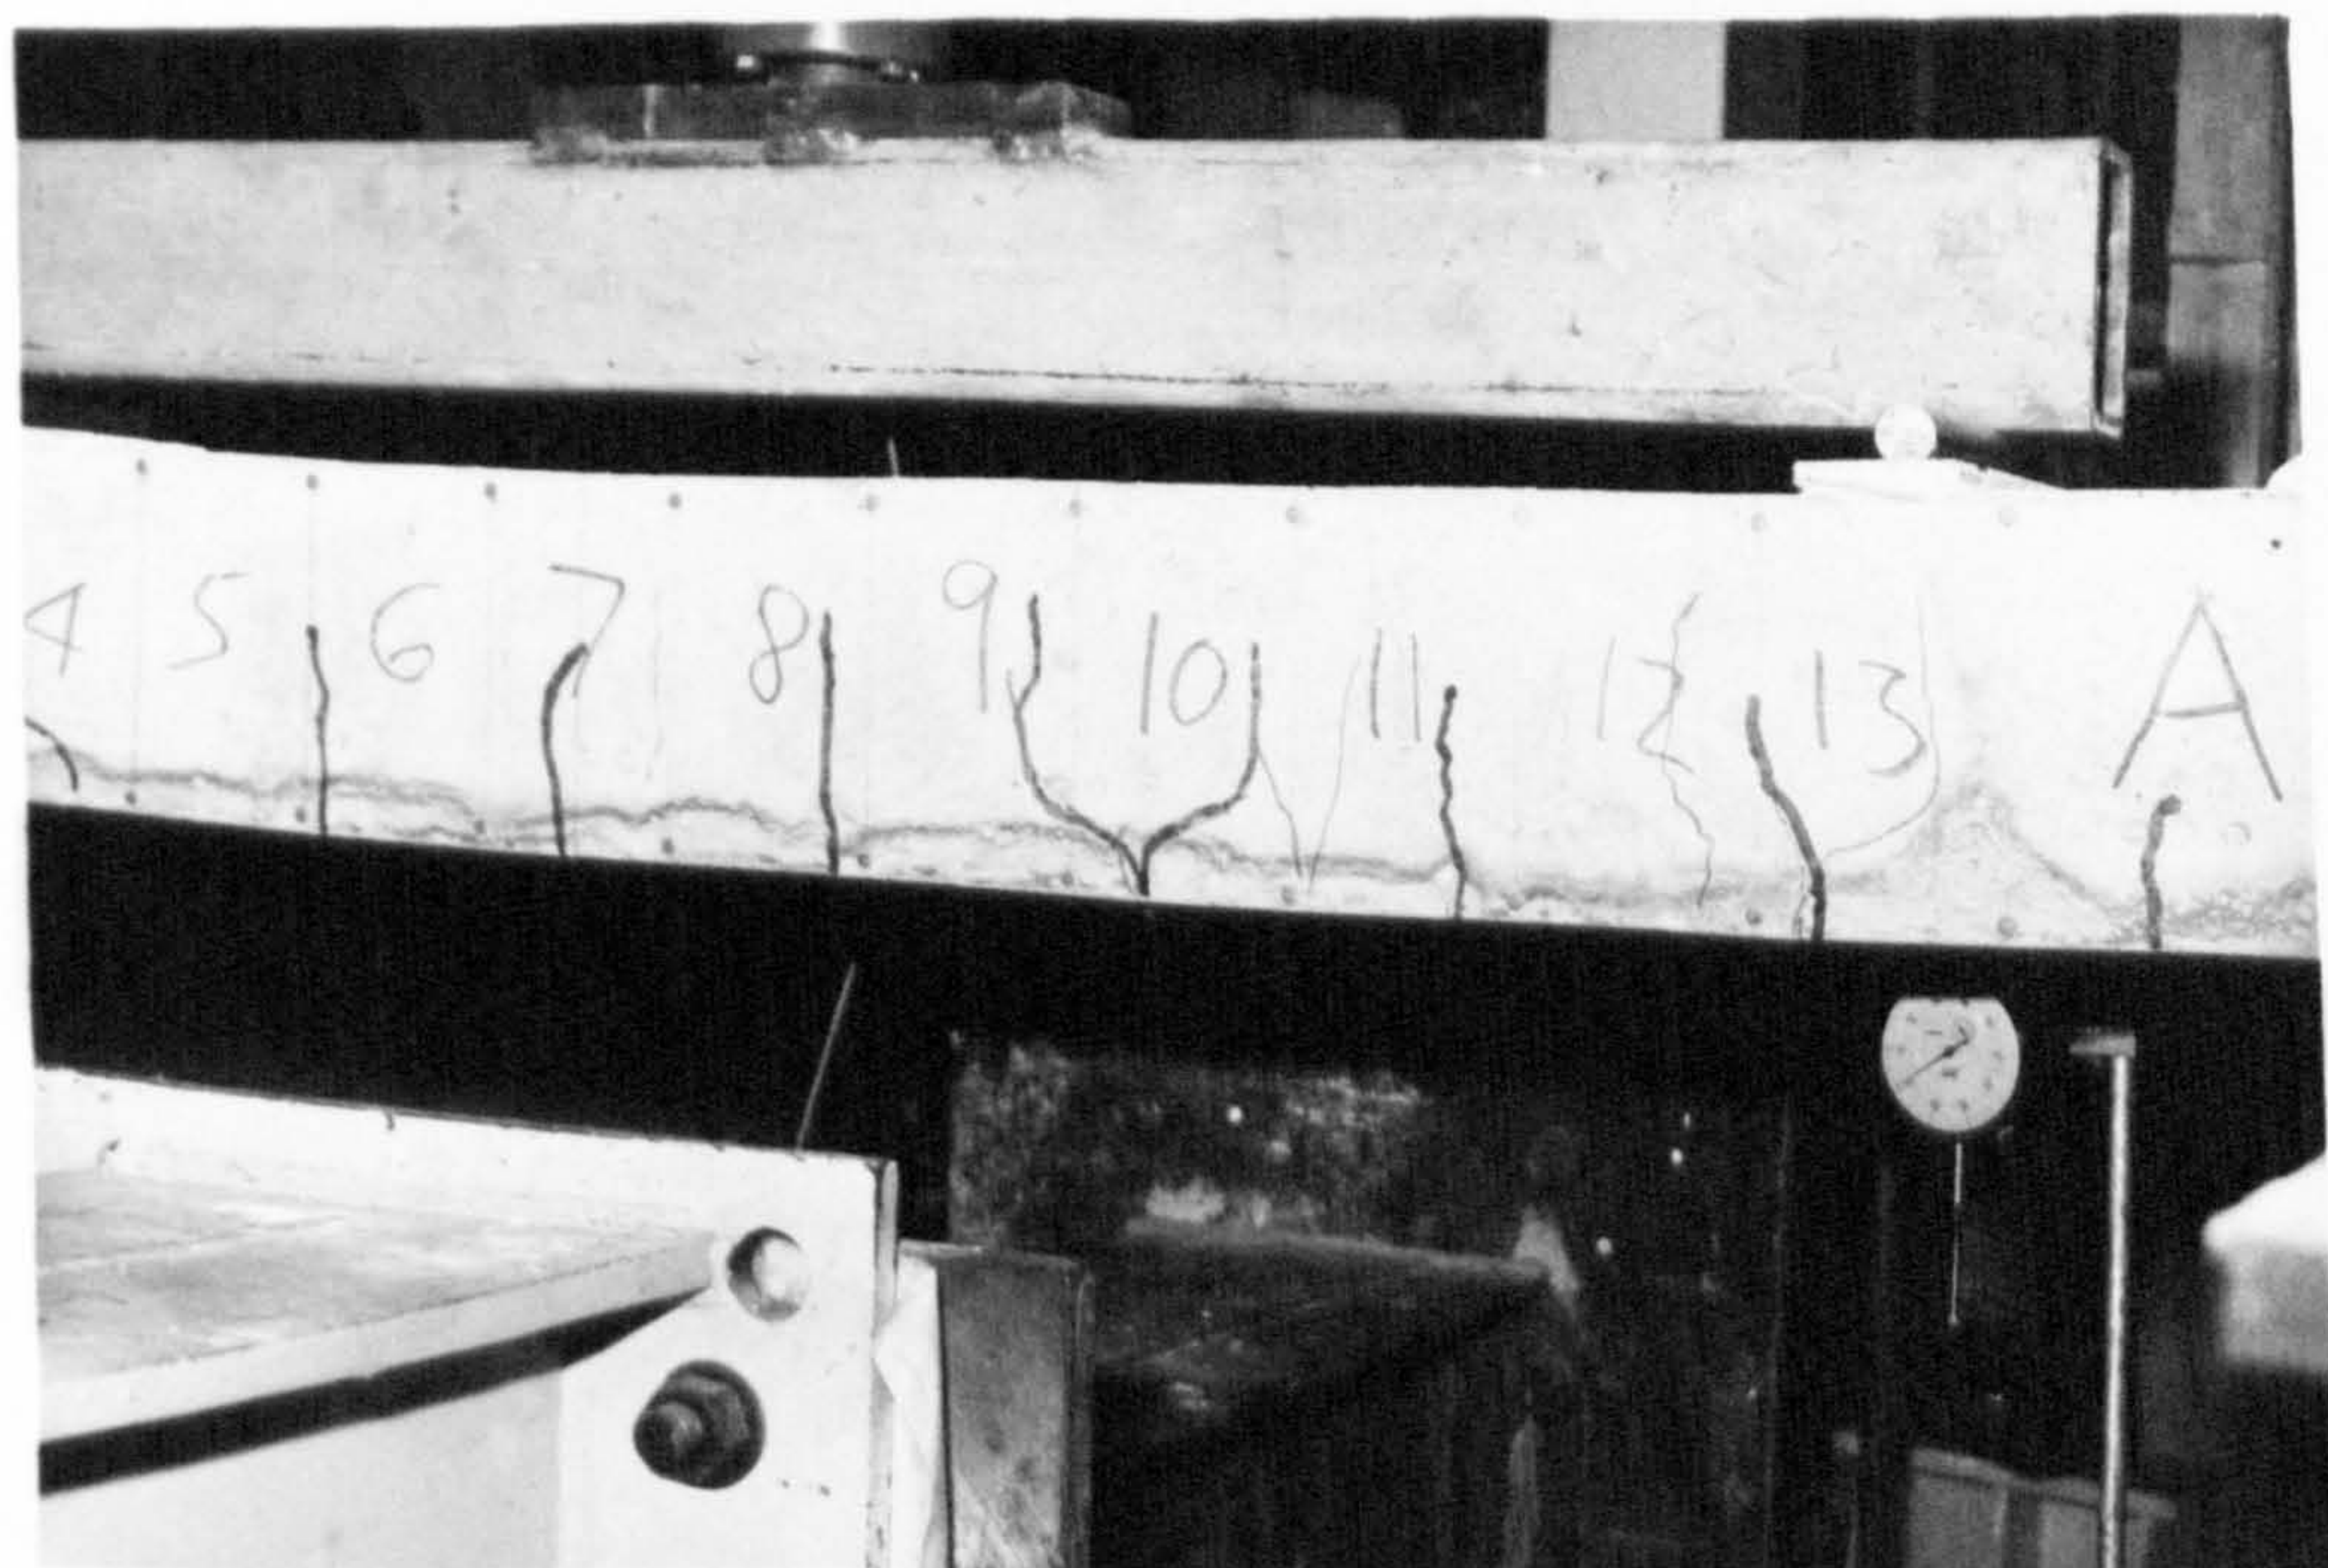
PLATE 3 Crack Pattern on Elevation
