Experimental Study on Carbonation Resistance and Water Absorbing Property of Concrete Crack with repair

Naoko Tsuchiya¹ and Kaori Nemoto²

Abstract. Existing RC Buildings have some cracks and the repairing service might last the buildings for long life. The durability of the RC component is evaluated by several ways as like as carbonation resistance test, permeability test, water penetration test, and so on. Therefore, it need to be measured how much advantage the concrete crack with repair have for the durability. The aim of this paper is to study on advantage of repairing a crack of concrete to the carbonation resistance and the water-absorbing property by the experimental way. The specimens were prepared in the following point. The finishing (direct finishing and mortal tile finishing), crack width (0, 0.05, 0.5, and 2mm), and choice repairing or not. All concrete specimens were formed 10 x 10 x 20cm and those W/C were 0.55. Then, the specimens were tested by the accelerated carbonation. After 4, 8 and 26weeks accelerated carbonation, the carbonation depth and the carbonation shape of the concretes were measured by 1% phenolphthalein reaction. Also, the amount of absorbed water

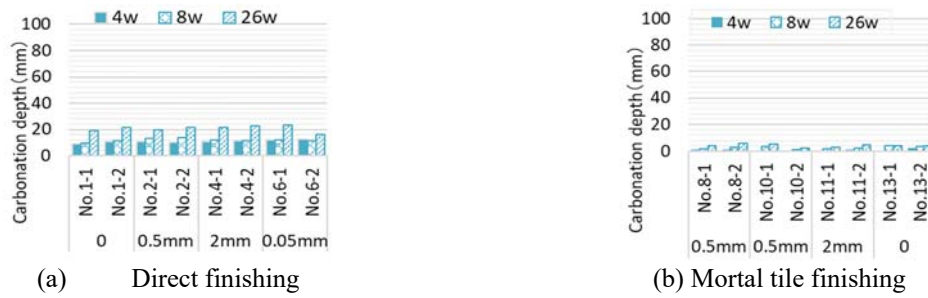
Figure 3. shows the carbonation depth on y-y' and z-z' cut side of the no-repair case. In case

Figure 3. The carbonation depth on y-y' and z-z' cut side of the no-repair case.

of the direct finishing, the carbonation depth at 4, 8 and 26 weeks were 7~13mm, about 12mm, and 16~24mm respectively. Also, it were under 3mm, 4mm and 6mm respectively in case of the mortal tile finishing.

From the results in Figure 3. and Figure 4., the carbonation depth at each term were same, regardless of repair or not. That shows the process of carbonation located on 5cm away from a crack were not relate with a crack or repair.

Figure 5. shows the carbonation depth on x-x' cut side of the no-repair case. From the results of 'max' of No.4 and No.6, the carbonation depth were about 20mm at 4weeks, that was twice of the result of y-y' and z-z' cut side at Figure 3 (a). And the results at 8 and 26weeks were so large as 30mm and 50mm. Also, the results of 'ave. of 2cm around a crack' of No.2, No.4, and No.6 were about 15~20mm at 4weeks, that was about half time of the result of y-y' and z-z' cut side. And No.2 at 26weeks were 100mm. Meanwhile, the result of No.1, which don't have cracks, at 4, 8 and 26weeks were about 10mm, 10mm and 20mm each, regardless of 'Max', 'ave. of 2cm around crack', and 'ave. of 10cm around crack', that was close to the results of y-y' and z-z' cut side.

Both 'Max' and 'ave. of 2cm around a crack' results were more than double for that of y-y' and z-z' cut side as showed in Figure 3. So, these 'Max' and 'ave. of 2cm around a crack' results of x-x' cut side were so larger than that of y-y' and z-z' cut side.

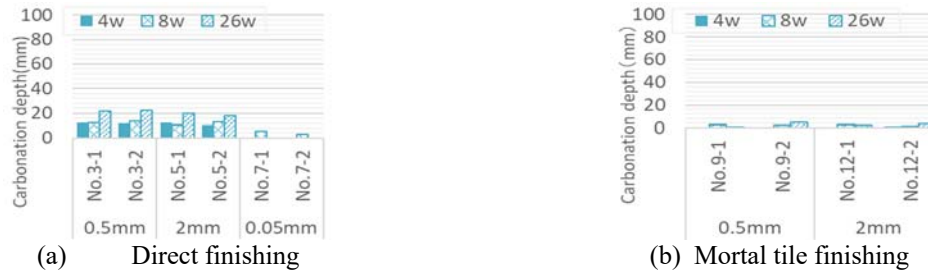
Figure 4. The carbonation depth on y-y' and z-z' cut side of the repair case.

Figure 4. shows the carbonation depth on y-y' and z-z' cut side of the repair case. Except No.7, the carbonation depth at 4, 8 and 26 weeks were 10~12mm, 12~14mm and 18~23mm respectively in case of the direct finishing, that was close to the results of the no-repair case. Also, it were under 2mm, 3mm and 5mm respectively in case of the mortal tile finishing, that was also close to the results of the no-repair case. Note, No.7 were coated at all face with the flexible synthetic resin emulsion, so carbonation did not go.

Figure 6. shows the carbonation depth on x-x' cut side of the repair case. The 'Max' of No.3 and No.5 at 4, 8 and 26 weeks were about 13mm, 13mm and 23mm, also that of 'ave. of 2cm around a crack' were about 11mm, 11mm and 18mm, and also that of 'ave. of 10cm around a crack' were 11mm, 11mm and 20mm respectively. So, these have no difference in measurement field. Add to that, these results were close to the results of No.1 (no-crack case) as well as y-y' and z-z' cut side showed at Figure 4.

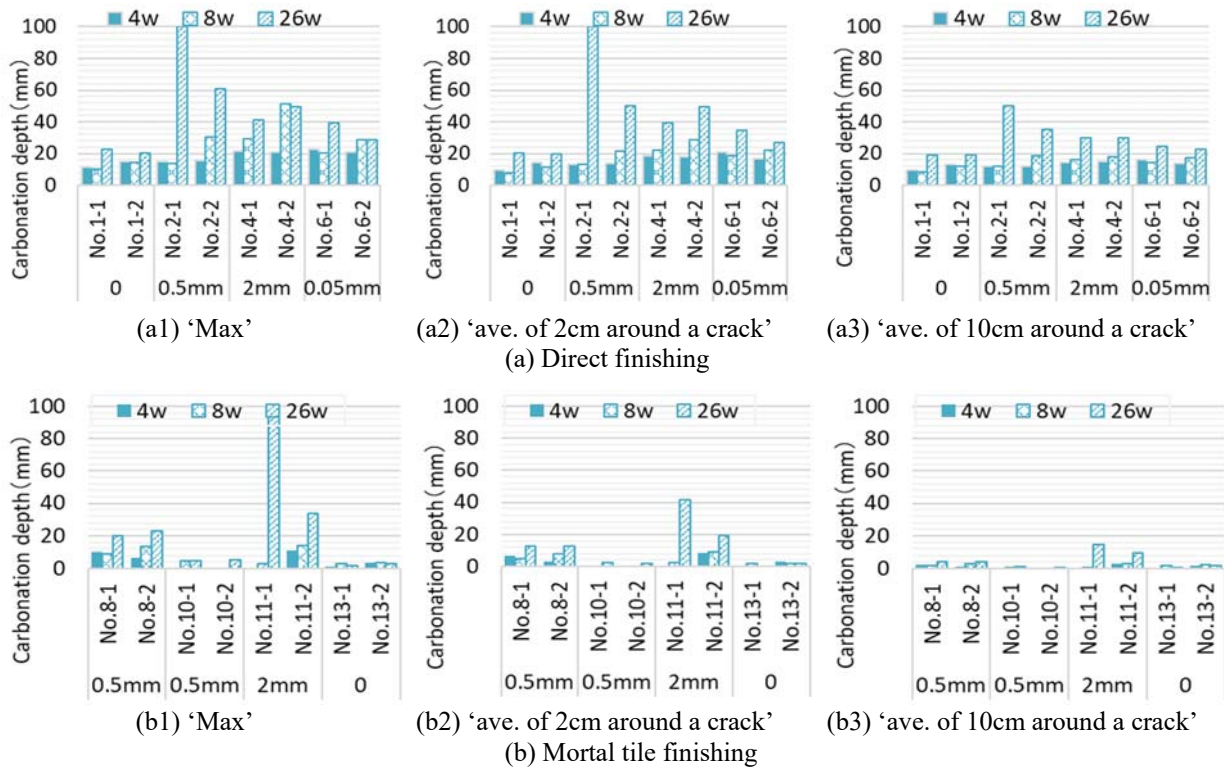
Figure 5. The carbonation depth on x-x' cut side of the no-repair case.

And then, focused on the mortal tile finishing specimens, the carbonation depth of No.8 'Max' at 4, 8 and 26 weeks were about 9mm, 12mm and 20mm, also that of No.8 'ave. of 2cm around a crack' were 5mm, 7mm and 13mm, and also that of No.8 'ave. of 10cm around a crack' were 3mm, 3mm and 4mm respectively. Likewise, that of No.11-2 'Max' at 4, 8 and 26 weeks were about 11mm, 14mm and 34mm, also that of No.11-2 'ave. of 2cm around a crack' were 9mm, 9mm and 20mm, and also that of No.11-2 'ave. of 10cm around a crack' were 3mm, 3mm and 10mm respectively.

And, results of 'ave. of 10cm around a crack' of x-x' cut side were not differ greatly from that of No.13 which have no crack as showed in Figure 3 (b). By the way, No.10 results show that carbonation didn't go at all as 0mm at 8weeks and 5mm at 26weeks, because this specimen have a concrete crack but no crack of tile.

In the case of the no-repair, the carbonation went rapidly located in 2cm around the crack but not rapidly at 10cm far from a crack, regardless of any finishing.

On a side note, the carbonation depth averaged located at 10cm around the crack of the no-repair specimens were close to that of the area far from a crack, and close to the no-crack case. It indicate that the influence of a crack appear little in large mass.

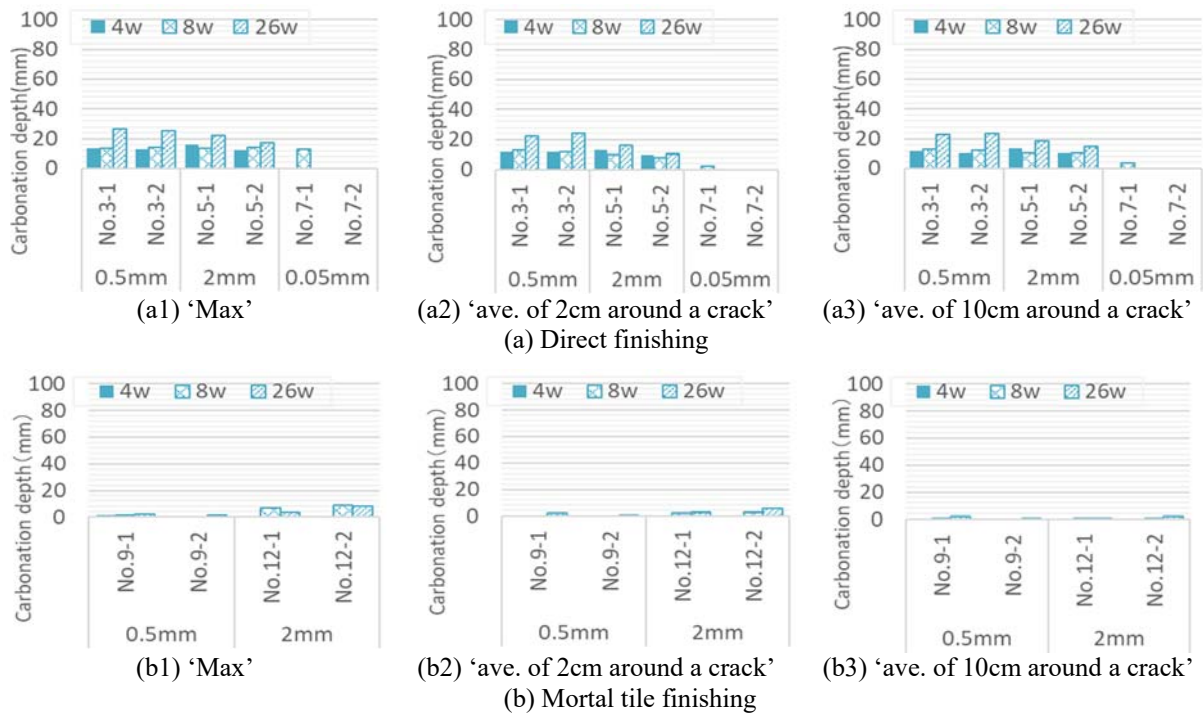
Figure 6. The carbonation depth on x-x' cut side of the repair case.

And, No.7 were coated at all face with the flexible synthetic resin emulsion, so carbonation have not gone.

As an exception case, the results of No.11 which have 2mm-wide crack shows the carbonation depth were small until 8weeks but it were large at 26weeks. Because of the repair method that block up by buried only surface layer but the filling didn't reach to deep part, the carbonation went rapid where the filling didn't reach.

And then, focused on the mortal tile finishing, the 'Max' of No.12 at 4, 8 and 26 weeks were about 0mm, 8mm and 6mm, also that of 'ave. of 2cm around a crack' were 0mm, 3mm and 4mm, and also, that of 'ave. of 10cm around a crack' were 0mm, 1mm and 2mm respectively. And the carbonation depth of No.9 at 4, 8 and 26 weeks were under 2mm regardless of the symbol. These were close to the results of the no-crack case as well as the results of y-y' and z-z' cut side.

On the other side, the carbonation of the specimens repaired went evenly from the exposure side and that were similarly to the no-crack case, although there is an exception.

From these, the repairing service have advantage of the carbonation resistance compared to crack left case, though it is not confirmed durability of the repair materials in itself.

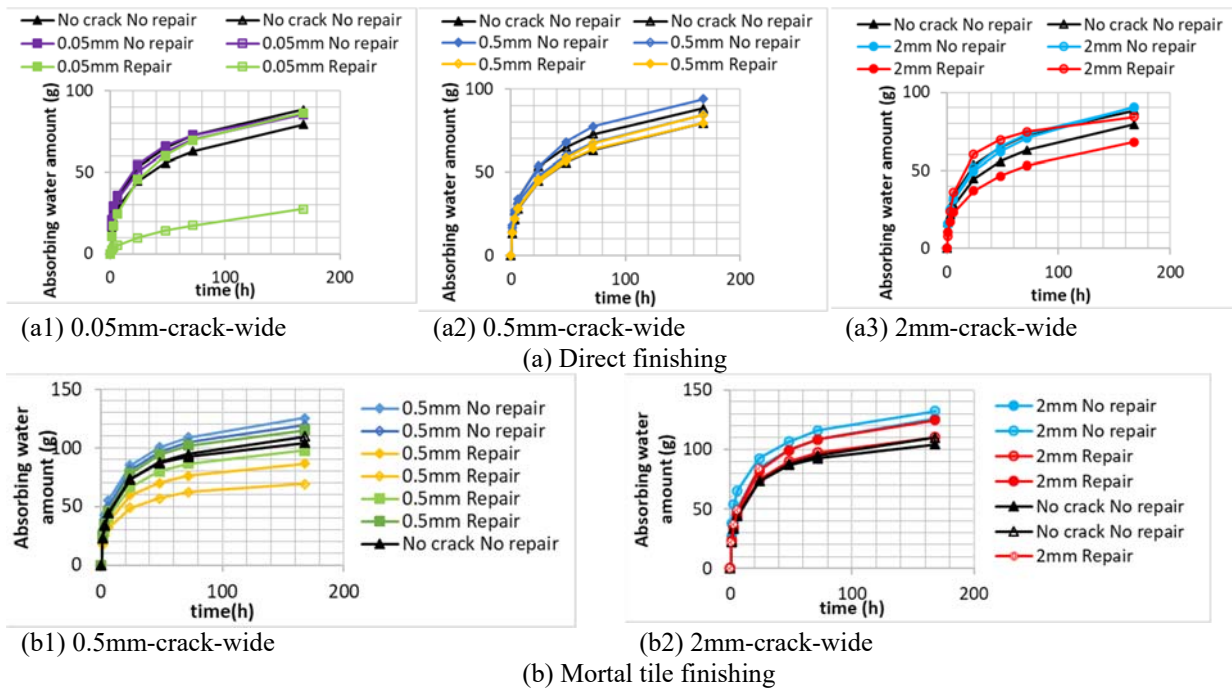
Figure 7. The amount of absorbed water

Figure.7 shows the results of the amount of absorbed water from the bottom side. From the results, the amount of absorbed water of the specimens having a crack were bigger than the no-crack specimens. Also, those of the specimens repaired were smaller than that of the no-repair, however there were exceptions.
