Deterioration of CLT under Humid and Dry Cyclic Climate

Keywords: *CLT, Humid and Dry Cyclic Climate, Delamination, Movement, Species.*

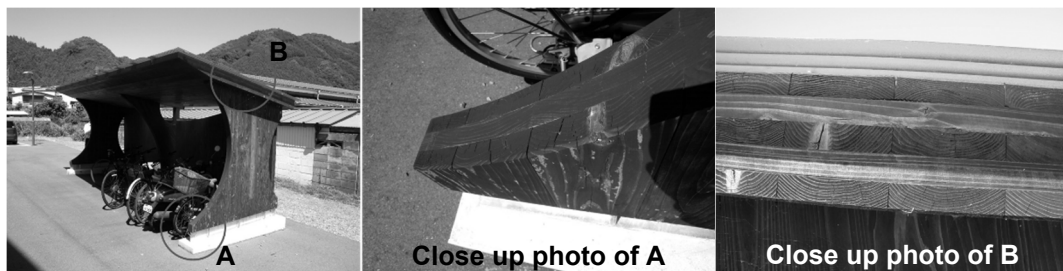
Figure 1 shows a bicycle parking space constructed with CLT panels for their walls and roofs. To protect the CLT panels from the sunshine and rain the panels were painted by some impregnated paint designed to protect wood from the outdoor climate. A certain number of check and shake was observed at the bottom of the wall panels and at the roof panels. And warp and delamination were also observed at the edge of the roof panels. The moisture, rain drop and sunshine (i.e. ultra-violet wave) may have caused these distortions.

Figure 1. Deformation of CLT exposed to outdoor climate (Bicycle parking space).

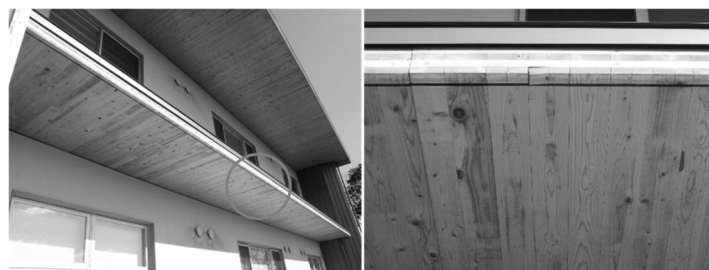
Figure 2. Deformation of CLT exposed to outdoor climate (Eaves of CLT flat roof).

Figure 2 shows the eaves of the CLT flat roof. As the edge of the panels was not covered with weather protecting materials such as steel sheet materials or ceramic boards the edge of the panels was fully exposed to the weathering force. And the panels had damages such as check and shake, warp and delamination.

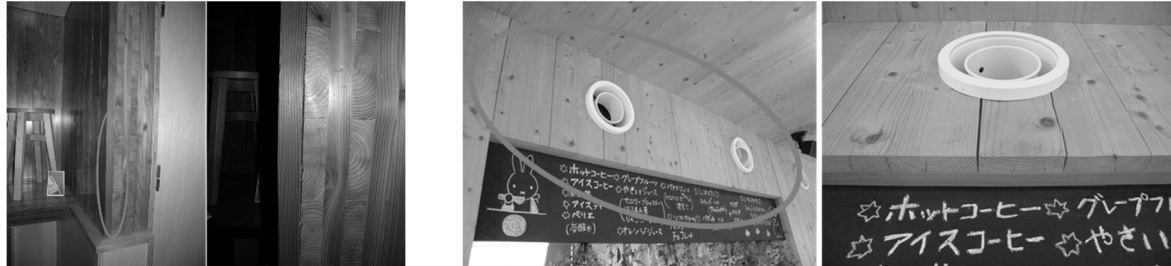
Figure 3(a) shows the delamination of the lamination of CLT panels used for the indoor partition wall. Figure 3(b) shows the check and shake and warp of the surface lamination of the CLT panels located close to the outlet of the air conditioner. The shrinkage of the surface of the CLT panels may have caused these types of distortion.

(a) Delamination of the surface lamination. (b) Check and shake of the surface lamination.

Figure 3. Distortion of the CLT panels under indoor climate.

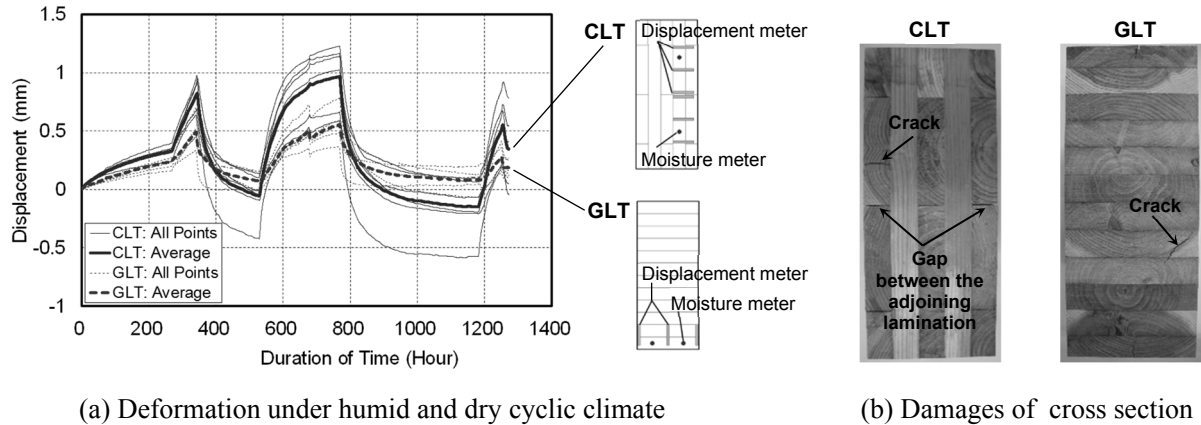
The measured deformation of the cross section of CLT and GLT under humid and dry cyclic climate was measured as shown in Figure 7(a). The narrow lines give the displacement of each measuring point and the thick lines give the average displacement of the measuring points. The deformation of CLT (solid line) is approximately 2 times larger than that of the GLT (broken line). CLT seem to have larger shrinkage and swelling than GLT. The damages of the cross section of CLT and GLT are given in Figure 7(b). Where GLT had only one standing out crack CLT had few cracks on its lamination and gaps between the adjoining laminations.

(a) Deformation under humid and dry cyclic climate

(b) Damages of cross section

Figure 7. Deformation of cross section of CLT and GLT under humid and dry cyclic climate.

- The deformation of CLT was approximately two times larger than that of the GLT. CLT showed larger shrinkage and swelling than GLT. The arrangement of the lamination is supposed to cause this difference.
- The film forming type paint seems to work well as to reduce the deformation of CLT under humid and dry climate. And the penetrating type paint seem to not work well as for reducing the deformation of CLT.
- One solution to reduce the moisture related deformation of CLT is to arrange the out most laminations of CLT so as to cover the surface of CLT with the sap wood side of the laminations.

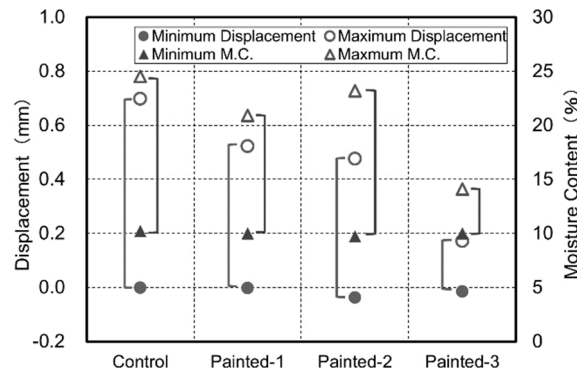
The movement of the laminations measured by the displacement meters no.1, 2, 5 and 6 are given in Figure 9. Figure 9 gives the maximum movement of the four measuring points. The movement of the CLT with no painting (control) was the largest and the movement of CLT painted with film forming type paint was the smallest. The movement of CLT painted with penetrating type paint was almost same to that of CLT with no painting.

Figure 9. Movement of displacement and movement of moisture content.

Note: ○ gives maximum displacement measured by the displacement meters no.1, 2, 5 and 6 and ● gives minimum displacement. ▲ gives maximum moisture content of the CLTs and ▲ gives minimum moisture content.

The tendency of the moisture content was almost similar to that of the displacement. The moisture content of CLT with no painting had the largest variation and that of CLT painted with

film forming type paint had the smallest variation. The film forming type paint seems to work well as to reduce the deformation of CLT under humid and dry climate. And the penetrating type paint seem to not work well as to reduce the deformation of CLT.

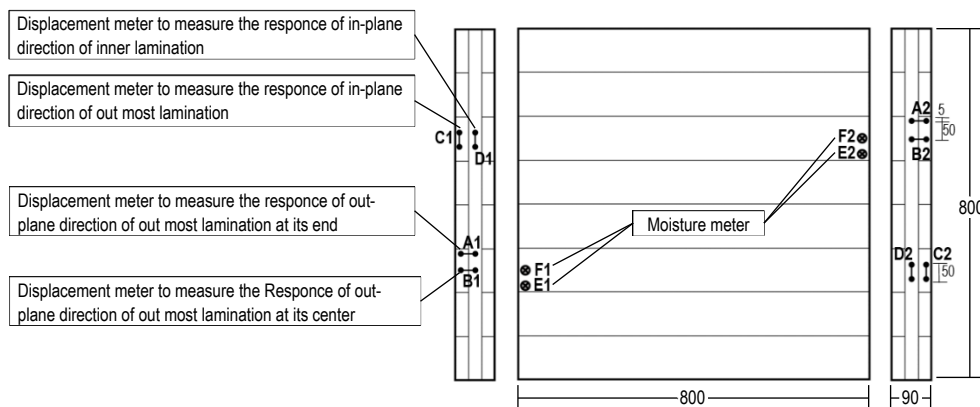
To verify the effect of the surface direction of the out most layer on the distortion of the laminations CLT composed of sap-side on its surface and CLT composed of heart-side on its surface were tested for their distortion. Figure 10 gives the size and shape of the test specimens and the location of the measuring points for deformation and moisture content. The test specimens were 800mm in length, 800mm in width and 90mm in thickness. And the species of the laminations were Larch (*larix kaempferi*) or Sakhalin fir (*abies sachalinensis*). These two species are the northern species in Japan and known as to have relatively high response for moisture content movement. The test specimens were set in a climate that was controlled as to have relative humidity 100% for 6 days followed by relative humidity 40% for 12 days and again relative humidity 100% for another 6 days. The response of the CLT under humid and dry cyclic climate was measured for two directions the out-plane direction and the in-plane direction as shown in Figure 10.

Figure 10. Size and shape of the test specimens, the location of displacement meters and moisture meter.

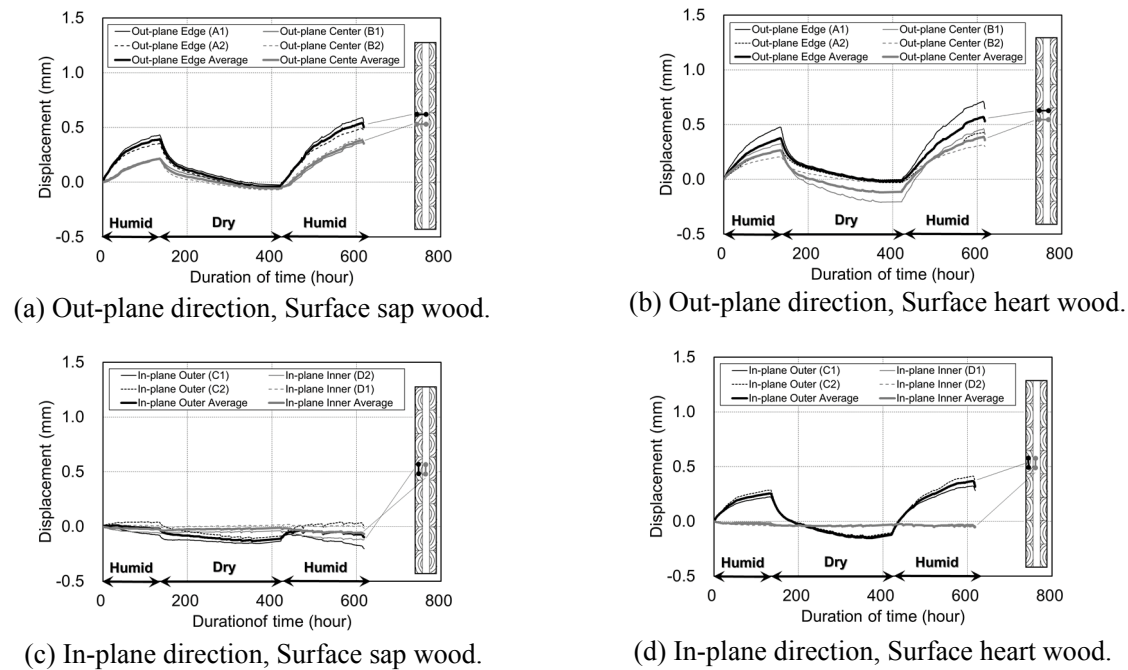
The out-plane movement of the out most laminations of Larch CLT under the humid and dry cyclic climate is given in Figure 11(a) and (b). And the in-plane movement of the out most laminations of Larch CLT under the humid and dry cyclic climate is given in Figure 11(c) and (d). The out-plane deformation of the out most laminations was larger than the in-plane deformation. And in general, CLT composed of laminations with heart wood side on the surface side had relatively larger deformation than CLT composed of laminations with sap wood side on the surface side. The test result for Sakhalin fir CLT was almost same to that of Larch CLT. These test results indicate that one solution to reduce the moisture related deformation of CLT is to arrange the out most laminations so as to cover the surface of CLT with the sap wood side of the laminations.

Figure 11. Response of the CLT under humid and dry cyclic climate (Larch).
