## Airborne Algal Growth on the Roofs of Membrane-Structured Residences in Cold Areas of Japan

**Abstract.** *Discoloration of building facades due to airborne algae is observed in our surroundings. The growth conditions of these algae are not fully clear yet, and efficient preventive measures have not yet been determined. This study was aimed at investigating the influence of ambient environment and building structure on algal growth. A residential building in the cold region of Japan was surveyed. The roof was a multilayered structure consisting of a semi-transparent film, an air layer, an outside insulation layer, and was supported by rafters. The soiled state was visually observed and recorded through pictures, and seemed to be particularly increased in autumn. Several black stripes appeared on the northeast (NE) roof four months after its cleaning. The soiling first appeared on the film backed by the rafter, and then extended to the film backed by the air layer. It rarely appeared on the southeast roof. The roof-surface temperature was measured and a stripe-shaped distribution was observed. The temperature of the film with rafter was higher and lesser than that of the film wi

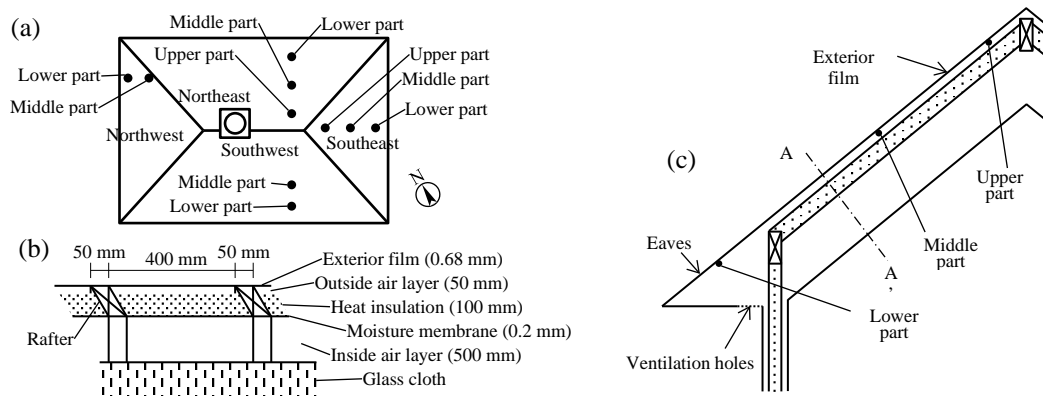
The one-story residential building that was considered for this study is located in Taiki town, Hokkaido, Japan, and is surrounded by open grassland. It has a hipped roof structure, with rafters arranged at intervals of 40 cm and insulations packed between them (Figures 1a and 1b). The part with a thermal insulation layer has a cross section with a six-layer structure comprising an exterior film, an outside air layer, the thermal insulation, a vapor-barrier, an inside air layer, and the glass cloth, from the outside (Figure 1c). All the materials are semi-transparent. The exterior film is made of a vinyl chloride film and a polyester base fabric and coated by fluororesin.

**Figure 1.** Overview of the measured house: (a) roof plan, (b) A–A' section of roof in (c), and (c) vertical section of the roof.

The surface temperatures of the roofs were measured through thermocouples and hygrothermal sensors. The thermocouples were fixed to the indoor side of the exterior film by tape, and the measured values were regarded as the surface temperatures because the film thickness was very thin at 0.68 mm. The surface temperature was measured at the upper, middle, and lower parts on the NE and southeast (SE) roofs, and at the middle and lower parts on the NW and southwest (SW) roofs, as shown in Figure 1a.

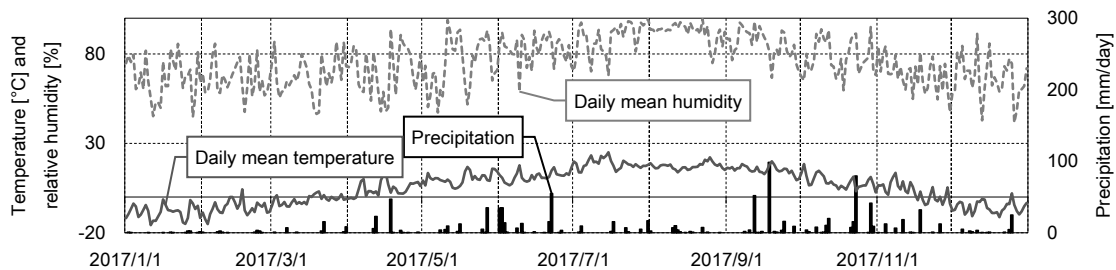
Taiki town is located close to the sea and has subarctic climate. Figure 2 provides a graphical representation of the outdoor temperature, relative humidity, and precipitation. The daily average temperature falls below freezing point in winter but rises to approximately 20 °C in summer. The relative humidity is over 80% in summer.

**Figure 2.** Outdoor temperature, relative humidity, and precipitation in Taiki Town, Hokkaido, Japan.

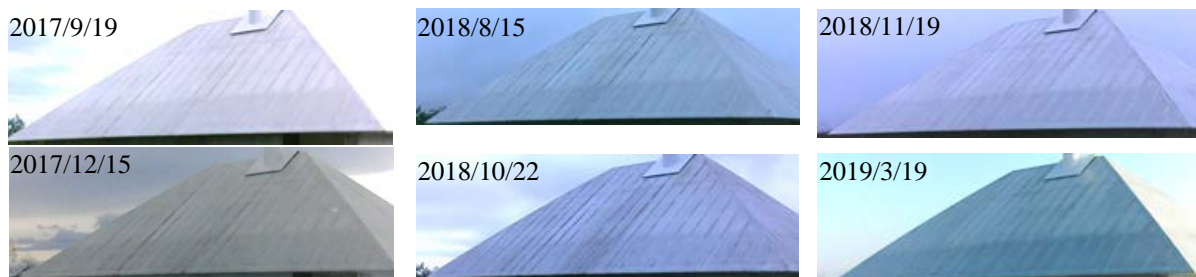
The photos of the NE and NW roofs from September 19, 2017 to March 19, 2019 are shown in Figures 4 and 5, respectively. The roofs were cleaned by brushing and high-pressure washing

on April 4, 2017, after which soiling was not observed on July 5, 2017. The soiling occurred again at the mid-left part of the NE roof on September 19, 2017, and was observed on the roof part downward from the chimney on October 20, 2017. On November 18, 2017, the soiling darkened but did not show further change until December 15, 2017. The soiling on the eaves faded on May 27, 2018, then became darker between June 21 and July 26, 2018. On August 26, 2018, the soiled area increased, the color darkened more than that on July 26, and gradually darkened further from September 22 to October 15, 2018. The roofs were cleaned again on October 22, 2018, after which soiling occurred at the left part of the roof downward from the chimney on November 19, 2018; this remained unchanged from December 23, 2018 to January 23, 2019. The stripe-shaped soiling increased in the area downward from the chimney and darkened on March 19, 2019.

**Figure 4.** Photographs of NE roof from September 2017 to March 2019.

In summary, the soiling hardly increased in the summer (July and August) and winter (December, January, and February) but increased from March to June and from September to November. The NW and NE roofs showed the same soiling tendencies.

Considering the water supply and temperature suitable for algal growth, the estimated time of the year when the algae can survive is shown in Figure 9. For example, on the NE roof, the surface temperatures were from 0 to 45 °C and condensation occurred from August to September 2017, the middle of July 2018, and from September to October 2018. Thus, the algae are predicted to grow during these periods. This prediction corresponds well to the result that the soiling was observed from July to November 2017 and from June to November 2018, as shown in Figure 4.

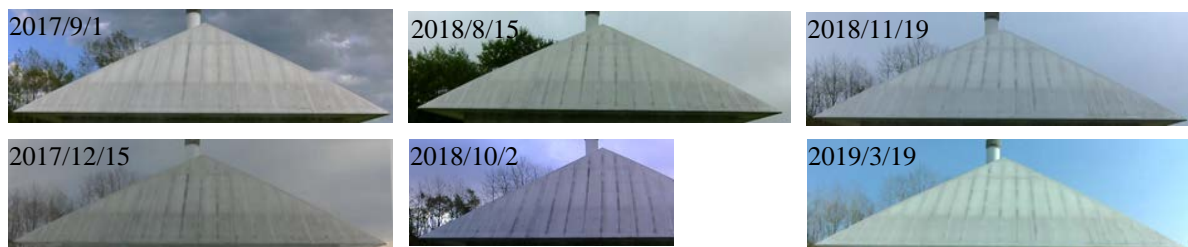
**Figure 5.** Photographs of NW roof from September 2017 to February 2019.

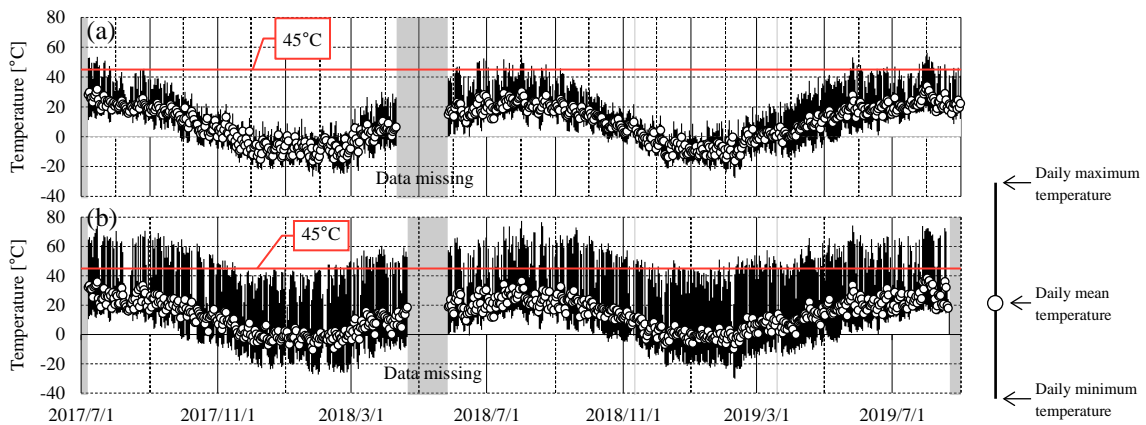
The annual surface temperature on the NE and SW roofs is shown in Figure 7, where high temperatures of over 45 °C can be observed from June to August on the NE roof, and from February to December on the southwest roof. On the NE roof, where the incident direct solar radiation was the least, the frequency of temperature higher than 45 °C was least (Figure 7a). The daily fluctuation of the surface temperature was large on the SW roofs (Figure 7b).

**Figure 7.** Annual surface-temperature change on (a) the NE and (b) SW roofs. The bar length and circles represent the daily-temperature difference and daily mean temperature, respectively.

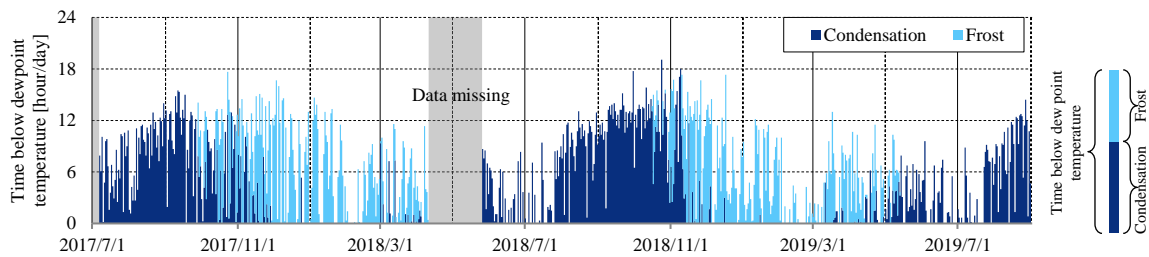
Figure 8 shows the time when the surface temperature was below the dew-point temperature of the outdoor air. Frost was assumed to occur when the surface temperature was below 0 °C. As shown in Figures 6, the surface temperatures on all roofs decreased below the dew-point temperature of the outdoor air because of the nocturnal radiation, and they dropped below 0 °C at night from November to April. Condensation occurred from May to October, and condensation per day was long especially from September to October. This period of condensation differs depending on the roof orientation; however, the frequency of occurrence shows only a very small dependence on the orientation.

**Figure 8.** Time per day that the surface temperature was below the dew-point temperature of the outdoor air. Air-layer part at middle part of NE roof.

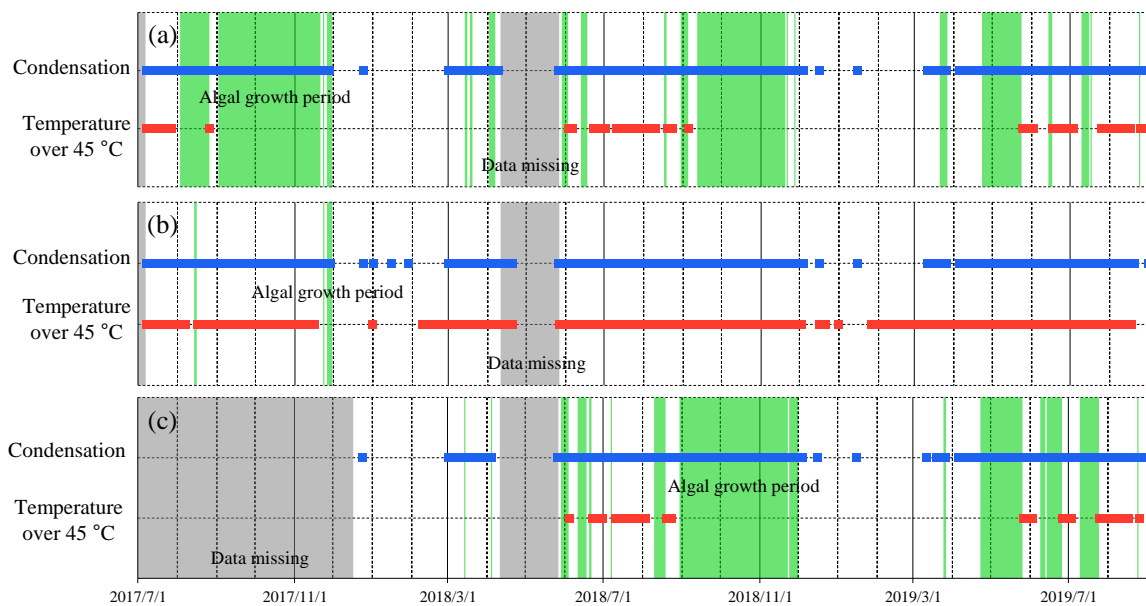
On the SW roof, the high temperatures of over 45 °C occurred all year round. Therefore, it is predicted that the algae could grow only in a limited time in February 2017, from the end of November to the beginning of December 2017, and a part of January 2018. These predictions well correspond to the observed result that soiling did not occur on the SW roofs.

**Figure 91.** Estimated period for algal growth because of the occurrence of the condensation and high temperature. Air-layer part of middle part of the (a) NE and (b) SW roofs. (c) Rafter part of the middle part of the NE roof. Condensation: the day when the condensation occurred. Temperature over 45 °C: the day when the daily maximum temperature reached over 45 °C.
