### INVESTIGATION OF TRAFFIC ACCIDENT PRONE AREAS RELATED TO EXISTING ROAD CONDITION AND DRIVER'S BEHAVIOR ALONG MENAGESHA- AMBO ROAD SECTION

**KEYWORDS:** Accident prone area, Cause of traffic accidents, Hazardous locations, Priority value, informative and warning signs.

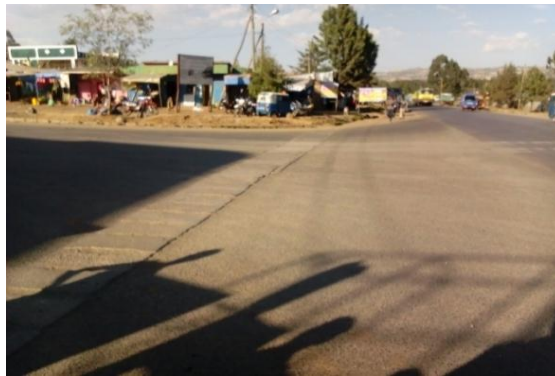
This location is found around Ethiopian road authorities size and weight control station. Its location is in town section. The countermeasure that should be applied on this road is: - Edge side and Central traffic marking should be painted. Also, Island should be provided in the intersection area. The sufficient pedestrian walking lane should be provided and also speed limit post should be installed.

**Figure 3.4: Gabriel Existing Road Condition**

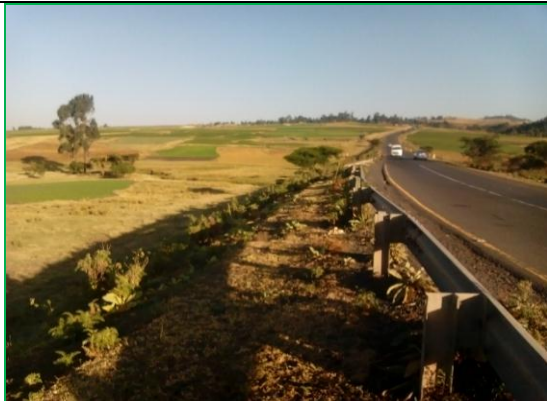
**Fig 3.8: Wacan Mazoriya Existing Road Condition.**

The countermeasures that should be undertaken are: a) Roadway width should be increased, b) proper guardrail should be installed, c) Climbing lane should be provided to assist the faster moving vehicles to pass, d) There is steep gradient, so that speed limit posts should be installed, e) Pavement marking is faded, so that it should be re-painted, f) There is the problem of Mis-phasing so that, the design should be reviewed.

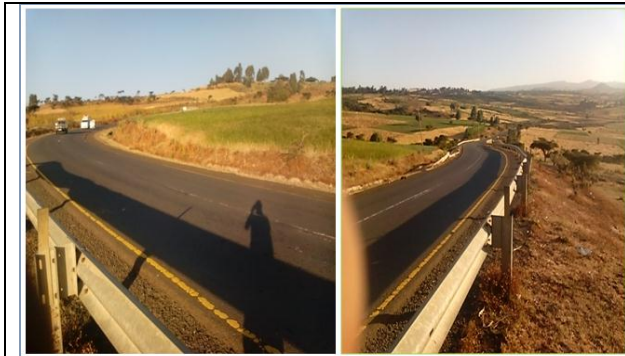
The obstruction inside the curve, which obstructing the driver's vision must be removed. The existing guard rail is not functioning and sufficient along with the left side so that it should be re-installed, and Traffic signs are needed inside the curve.

**Figure 3.10: Minini Existing Road Condition.**

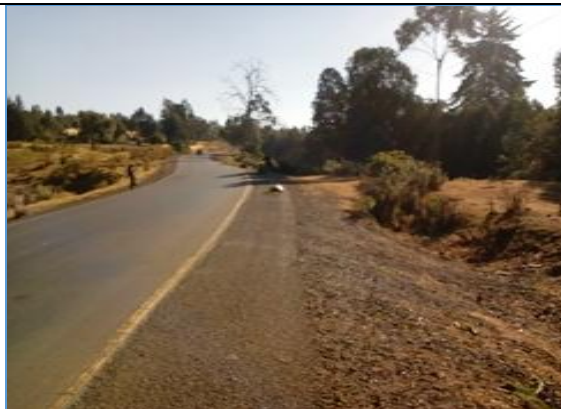
**Figure 3.12: Chirixisting condition.**

Obstruction near the curve should be removed (trees are around). Speed limit posts should be installed. Since the shoulder width is not sufficient should be increased. Road side Delineator should be installed along the road.
