Refurbishment and end of life roof membrane structure of the Teatro Verdi in Montecatini Lucca

C. Vannelli

* Canobbio Textile Engineering Srl

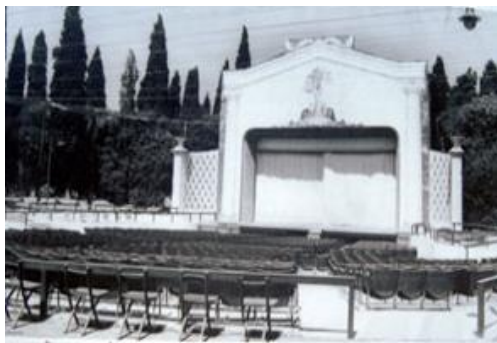
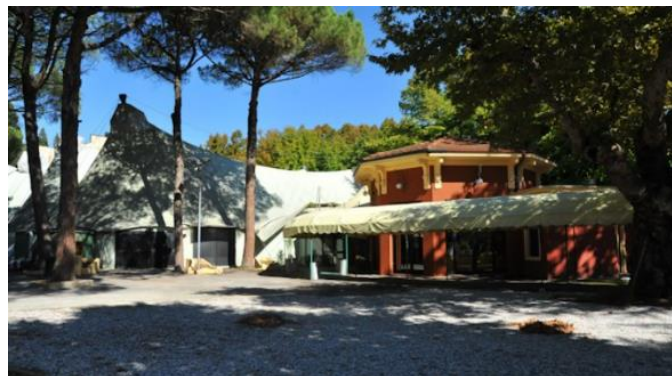
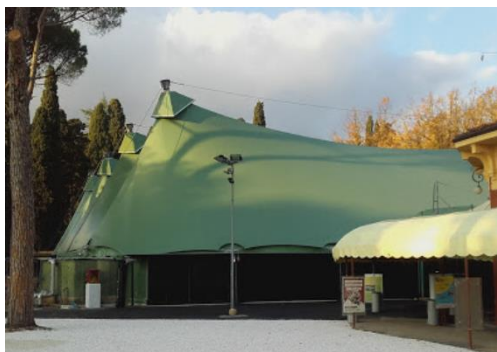
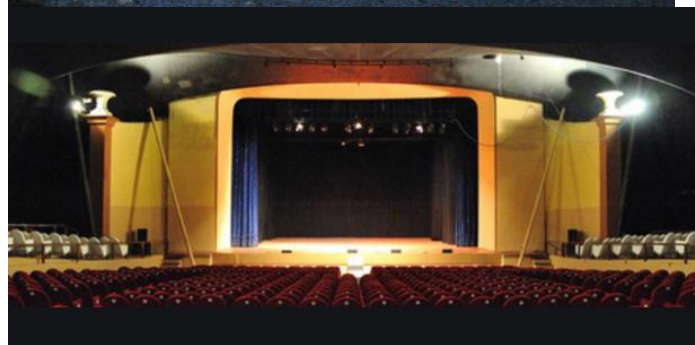
Pictures of the evolution of the structure during the years till the substitution of the roof membrane.
