THE USE OF A BUILDING INFORMATION MODEL TO SUPPORT SEISMIC ANALYSIS: APPLICATION TO THE NATIONAL PALACE OF SINTRA, PORTUGAL

Keywords: Historical Masonry Buildings, Laser Scanning, H-BIM, Seismic Analysis, Sintra National Palace

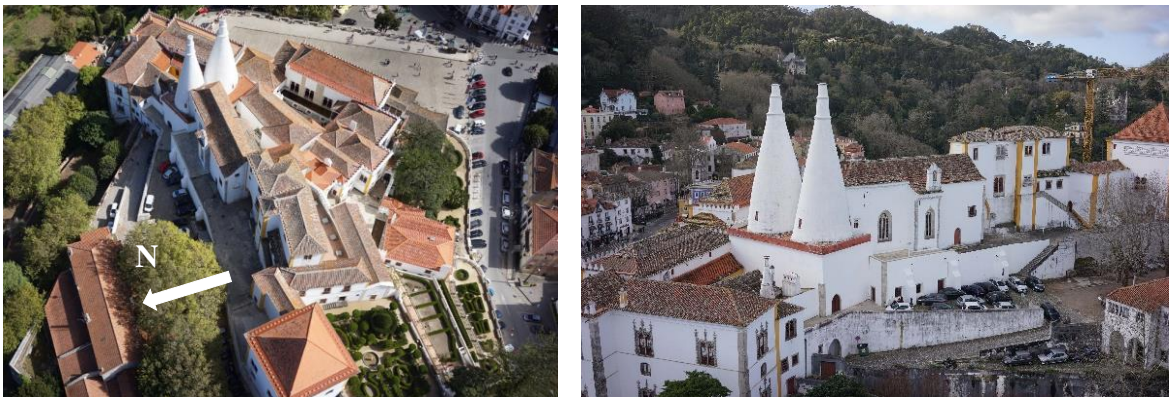
Figure 1: A top view of the National Palace of Sintra (left); The north view of the palace with the chapel on the right side of the chimneys (right)

In this paper, a methodology for a BIM-based system implementation for the National Palace of Sintra (Figure 1), in Portugal, is described. The National Palace of Sintra is the most important building in the town centre and one of the most visited palaces in Portugal. It was the royal dwelling of the Portuguese royalty and its value is immeasurable. Given its cultural and social importance, there is undoubtedly the need for its preservation and documentation.

The Chapel (Figure 1), on the north side of the palace, is chosen to describe and illustrate the procedures followed in this work.

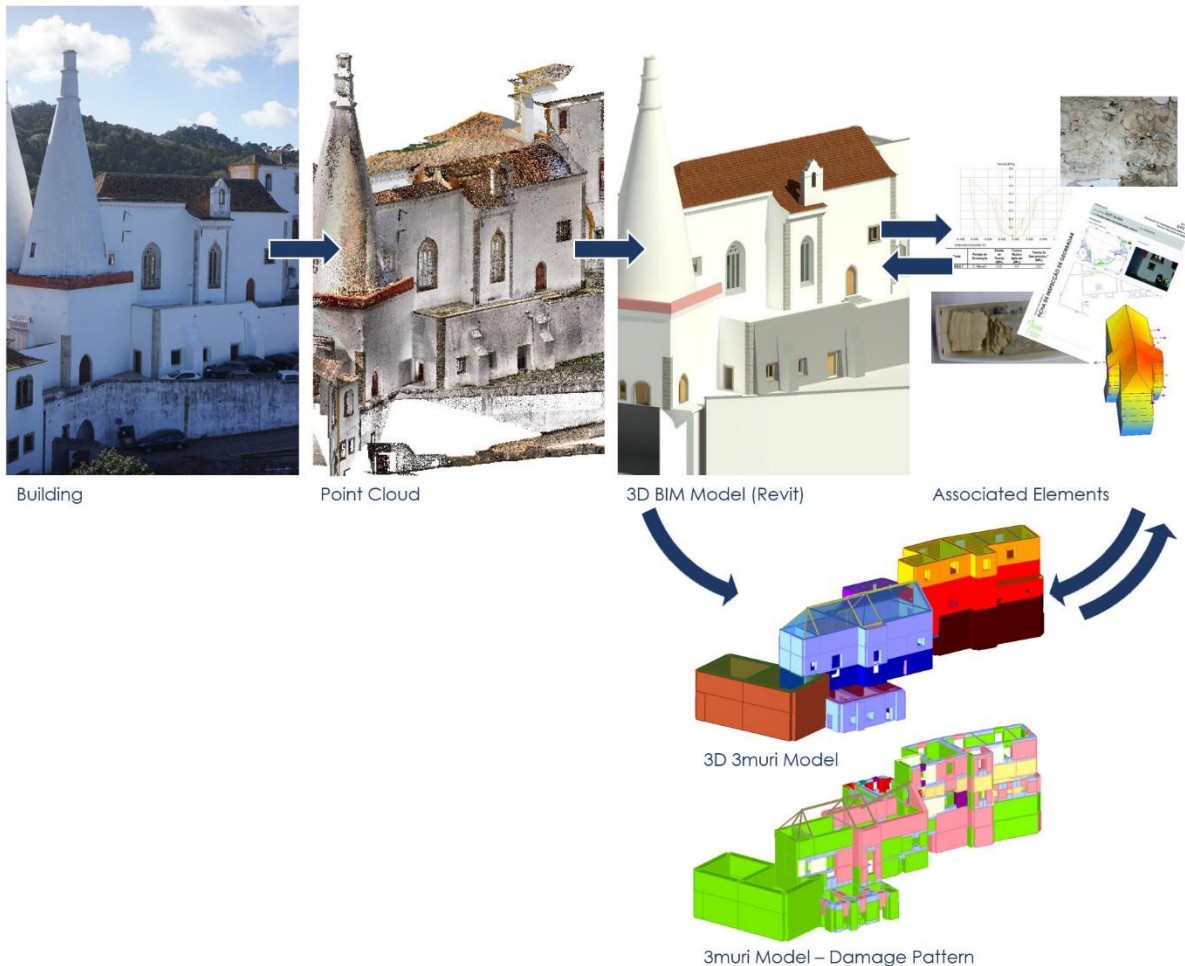
Figure 2: Main steps of H-BIM development process applied to the Chapel

For the development of the H-BIM model [3], three main steps are highlighted, as

schematically represented in Figure 2. Firstly, the geometry of the palace was acquired with a combination of terrestrial laser scanning (TLS) and unmanned aerial vehicle (UAV) techniques, covering the 11 levels of the palace, which correspond to 244 spaces (e.g. rooms, outdoor gardens, patios) and surrounding environment locations. The two-point clouds datasets were combined into a single coherent H-BIM model and modelled using the Autodesk Revit® software, enabling its conversion to individual surfaces and objects. This model served later as a basis for the construction of the numerical model used in the seismic assessment.

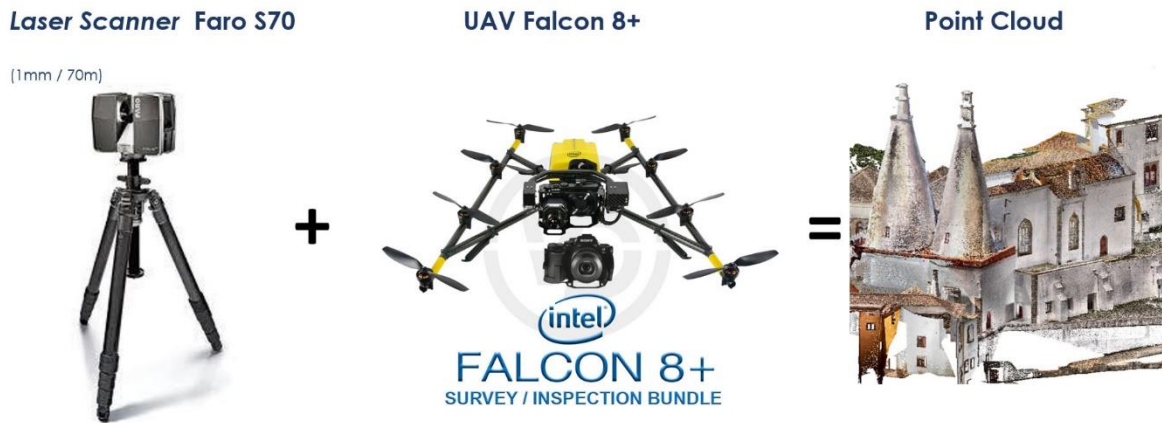
Figure 4: Equipment used for the geometric survey of the PNS: Faro Focus S70 laser (left); Falcon 8+ UAV (middle); generated point cloud (right)

The geometrical survey of the entire palace was performed using a Faro Focus^S 70 and a Topcon Falcon 8+ UAV (Figure 4).

A total of 1397 scans and 13 flights were carried out for the total survey of the palace, indoors and outdoors, as well as the surrounding environment, including 6772 photographs collected, of which 1478 with the UAV.

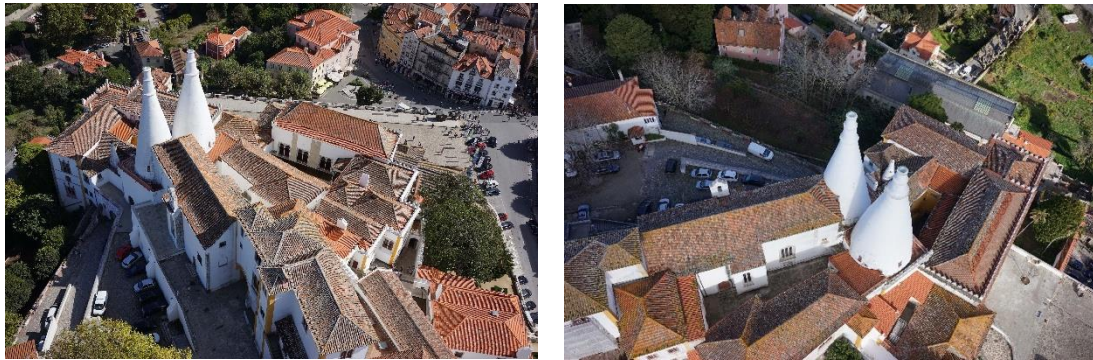
Figure 5: Aerial photograph of the parts of the palace (including the Chapel) collected by the UAV.

For the acquisition of outdoor data, namely roofs, terraces, the highest areas of the facades and gardens, the UAV was used (Figure 5) to provide a point cloud produced using photogrammetric processing techniques.

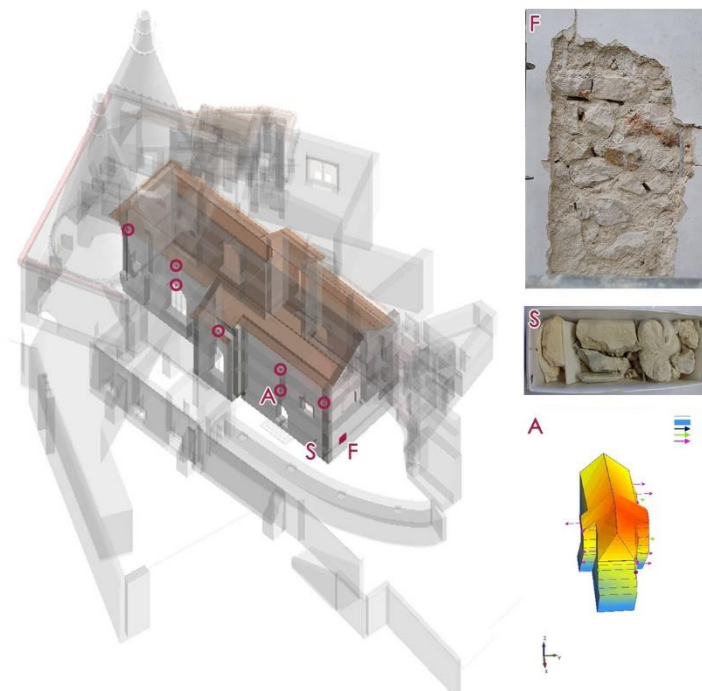
Figure 6: Flat-jack tests, removal of masonry samples and ambient vibration *in situ* tests performed in the Chapel: Survey placement (left) and attributes (right)

The locations of the removal of masonry samples, flat-jack tests, ambient vibration tests and GPR tests were defined and represented in the BIM model (Figure 6 and Figure 7). All the main results obtained with experimental *in situ* are linked to the model or added to it as attributes.

In the palace, the locations for the collection of samples and flat-jack tests were chosen on the main structural walls that characterize the main periods of construction, taking into consideration the various limitations, such as the existence of tiles or paintings. Both tests were carried out, whenever possible, on the same wall, or on adjacent walls. Nevertheless, for the case of the chapel, the masonry sample (S, Figure 6) was collected on the north wall, while the flat-jack test was performed on the west wall (F, Figure 6). In fact, the time slice obtained in the north wall from GPR02 test, as shown on the bottom picture of Figure 7, presents a former window that was later filled with a different type of masonry. This result prevented the flat-jack test from being carried out on the same wall as the sample collected, as initially planned.

A campaign of ambient vibration tests was performed in some of the palace's bodies chosen for their structural importance, existent damages and history. The determination of the dynamic behaviour of the structures (frequencies and the modes of vibration) is crucial to calibrate the numerical models. To measure the dynamic response of buildings, force-balance accelerometers of high sensitivity (80V/g) were used: six uniaxial EpiSensor ES-U2 and one triaxial EpiSensor ES-T, from Kinematics Inc. To illustrate the type of results reached, in Figure 6 it is possible to observe the fundamental mode of vibration of the chapel (right, bottom), along with the sensors' positions (the circles in red in the BIM model and the red arrows on the right bottom image correspond to the position and the direction of the sensors). The first mode corresponds, as expected, to the vibration of a beam with two ends constrained.

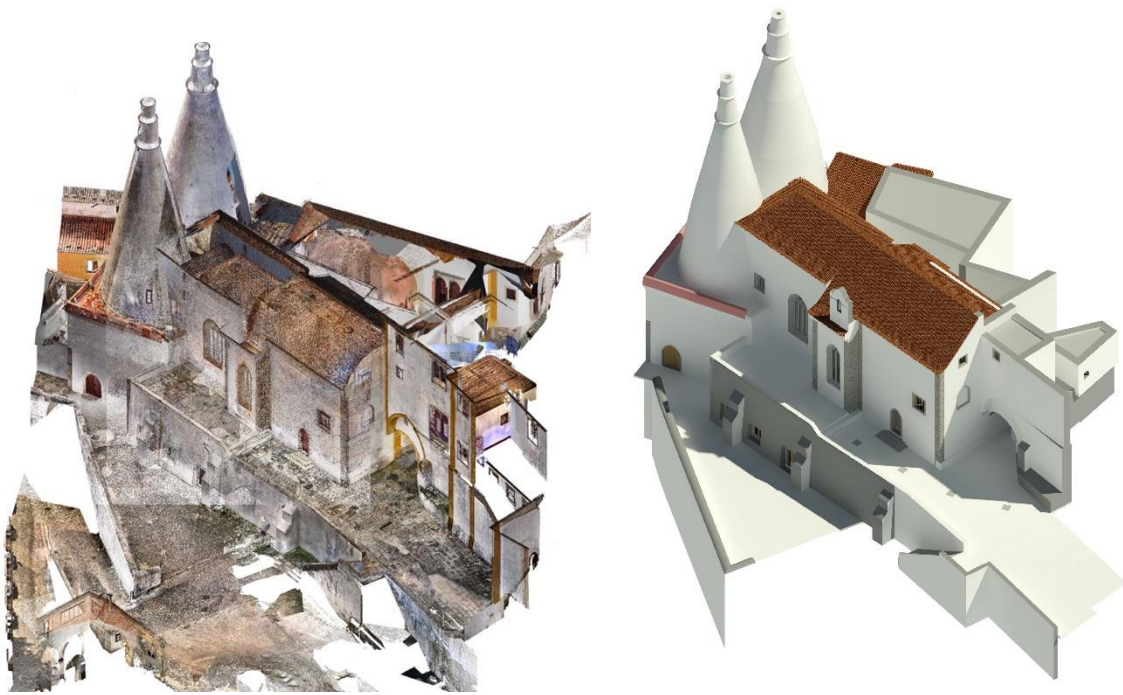
Figure 8: Point cloud dataset (left) and north view of H-BIM model (right)

The final point cloud dataset of the chapel is presented in Figure 8 (left), after cleaning the noise data from features both outside of the palace (e.g. surrounding buildings) and the interior non-structural and non-architectural elements (e.g. furniture). The complete H-BIM model is presented in Figure 8 (right), and in it is possible to access different type of data for individual elements or sections of the building, including horizontal or vertical sections (Figure 9). The detailed geometric representation obtained allows to develop adequate structural models for the seismic assessment, for the identification of vulnerabilities and to recommend eventual future mitigation strategies.

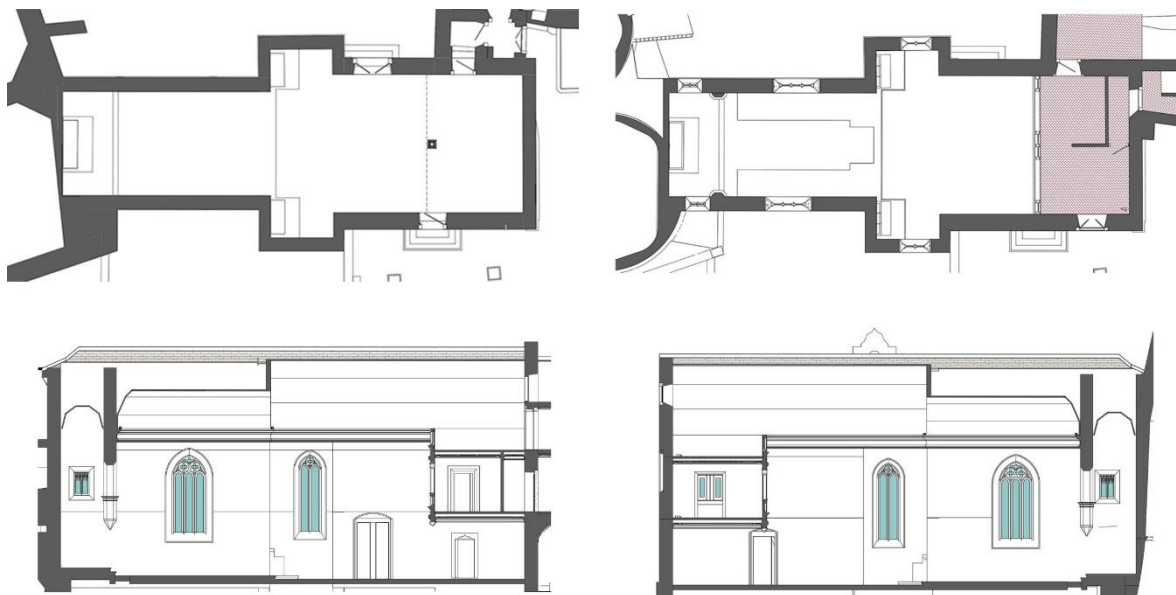
Figure 9: Horizontal sections (top) and vertical sections (bottom) and of the BIM model of the chapel

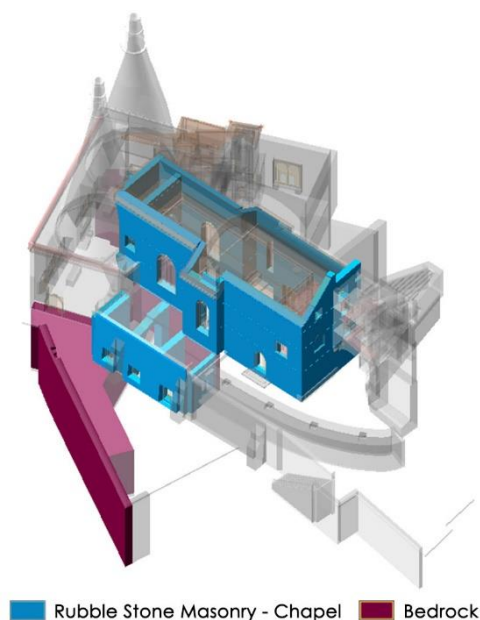
Figure 10: Mechanical properties of the masonry walls

The H-BIM was used to develop the building's 3D numerical model in the 3Muri [6] software. Lately, the results of the structural analyses performed in 3Muri were introduced in the H-BIM model. The results of ambient vibration tests and flat-jack tests together with the performance of modal analysis and using as reference the values given in Italian Standard [7]

allowed the correct mechanical characterization of the materials, which was after linked to the H-BIM model. Figure 10 illustrates the calibrated mechanical properties of the masonry walls of the chapel.

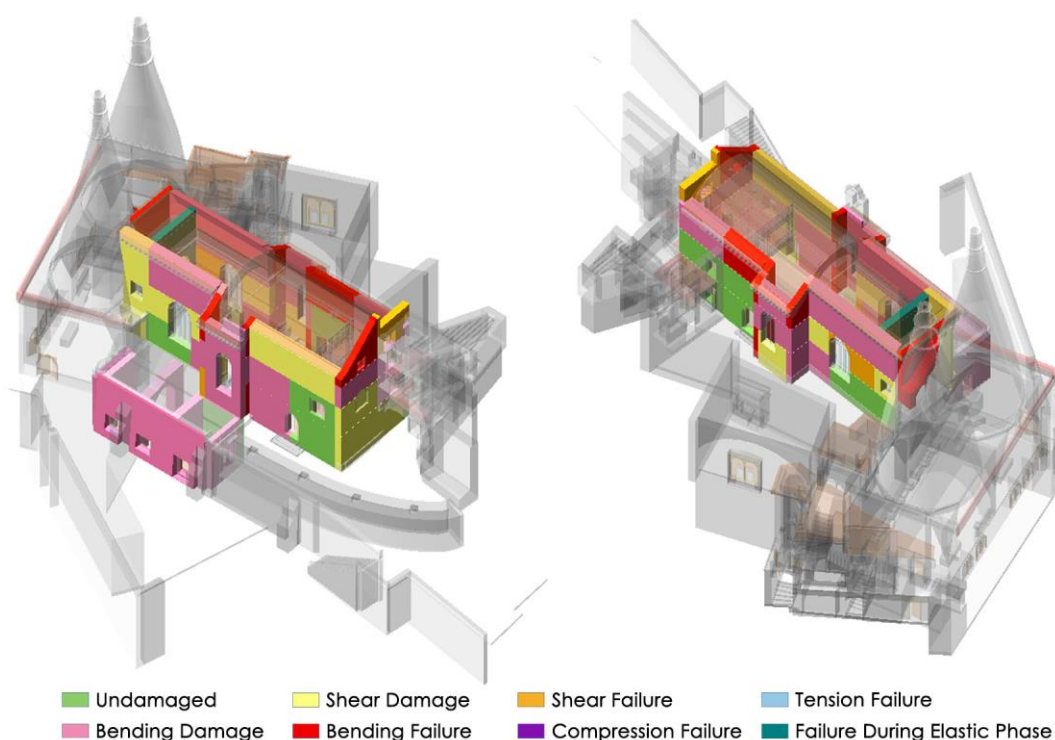
Figure 11: Distribution of damage in masonry walls at a near collapse limit state: north view (left) and south view (right)

For the seismic assessment of the palace, the in-plane and out-of-plane responses have been carried out by developing nonlinear analyses [4]. However, only the results for the in-plane response are herein represented. 3Muri performs structural and seismic analysis of masonry buildings, is based on the equivalent frame modelling (EFM) approach and allows performing nonlinear analyses of entire 3D building models. In Figure 11, the distribution of the damage of different masonry walls is represented for the near-collapse limit state, as required for monuments according to Part 3 of Eurocode 8 [8]; this extreme situation allows an easy and clear identification of the most vulnerable structural masonry walls and the type of behaviour (shear or bending) which will control their performance. The results shown in Figure 11 were obtained having performed nonlinear static analyses in the two main directions of the chapel [4] and present a combination of the worst outcome of each analysis.

The representation of the distribution of damage in masonry walls through the H-BIM model facilitates spatial reading and enables easy identification of the most vulnerable structural elements and thus the type future interventions to be implemented in the seismic retrofit stage.
