CALIBRATION OF A FEM MODEL WITH COMPLEX GEOMETRY: THE CASE STUDY OF SANTA MARIA MADDALENA CHURCH IN ISCHIA, ITALY

Keywords: FEM model, calibration, OMA, heritage structures, Baraccato system, modeling

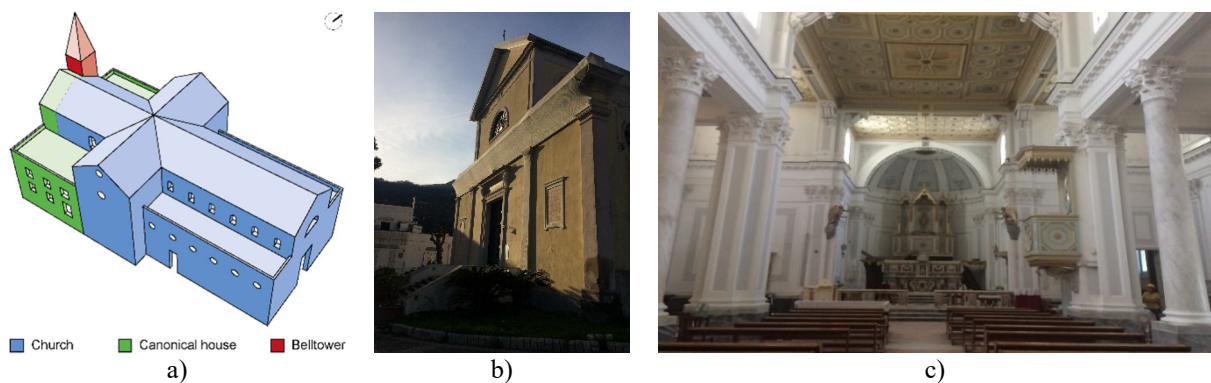
Figure 1: a) Volumetric representation, b) external view of the church, c) internal view of the church

As sketched in Figure 1, the church is composed by the religious spaces arranged with the typical Latin-cross shaped plan configuration (blue), a two-story back part, which hosts some spaces for the parish's activities and the priest's house (green), and the bell tower located in the north-western corner (red). The front part consists of an almost rectangular footprint of dimensions 39.04 m x 20.72 m with five different height levels. The maximum heights of the church are 16.32 m and 22.30 m for the roof top and the bell tower, respectively. It is important to underline that 6 rows of columns are located along the central nave up to the transept. The church covering is supported by a simple system of Palladian timber trusses, aligned along its longitudinal direction.

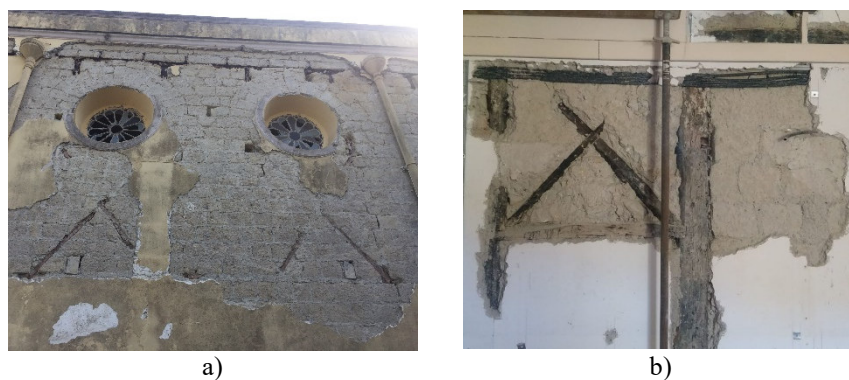
Figure 2: a) Iron-Baraccato wall panel, b) timber-Baraccato wall panel

The particularity of this building is the use of a mixed system for the load-bearing walls, made of Neapolitan yellow tuff blocks and either chestnut timber or iron elements. In the front part, the church is composed by the mixed iron-masonry technology (Figure 2a), with masonry enveloped in two layers of iron frames which are connected transversally through the

Additionally, the use of the traditional Baraccato system (later addressed as ‘timber-Baraccato system’), with timber frames embedded inside the masonry texture, was also detected in the back part (Figure 2b). As mentioned above, this constructive system is widespread in Southern Italy as one of the first engineered earthquake resisting systems developed between the 18th and 20th centuries [13]. The use of the two different constructive systems together in a religious building defines the peculiarity of the building itself. The reason for the use of both technologies in the same building is not evident in any reference known to the authors, both were indeed identified by the building regulations as the recommended systems to apply in the reconstruction. However, the use of the iron-Baraccato technology for the main portion of the church and, conversely, the use of the timber-Baraccato one for the rear one may be due to economic reasons.

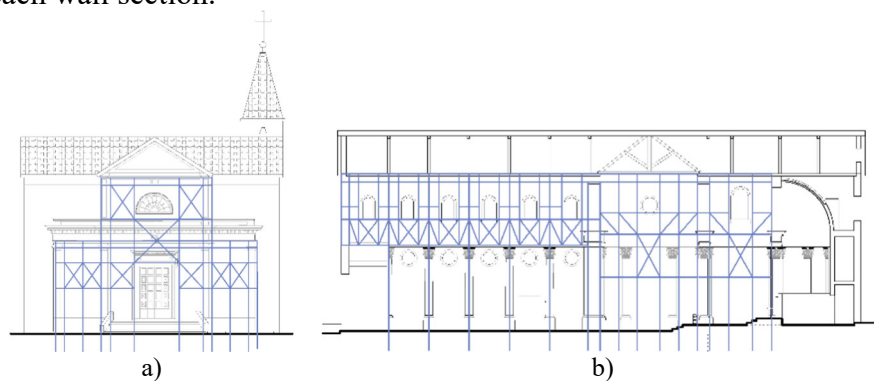
Figure 3: Layouts of the iron frames of the system: a) front façade, b) central nave

walls thickness. This technology was identified as the so-called ‘iron-Baraccato’ system for the similarity between the layout of the iron frames and the layout of a regular Baraccato panel ([8], [11]). Some *in-situ* investigations allowed to identify this layout that is presented in Figure 3. The frames encaging the walls constitute a rigid skeleton whose principal advantage to the structural behavior is the connection that they provide between the various structural units. They primarily assure the connection between orthogonal walls, floors and columns. The use of the iron also in these structural units, indeed, enables a structural continuity of the iron frames of the walls and their metallic elements which connection is easily and effectively resolved. Lastly, the presence of a double layer of iron frames tied with each other provides to the walls a certain level of confinement, which increases the overall strength of each wall section.

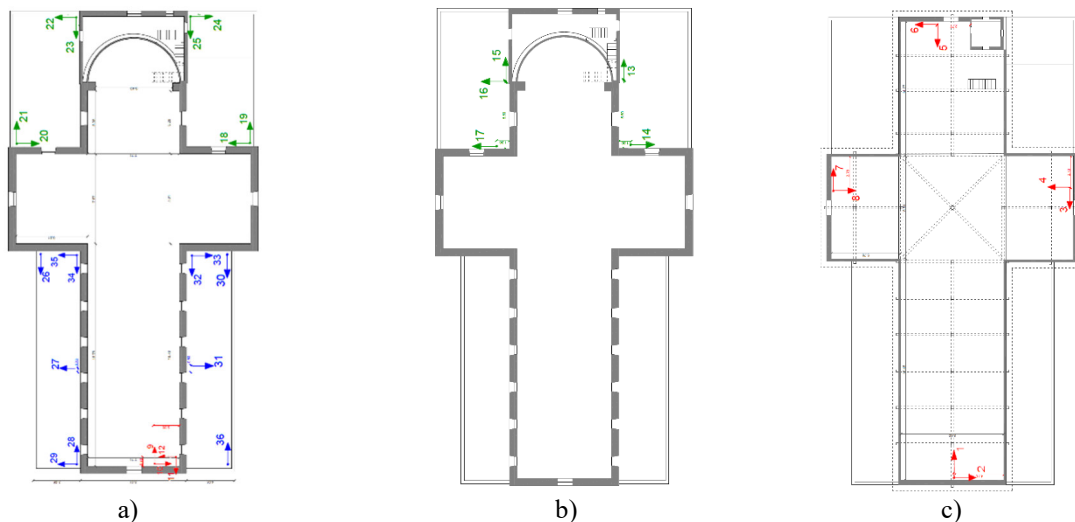
Figure 4: Location of the accelerometers at a) +7.35 m level, b) +10.00 m level and c) +11.80 m level

Two different test setups were used, with measurement points located at three different levels of the church, as shown in Figure 4. The measurements reported in red color are the ones that were maintained in the same position for the implementation of the two setups, in

green the ones corresponding to the first setup and in blue to the second setup.

The data were collected using ceramic piezoelectric uniaxial accelerometers with high sensitivity (10.0 V/g), low noise ($0.13 \mu\text{g}/\sqrt{\text{Hz}}$), resolution of 10⁻⁵ g rms and frequency range of 0.1-200 Hz. They were firmly anchored to the church walls by means of metallic plates avoiding damaged zones and plaster detachments, in order to assure good quality readings. The two setups recorded ambient vibrations for a total time of 3600s with a sampling frequency of 100 Hz. More details can be found in the work of [11].

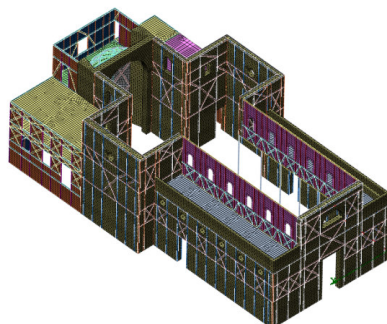
Figure 6: Representation of the 3D FEM model of the church (roof ties omitted) [12]

An initial tentative model was implemented with the following characteristics to be inspected during the calibration phase. In general, the linear elements of the church, i.e. iron and timber frames of the load-bearing walls, columns, timber beams of the apse dome, ties, etc., were represented with 3D beam elements self-standing or embedded in other elements. The two Baraccato walls typologies were modeled with different strategies: a) 3D solid elements with imprinted and embedded 3D beams for the iron-Baraccato walls, b) regular curved shells with imprinted beams for the timber-Baraccato walls. The metallic floor slabs of the building were represented with regular curved shells, implementing orthotropic behavior with relevant stiffness along the beam orientation direction. The roofing system, consisting in a non-thrusting timber system composed of king post trusses, was modeled through the application of an equivalent mass at the top of the model distributed along the roof perimeter. Lastly, as first tentative and not to overweigh the complexity of an already size relevant model, the boundary conditions representing the interaction of the church with the soil were set to perfectly fixed conditions. Figure 6 presents a view of the mesh of the numerical model.

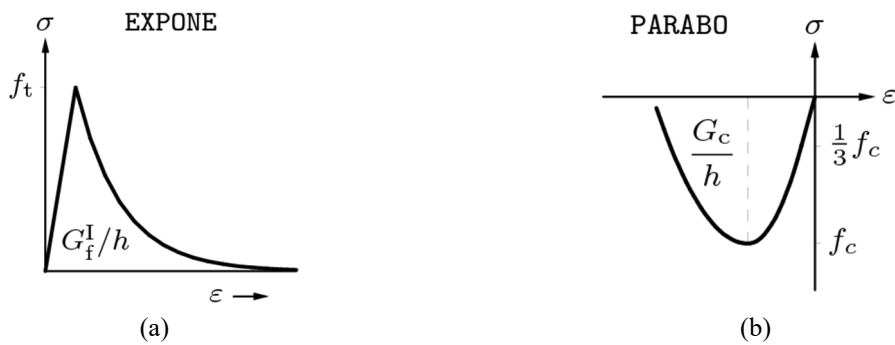
Figure 7: Stress-strain diagrams adopted for the behavior of masonry in a) tension and b) compression

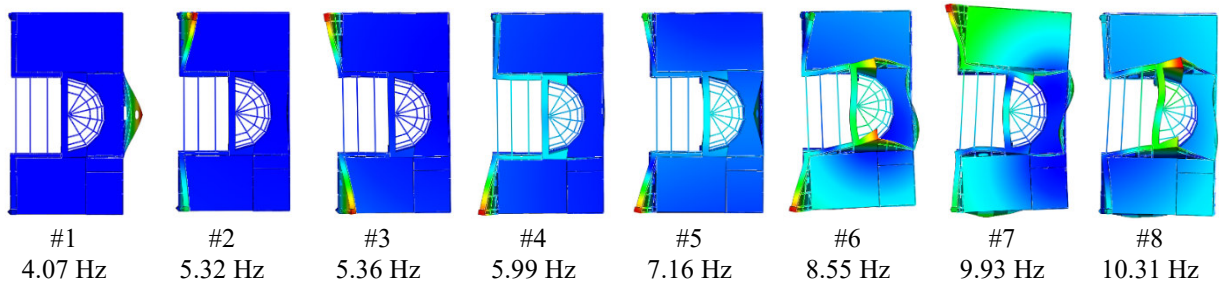
Figure 8: First eight modal shapes of the MG_01

In order to inspect the structural relevance of the rear portion of the building, a partial model was developed by extracting the back portion from the original model (MG_01). This step allowed to highlight, firstly, the great geometrical stiffness of this portion, witnessed by the lack of global modes for frequencies of the order of 10 Hz (Figure 8). Secondly, it was noticed that the modal shape of the church portion is still governed by the L-shaped walls of the transept which do not allow the development of proper translational modal shapes. Lastly, as expected, the layout of the timber frames scarcely influences the modal shapes of the sub-

structures, as evidenced in the analysis of a model with the complete absence of timber elements (MG_02), while having relevance in the modal frequencies as evidenced in Table 2.

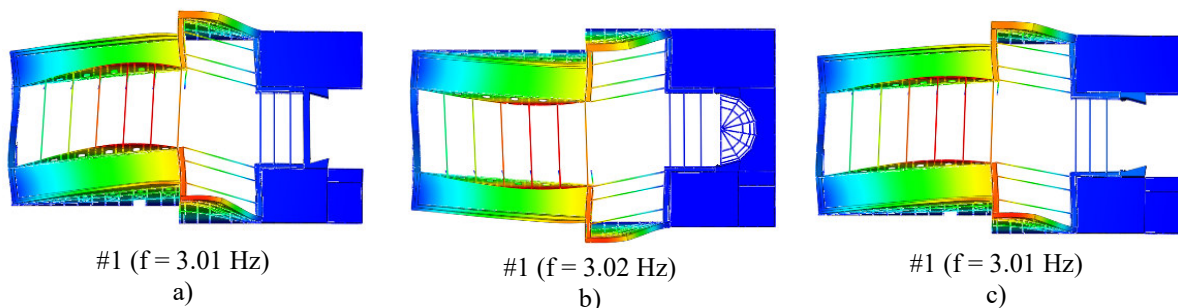
Figure 9: First global modal shapes of the models a) MG_03, b) MG_04, c) MG_05

Besides, the structural stiffness of the rear portion was inspected also with a global model in which the back wall of the canonical house is weakened in various ways: suppression of the central section of the canonical house (MG_03), suppression of the masonry arch at the top of the apse (MG_04), and combination of the two scenarios (MG_05). In fact, the contribution of stiffness of a long wall such as the back wall of the canonical house, along with the apse dome and arch, is relevant to the definition of the global behavior. Conversely, the analyses evidenced that the translational response of the structure is governed by the high stiffness of the western branch of the transept and by the higher deformability of the eastern branch and the naves, so the back wall and apsidal section stiffness contribution is irrelevant (Figure 9). For these reasons and for consistency with the geometrical survey, these elements were kept as original in the final model and further calibration strategies were adopted for the modal shapes.

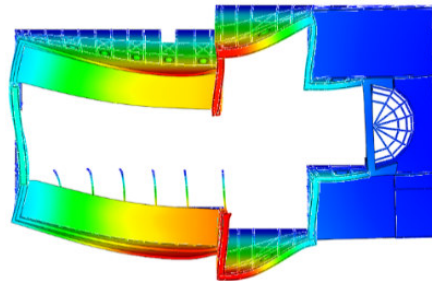
Figure 12: First modal shape of the final model (MR_02) removing the upper walls of the central nave

However, the modal shapes obtained still hardly correspond to the experimental ones. In fact, the modifications implemented allow a more coherent transversal behavior of the naves, the transept and the back portion, but a relevant deformation of the longitudinal walls of the central nave in the transversal out-of-plane direction is also detected. More studies were performed in order to try to limit the latter behavior by incrementing significantly the stiffness at the roof level, but no significant improvements were found. Conversely, it can be observed that the performed test setup was not able to catch this behavior since no accelerometers were placed at the top-middle location of the second-story walls of the central nave (Figure 4). Hence, the experimental results can only be compared with a partial numerical model in which the upper walls of the central nave are removed, which provide a good shape approximation indeed (Figure 12).
