## CHARACTERIZATION OF HISTORIC MORTAR SAMPLES AND PERIOD ANALYSIS: A CASE STUDY

**Keywords:** Lime mortar, Roman mortar, Byzantine mortar, rubble masonry, mortar characterization

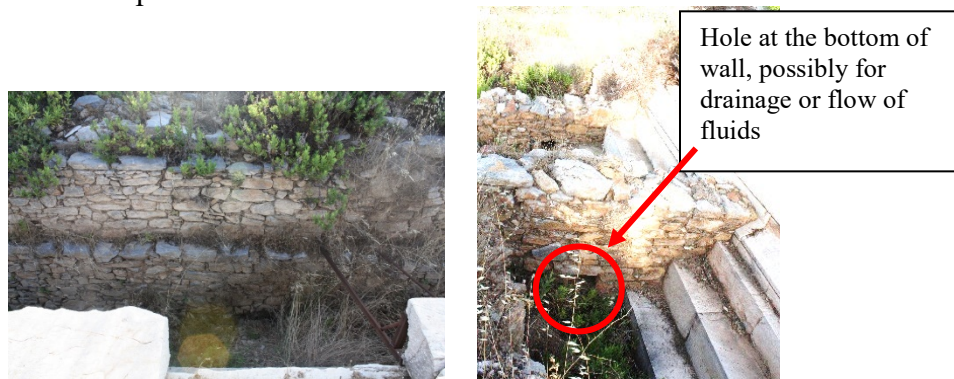
Figure 2. (a) The retaining wall on the north side, (b) One of the perpendicular walls with bottom hole on the east side

Further, the workmanship of the retaining wall is slightly different from the eastern walls perpendicular to the temple, where the rubbles are relatively larger and the mortar joints between the stone is thinner. Nevertheless, all of the building stones appear to be from the region and have similar geological characteristics [3].

In addition to Dodd's theories, the authors of this paper hypothesize that the eastern area with perpendicular walls to the temple may be used either for washing of the grapes or for additional areas of fermentation (Fig. 2). Areas that necessitate human labor were likely

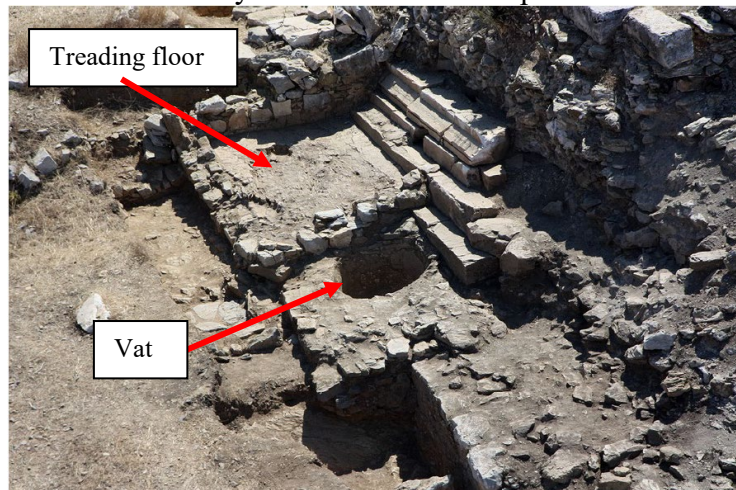
Figure 3. Antiochia ad Cragum wine press (source: Dodd, 2020)

The wine press components identified on site include a treading floor and a collection vat (Fig. 3). The production process in the Antiquity involved several steps and several areas, which are identified at the Antiochia ad Cragum site. According to Dodd [2], regional archaeological discoveries and established history of the region permits the probable assumption that grape vines were located relatively close to the press in the surrounding fields and terraces. This would lower the transport costs as well as reducing loss of the prized first juices released by the grapes as they are transported. Harvested grapes were then brought to the press in baskets and gathered nearby for sorting, the removal of unwanted matter, and, depending on the type of wine produced, dehydration. Dodd notes *“It is possible that the large disused temple floor above was used as a space to dry grapes on mats for the creation of raisin wine.”* Then the grape juice (must) was extracted either with static pressure under their own weight, but more likely for this location, by crushing underfoot on the treading floor. The juice then flows downward (the floor is slightly canted towards the vat on the west side) until it flows through a ceramic pipe (discovered on the site) and into the vat. The must then settled in the collection vat for filtration purposes. Any suspended settleable sediment (remaining heavy solids and residues) was bedded in the base depression of the collection vat. This process could be completed, with additives, in as fast as three days in antiquity. After this, fermentation took place, but Dodd states that it is difficult to interpret where and in what form did fermentation occur at this site. Two theories are offered by Dodd, with more plausibility of in-vat fermentation and wine production in limited amounts. Reader is referred to Dodd [2] for a more detailed study of the wine workshop at Antiochia ad Cragum.

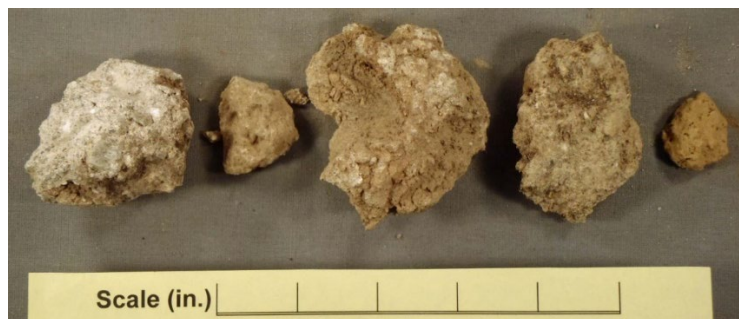
Figure 5. The as-received appearance of the five mortar samples are pictured from Sample M1 (left) to Sample M5 (right).

Five mortar samples were collected in 2018 from the areas shown in Figure 4 as M1 through M5, and described in Table 1. The samples (Fig. 5) are identified as soft and friable (*i.e.* exhibited low cohesive strength).

The analysis showed that all samples are hydrated lime-sand mixtures and no evidence for hydraulic lime was found. The paste ranged in color from buff to tan to light tan between the four samples (M1 through M4) as shown in Figure 5.

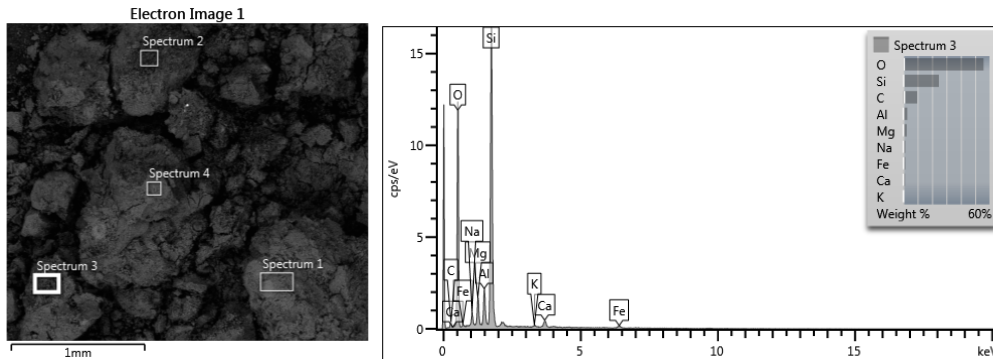
Figure 6. SEM results for sample M1

SEM analyses show that, in some portions of the mortar, there are layers of clay minerals (Fig. 6). Further, the binder was amorphous in texture mainly composed of calcium carbonate ( $\text{CaCO}_3$ ) (Fig.7c). Calcium carbonate is likely from the calcite rock that was used to produce the lime. Muscovite fragments and quartz are also observed throughout the mortar (Fig. 8). These two relatively less observed materials may be present in the calcite rocks used in the lime production. Samples M1, M2, M3, and M4 all contain hydrated lime lumps that were generally free of impurities (Figs. 7-9). The lime lumps were typically smaller than 0.5 mm but lumps with maximum sizes of approximately 3 mm to 5 mm and larger are observed as well. Shrinkage cracks, typical for lime-based mortars, were also observed during the petrographic analyses (Fig. 8). M1 has a relatively richer calcite amount as revealed in its whitish color in thin section analyses (Figs. 7 and 9) and in the form of relatively higher calcite peaks (exceeding

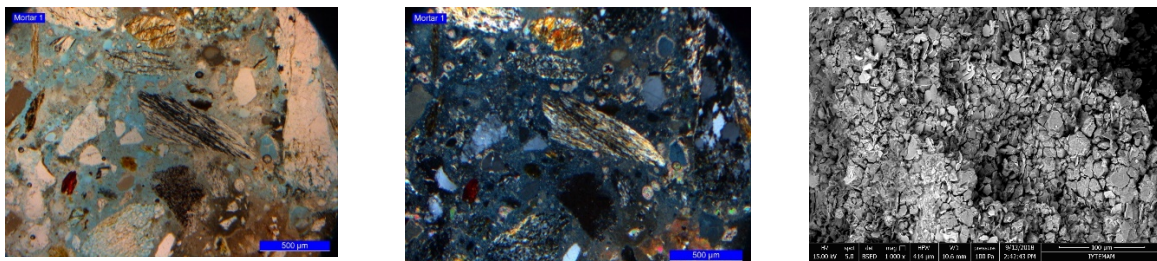
Figure 7. M1 sample: a) thin section microscopic image using plane-polarized light, b) thin section microscopic image using cross-polarized light in magnification of 500; c) calcite crystals in form of white pebbles at magnification of 1000x in the SEM image.

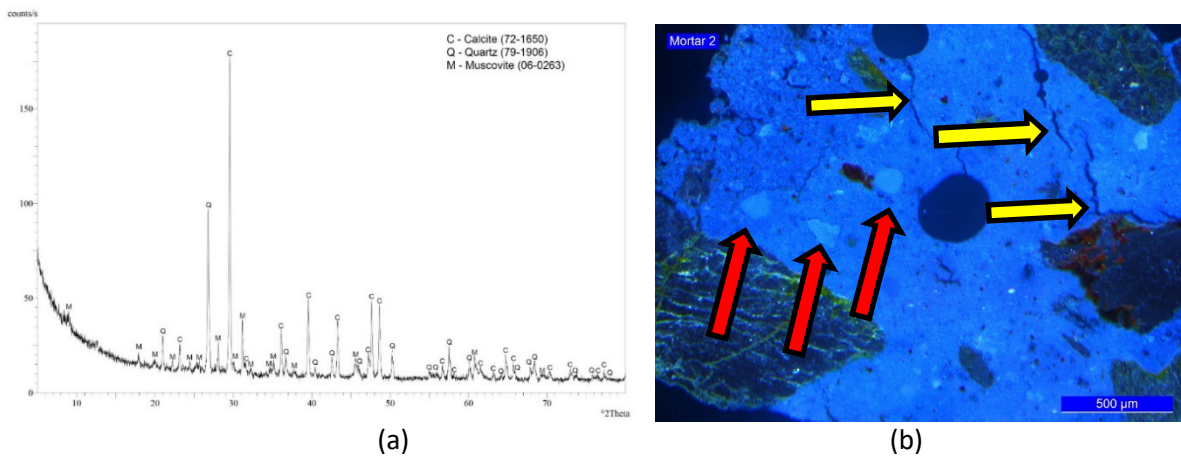
Figure 8. (a) XRD pattern of sample M2; (b) Hydrated lime lumps (red arrows) and shrinkage cracks (yellow arrows), pictured in thin section of sample M2 using oblique reflected light.

An abundant amount of void space is observed in samples M3 and M4, which are mortar and plaster samples from the Byzantine walls, respectively. The difference between void volumes may be related to placement techniques in addition to variations in initial water-to-solids content of the freshly mixed material. M2 has relatively more binder (Fig. 9). The sand in the samples consists primarily of calcite, mica, quartz, quartzite, and metamorphic rock fragments (either phyllite or schist), as revealed in both the thin section and XRD analyses (Fig. 7 and 8). The maximum-sized sand particles range from approximately 4 mm to 8 mm. The sand particles are sub-angular to rounded, well graded, and uniformly distributed. In addition, variability in volume of sand is observed between the samples with fewer fine-sized sand in M2 than in the other four samples. Presence of more binder and less sand may be related with an intention of achieving a fine mortar within the press. Cellulose fibers are observed on fracture surfaces of sample M4. In the Byzantine era, plasters with cellulose reinforcement were commonly used to reduce shrinkage cracks and improve tensile strength [5-6].
