# CONSERVATION OF HISTORICAL REINFORCED CONCRETE STRUCTURES

**Keywords:** Historical Reinforced Concrete Structure, Cupola, Hollow Block Slab

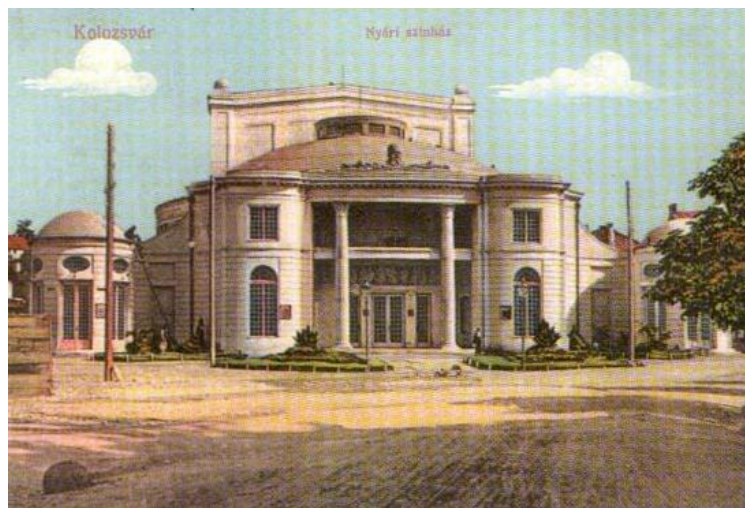
**Figure 1:** The original neoclassical building (postcard from 1914)

an “opeion” and “tambour” at the top and a perimeter ring at the bottom which rest on vertical masonry pillars. The original form of the building is presented in Figure 1.

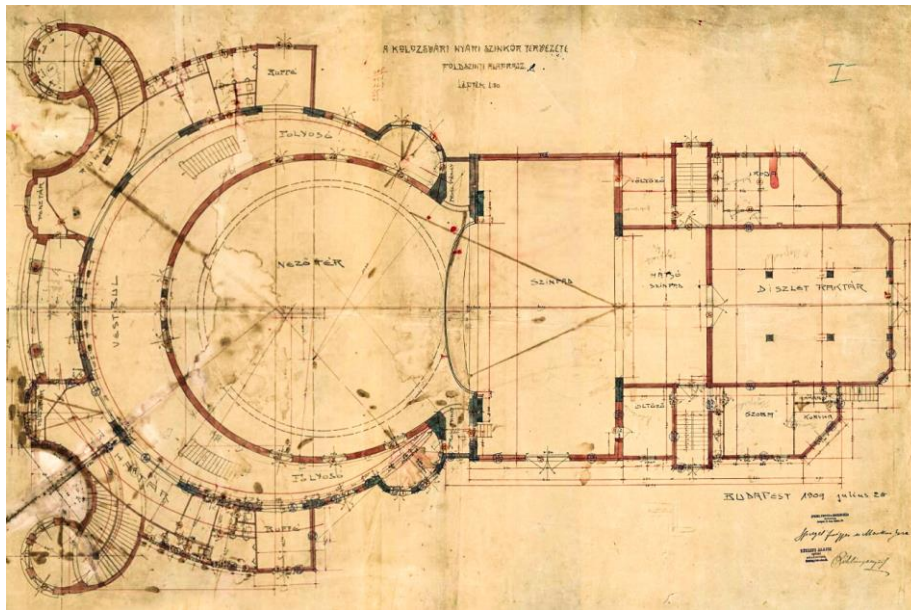
**Figure 3:** Ground floor plan, original project from 1909, National Archives of Hungary

The whole building is composed of several blocks corresponding to a classic organization of the space for the required function (Figure 3). The main block is that of the public hall on a circular plan, covered with a spherical cupola. More than half of its perimeter is surrounded by a circular corridor, covered with a toric shell, also unique at that time. The stage building arises behind the main hall and continues with the storage and cloakrooms.

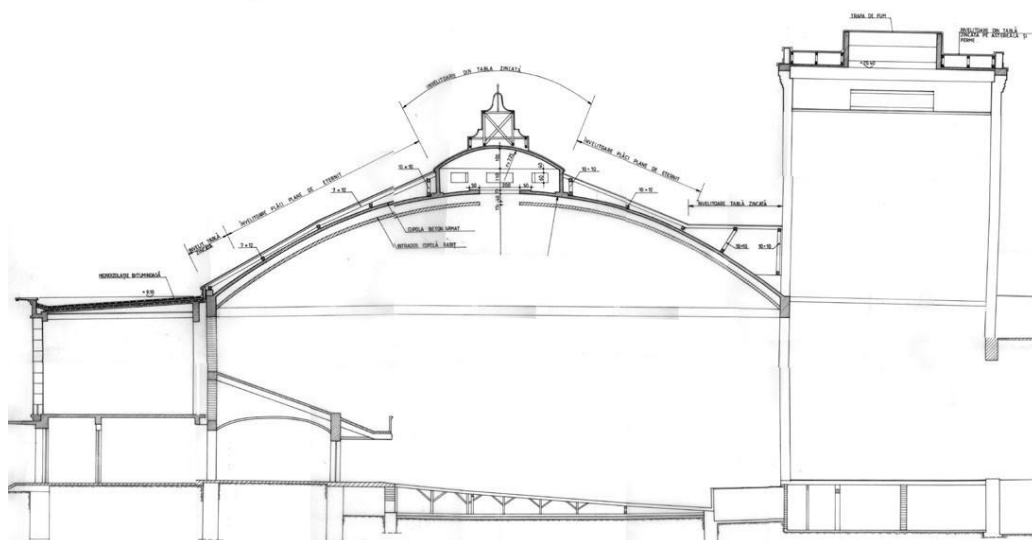
**Figure 4:** Cross-section: timber structure over the cupola, intervention project from 1959

The spherical dome was designed and built with a 21.98 m radius of curvature, 27.72 m span, and 5.00 m rise and has been preserved to this day (Figure 4). There are two superposed thin shells: a 12 cm thick upper shell with its thickness slightly increasing towards the basic ring and below – at 25 cm – another shell with a constant thickness of 8 cm, which supports the ornamental plastering of the ceiling. The two shells are connected to each other by steel wires of 2 mm in diameter placed every 40 cm apart. On the top of the cupola, there is a tambour of reinforced concrete with a wall thickness of 16 cm, 6.00 m in diameter and 1.30 m in height.

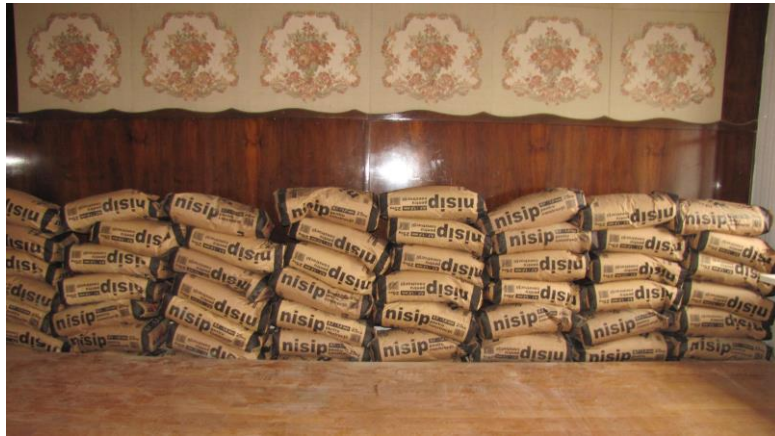
**Figure 8:** Sandbags as test loads added over the slab

The maximum load of 3.5 kN/m was applied incrementally using sand bags (Figure 8). The problem of ensuring that one way spanning members under test are actually subjected to the assumed test load is often difficult, due to load sharing effects. Isolation of ribs subjected to test from the surrounding structure would be preferred but saw cutting of monument is not acceptable.

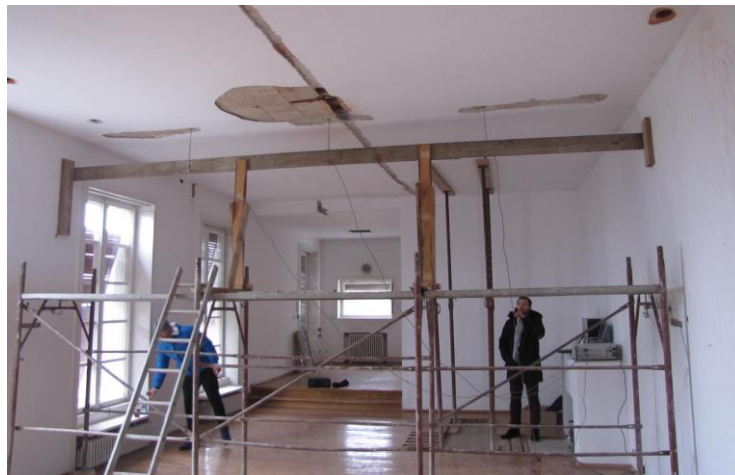
**Figure 9:** Slab Deflection measurement with displacement transducers

Displacement transducers, clamped to independent support, at midspan and  $\frac{1}{4}$  points (Figure 9) measured and transmitted deflections to acquisition data center. Plastering was removed from

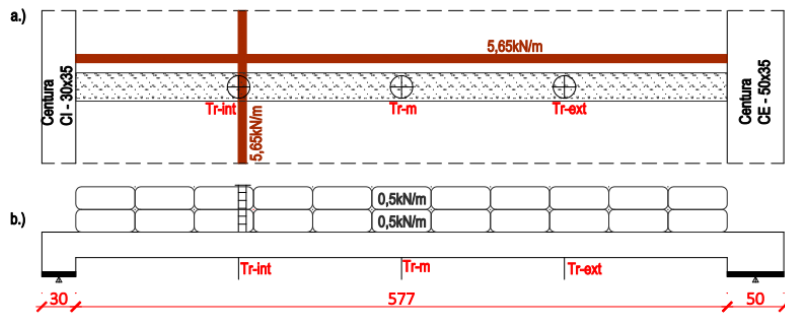
Figure 10: Slab strip scheme (a) plan and (b) section

A structural analysis of slab strip was carried out using ATENA (Advance Tool for Engineering Nonlinear Analysis). The model contains the reinforced concrete elements, meshed with 3D FE, and non-structural elements (plastering, hollow blocks, partition wall) were considered as loads.

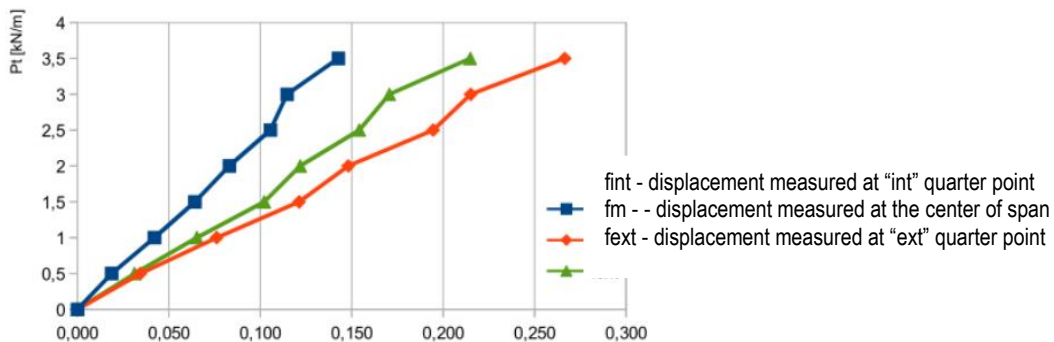
Figure 11: Measured deflection during load test [mm]

Like the in-situ test, loads were added incrementally, considering the same step of 0.5 kN/m. The maximum deflection measured at midspan is 0.27 mm, for load step 7, corresponding to a distributed load of 3.5 kN/m (figure 11). Although test loads were applied symmetrically, due to load sharing and stiffening effect of partition walls, slab deformation is not symmetrical, having different values in quarter points.

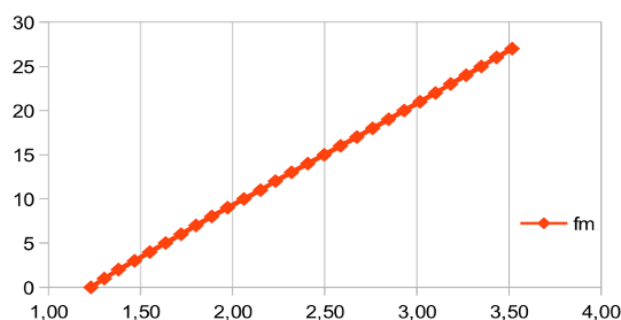
**Figure 12:** Calculated deflection for 27 load steps [mm]

The numerical analysis results were calibrated in a conservative way, obtaining for the seven equivalent load steps almost 1 mm deflection. Dead load is not counted as a load step, but one can observe that it produces a 1.2 mm deflection (figure 12). The 27<sup>th</sup> load step corresponds to a uniform distributed load of 13.5 kN/m, which is not the ultimate load, but a satisfactory characteristic serviceability limit load, causing cracks of maximum 0.3 mm width. This demonstrates the initial assumption concerning construction stage deflection of slab.
