CONTINUOUS STRUCTURAL MONITORING OF ADOBE BUILDINGS: SUMMARY OF A THREE YEARS EXPERIENCE IN PERU

Abstract. *The paper describes in detail the application of a vibration-based structural health monitoring system installed in the “San Pedro Apostol” church of Andahuaylillas located in Cusco (Peru), a 16th century adobe church considered a representative example of South America baroque architecture. The results of three years of long-term vibration and temperature and humidity monitoring program are reported in detail in the paper, with a focus on the long-term and short-term correlations between natural frequencies and environmental parameters. The results demonstrate that an accurate estimation of the first eight frequencies in the range 2-6 Hz is possible in the case of complex adobe structure and the existence of an annual cyclical behavior of the natural frequencies with a clear correspondence with the changes in environmental conditions due to seasonal influences. The performed correlations of ambient conditions and structural parameters confirmed the presence of different timescales and their not negligible influence in the case of a vibration-based structural health monitori

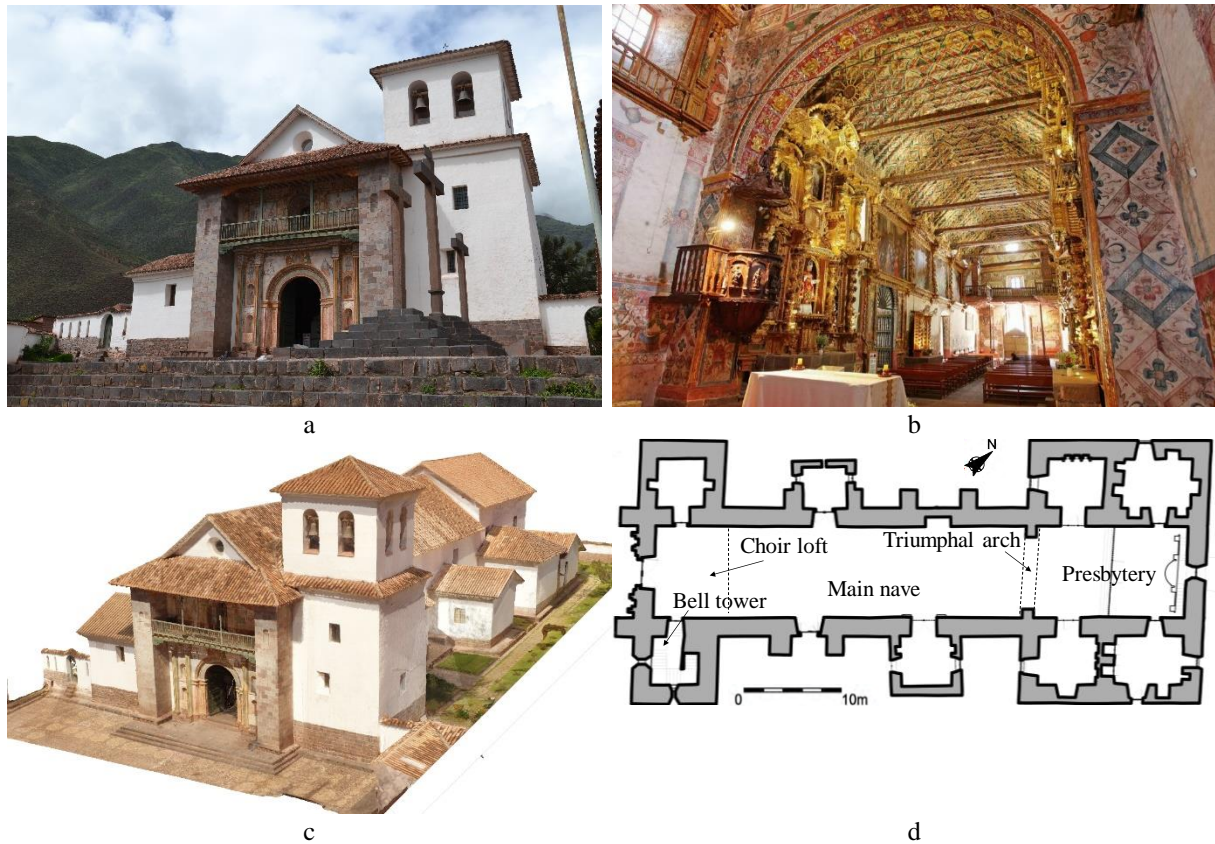
Figure 1: “San Pedro Apostol” church of Andahuaylillas: (a) exterior view, (b) interior view, (c) 3D reconstruction, and (d) plan view at the height of the base.

The “San Pedro Apostol” church is located in the main square of the Andahuaylillas, a village close to the Cusco city, in southeastern Peru, in the Andean region and it is considered the most emblematic colonial adobe church of South America (Fig. 1a). The church was built by Jesuit in the 16th century and is known as the “Sistine Chapel of Latin America” for its inestimable mural painting (Fig. 1b). The church covers an area of 61 x 27 m (Fig. 1c), with a main nave of 58 x 12 m and a height of 10 m, and it is connected directly to the baptistery, the bell tower, two later chapels and, by a triumphal arch, to the presbytery (Fig. 1d). The adobe walls have a variable thickness from 1.10 m to 2.00 m and a stone masonry foundation with a height of 1.5 m. The longitudinal walls of the nave are connected by wooden tie-beams and

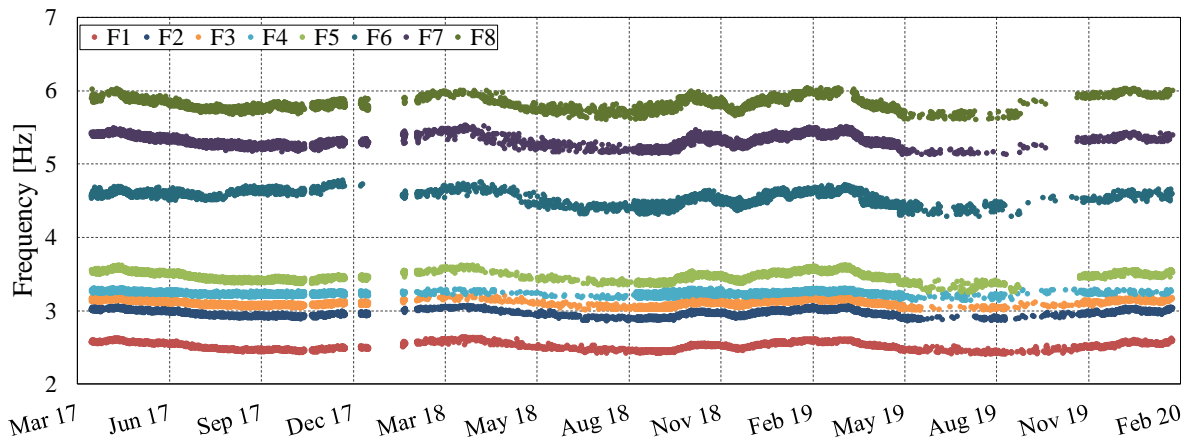
Figure 4: Time evolution of the first eight natural frequencies of the “San Pedro Apostol” church from March 2017 to November 2019.

The analysis of the recorded ambient vibration data was performed, and the results are presented in Fig. 4. As shown, the first eight frequencies of the adobe church were clearly detected in the range 2 Hz and 7 Hz. As shown, the results indicate a seasonal influence during the monitoring period. Lower frequency values were reached during colder months (between June and September), while higher values in the summer months (between December and March). An irregular behavior was detected close to November 2018 with a local decrease of all the identified frequencies.

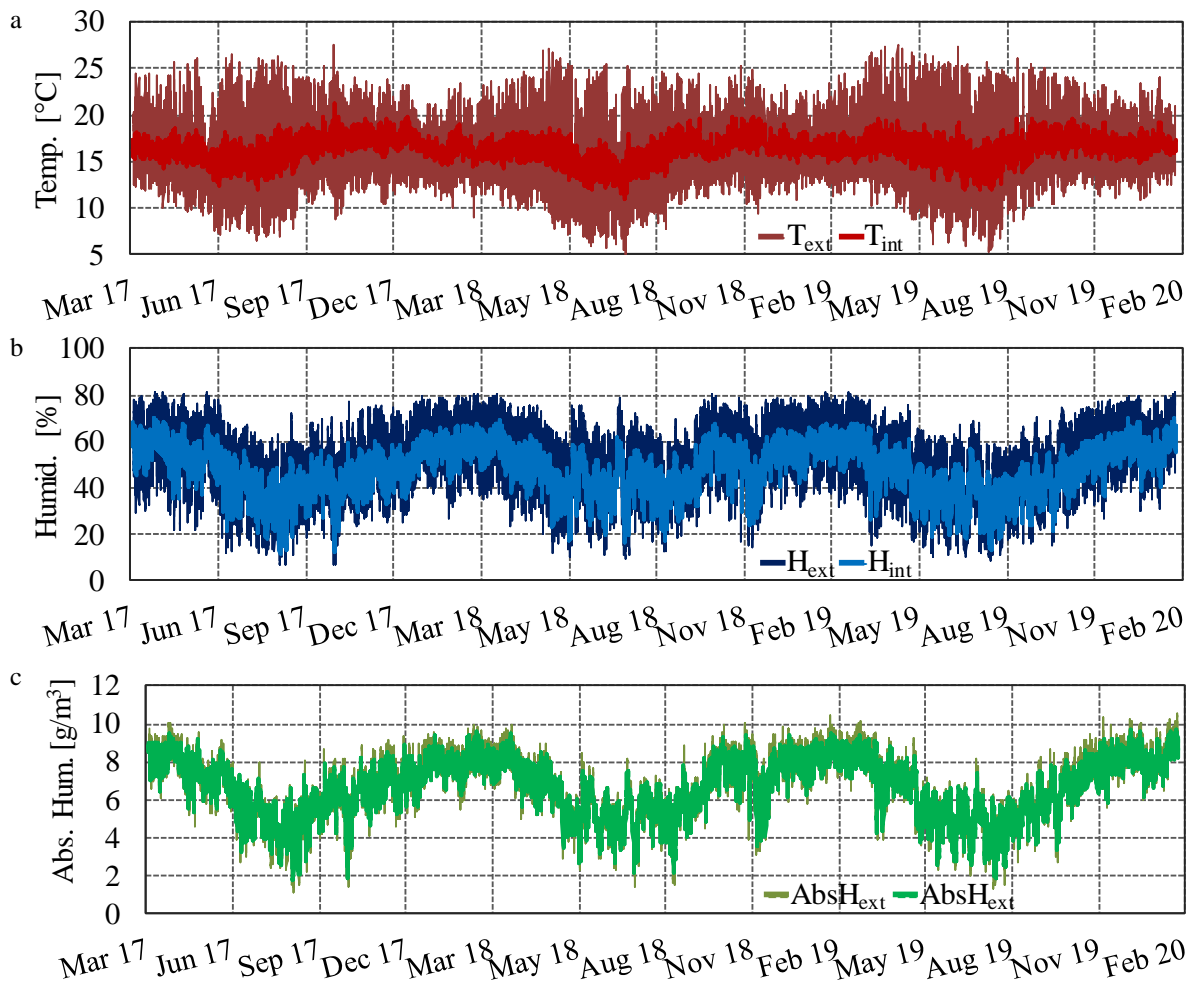
Figure 5: Time evolution of the church's ambient temperature and humidity: (a) external and internal ambient temperatures T_{ext} and T_{int} , (b) external and internal relative humidity H_{ext} and H_{int} , and (c) external and internal absolute humidity $AbsH_{ext}$ and $AbsH_{int}$.

The results of the ambient temperature and relative humidity evolution are shown in Fig. 5. The external ambient temperature (T_{ext}) exhibits a not clear seasonal trend of the data with higher daily variations in the summer period and lower in the winter one (Fig. 5a), reaching a maximum value of 28°C and a minimum value of 5°C during the monitoring period. On the contrary, the internal ambient temperature records (T_{int}) shows clear seasonal trends, with an increase of the values during the summer period and a decrease in the winter one (Fig. 5a). An attenuation phenomenon of the daily thermal variation compared to the external ambient records, reaching a maximum value of 21°C in winter and a minimum value of 11°C in summer. Similar attenuation between external and internal measurements was recorded in the case of relative humidity (see the external relative humidity, H_{ext} and the internal relative humidity, H_{int} of Fig. 5b). The values of the external relative humidity range between 82% and 7%, in comparison with the values of the internal relative humidity that range between 71% and 12%. Clear seasonal trends were also detected with a humidity drop in the winter period (between June and September) in both external and internal values.

Aiming at developing a single variable that integrates information of ambient temperature and relative humidity, the external and internal absolute humidity ($\text{Abs}H_{\text{ext}}$ and $\text{Abs}H_{\text{int}}$, respectively) were calculated to achieve a better understanding of the effects of thermohygrometric parameters on the natural frequencies of the adobe church (see more details of how this variable is calculated in [13]). In particular, $\text{Abs}H_{\text{ext}}$ and $\text{Abs}H_{\text{int}}$ were calculated using the recorded data of $T_{\text{ext}}/H_{\text{ext}}$, and $T_{\text{int}}/H_{\text{int}}$ sensors, respectively, and they represent the amount of water vapor in the external and internal air of the church. The results of the calculated absolute humidity values in the entire monitoring period are showed in Fig. 5c. A clear seasonal decrease (from 10 g/m^3 to 2 g/m^3) was recorded for both parameters in the winter period, with an irregular behavior detected close to November 2018, with a clear similarity of the time evolution of the identified frequencies. Furthermore, high capacity to reduce the variation between the external and internal measurements is shown by this calculated parameter.

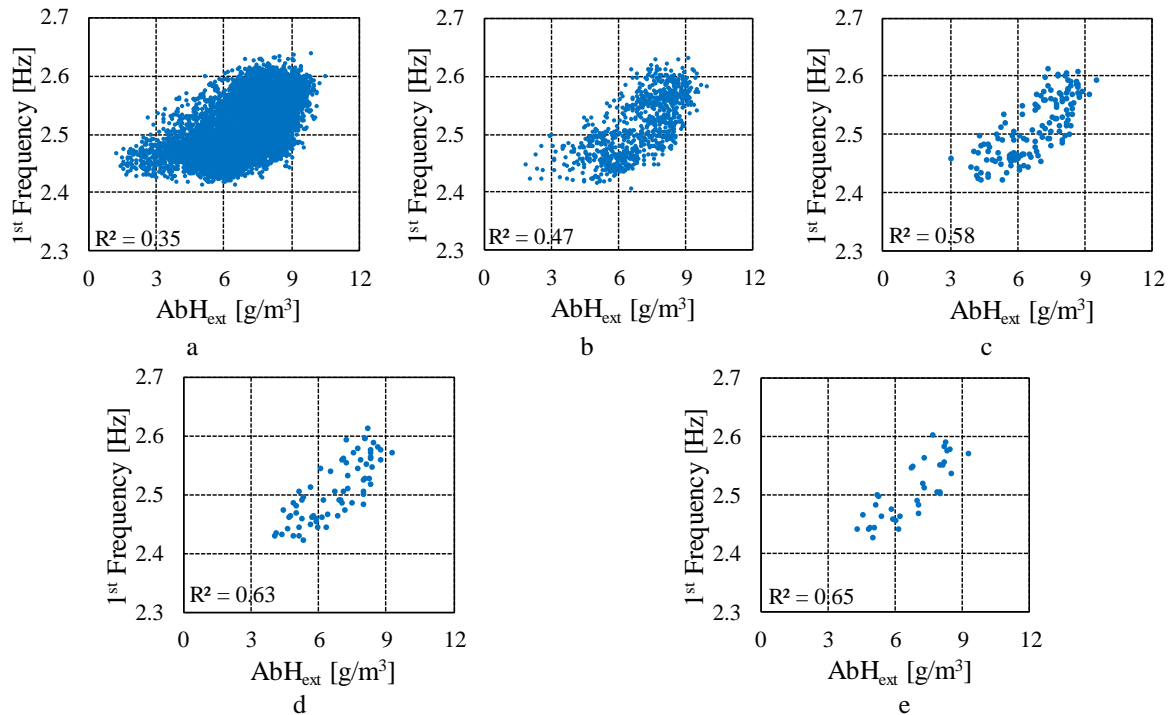
Figure 6: Correlation coefficients distribution between the first natural frequency and external absolute humidity: (a) raw data, (b) data filtered by a daily average, (c) data filtered by a 7 days average, (d) data filtered by a 15 days average, and (e) data filtered by a 30 days average.

Fig. 6 shows the correlation distributions of the first frequency with the external absolute

humidity corresponding to the entire monitoring period. Aiming at analyzing the influence of the environmental parameters on the frequency with different timescales, the raw data was filtered by averages with different timescale. In particular, Fig. 6a shows the correlation distribution obtained by the raw data. Fig. 6b shows the correlation distribution obtained by filtering the raw data with a daily average (the mathematical average was carried out with the 24 data recorded in one day). Finally, Fig. 6c, Fig. 6d, and Fig. 6e show the correlation distribution obtained by filtering the raw data by averaging the data of 7 days, 15 days and 30 days, respectively.

The results show that the correlation coefficients between the raw data of the first frequency and external ambient humidity are almost good ($R^2=0.35$) with a positive trend. The results of the correlation distribution with the daily average filtered data show a higher value of correlation coefficient ($R^2=0.47$) with a clearer positive trend. The results improve with the 7 days average filter, reaching a correlation coefficient of 0.58. Finally, with the 15 days average filter and the 30 days average filter, there is a slight improvement of the results, reaching a correlation coefficient of 0.65.
