HISTORICAL ANALYSIS AND IN-SITU INSPECTIONS OF A CULTURAL HERITAGE MASONRY BUILDING

Keywords: Historical Structure, Masonry, Historical notes, Non-Destructive Inspection

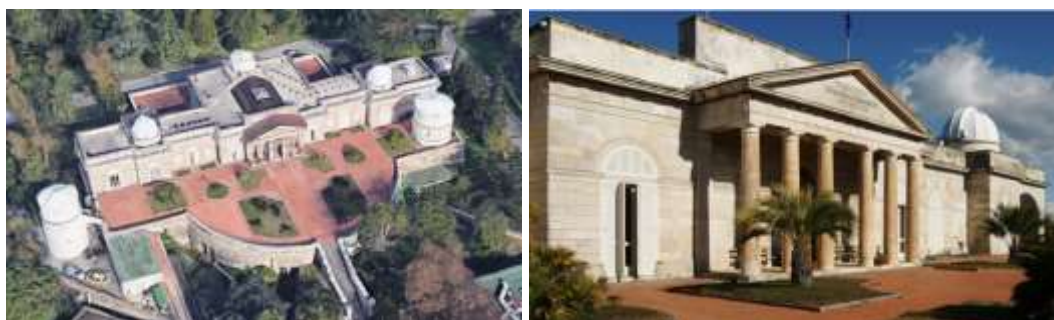
Figure 1: General view of the Astronomical Observatory of Capodimonte in Naples.

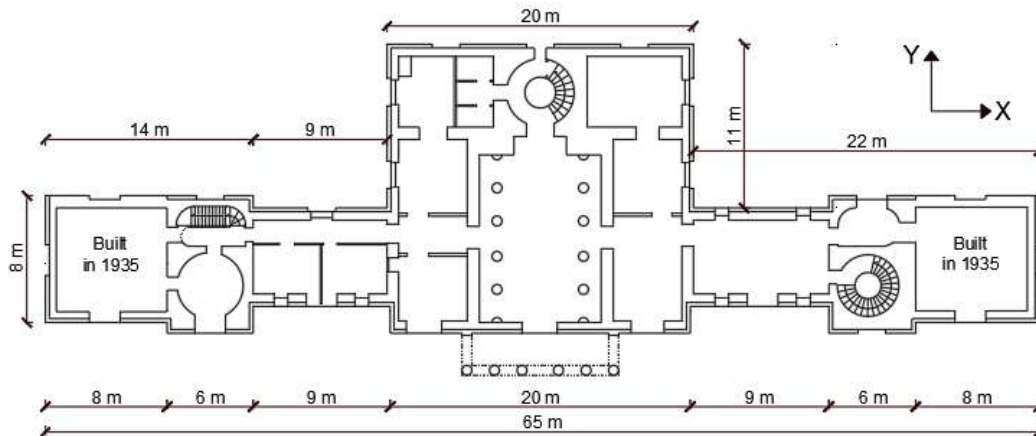
As a preliminary step, the complexity of the building required to get hold of a detailed knowledge of its geometry. Therefore, a complete in-situ inspection was carried out for understanding the organization of the structure. The plan layout of the ground floor of the astronomical observatory is reported in Figure 2. The building was realized using tuff (natural

volcanic stone) masonry typical of the Italian region where is located. The plan has an elongated rectangular shape and approximately its dimensions are $65\text{ m} \times 20\text{ m}$. The construction has two stories; both the underground floor and the ground floor are approximately 4.0 m high. The thickness of the walls varies between $1.00\text{--}1.55\text{ m}$ at the underground floor, where it was not always possible to do the measure, and $0.50\text{--}1.00\text{ m}$ at the ground floor. A particular feature of this building is due to the presence of a heavy stone cladding whose thickness equal to 25 cm was measured by means of a hole. This aspect is particularly important in a seismic analysis as it behaves as an additional mass.

The main entrance to the building is preceded by a pronaos surmounted by an architrave, the tympanum and other classical elements of the Greek temple architecture. In the building it is possible to recognize three main blocks: a central square block and two rectangular lateral blocks. The main rectangular room (central atrium) is characterized by two lines of marble columns and it is covered by a barrel vault with a glass skylight. Also, the lateral zones adjacent to the central atrium, are covered by barrel vaults or hemispherical dome, except the last rooms at the two ends that were added in 1935 using the same stone for masonry while the floor was realized by iron beams and clay tiles.

Figure 2: Plan layout of the ground floor.

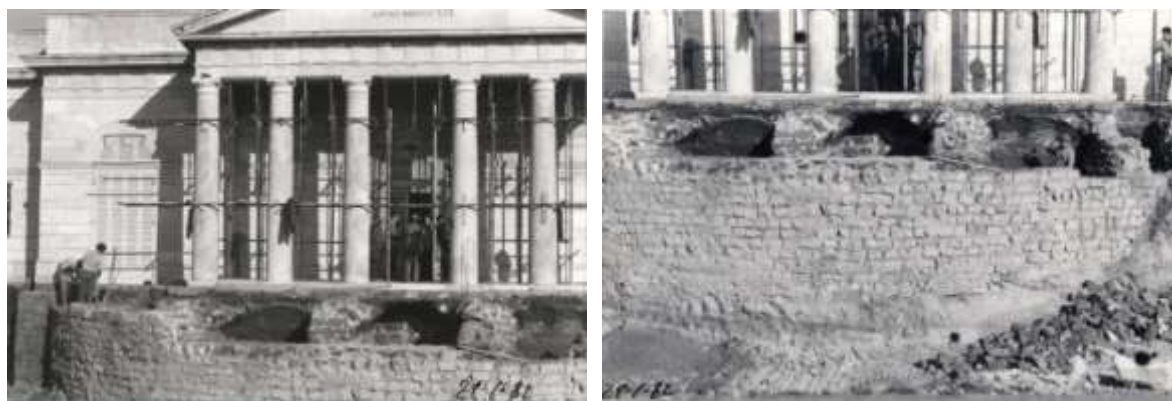
Figure 4: Works for the realization of the Auditorium in 1982.

In fact, from the photos it is clear that the external circumference and the radial corridors surmounted by main and secondary arches, in accordance with the project of Figure 3a, had actually been constructed at the level currently buried in the square in front of it. Figure 5 shows the overlap of the current plan of building and the project designed by Stefano Gasse, suitably scaled considering the palm-meter conversion. This hypothesis is not surely confirmed underlining the great difficulties related to the identification of the structure of the underground

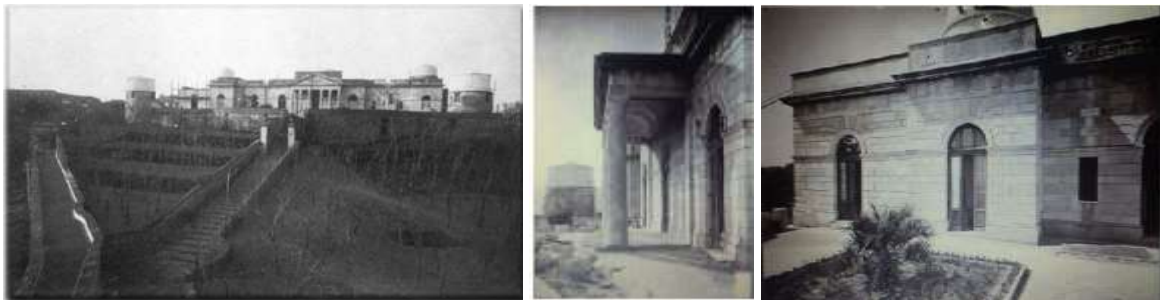
The building was completed in 1819 but it has undergone some changes during the time especially when two rooms on two extreme sides in the longitudinal direction were realized in 1935 (Figure 3a and Figure 6), as written in other documents. Albeit the new parts were designed to be integrated in the same style of the original building they can be distinguished by the presence of a coating and a cornice in mortar and not in natural stone as for the ancient construction. Furthermore, the connection of the two new end rooms required a reorganization of the original end rooms changing the door positions and removing a large masonry column visible in the original plan in Figure 3b, that supported a telescope.

Figure 6: Enlargement work of the building in 1935.

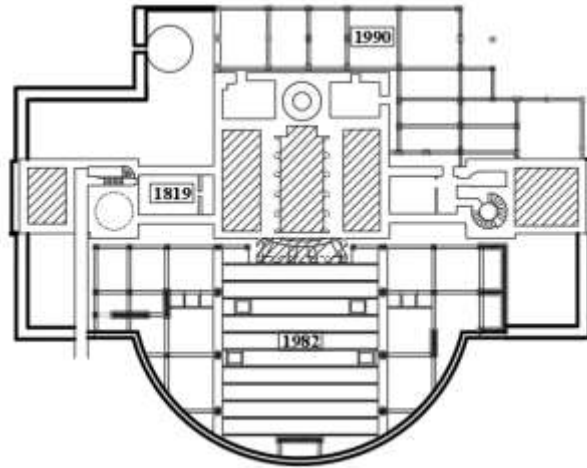
Further interventions were realized over the time along the perimeter with the construction of two buildings separated by a joint which were built by emptying the soil contained in the boundary wall of the courtyard in front and behind the observatory. Figure 7 show a complete layout of the underground level of the building including the boundary wall, the auditorium built in 1982 and the library built in 1990.

Nevertheless the real configuration of the basement, where the rooms with filling in the plan of Figure 7 are not accessible is still uncertain; in fact some zones as the central atrium, visible from the photo in Figure 8 taken during the construction of the auditorium, probably are empty while others as the side areas of the atrium are presumed to be full of soil because after the realization of some structural elements in shaped excavation the soil wasn't removed.

Figure 7: Complete layout of the basement.

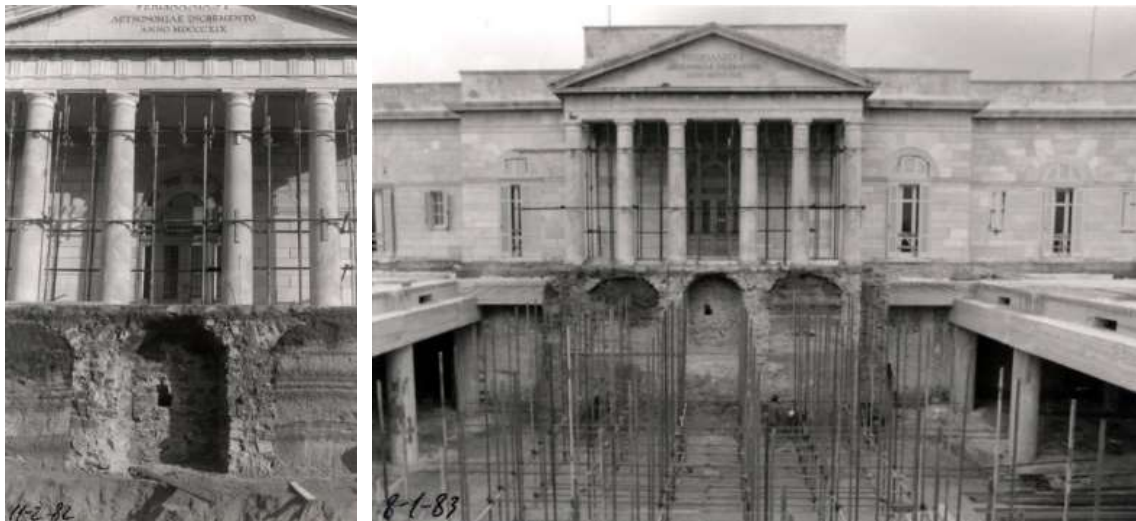
Figure 8: Photos of the working construction of Auditorium in 1982.

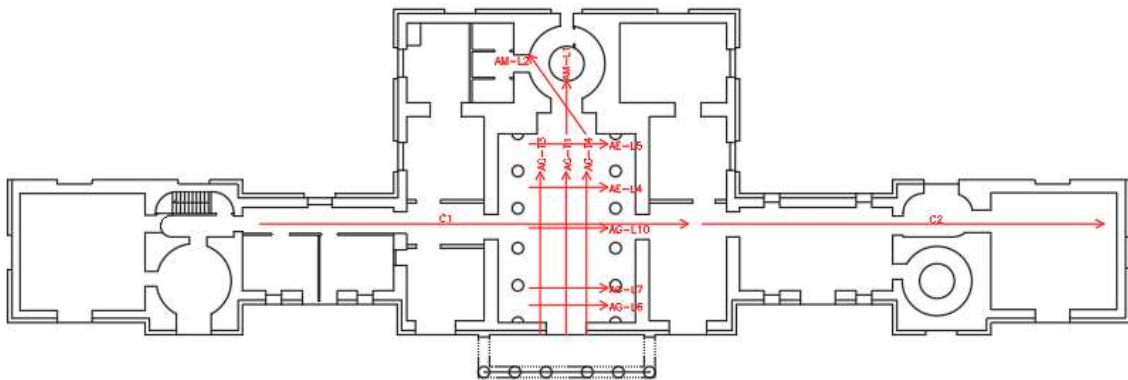
In this case the onsite investigation of the building was supported by high frequency radar scanning. The sections investigated, concentrated mainly in the central atrium area are shown in Figure 9.

Figure 9: Section investigated by georadar.

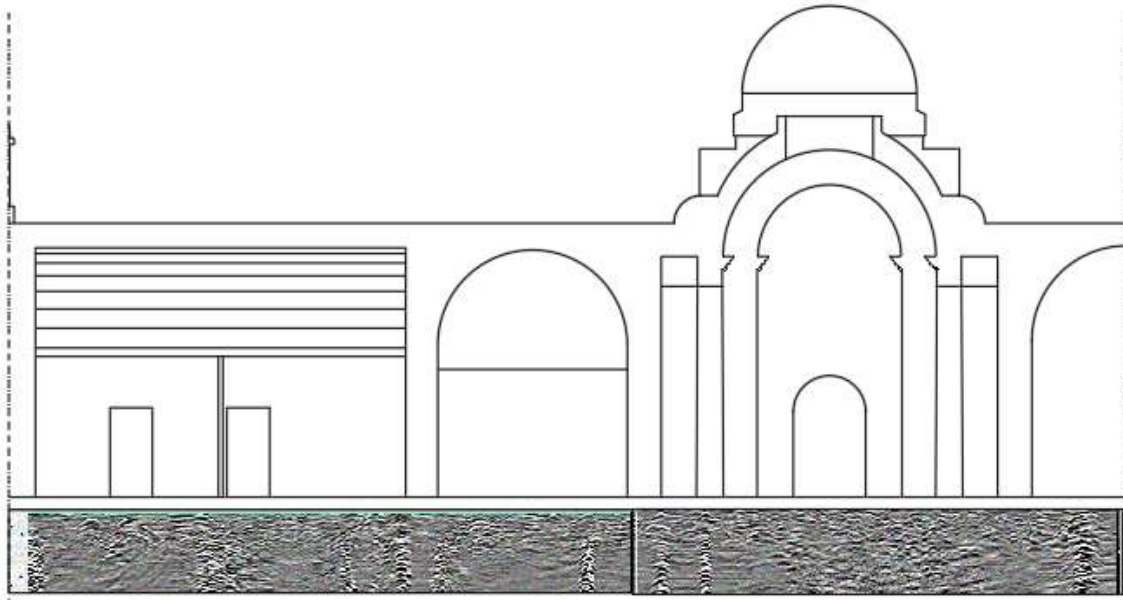
Only the most important results produced as radargrams, i.e. grey scale intensity charts giving the position of the antenna against the travel time, are reported. The radargram acquired along the corridor (Figure 10 and Figure 11) in the longitudinal direction gives a lot of information about the presence of walls, vaults and the detection of the fully and empty zones of the underground level. For the analysis of the results it should be considered that the small waves continuous along the depth with a hyperbolic shape correspond to a presence of a wall instead small hyperbolic waves at variable depths should correspond to the presence of a vault. The areas where the response is characterized by the absence of reflections can be considered fully of soil, while all areas where there is a very dense set of points can be considered empty.

Figure 10: Radargram along the corridor C1 in longitudinal direction.

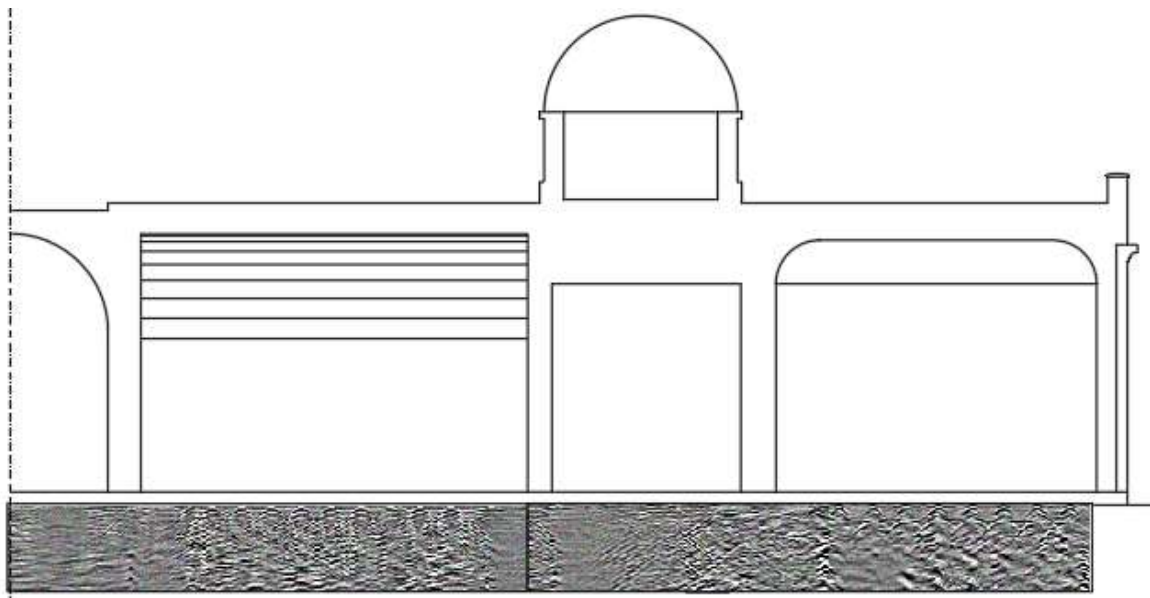
Figure 11: Radargram along the corridor C2 in longitudinal direction.

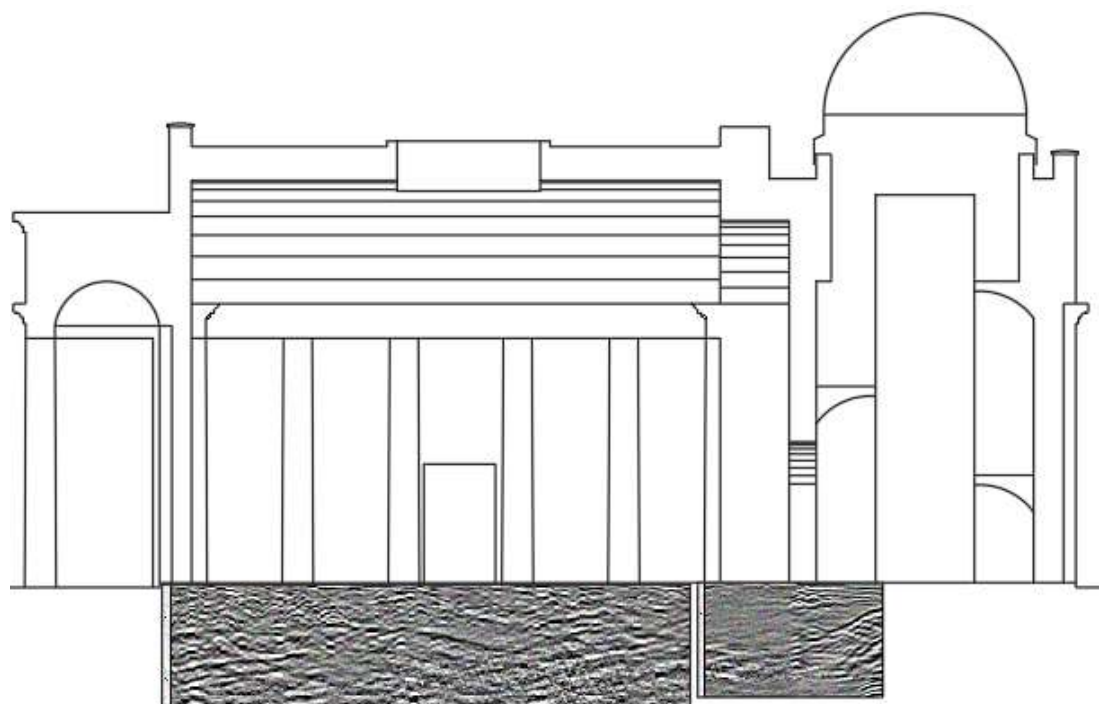
The interpretation of the radargrams in the transversal direction is more challenging as the profiles are much shorter. In detail, for example, the radar profile AG-T1 (Figure 12) shows an initial area with quite regular hyperbolic reflections at variable depths, probably due to presence of a vault. Right after, from the middle to the end of the radargram reflections due to

voids can be observed. Instead in the middle part of the radargram AM-L1, hyperbolic waves continuous in height are shown suggesting the presence of walls while the reflections at the end of the radargram are indicative of the continuation of the circular column at the stairwell up to the basement. It should be noted that despite the analysis of historical documents, the execution of the surveys and investigations also by means of georadar was important.

Figure 12: Radargram AG-T1, AM-L1.

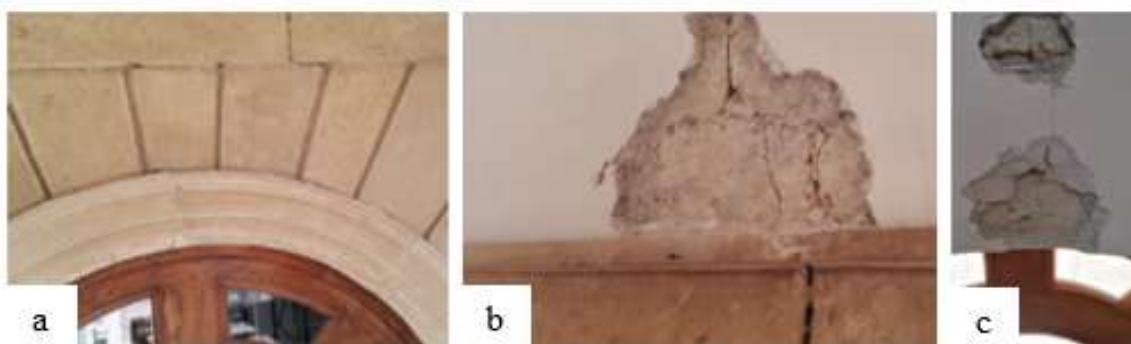
By direct visual inspection (July, 2019) it was possible to notice the current damage level of the historical building in terms of cracks and material decay. The majority of cracks are visible in the central atrium, on the lintels of the doors and windows and the vaults of the ground and underground floor. In particular a crack (Figure 13) was found at the stone frame of the arched entrance door on the outside but some slight cracks also branch off on the inside. An essay was carried out by creating a pocket of 50 cm x35 cm, seeing that the crack affects the tuff blocks that make up the vault and affects the entire thickness of the wall. The crack is probably a local phenomenon due to the tension stresses at the intrados of arch key.

Figure 13: a) Crack at the stone arch of the entrance door; b) external essay; c) internal essay.

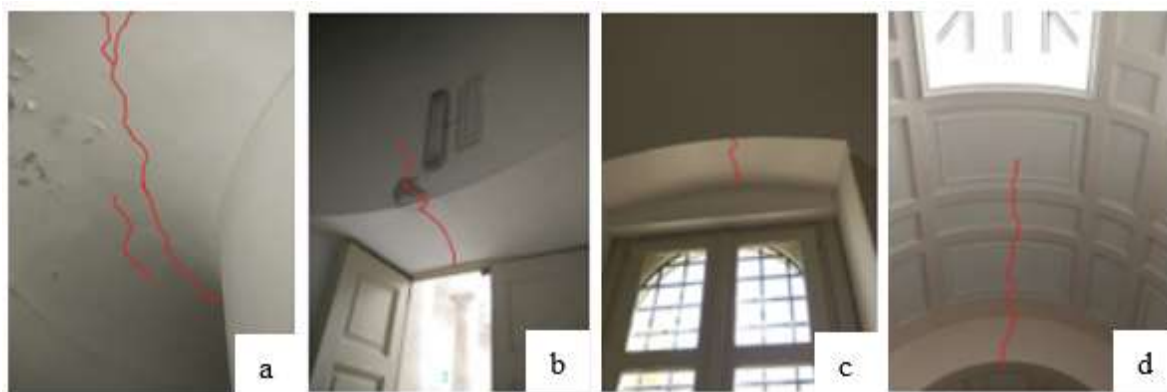
The upper part of the spiral staircase is closed by a vault which has a lot of cracks (Figure 14 a), typically visible along the key of the vault where the maximum tension stress occurs. In fact, when the plaster was removed for an area of about 30 cm x 30 cm and a hole was realized through the thickness of the vault, it resulted made by one red brick 4 cm thick, that is a very thin structure sensible to bending effects. Another crack was visible in the middle of the entrance to the spiral staircase, therefore it was investigated removing the plaster (Figure 14b). It was observed that the entrance was realized without a stone or wood lintel even it is approximatively plane and not really an arch, thus the crack is due to bending effects.

Other widespread cracks due to the absence of lintels were found at all the openings (doors and windows) of the rooms of the building (Figure 14 c) while slight cracks were found at the barrel vaults covering some rooms (Figure 14 d). All the cracks appear as local phenomena due to the low strength of the masonry in tension and degradation of the mortar but they don't indicate a local or global failure mechanism.

Figure 14: Crack at the vault (a) and the entrance (b) of the staircase; c) crack due to the absence of lintels; d) barrel vaults crack.

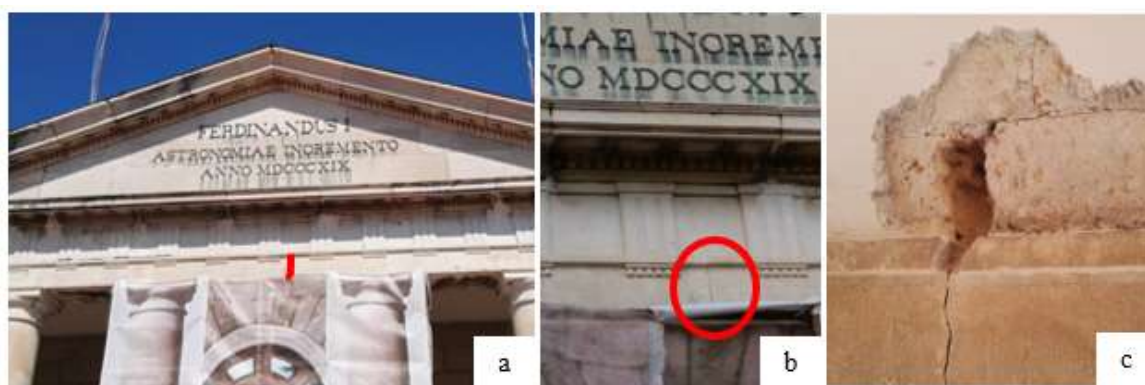
Finally, a vertical crack is located at the midspan of the stone lintel of the pronaos (Figure 15 a) that is actually shored up. An assay was performed at the crack on the internal side of the pronaos to check the stones of the vault that is supported by the stone lintel (Figure 15 b). The tuff block 28 cm thick used to realize the vault resulted not cracked confirming that the damage regards only the stone lintel and it is caused by the tensile stresses in bending together with the stone degradation (Figure 15 c) due to uncorrect raining water disposal.

Figure 15: Crack at the midspan of the stone lintel (a-b); c) essay at the internal side.
