NUMERICAL ANALYSIS OF HISTORICAL REINFORCED CONCRETE SHELL

Keywords: Historical Structure, reinforced concrete shell, numerical analysis

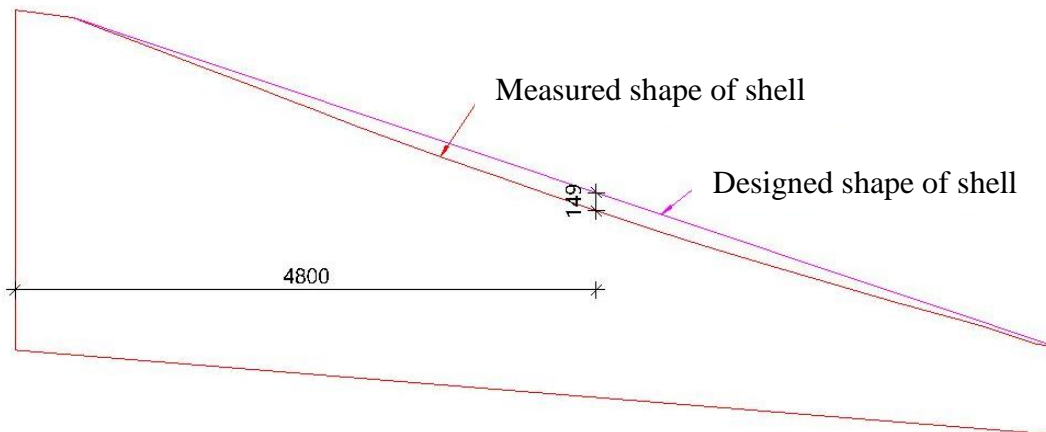
The shells show obvious deformations (Figure 2, 3) and their center line deviates significantly from the ideal shape of the shells from the project. This shape fundamentally affects the unsatisfactory static behavior.

Figure 2: Longitudinal section of the shell at the point of greatest deformation, added shape according to the design

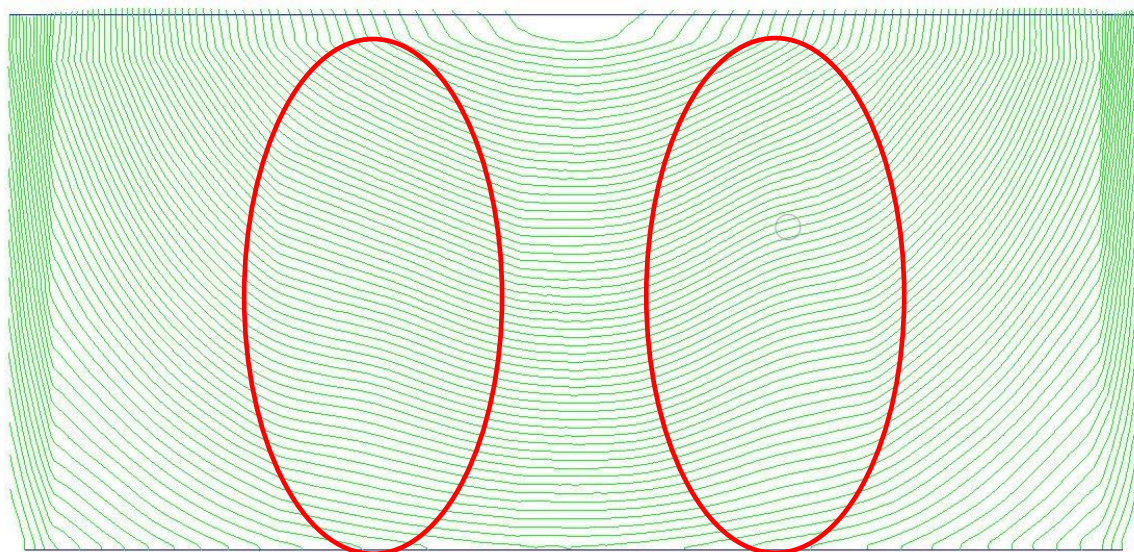
Figure 3: Contour line after scanning the bottom surface of shell 7 in field 5 - plan view. Areas with pronounced bulges marked.

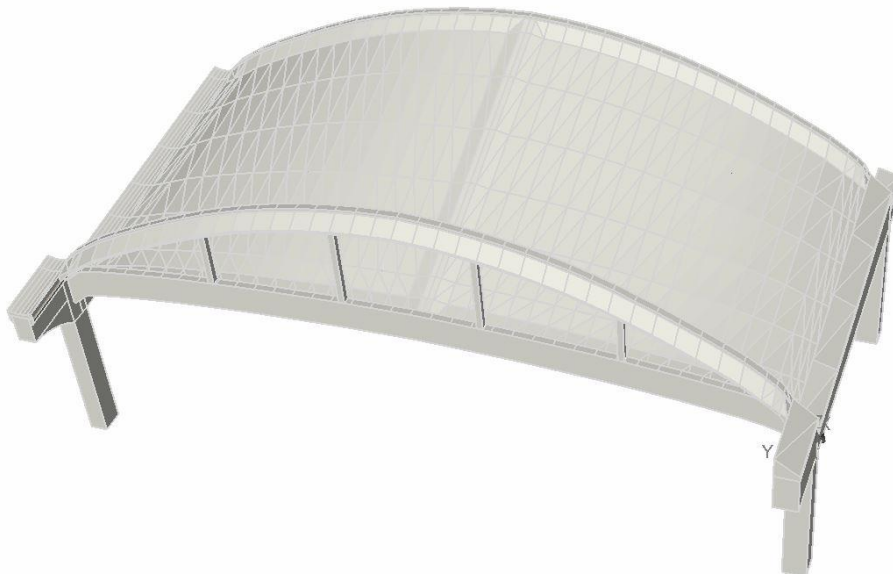
The shell is modeled with the thickness by the project - it is 50 mm, which is measured vertically. The shell is double curved, so it is divided into a series of smaller elements to make the mesh element generator able to work with these elements. As a result, the model with the ideal shell shape consists of 320 macroelements (Figure 4).

Figure 4: Model of ideal shell shape

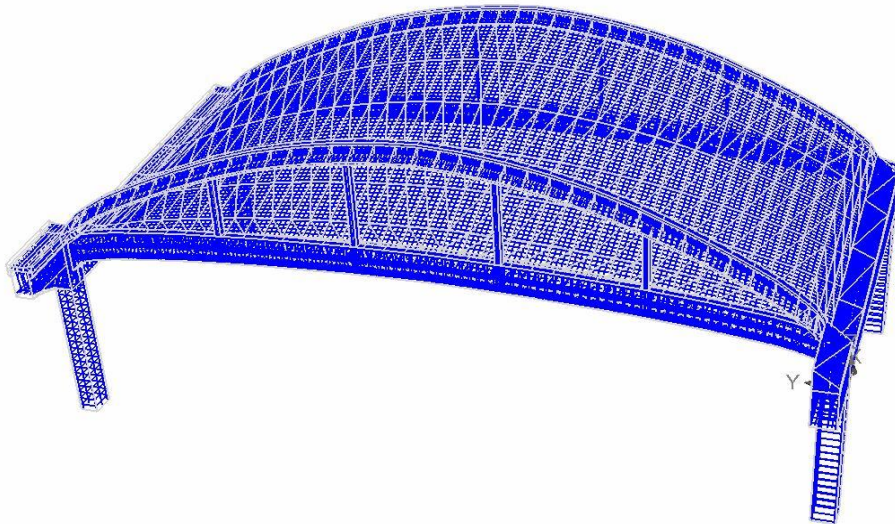
The model is reinforced according to the drawings of the preserved historical documentation. All members are inserted into the model as discrete models (= each member is physically modeled and can show stress). The shell is reinforced with $8\text{Ø}5.5$ per meter in both directions, and the upper reinforcement is added at the point of attachment. Reinforcing profiles of diameters 14, 16 and 20 mm for longitudinal reinforcement (including bends) and diameters of 5 and 7 mm for stirrups are inserted into the beam members. Typical stirrup spacing is 200 mm. The model contains 2033 bar reinforcements (Figure 5).

Figure 5: Model with reinforcement

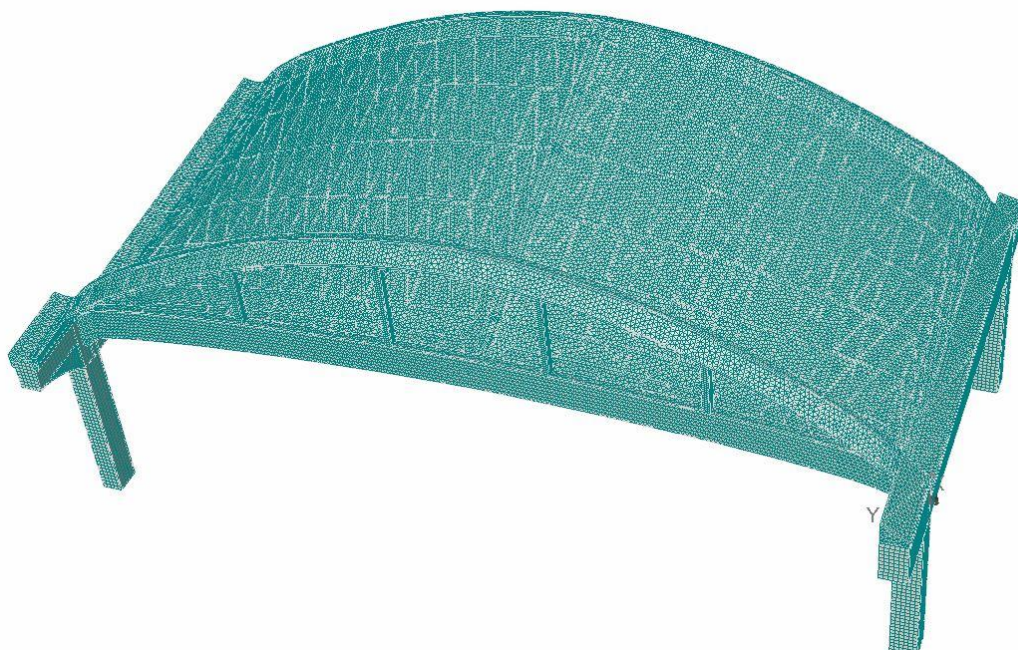
The model consists of a finite element mesh with a global mesh edge size of 100 mm. Most of the macroelements are meshed by tetra elements. The model consists of 307 623 finite elements in total (Figure 6).

Figure 6: Model with generated finite element mesh

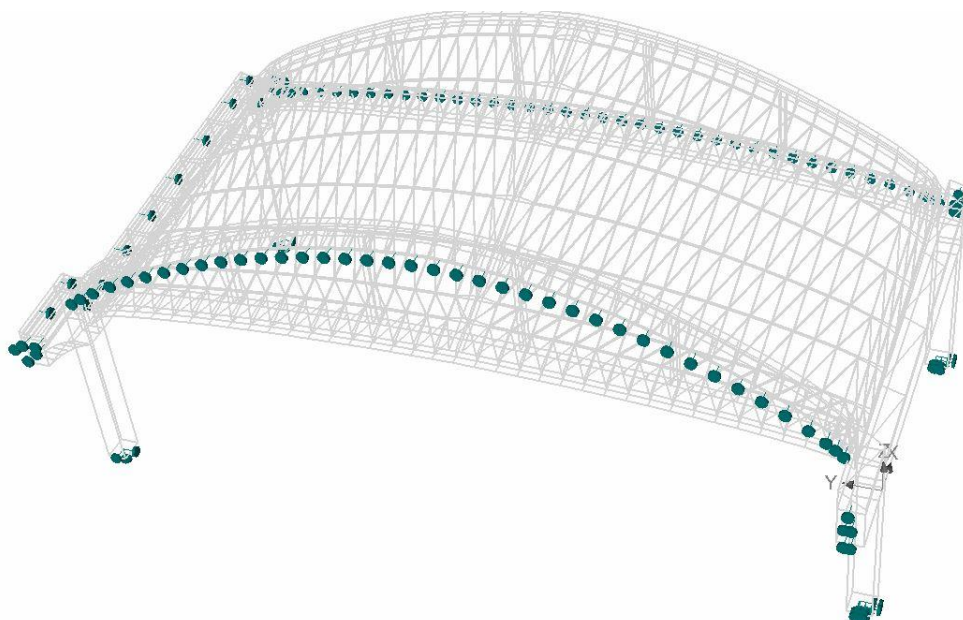
The support of the model is realized as a fixed support on the lower surfaces of the columns, supplemented by the conditions of continuity on the parts of the structure, which are connected to the surrounding parts of the roof – supports, which prevent rotation and horizontal displacement in direction of supported face. (Figure 7).

Figure 7: Model with applied supports

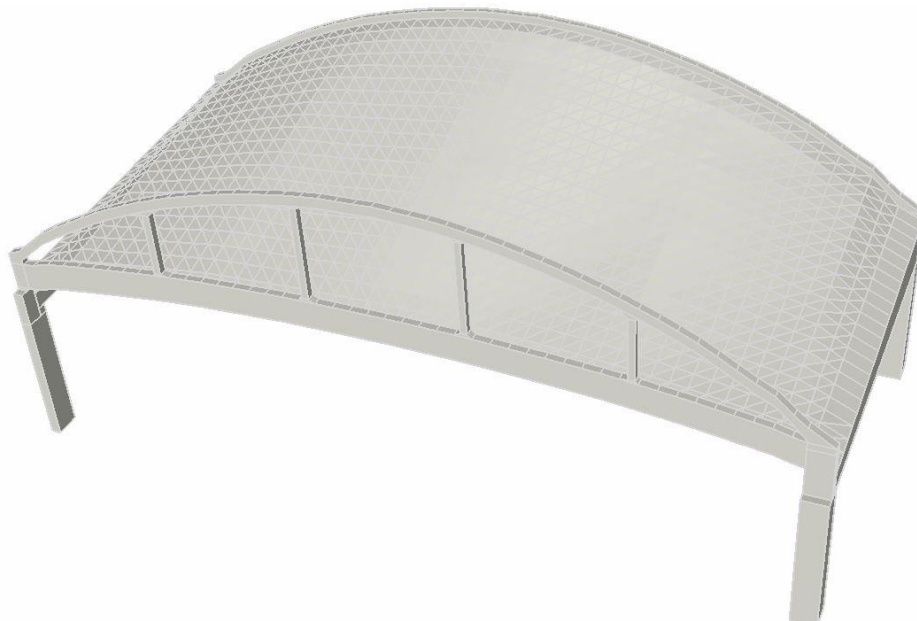
The shell is modeled with an average thickness according to the survey - it is 48 mm, which is measured vertically. Shell elements were divided according to the needs of the program into smaller partial parts (shell on parts approx. 0.4×0.4 m - for the possibility of capturing deformations), some elements were divided into triangles (elements of the shell). The model consists of a total of 2116 macroelements (Figure 8).

Figure 8: Model of actual shell shape

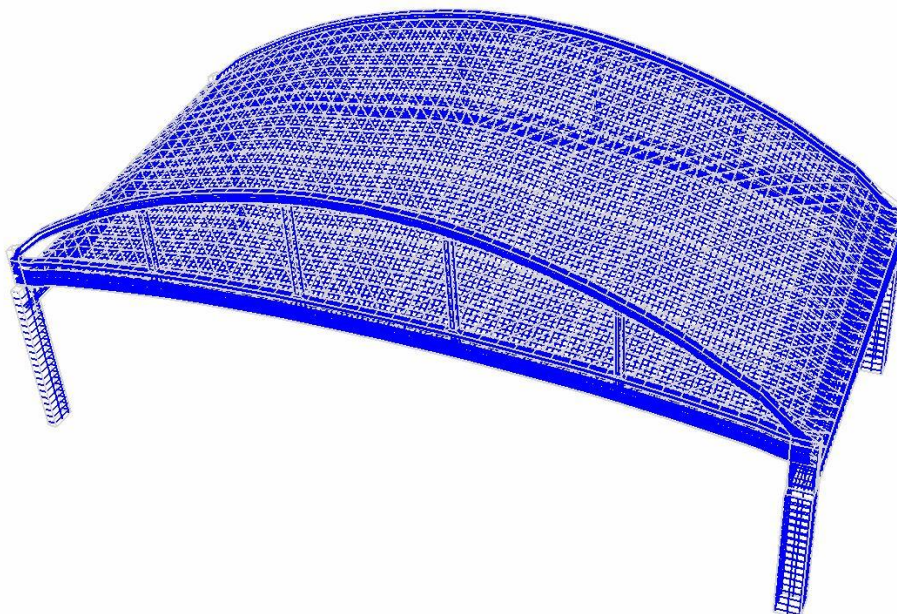
The reinforcement of the model is almost the same as the model with the ideal shape. The difference is due only to the unsymmetry of the structure. The reinforcement bars of the shell follow the deformed shape. Reinforcement of beams is simplified - instead of bent

reinforcement, straight profiles are used to match the number of reinforcement bars in critical sections. The model contains 974 bar reinforcements (Figure 9).

Figure 9: Model with reinforcement

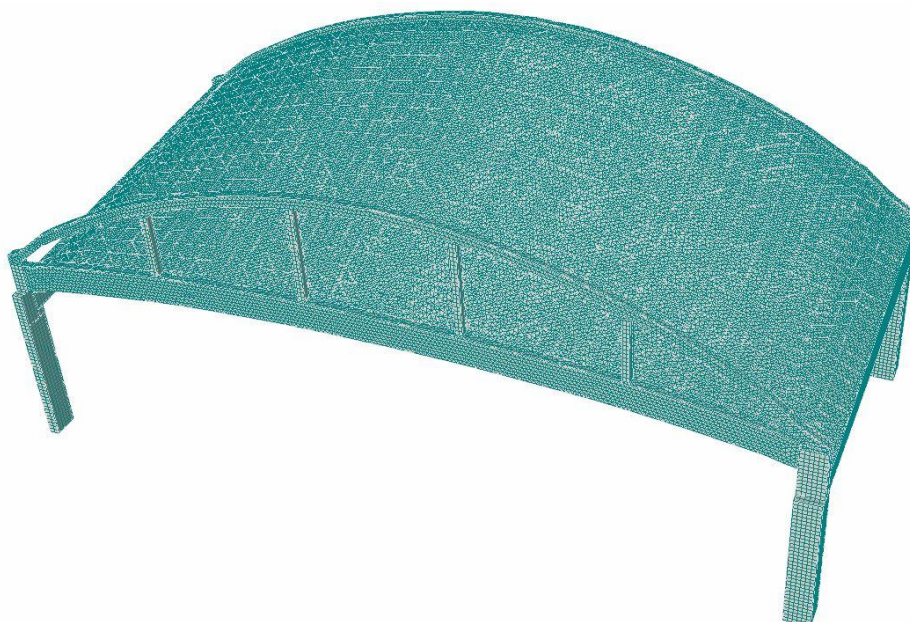
The finite element mesh is generated according to the same principles as described for the ideal shape model. The model consists of 277 613 finite elements in total. Model supports, snow and temperature loads are also the same (Figure 10).

Figure 10: Model with generated finite element mesh

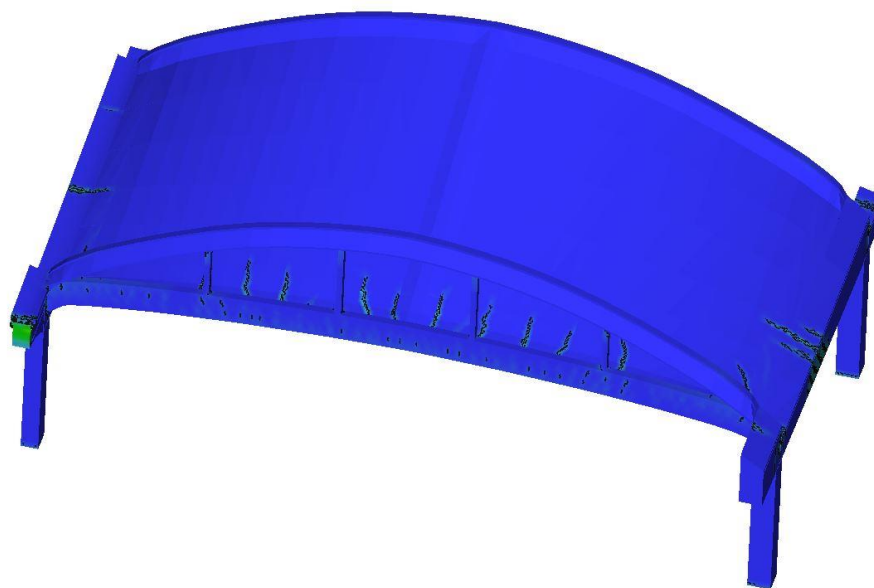
Calculations have shown that the weak points are in particular the supporting structures, namely the arc tie rod, frame joints and column (Figure 11, 12). The design is strongly influenced by volume changes due to temperature load. The dilatation units are relatively large and the deformations add up. Cooling of the structure results in tensile stress of the elements (a possible source of cracks for both the shell and the beam members), warming then stresses the structure by pressure (potentially there is a loss of stability and buckling of thin-walled elements)

Figure 11: Cracks at ideal shell shape model

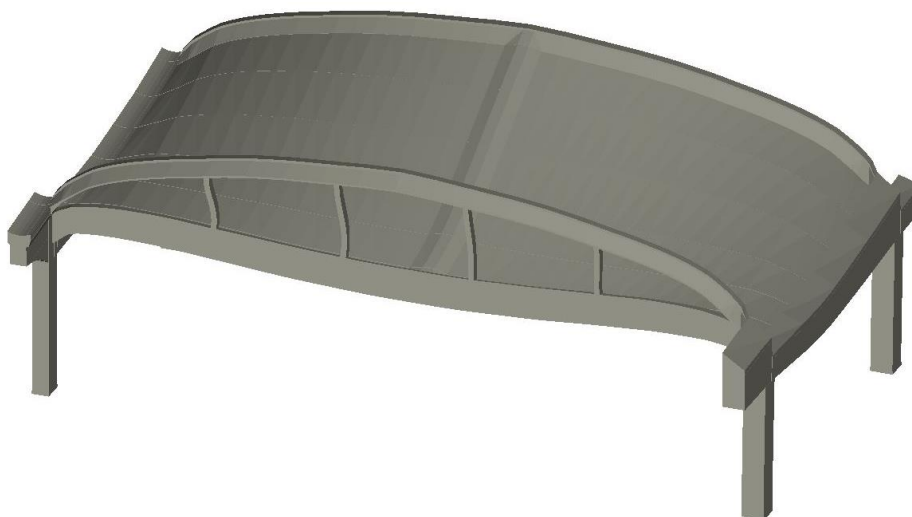
Figure 12: Deformed model of ideal shell shape, deformation scale 100:1

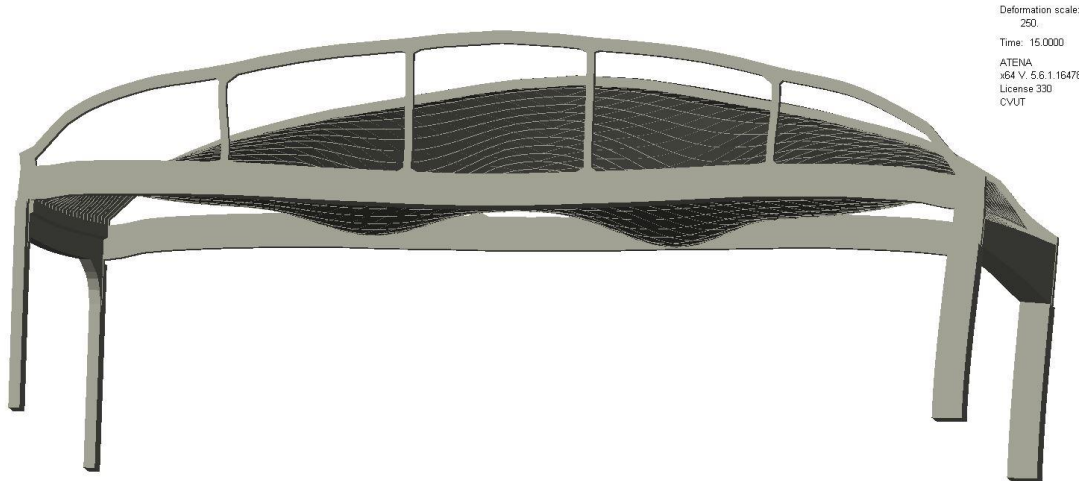
The results are based on the assumptions outlined above and are of an informative nature and very approximate. Generally, it can be stated that tensile stresses occur at the structure at the point of “bulges” and continue to contribute to the deterioration of the current state (Figure 13). According to the survey, deformations of up to 150 mm occur on the structure, a value that indicates a serious problem.

Figure 13: Deformed model of actual shell shape, deformation scale 250:1

The vast majority of shells typically have a deformed shape formed by two bulges (see Figure 13). The absolute size of the bulges varies from shell to shell. According to the survey, deformations of up to 150 mm occur on the structure, a value that indicates a serious problem.
