RECONSTRUCTED OVERHANGING BATTLEMENTS. EXECUTIVE TECHNIQUES AND THEIR VULNERABILITY IN THE STRONGHOLD OF ARQUATA DEL TRONTO (ITALY)

Keywords: Fortified Buildings, Overhanging Battlements, Seismic Vulnerability

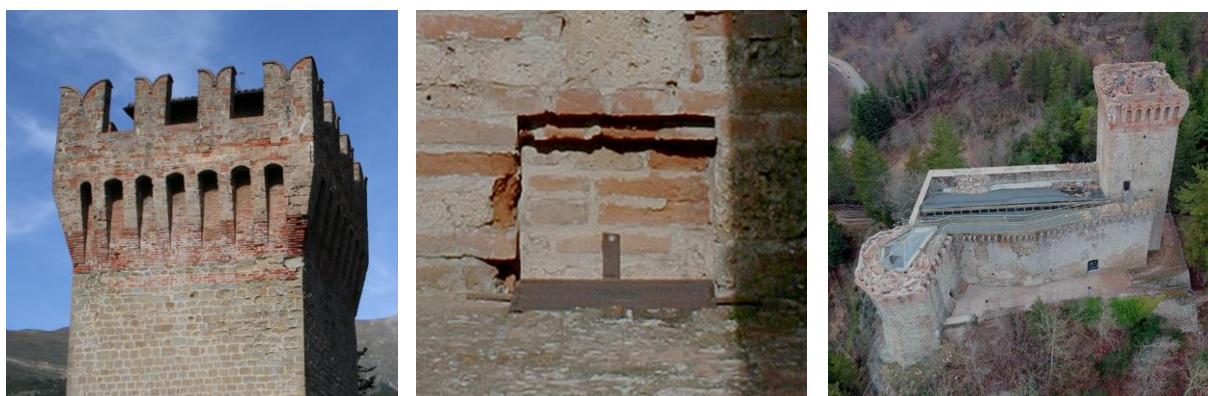
Figure 4: From the left: battlement of the donjon and one of niche above the machicolations in 2012 (user: interminatispazi - wikimedia commons); view of the stronghold of Arquata after the earthquakes of 2016 (courtesy of the Arquata del Tronto Municipality).

Parapet and merlons are 40 cm thick, but rectangular niches (about 40 cm high, 50 cm wide, 13÷15 cm deep) were obtained in the thickness of the parapet itself to reduce corbelled masonry protrusion (in the middle, fig. 4); this allowed to widen machicolations without reducing the net passage within a *chemin de ronde*, that did not exceed 1.60 m in width. Therefore for about half of its length the thickness of the parapet was reduced to 25 cm, while the external face of the tower wall tilted inwards to increase the width of the machicolations. In this way the overall protrusion of corbels was no more than 60 cm, with a height of about 2.4 m. Although modified several times, the construction of the parapet and merlons is revealed by the damage they suffered: they consist of two external wythes made of brick and tuff stones and a nucleus built with less carefully, mainly in probably reused bricks; some larger tuff blocks act as headers. Above the machicolations, masonry was supported by single

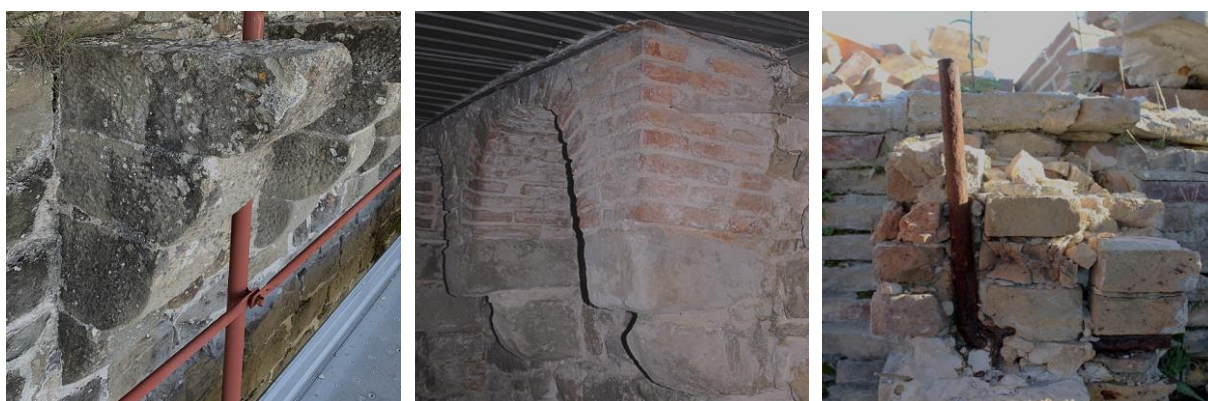
Figure 6: From the left: stone cantilevers in the corbels of eastern curtain wall; stone cantilevers supporting brick arches; I-beam with L shaped anchor bar in one of the brick masonry corbels of the polygonal tower.

In the works of the first two decades of the 20th century two other overhanging battlements were rebuilt, using techniques very different from the one that has already been examined. On the eastern curtain, the building site was active between 1908 and 1909 [26]. The corbels of the external façade (on the left in fig. 6), towards the town, are made up of four rectangular-shaped sandstone cantilevers which – fixed in the core conglomerate – cross the external wythes and progressively protrude. The free end of each cantilever is rounded to form a quarter of an ellipse, which originates at the end of the cantilever below; the corbel has the shape of a scalene right triangle in which height is about 1 m and protrusion about 60 cm. The spacing of the corbels is about 60÷75 cm, while their width is 20 cm. To prevent stone cantilevers overturning, wrought iron straps were placed to connect them to the masonry. Parapet and merlons were never rebuilt. The cantilevers are still largely ancient as documented by the photos of the early 20th century. The additions are recognisable by workmanship and decay.

ronde: this has corbels about 30 cm wide, made of two layers of sandstone cantilevers, the lower one is rounded, the upper one has a simple parallelepiped shape; they support brick arches one header thick and three header deep (about 40 cm) (in the middle in fig. 6). In this case the corbel spacing is more than 1 m. Some of the stone cantilevers are ancient, the whole is a probably faithful interpretation of existing traces. Apart from some percolation, due to the cracks produced in the concrete cover that should have waterproofed the top of the wall, this system has not reported any damage.

The reconstruction of the battlement of the pentagonal tower started in 1908-09, but it was later abandoned. Neither the internal space of the tower was covered with the designed vault, nor the stairs were built, nor the *chemin de ronde* was finished. In some photos taken before 1990, the last was covered by a discontinuous layer of soil [29]. No traces of pre-existing structures were left. The overhanging battlement was Viviani's invention. He reinterpreted the crenellation of the donjon: the structure was entirely made of bricks on the discontinuous plane of the perimeter walls. The stepped corbels projected from the vertical masonry; the distances from each other varied – about 30÷60 cm – while their width is uniform and about 40 cm, i.e. three headers. The small arches are made of rowlocks reinforced by headers above, however their out-of-plane depth doesn't exceed half the thickness of the superior parapet: as in the donjon, to widen the machicolations, in correspondence with each of them the parapet had a niche, whose back is aligned to the arch. The top of the niches is horizontal, and the parapet is made of two external wythes between which there is a casting of broken bricks and hydraulic lime or cement. Accentuating a peculiarity of the donjon, in the machicolations the façade masonry tapers inwards with an inclination almost mirroring that of the corbels. In this way the parapet rests only on the corbels, entirely overhanging outside the walls of the tower. On this unstable base, Viviani designed heavy angular merlons loaded with a triple dovetail. This battlement is a sort of autonomous screen: on the curtain walls no battlement was built, which would have partially contributed to the stability of the extreme merlons. Thus some merlons collapsed (and were rebuilt) several times, in particular after the 1943 earthquake; finally all the merlons were reconstructed during the last restoration campaign in 1992 [29]. So it's easy to understand the failure in 2016. The rigid block of merlons and parapet crushed the internal part of the pilasters between the niches, and fell in blocks on the *chemin de ronde*, thanks to its more resistant mortar. The damage suffered by the upper part of the corbels has brought to light various metal elements inside them, in a non-systematic way: tie rods with anchors are positioned at the springs of the arches, just below the parapet; about 30 cm lower, inside the masonry of the corbels, some I-beams show a hole at the end of their web, inside which a circular L-shaped bar is inserted (on the right in fig. 6).
