REINFORCED CONCRETE FLOORS IN HISTORIC BUILDINGS FROM THE BEGINNING AND THE MIDDLE OF THE 20TH CENTURY – EXAMPLES OF STRUCTURAL STRENGTHENING IN THE PROCESS OF REVITALIZATION

Keywords: Historical Building, Concrete Slab Floor, Assessment, Strengthening

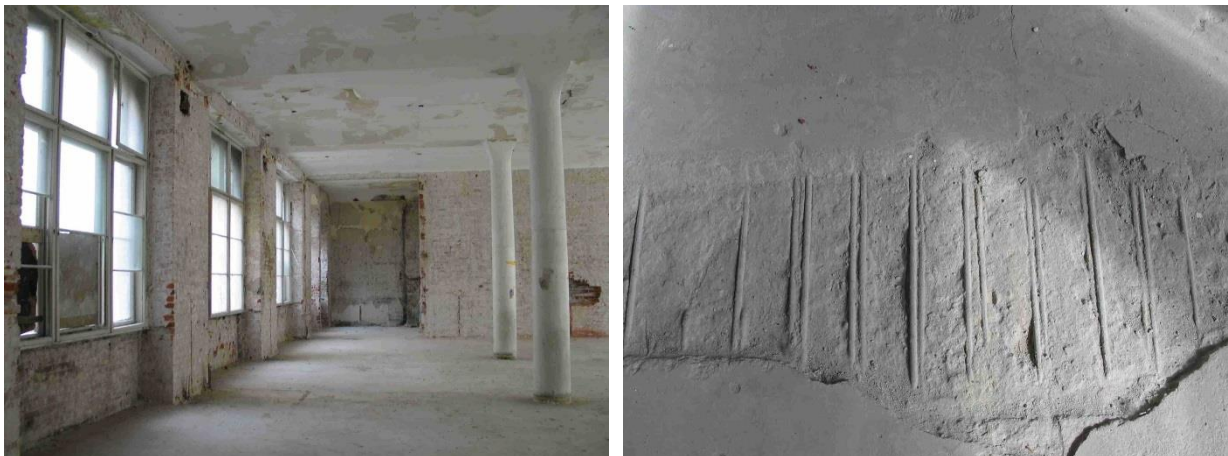
Figure 5: General view and rebar exposure of Koenen plate floor in a public service building

The reinforcement was anchored at the top of the slab in various ways: hooks at the upper flanges of the girders or a flat steel that was held by steel anchors mounted in masonry walls. By coupling the reinforcement with the wall clasp it was possible to achieve a high degree of clamping for the peripheral area using the wall dead load. Spans of up to 8.0 m were achieved for that floor. That type of floor can be often met in the 19th/20th century public service buildings in the Lower Silesia region (Figs 4 & 5).

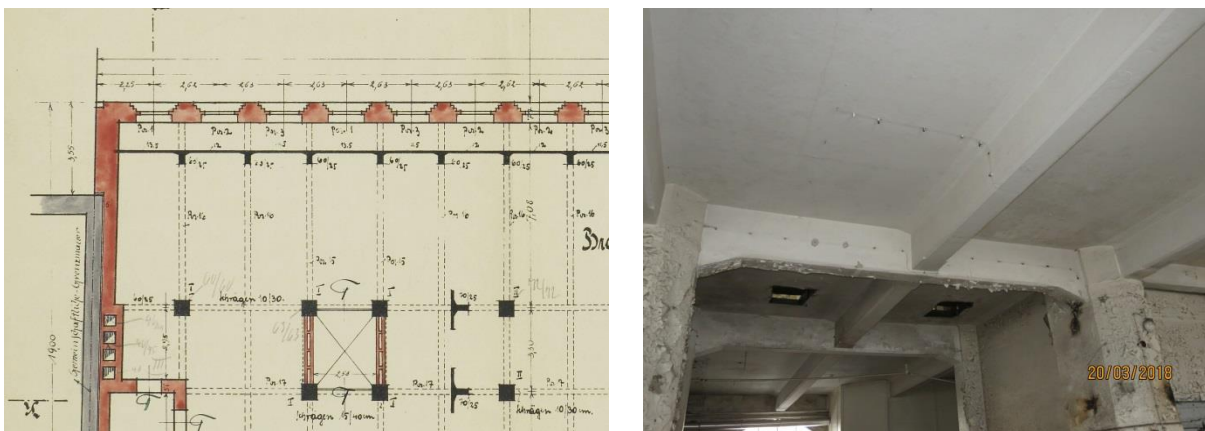
Figure 8: Archival drawing and general view of the RC rib floor in a bakery plant (1913)

The second object is a heritage industrial building of bakery flower warehouse built about 1913 (Fig. 8). The edifice has 8 floors above the ground, but has no basement. Although the external walls of the building are made of brick masonry, the main bearing structure is made of reinforced concrete: pillars, rib-slab floors, and roof frames on two attic floors. The assessment was made with an aim to determine the possibility of reconstruction and adaptation of the warehouse building to new utility purposes, and in turn, to extend its service life. Currently, the building is under refurbishment process.

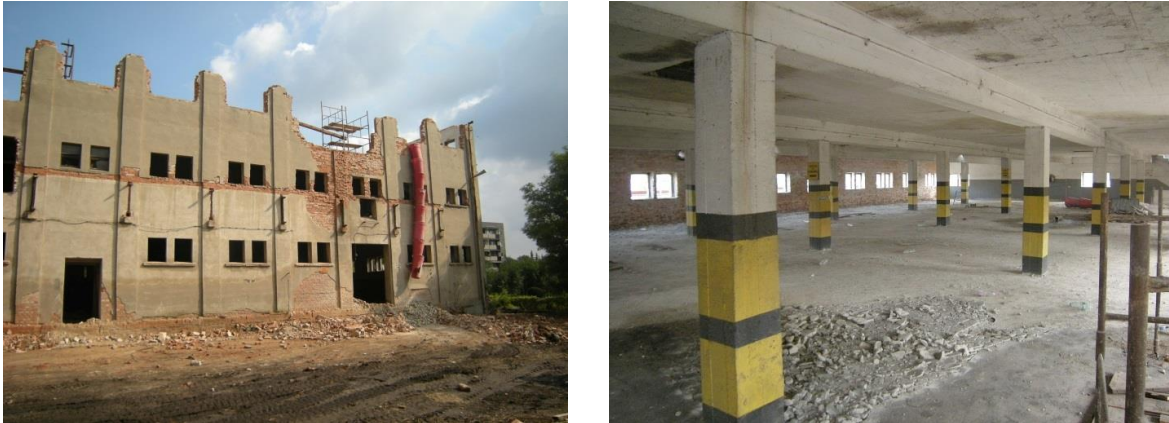
Figure 10: View of warehouse after partial demolition and the rib floor structure in a ground floor (1950)

The next two buildings (Figs 9 & 10) are not so spectacular examples of the historic RC structures, but present the simplicity, clarity and usefulness of the use of this material in shaping the space of industrial buildings regardless the passage of time and the development of design methods and properties of the materials used.

In both cases the assessments of technical condition of buildings (including fire resistance demands) were conducted due to designed change of their future utility functions. Based on the non-destructive techniques (rebound hammer and pull-out methods) used and study of historical literature it was assumed that the concrete in the structure corresponded with concrete classes of C12/C15. According to the literature data and taking into account the age of the construction, it was determined that post-German so-called "commercial steel" with the design strength 150 MPa was used for reinforcement. Basing on the static and strength calculations it was determined that the carrying capacity of the floors in the considered buildings was sufficient to carry on new loads without necessity to strengthen their structure. The only necessary repair would be connected with improving the floors' fire resistance by creating a new spray on their lower surface which would increase the thickness of the concrete cover of the bars, by the use of nano-concrete plaster, for example.

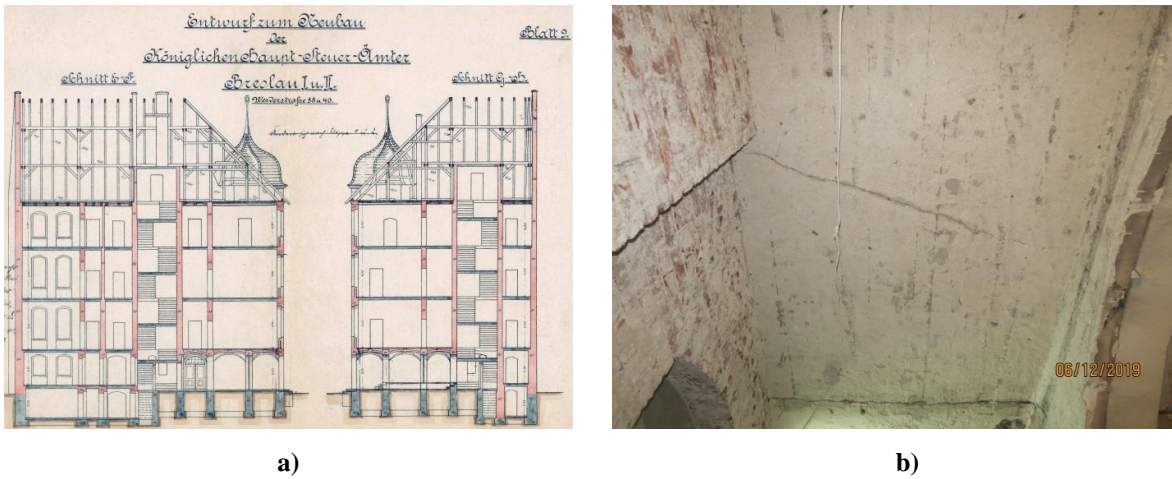
Figure 11: a) Archival drawing of building cross-section; b) typical cracks in floor slabs

The analyzed building was erected about 1909. Before the 2nd world war the building was the seat of the Central Customs Office, after the war it served as militia barracks. The building has 4 floors above ground (ground floor and three floors), an unused attic and is partly a basement (Fig. 11.a). The structural system of the building is two-bay one, with corridors located along the inner courtyard. The building's structure is traditional: the foundations are brick masonry ones; the load-bearing walls are made of brick; the floors are in the form of reinforced concrete slabs, locally are made with use of the prefabricated reinforced concrete panels. The roof truss is wooden, covered with ceramic tiles. Above the ground floor slabs were found in the form of cross-reinforced concrete slabs in rooms and unidirectional reinforced slabs in corridors. The structural thickness of the floors varied from 10÷12 cm in corridors to 16÷20 cm in rooms.

Numerous cracks were found in slabs over the corridors, especially at the ground and first floors. Those damages were caused by corrosion of reinforcement, poor concrete adhesion to band-iron and its torsion during concreting. In almost all the RC floors diagonal scratches of the panels were found in the slab corners (Fig. 11.b). These are typical cracks for thin reinforced concrete slabs, without upper reinforcement near supports. Such reinforcement was not found in the exposures and during rebar scanning tests.

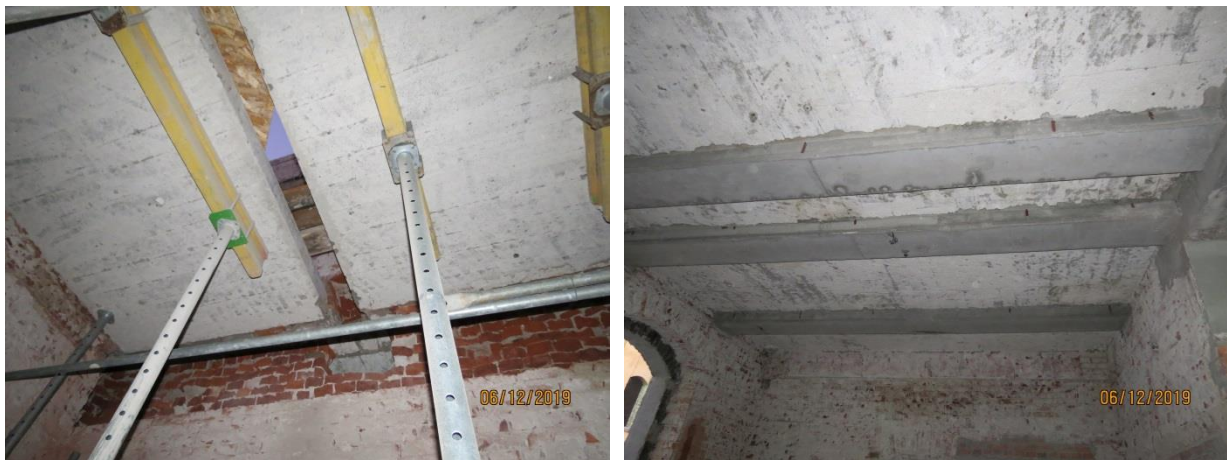
Figure 13: a) Floor slab with cuttings; b) floor with additional inverted T-shape RC girder supports

The static and strength calculations carried out, preceded by the above mentioned material tests, showed that the reinforced concrete slabs above all the storeys did not have sufficient capacity associated with the residential, hotel or office function. This led to make a decision of strengthening all the floor slabs. Some techniques (Figs 12.a÷d) were considered, but finally construction of additional supporting inverted T-beams were applied (Figs 13.a,b).

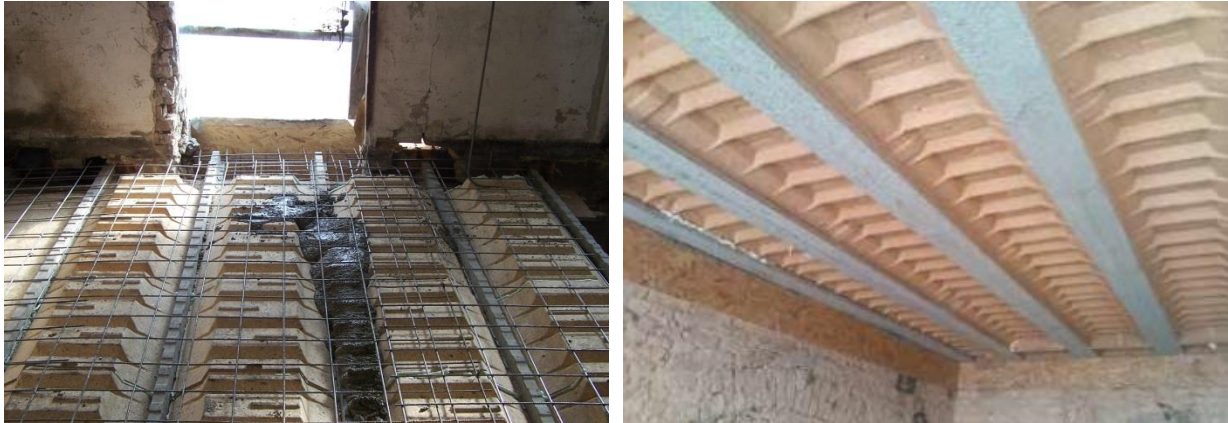
Figure 16: View of the RECTOLIGHT concrete floor

Originally, ceilings were considered to be made as traditional RC panel slabs on steel beams or modern rib-and-slab floor (RECTOR type) (Fig. 16). RECTOLIGHT floors are beam-honeycombed, prefabricated dense ribbed slabs. These floors consist of prestressed concrete beams and ceiling fillings made of pressed wood. The system is supplemented with: supporting reinforcements, welded steel mesh and monolithic concrete made on site. The biggest advantage of this system floor is its lightness and easy installation, which are of great importance when performing works in historic buildings located in the city center.

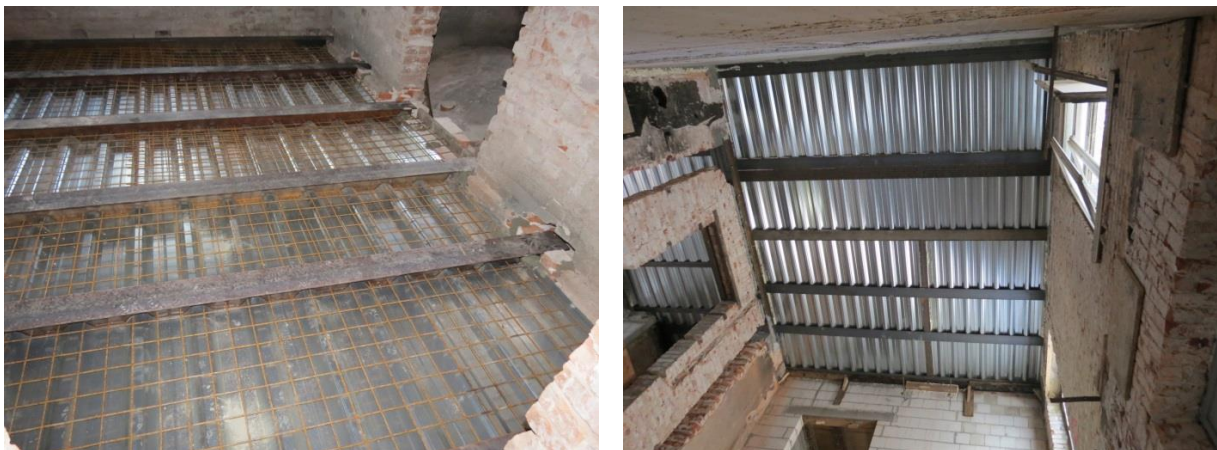
Figure 17: View of the composite floor

However, in the final solution, due to economic reasons, new inter-story floors were designed in the form of composite reinforced concrete slabs, made on lost formwork made of trapezoidal steel sheets, based on steel I-beams (Fig. 17).
