REINFORCEMENT AND CONSOLIDATION OF MASONRY STRUCTURES. SUCCESSFUL CASES IMPLEMENTED: FROM THE STUDY TO THE EXECUTION PHASE

JOSE DOBÓN^{1*} AND MIGUEL A. SORIA²

Keywords: Masonry, Structural Strengthening, Hydraulic Natural Lime Mortars, Steel Fibers, Basalt Fibers

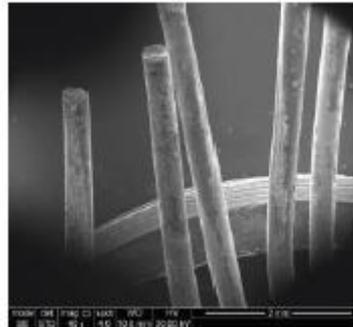
Figure 2: sole cordon SEM image

Cordons are galvanized obtaining a material that is not affected by the corrosive agents and it make them appropriate for different exposure environments. Zinc coating is ruled by EN 10244 – 2 being the zinc quantity great to 15,97 g/m². In Figure 2, it shows a SEM image of the 40 times augmented filament to determine the thickness and the mineralogy of the zinc coating, in order to do the process quality control.

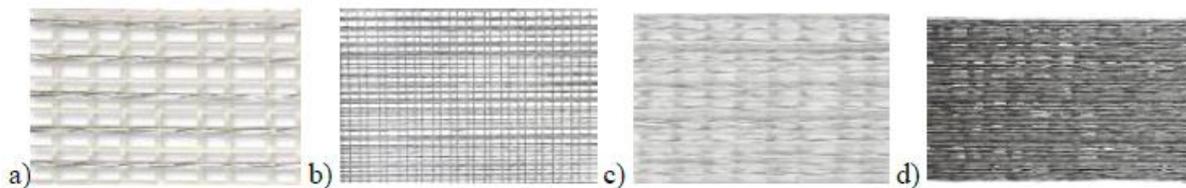
Figure 3: four different steel fiber fabrics densities, cordons per centimetre: a) 1,57; b) 3,19; c) 4,72 and d) 7,09

Steel fiber fabrics are available in four different densities, based on the distances between cordons. The two with the lowest density, 1,57 and 3,19 cordons per fabric centimeter respectively, are adequate to be used with mineral matrix, whereas the two with highest densities, 4,72 and 7,09 cordons per centimeter, must be installed with epoxidic matrix, Figure 3.

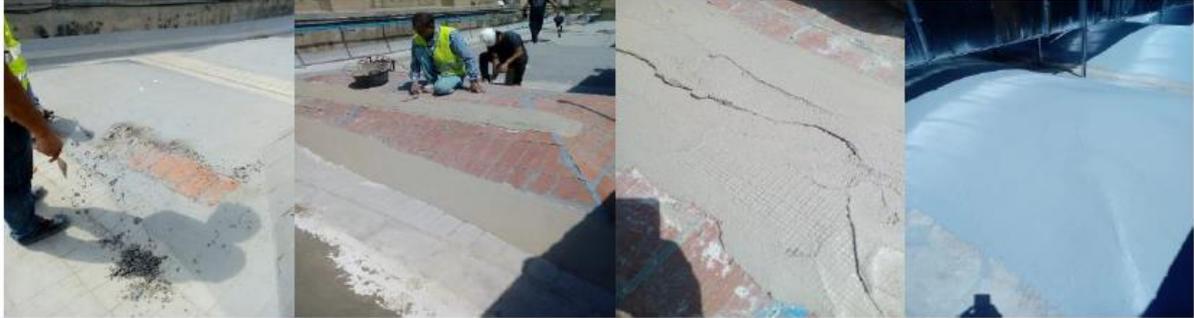
Figure 5: Vaults extrados

1. Removal of old coatings
2. Support preparation
3. Application of the structural reinforcement mortar, GeoCalce F Antisismico.

4. Installation of the GeoSteel G600 fabric.
5. Fabric anchor > 30 cm.
6. Application of the structural reinforcement mortar, GeoCalce F Antisismico, in order to cover the fabric.

In Figure 5, it is shown the different installation phases of the structural reinforcement and the waterproofing system applied. This treatment ensures the transpirability of the support materials.

The vaults are cracked, they are visible from its intrados and distributed along their ribs. After the analysis, it is determined that the degradation cause is the lack of waterproofing in the vaults affecting to their structural integrity. It is decided to do a structural reinforcement by the extrados vault, due to their intrados can not be covered by esthetical reasons. Together with the intervention, the cause of the degradation is removed by waterproofing the vault with materials capable of ensuring the transpirability balance and with an elastic behavior similar to the original structure.

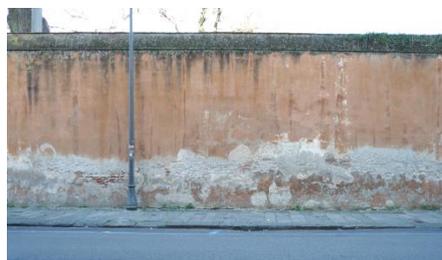
Figure 6: Perimeter wall status

The deformation's diagram shows the tipping phenomena up to 9 cm, which are achieved due to the hystoric vegetation located close to the perimeter. Their roots go through the wall foundation and enter into the pavement, even breaking it. In these zones, where the vegetable level is higher than 80 cm, there is humidity over the wall at the outside zone. It degrades the coating and disaggregate the surface (Figure 6).

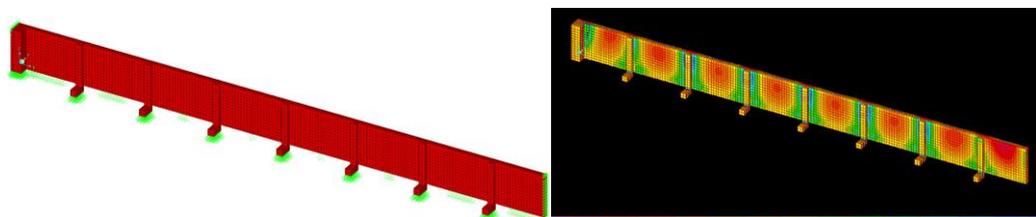
Figure 7: Structure modelling and stress diagram

This tridimensional calculus model used for the structural analysis made with finites elements is shown at Figure 7. Seismic forces are assessed as equivalent static forces; in the Figure 7, it is also shown the stress diagram.

The masonry walls between buttresses were reinforced facing flexional stresses supposing a continue beam diagram. It was made with longitudinal bands, GeoSteel G600, installed with natural lime hydraulic structural mortar, GeoCalce F Antisismico.

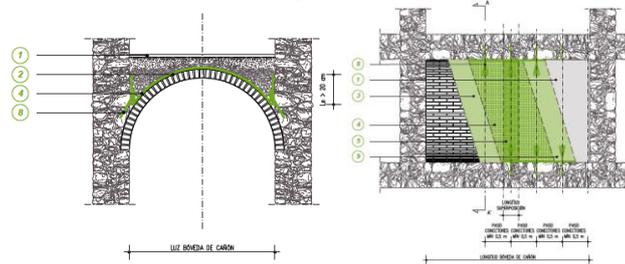
Figure 8: Extended extrados reinforced system for barrel vaults schema

The proposal done is the one on shown on Figure 8:

1. Removal of old coatings
2. Support preparation
3. Application of the structural reinforcement mortar, GeoCalce F Antisismico.
4. Installation of the GeoSteel Grid 2000 fabric.
5. Overlap length > 30 cm.
6. Anchor length > 20 cm.
7. Overlap anchor length > 30 cm.
8. Mechanical connector done with GeoSteel G600 fabric. Application of the structural reinforcement mortar, GeoCalce F Antisismico, in order to cover the fabric.

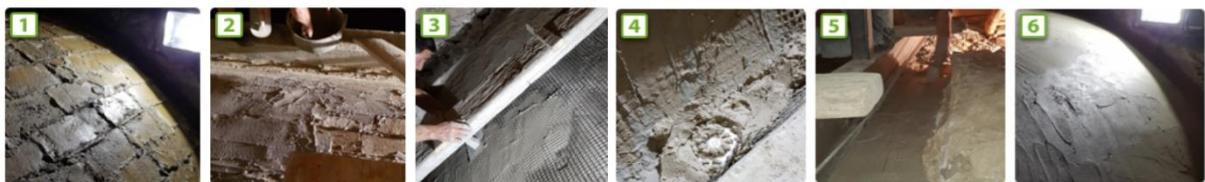
Figure 9: Phases done during the vaults reinforcement application

The reinforcement done helps to avoid the vaults from the collapsed produced by the plastic joints due to the lack of tensile strength of the masonry. This typology of reinforcement helps improving the structural performance of this kind of structure offering a ductile breaking behavior, besides improving their mechanical resistance. The intervention was done in the following phases, as shows Figure 9:
