RESILIENCE AND VULNERABILITY OF HISTORICAL CENTERS: THE CASE OF THE DISTRICT OF CAMERINO IN THE MARCHE REGION

Keywords: Historical Centers, Masonry, Earthquake, Resilience

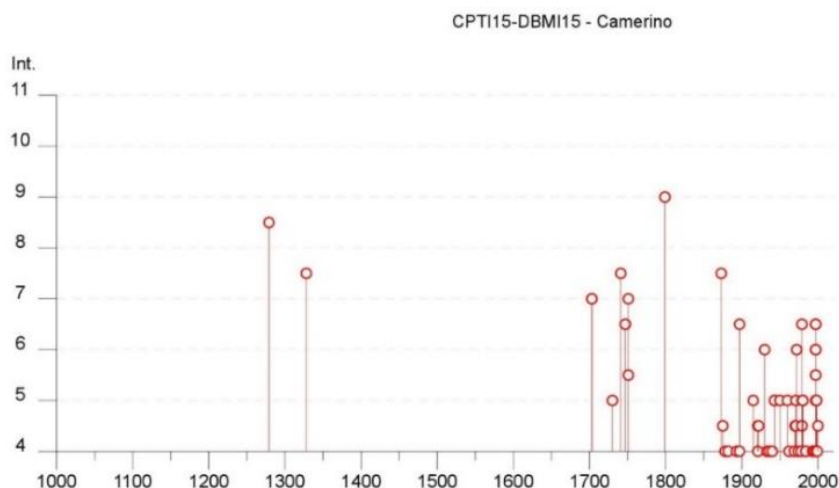
Figure 3: List of historical Earthquakes by INGV site
<http://www.mi.ingv.it/terremoti-storici/> [view on 28.01.2020]

Figure 3 shows the most important events that affected the municipal area. The most significant events, excluding the most recent, are those of 1279, recorded in the Umbrian-Marche Apennines, the one of 1328 and 1703 in Valnerina, then the 1799 earthquake with an epicentre in the Camerino area, one in 1873 always in the Apennines, in 1979 in Valnerina and finally the one in 1997 which once again struck the Umbria-Marche Apennines.

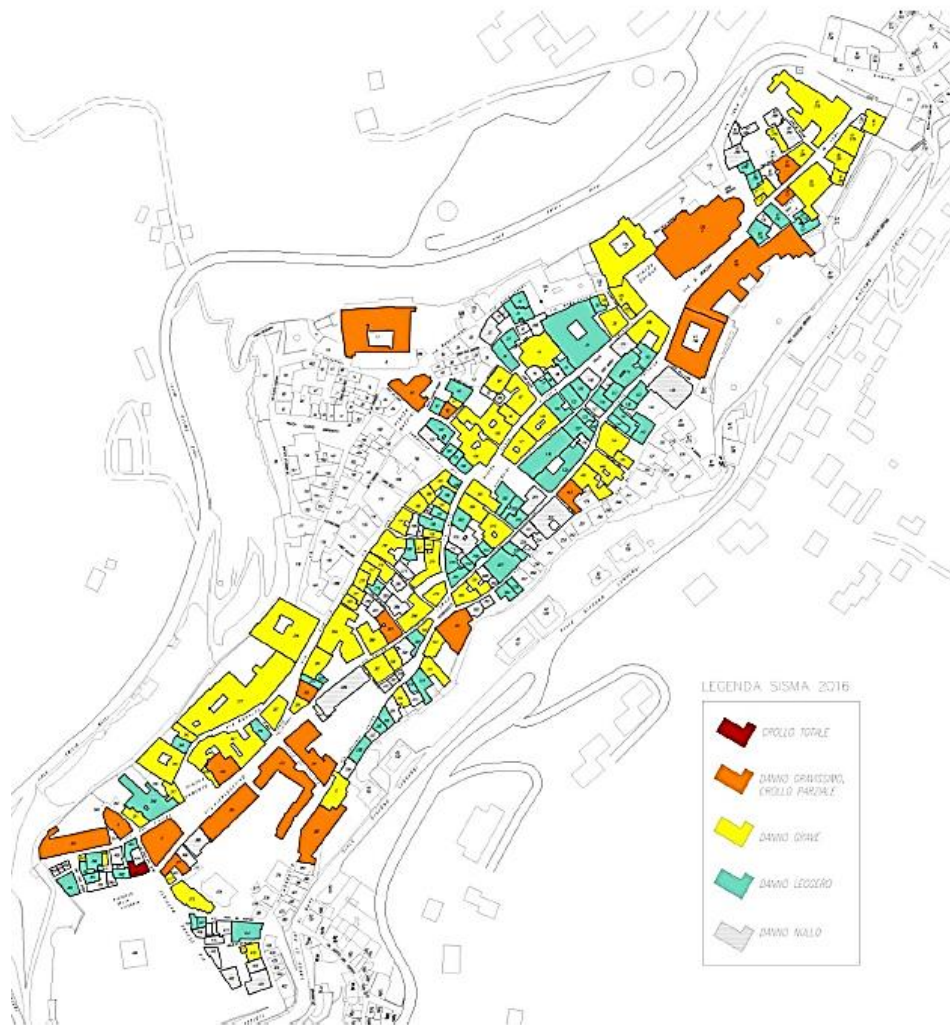
Figure 5: Representation of the levels of damage detected through the filing method (elaboration from QGIS Platform, 2019)

The damage levels are detected through the archiving method and provide a classification based on 5 degrees from the most serious (total collapse) to the lowest (zero damage). All visible damages were assessed - building by building - and classified according to each damage level which is represented with a different colors. The mapping of the damage levels (Figure 5) shows a difference in behaviour between the various areas of the historic centre: most of the buildings (70%) are classified in the worst categories (serious and very serious damage with partial collapse). These levels of damage justify the extent of the red zone also following certain safety measures.

Some building clusters in the central area already restored following the 1997 seismic events, resisted better than other clusters in which the consolidation interventions had not been carried out or the works had been partially carried out. Furthermore, the most damaged

Buildings with outcome A were assigned the “no damage” rating (figure 5 – grey), while for buildings that reported B/C/D as a result, a “minor” damage level was generally assigned (figure 5 – light blue). With regard to outcome E, on the other hand, the level of damage was divided into two: “significant” (figure 5 – yellow) and “serious” (figure 5 – orange), depending on what is reported in the specific table regarding the damage identified.

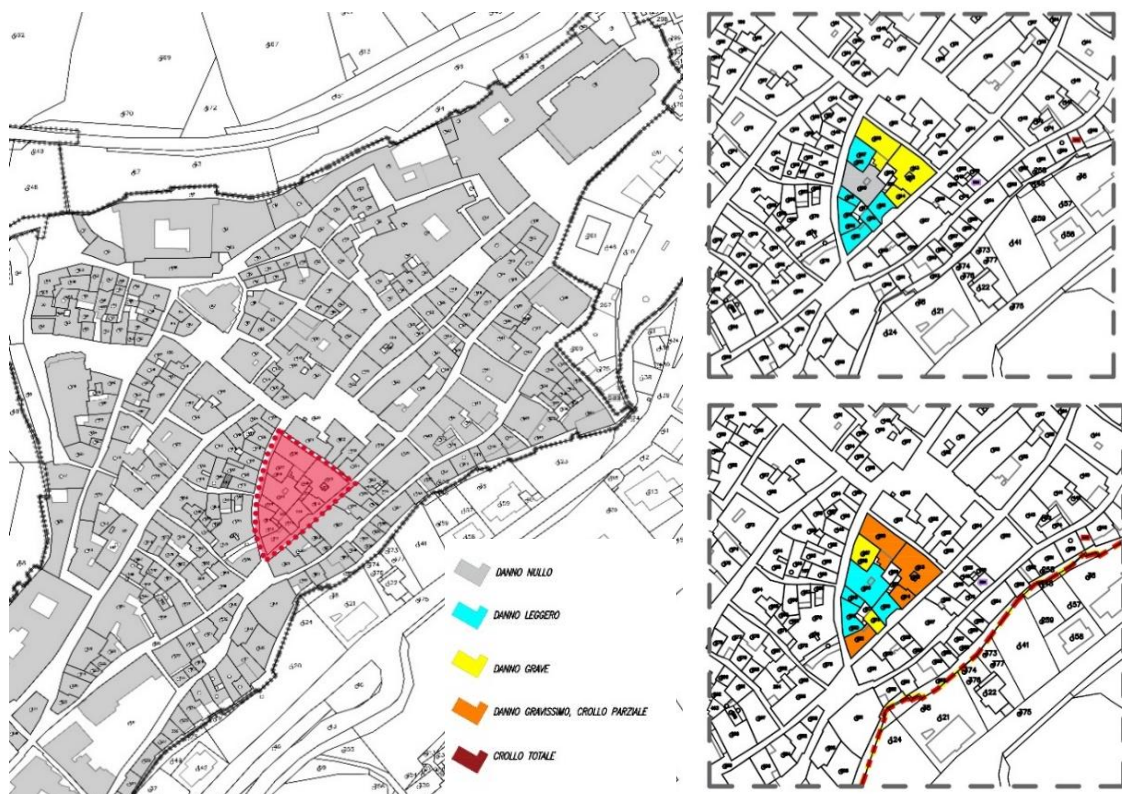
Figure 8: Comparison of the results of the two expeditious investigations. The global survey in the upper right corner and AeDES forms analysis in the lower right corner.

The identification of the damage is shown below, comparing it with the system used in the previous paragraph with the pilot cluster. As can be seen from figure 8, the results obtained from the two types of expeditious analyzes are consistent in the presence of the damage, but, as

we can see, in the map on the upper right corner (the one relating to the global survey carried out through external inspections) the damage appears to be underestimated. Specifically, there are buildings that apparently have not suffered any damage outside, however, they are unusable.

From the investigations carried out on the whole historical centre of Camerino, this inhomogeneity of the damage between inside and outside is due to the great inhomogeneity of the elements constituting the masonry (mortar and brick). The walls are, in fact, mainly double leaves walls, which cannot be analyzed as a monolithic wall as it is made up of three distinct parts (the two leaves and the internal core generally made up of inconsistent material). The two vestments, moreover, are often not connected to each other and this generates a different behaviour between inside and outside. In clusters, moreover, the connection between the walls is often non-existent or weak.

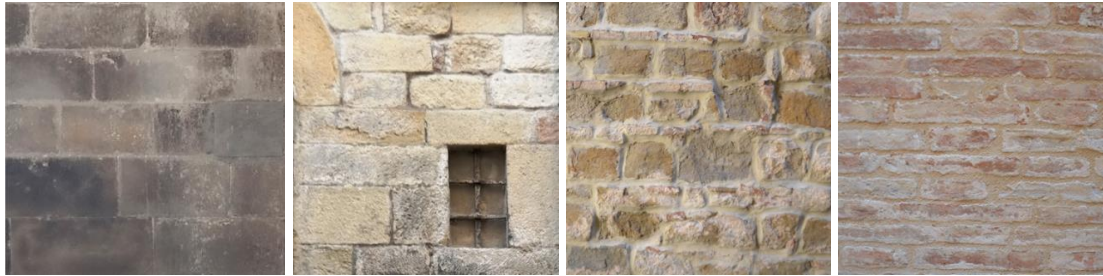
Figure 9: The most common types of masonry in Camerino: 1 - f) Masonry with square stone blocks; 2- e) Regular-block masonry of soft stone (tuff, calcarenite, etc.); 3 - c) Split stone masonry with good texture; 4 - g) Solid brick masonry and lime mortar.

The masonry works are listed according to 8 typologies, some well-built others with limited respect for the “regola dell’arte” and therefore with a low Masonry Quality Index (IQM) [9]:

- a. Chaotic stone masonry (pebbles, erratic and irregular stones);
- b. Brickwork with rough-hewn segments, with uneven wall thickness;
- c. Split stone masonry with good texture;

- d. Uneven soft stone masonry (tuff, calcarenite, etc.);
- e. Smooth-block masonry of soft stone (tuff, calcarenite, etc.);
- f. Squared stone block masonry;
- g. Solid brick masonry and lime mortar;
- h. Semi-solid brick masonry with cement mortar.

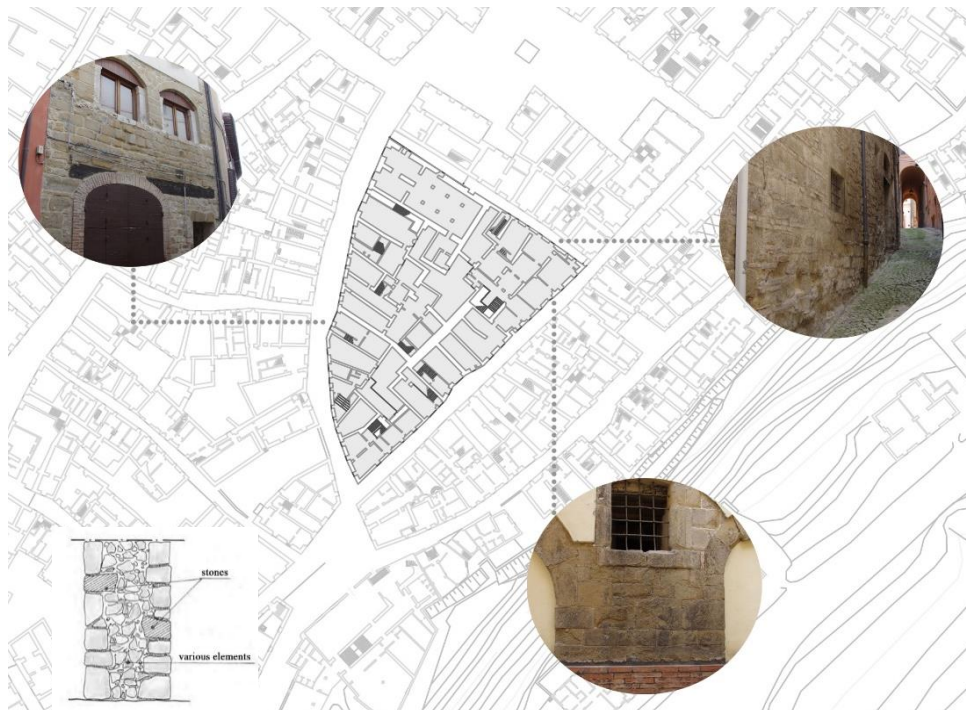
Figure 10: Characteristic walls of the pilot cluster, consisting of terraced typological units, in some cases recast into more complex buildings that show evident signs of transformations (Elaboration Barchetta, 2019).
