SEISMIC PERFORMANCE EVALUATION OF BOX-SHAPED WALL STRUCTURES BUILT WITH THICK EARTHEN WALLS

Keywords: Traditional Japanese Structure, Mud Wall, Loading Test, Response Spectrum Method

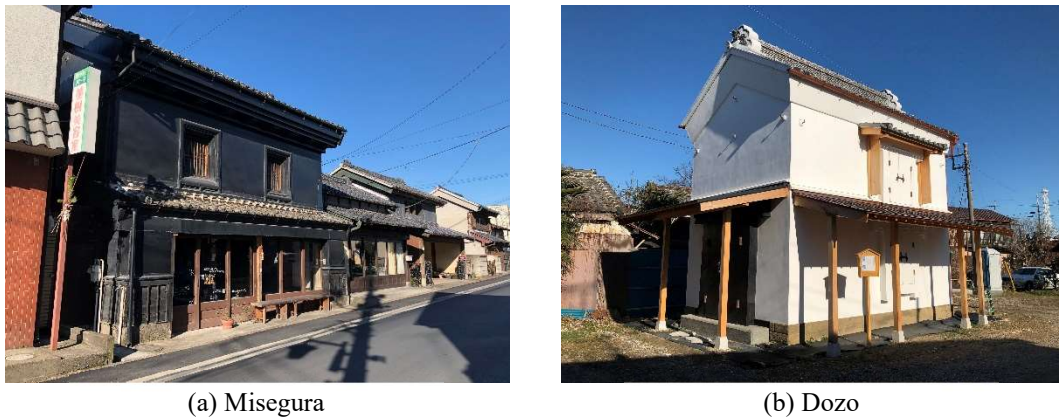
Figure 1: Examples of dozo structures

Methods of mixing soil with organic fibers, such as straw, and fixing soil on a substrate knitted with bamboo or wood have been used for construction worldwide [1–7]. Earthen walls have also been used in Japan since a long time ago. A type of traditional Japanese building is the “dozo-dukuri,” which is a box-shaped wall structure built with thick earthen walls. The structure is referred to herein as the dozo structure. Figure 1 shows examples of dozo structures, including “misegura,” which are dozo townhouses intended to be multiuse shops or dwellings, and storehouses, called “dozo.” The northern Kanto region and their surroundings form a distinctive historical townscape because these traditional Japanese buildings built from the end of the Edo Period to the early Showa Period (approximately 70–180 years ago) were constructed in rows and clusters. Dozo structures have earthen walls that are 200–300 mm thick at their outer circumference for protection against fire. Although originally used as warehouses, these structures came to be used as stores, parlors, and other kinds of buildings in modern times.

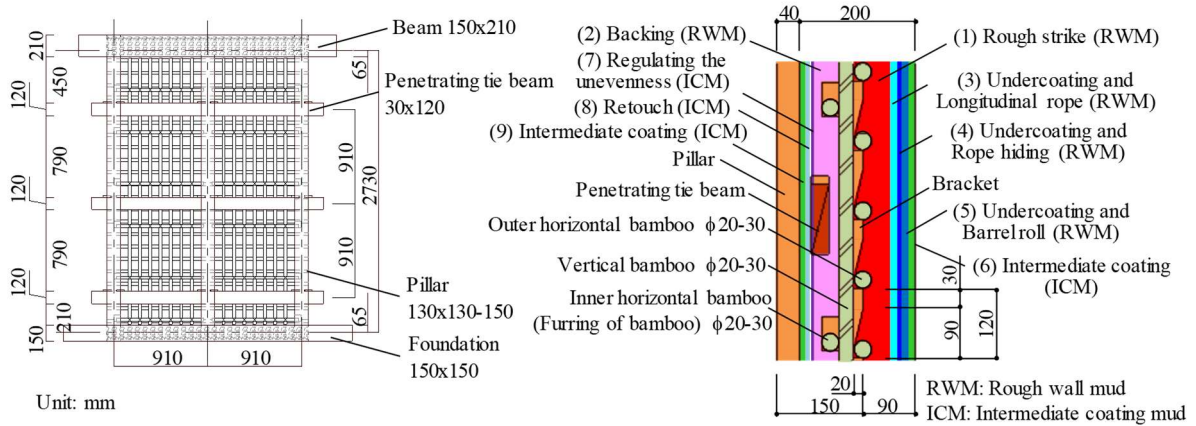
Figure 5: Shapes and dimensions of the Type B specimen

Figure 5 shows the shapes and dimensions of the Type B specimen. Table 2 presents the materials and specifications used. The specimen shapes and dimensions and the materials used were basically the same (i.e., width: two 910 mm spans and height: 2730 mm). The joint between the pillar and the horizontal frame was shaped such that the pillar end did not touch the horizontal frame, even in the case of a significant deformation. By doing so, we ignored the resistance caused by the pillar sinking into the horizontal frame; hence, we could observe only the wall panel performance.

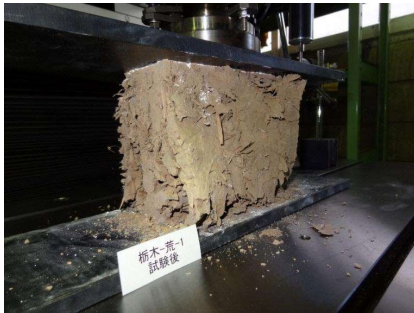
Figure 6: Situation of the material tests

Table 3 lists the composition of the rough wall mud and the intermediate coating mud used in the test specimens. Figure 6 illustrates the compression strength tests for the two types of mud performed according to the method developed by the Japanese Housing and Wood Technology Center [10]. Table 4 presents the compression strength test results. Figure 7 shows the stress–strain curves with an average of six samples.

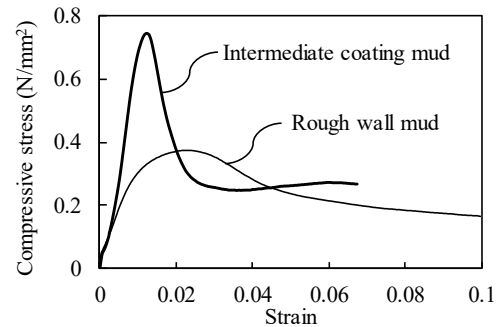
Figure 7: Stress–strain curves with an average of six samples

Sample	Thickness [mm]	Number of samples	Age [day]	Maximum compression strength [N/mm ²]			Density [g/cm ³]
				Min.	Max.	Average	
Rough wall mud	70	6	43	0.371	0.391	0.378	1.30
Intermediate coating mud	70	6	41	0.700	0.801	0.758	1.62

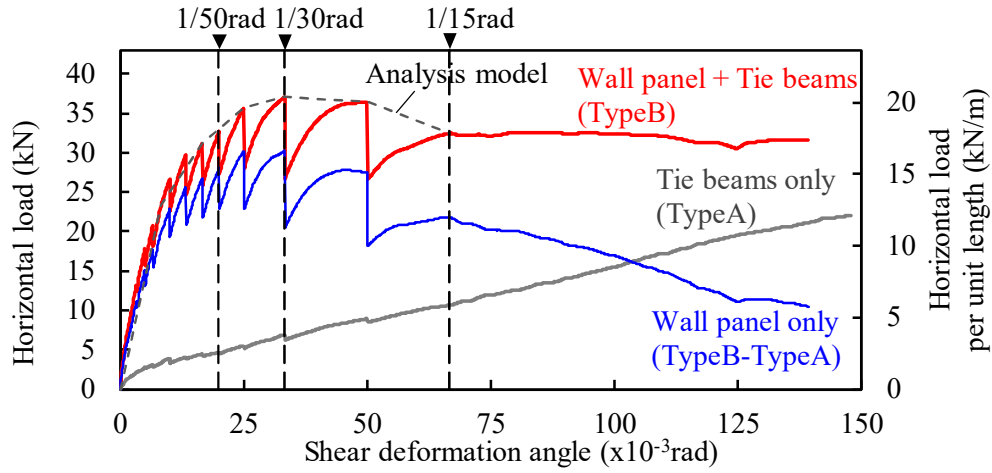
Figure 10: Skeleton curve comparison during positive loading

Figure 10 shows the skeleton curves during the positive loading of the type A and B specimens and the restoring force of only the mud wall panel subtracting the Type A specimen from Type B at the same deformation. After the maximum proof strength was obtained, the resistance strength of the mud wall panel decreased; however, with Type A, the resistance strength of the penetrating tie beams increased with the horizontal deformation. We confirmed

the toughness of the thick earthen walls by maintaining a proof strength of 84% or higher of the maximum up to the final deformation by balancing the mud wall panel resistance and the penetrating tie beam resistance.

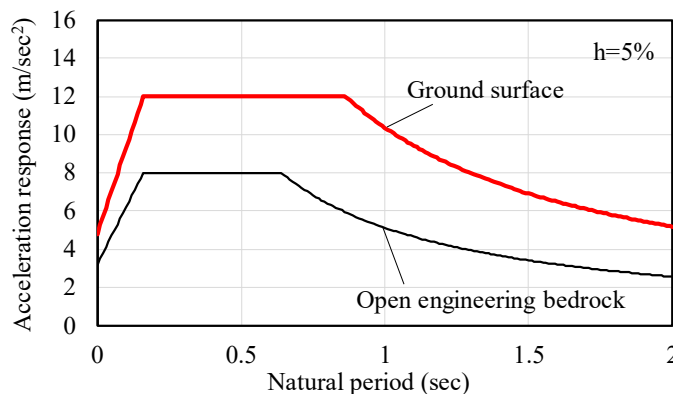
Figure 13: Acceleration response spectra ($h = 5\%$)

design standard. Figure 13 shows the acceleration response spectra ($h = 5\%$) at the open engineering bedrock and the ground surface amplification.

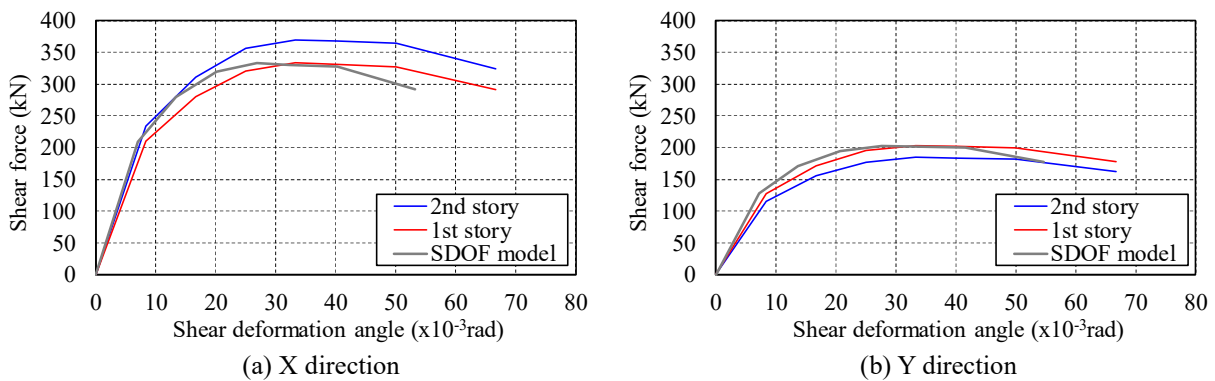
Figure 14: Restoring force characteristics

All the horizontal strength resistance elements must be added to accurately evaluate the restoring strength characteristics of a building. Examples of the horizontal strength resistance element of the target building included the earthen and hanging walls and bearing of penetrating beam and timber connection, among others. However, the contribution of the strength of the full surface earthen walls arranged to surround the outer periphery of the building was very dominant; hence, the restoring strength characteristic of the building was simply evaluated herein considering only the full surface walls. Figure 10 shows the skeleton curve used for the calculation in comparison with the horizontal loading test results. The restoring strength characteristic of the target building was evaluated by multiplying the horizontal strength per unit length, which was calculated by dividing the horizontal strength of the test result by the specimen width of 1.82 m, by the wall length for each floor and direction. Figure 14 illustrates the restoring strength characteristics of each story and the equivalent single degree of freedom (SDOF) model in each direction. The base shear coefficients at the maximum proof strength were 0.75 and 0.46 in the X and Y directions, respectively.

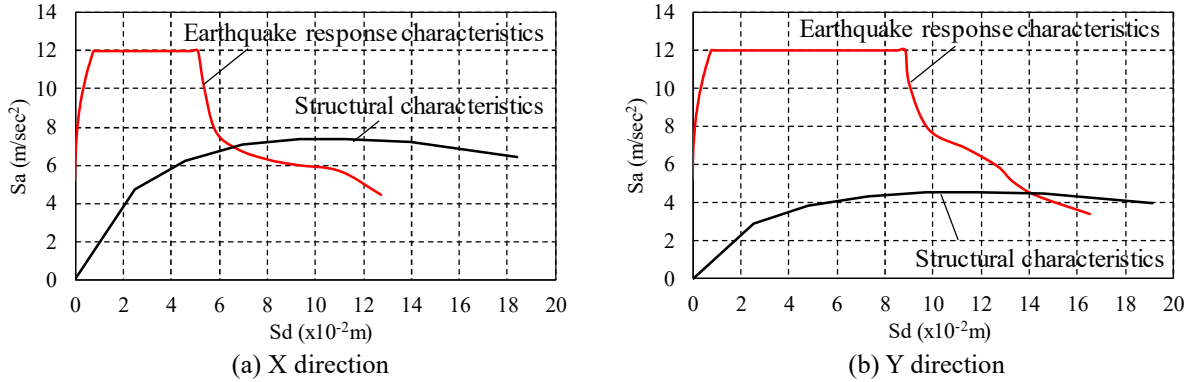
Figure 15: Structural characteristic curves (S_a - S_d spectra) of the SDOF model

Figure 15 shows the structural characteristic curves (S_a – S_d spectra) of the SDOF model. Table 6 presents the maximum response deformation angle and the base shear coefficient at that deformation. The maximum response deformation angles of the first story (i.e., $1/42$ rad in the X direction) were larger than those of the second story (i.e., $1/21$ rad in the Y direction) in each direction. The base shear coefficients at that deformation were 0.71 and 0.45 in the X and Y directions, respectively.

Traditional timber frame structures in Japan can often be judged to have sufficient deformation capacity up to the story deformation angle of approximately $1/15$ rad. In addition, the earthen wall performance confirmed in the test was observed at a certain strength level even at a large deformation of $1/15$ rad or more without brittle fracture. Furthermore, the planar shape of the target building was rectangular, and the torsional vibration influence was small. Considering these things, if the maximum response deformation angle is similar to that in the

calculation results or less, then the possibility of a building collapse due to the assumed ground motion is low. However, the response deformation exceeds the maximum proof strength, and seismic reinforcement is deemed desirable for controlling the response deformation when emphasizing restorability and continuity of use.
