THE INFLUENCE OF CIVIL WORKS ON HERITAGE ARCHITECTURE, EL VERGEL, CUENCA - ECUADOR

World Heritage City Project, Faculty of Architecture and Urbanism,
University of Cuenca, Cuenca, Ecuador,

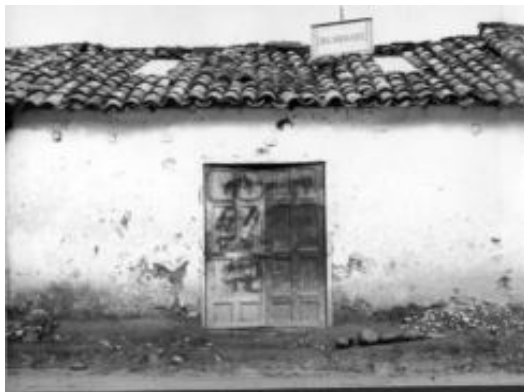
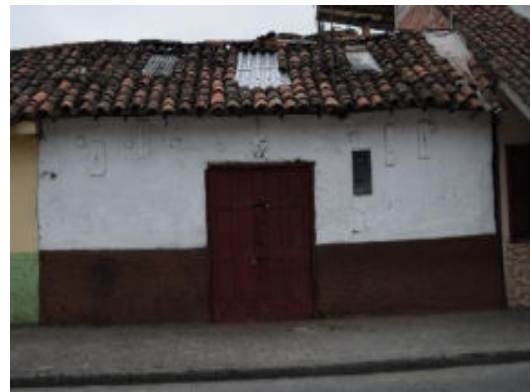
One of the works that most affected the Las Herrerias Street was carried out in the year 1961. Several portals were removed and the level of the buildings relative to the street was changed, due to the widening and paving of the new street, causing a considerable change in the neighborhood. Figure 2 shows how the level of the sidewalk ascends above the lower level of the building, causing the door to be cut off, water filtrations, danger of tripping over when entering and leaving the building, and a general change of its appearance.

Figure 2: a) Vernacular building in the Las Herrerias Street before the street was paved
Source: a) Photographical archive of the Municipal Foundation "El Barranco"
b) Vernacular building in the Las Herrerias Street after the street was paved
Source: b) Photographical archive of the World City Heritage Project

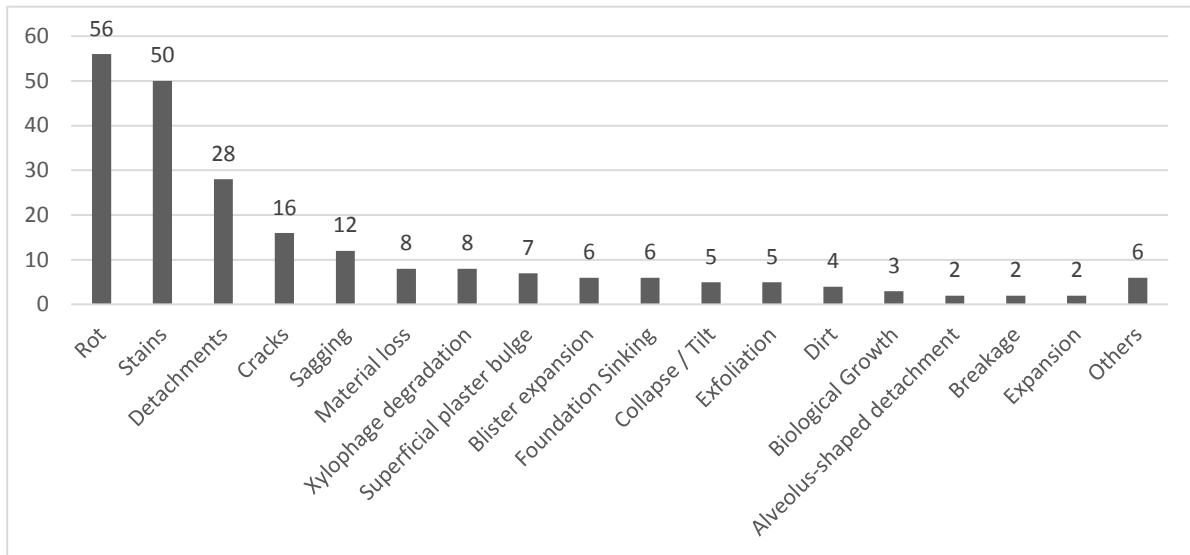
Without a doubt, the Maintenance Campaign was a challenge, since many of the buildings had considerably deteriorated roofs, columns and facades. The main problems consisted in rotten column bases, leading to a settling of the second floor and affecting the adobe walls as well as the roofs. Furthermore, the landscape was affected by the multitude of wires of different types, use and service [9]. Of a total of 226 damages, rot, stains and detachments account for more than 50%, as shown in figure 3.

Figure 3: Total number of identified damages before the Maintenance Campaign
Source: World City Heritage Project, 2018

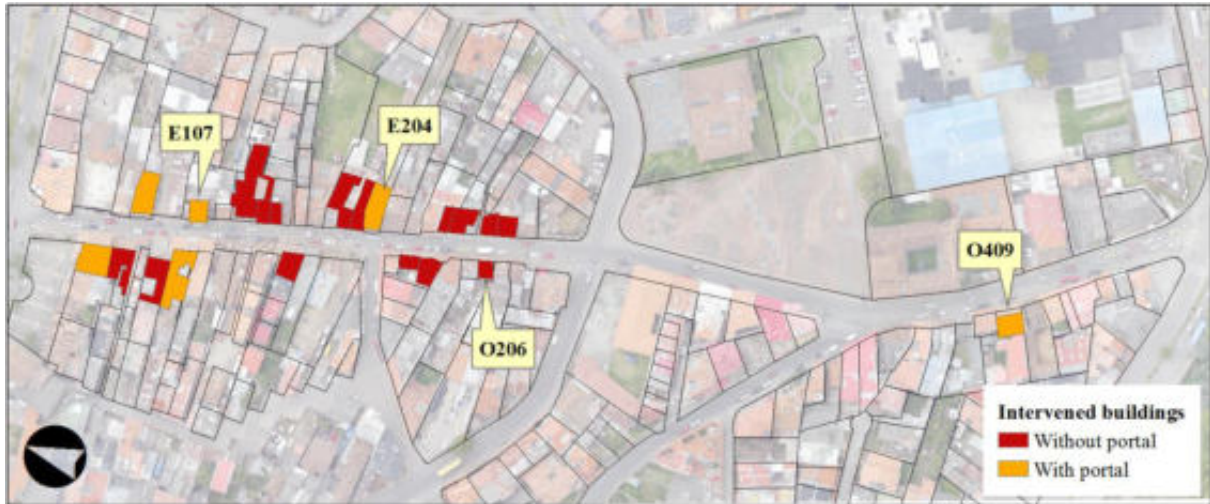
The effects caused by poorly carried out civil works in the Las Herrerias Street affect the most modest buildings. Especially the columns of the portals got damaged. During the Maintenance Campaign several stone elements, which served as column bases were found buried and as a consequence the wooden columns came into contact with the ground (due to a loss of height of the base) resulting in rot and loss of structural strength. Figure 4 highlights the buildings intervened during the Maintenance Campaign and those with portals. All have

structural problems due to a weakening of their columns. Of the 6 buildings with portals, 5 had columns in direct contact with humidity or with buried bases and all of them were intervened and remedied.

Figure 4: Buildings intervened during the Maintenance Campaign and buildings with portals
Source: World City Heritage Project, 2018

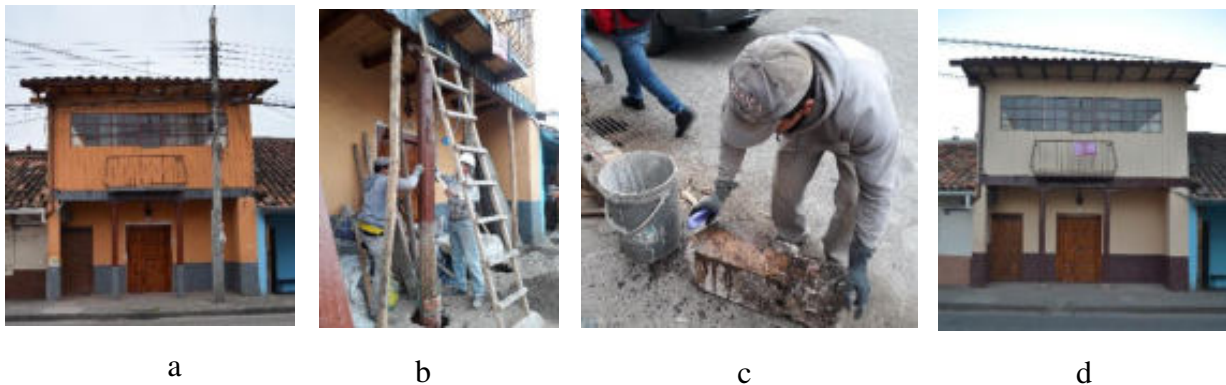
Figure 5: León House (E204); main facade before the intervention; b) showing of the portal during the replacement of the bases; c) original unburied bases; d) columns after the intervention
Source: a, b,c,d) Photographical archive of the World City Heritage Project, 2018

A specific example is that of the León House (fig. 4, building E204), which had its stone bases buried several centimeters below the current ground level and replaced by cement coating as shown in photo a). Due to its contact with the ground, this caused an increase of moisture in the columns, leading to the bending of the beams that support the second floor. This type of protection not only affects the strength of the wooden column structure, but there is also a loss of value of the vernacular building due to not maintaining the traditional construction system. Figure 5 shows the situation before, during and after the Campaign.

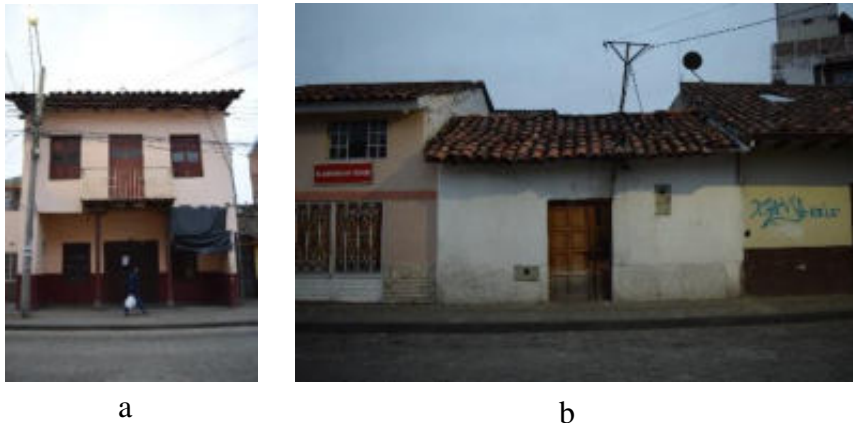
Electrical installations: the building E204 (figure 5^a) is one of the few buildings that continues to have a vernacular constructive system of adobe on the ground floor and wood on the second floor. In this building the electrical installations were a danger due to the build-up of electrical wires close to its main facade. Similar situations were found in buildings E107 (figure 6a) and O206 (figure 6b), where posts with electrical wires were positioned through their wooden roofs, causing damages to their structures, ceilings, walls and plasters due to rainwater filtration.

Figure 6: Buildings with threats because of electrical installations: a) E204, b) E107 and c) O206
Source: a, b) Photographical archive of the World City Heritage Project, 2018

To change this situation, during the Maintenance Campaign the University of Cuenca requested from the local Electricity Utility to study, coordinate and execute the relocation of the 6 involved posts and the burying of its wires. Due to the proximity of the wires to the roofs and the location of the posts in the middle of the sidewalks, this constituted an obstacle both for the access of the owners to their buildings as well as for the free movement of the pedestrians, in addition to directly affecting a window and the aesthetics of the buildings. It is worth mentioning that a Center for the Blind is located in this street, for which the public space needs to offer the necessary facilities. The local Electricity Utility carried out the complementary works of burying the wires within the Maintenance Campaign's intervention area of the street. This also allowed for a coordinated action between the Public Utilities of telecommunications, drinking water, sewage and sanitation to remove the so-called dead wires. In this way, an intervention of the urban space was realized that improved the quality of the services in the area and the image of the neighborhood.
