THE NDT INVESTIGATIONS CARRY OUT AT THE ARUDJ CATHEDRAL, ARMENIA

Abstract. *Arudj Cathedral, Armenia, is an example of early-Christian domed-hall that dates 671-672. A deep structural analysis of the building was developed by Politecnico di Milano, during the II° Level Master for Architects and Archaeologists named “Restoration Training and Support to Local Institutions for the Preservation and Conservation of Armenian Heritage”. The preservation project mainly focuses on deepen the knowledge level of the building in relation to the architectural and structural aspects in order to offer a working method with the aim to propose and teach alternative solutions for static and seismic consolidation.*

This paper reports the NDT investigations of the surveys carried out at the Cathedral of Arudj and the results obtained at the laboratory of the Politecnico di Milano.

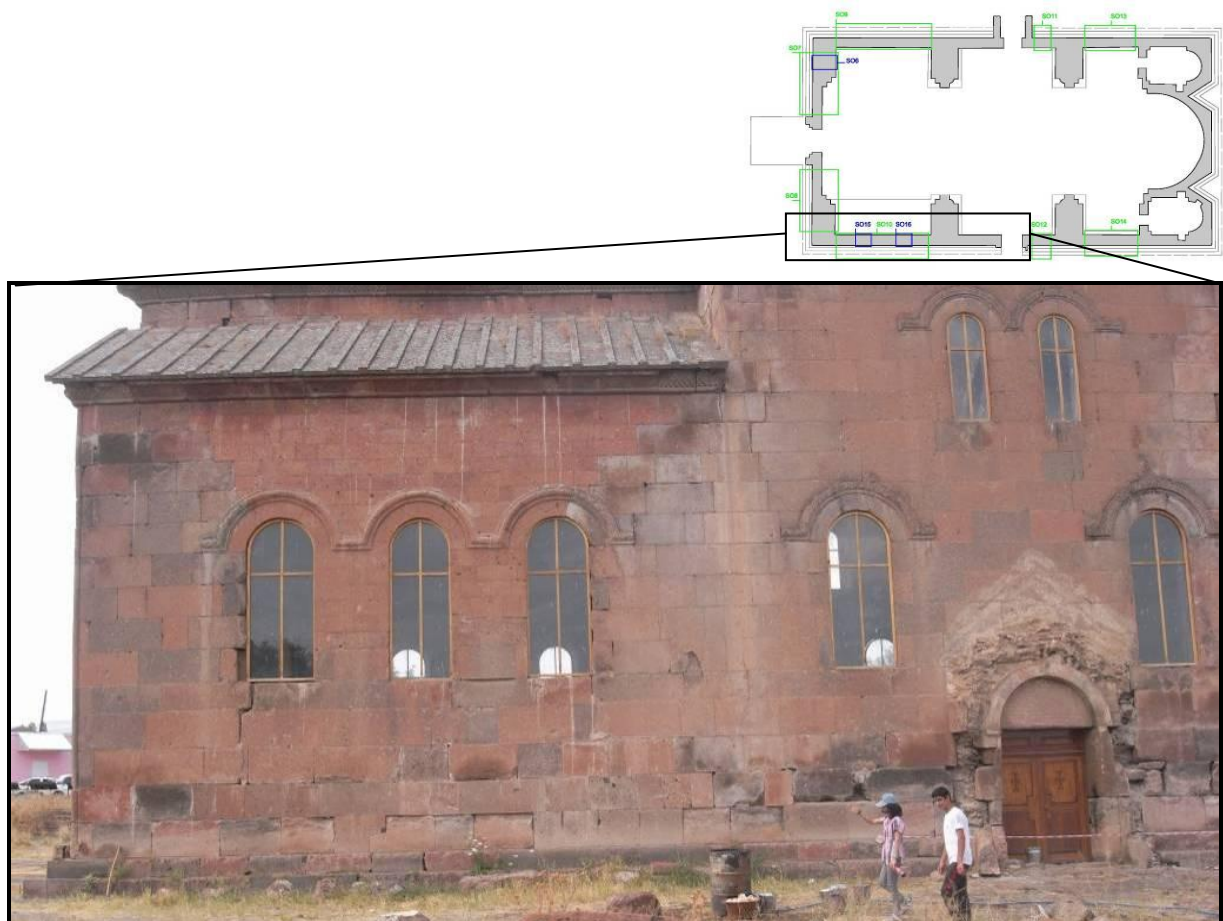
For the purposes of this article, the results of the tests conducted on a single portion are reported, in order to facilitate the comparative reading of the investigations. The portion under consideration (Fig. 1) was chosen as characteristic of the complex in terms of materials and construction technique, but at the same time, representative of the borderline case as it was seriously damaged by important instability phenomena.

Figure 1: The selected structural portion belonging to the North front

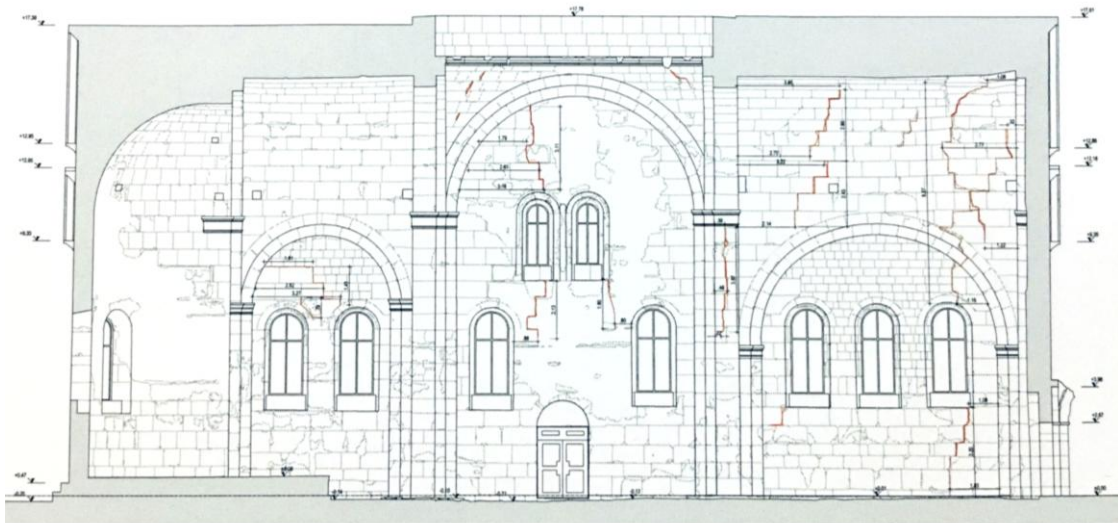
Figure 2: The internal side of the South front, the main cracks are underlined by circles.

The visual inspection and non-destructive techniques performed on the Cathedral of Aruch allowed to highlight the critical issues especially regarding the structural aspect. The crack pattern survey highlighted the main active kinematic mechanisms such as the rotation of the facade, the overturning of the tympanum, the thrust of the arches and vaults on the lateral structural elements and the weak connection of the main facade. The damages are due both to some original geometric imperfections and to seismic events, which have occurred in the past. In fact, Aruch is located in an area characterized by a very high seismicity.

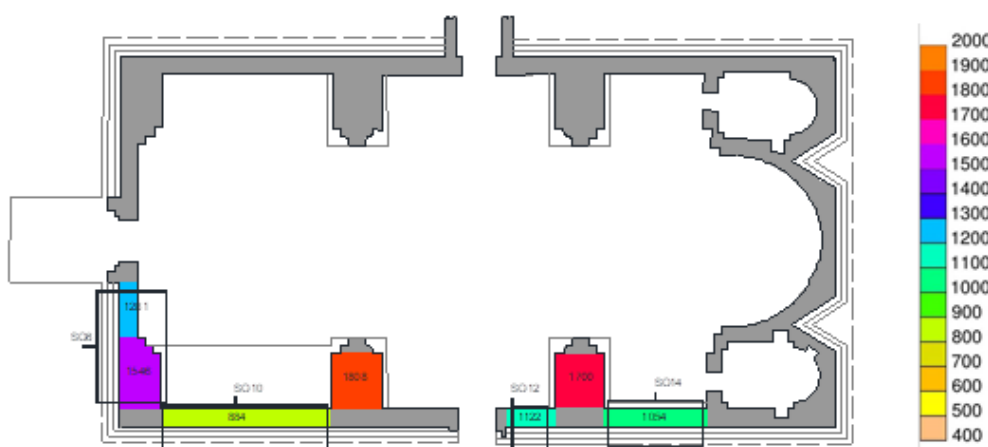
Among the ND investigation methods, the sonic methods are with no doubt, the most widely used [7]. The testing technique is based on the generation of sonic or ultrasonic impulses at a point of the structure. A signal is generated by a percussion (transmitter) and collected through a receiver which can be placed in various positions. The elaboration of the data consists in measuring the time the impulse takes to cover the distance between the transmitter and the receiver. The use of sonic tests for the evaluation of masonry structures has the following aims: (i) to qualify masonry through the morphology of the wall section, to detect the presence of voids and flaws and to find crack and damage patterns; (ii) to control the effectiveness of repair by injection technique in others which can change the physical characteristics of materials [8]. In agreement with the NDT survey plan, sonic tests have been carried out on the most damaged part of the walls, sixteen areas were detected to analyze all the pillars and a large part of the masonry. As requested, the equipment used for the survey is composed by an impact hammer as transmitter, an accelerometer as receiver and by an d a DAQ board to acquire data. In figure 3, the velocity average recorded in few wall portions is

visible. In table 1 it is possible to observe the speed differences between the original pillars and those subject to the restoration intervention made with new stones.

Figure 3: The sonic test investigations, marked in according with the proper color of the corresponding velocity class. At the top right the reference plan with the wall thicknesses

The sonic investigations carried out on the south front masonry and pillars have shown the difference density between the original materials and the new one (always stones) used for the restoration. Furthermore, the recorded data show that the pillars have a slightly dispersed sonic velocity values, this is indicative of a good state of conservation; in the masonry the results are different: the velocities are particularly low and dispersed. The lowest speeds are recorded in the south-facing walls which present the greatest deterioration on the masonry, in fact important crack patterns have been highlighted too.

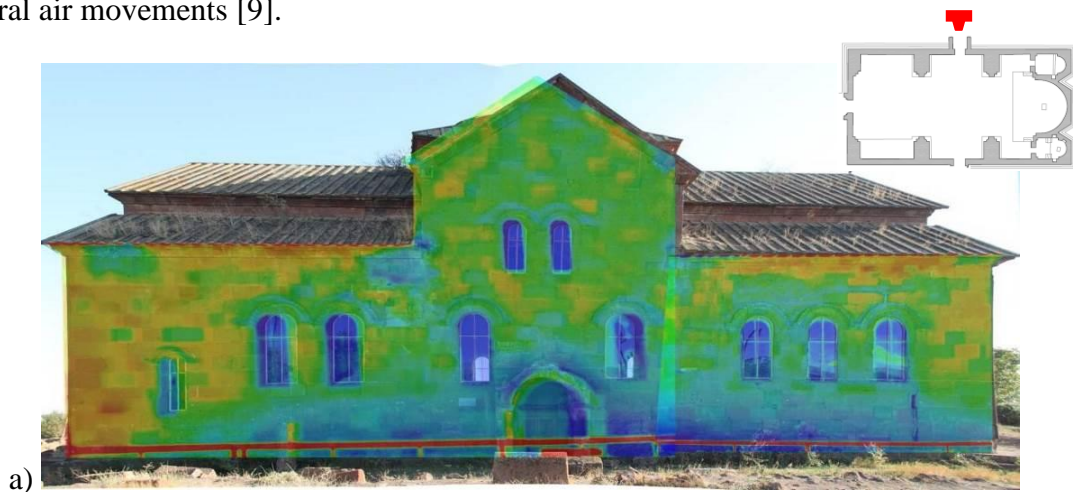
Figure 4 shows the presence of moisture and the capillary rise, thanks to the camera which identify the coldest surface areas, where there is continuous evaporation. The evaporation is due to the difference in R.H. between the inside of the masonry and the environment outside and to natural air movements [9].

Figure 4a: The thermography test investigations, conducted on the North front external side.

The thermographic investigations carried out both on the south and north fronts have highlighted the presence of capillary rise and, especially in the southern prospect, a very high temperature during the recovery, this identifies an ongoing evaporative process and a wide temperature ranges, one of the main deterioration causes surveyed on these walls.

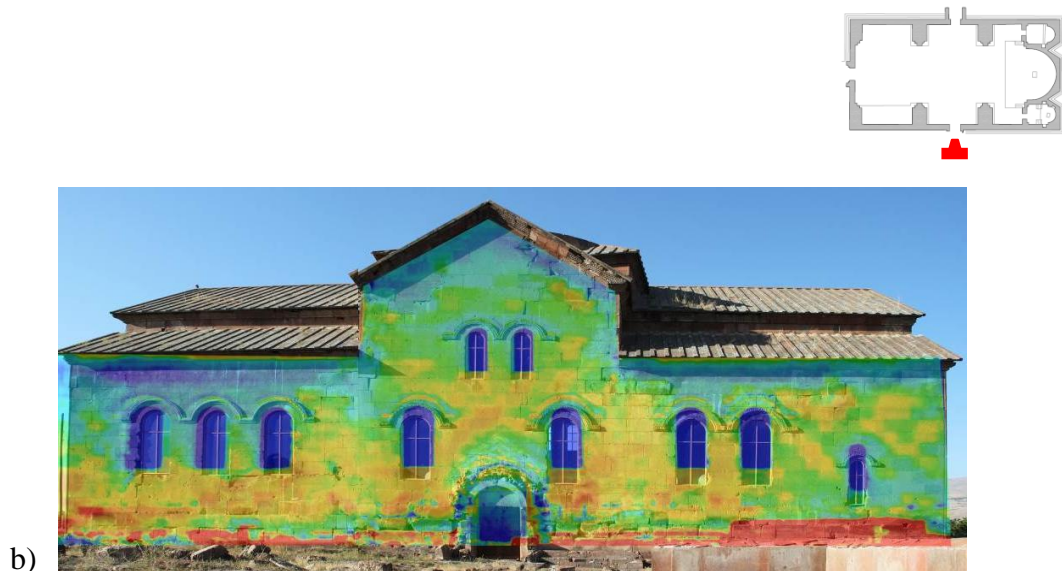
Figure 4b: The thermography test investigations, conducted on the South front external side.

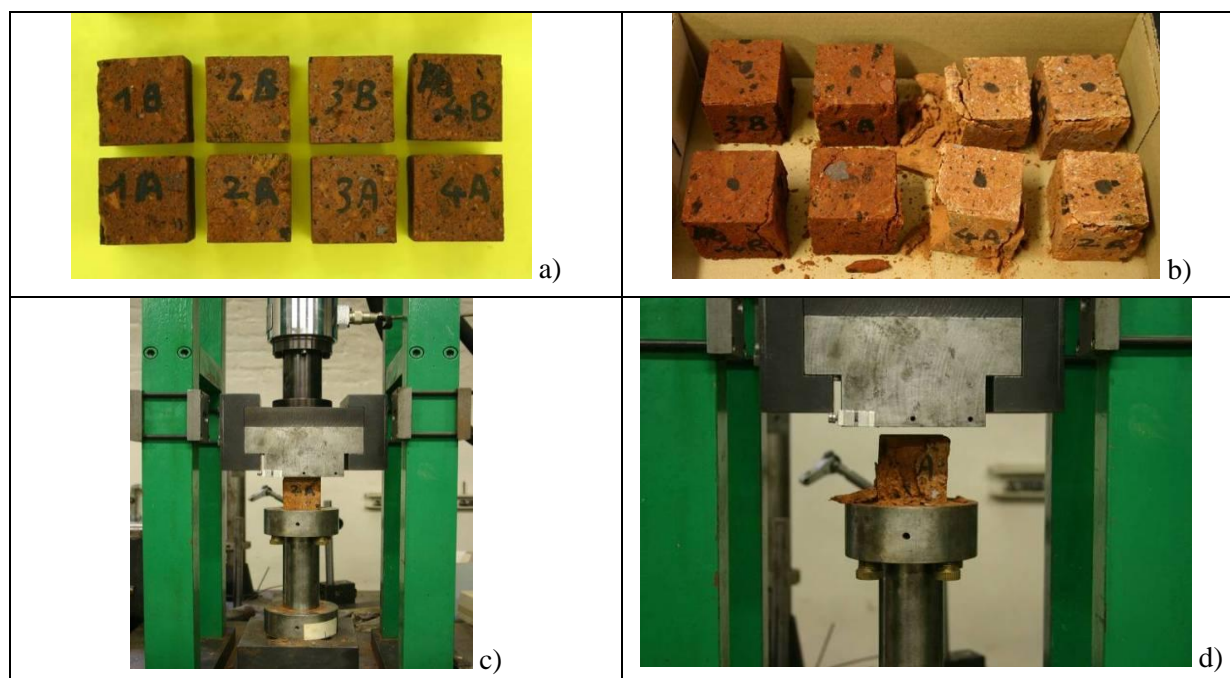
The materials sampled from the walls of the Cathedral were tested in laboratory to be characterized (Figs. 5, 6). Prisms of about 50x50x50 mm and 50x50x150 have been obtained from the stone and have been subjected to two series of uniaxial compression tests, dry (Tab. 2) and wet (Tab. 3) after being characterised through ultrasonic tests (Tabs. 4-5).

Figure 5: a) Prisms before test; b) Prisms after test; c) and d) Prism during compressive test.

The results relating to laboratory tests have shown the different compression behavior of saturated stones and dry ones. The ultrasonic speeds of the stone elements tested in the laboratory and the data recorded in situ, demonstrate the good state of conservation especially of the pillars building materials.

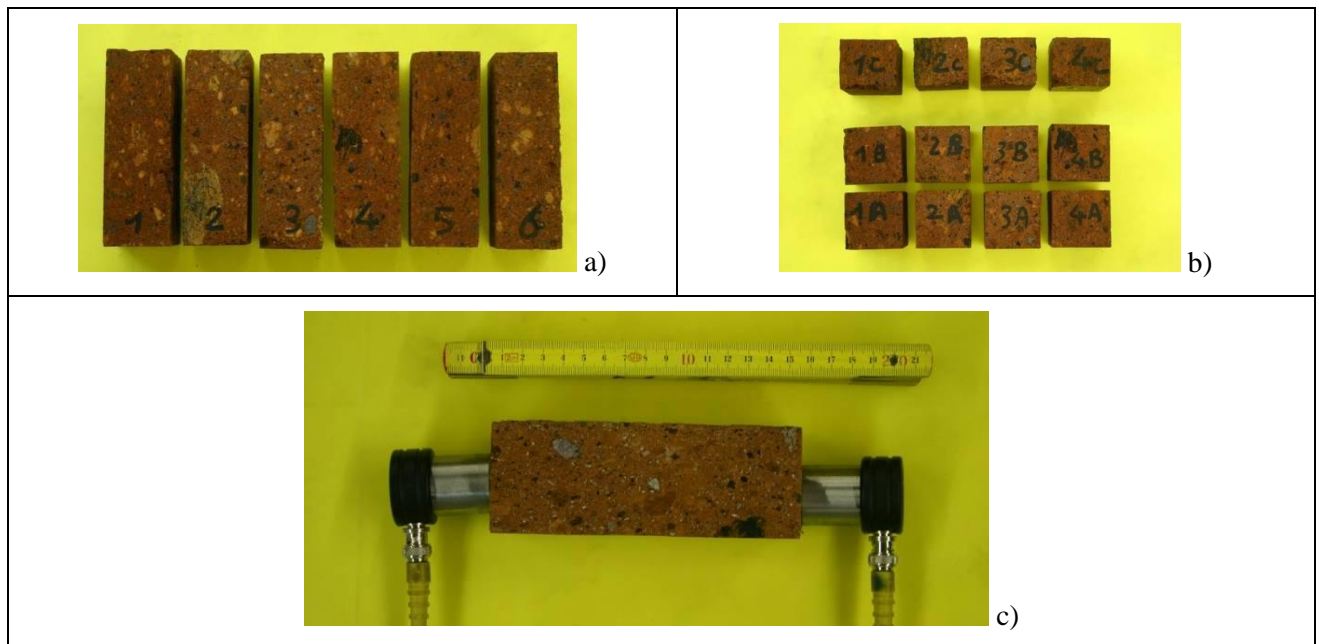
Figure 6: a) Prisms cut and rectified; b) Cubes cut and rectified; c) Prism during measurement

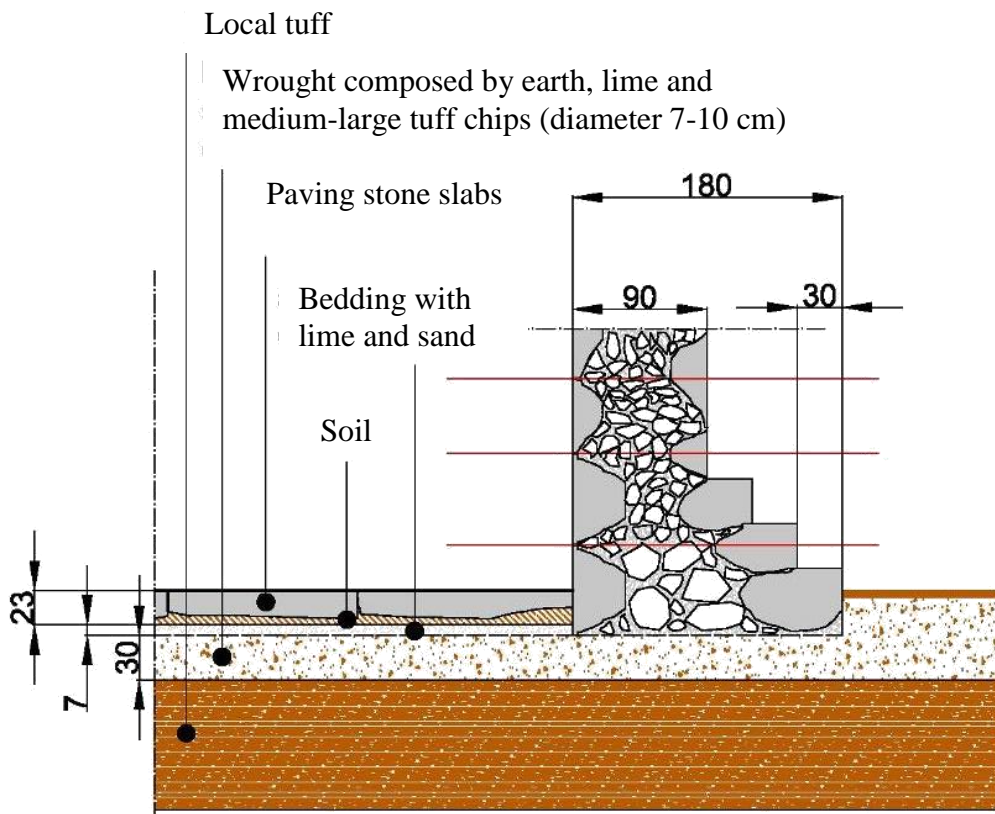
Due these investigations, both on site and in the laboratory, to some punctual inspections and to the comparison with similar cases located nearby, it has been possible to characterize the masonry by providing a hypothetical schematization of the wall section and its connection to the foundation structure. From what emerges from a preliminary analysis of the masonry, it can be assumed that the section can be defined as a three layers: two masonry facings (internal and external) and, the third one, composed by a filling in mortar and medium / large sized stones (Fig. 7). The longitudinal section of a type ashlar has an almost conical extrusion towards the inside and, thanks to this alternation, the middle layer is reduced, the internal and external facing are partially damped and the masonry acquires greater homogeneity and compactness. The masonry has a section of 90 cm and, at a height of about 60 cm from the walking surface, it progressively increases by 30 cm at a time until doubling thanks to a system of external steps adhered to the masonry through the filling that composes them. From a static point of view, this system recalls the structural benefits of a scarp wall (Fig. 7).

Figure 7: Hypothesis of the wall and foundation
