## THERMAL BEHAVIOR ASSESSMENT OF TWO TYPES OF ROOFS OF THE DOMINICAN VERNACULAR HOUSING

PRIETO-VICIOSO. ESTEBAN<sup>1\*</sup>, RUIZ-VALERO. LETZAI<sup>2</sup>, FLORES-SASSO.  
VIRGINIA<sup>2</sup>

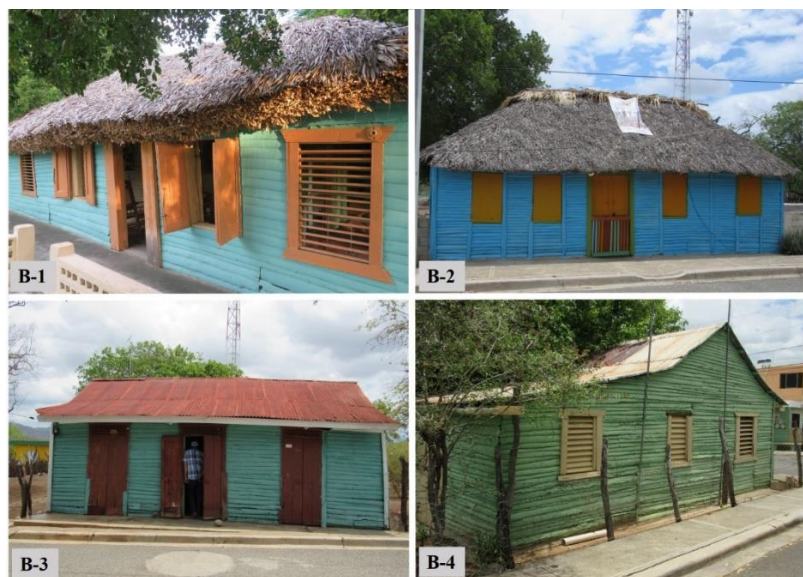
Four houses were assessed for this research all located in the Baní Valley, province of Peravia, in the south of Hispaniola Island. Two of them with roofs of cana palm leaves (B-1 and B-2) and two with roofs of corrugated zinc sheets (B-3 and B-4). The B-1 is located in Villa Sombrero and B-2, B-3, B-4 in Sabana Buey (Fig. 1).

Figure 1. The four houses assessed.

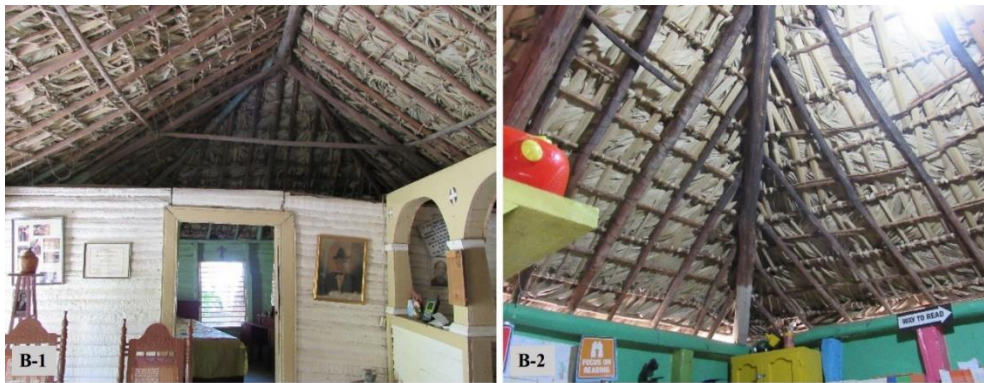
The *bohios* B-1 and B-2 with a Cana palm leaf roof is a type of vernacular housing commonly used in the Valle de Baní, consisting of a simple volume with a rectangular floor plan, with a gabled roof and small eaves that protect the four facades. Its supporting structure is based on wooden forks, buried in the ground, joined at the top by the sill, on which rests the lock that supports the thick cover of cane palm leaves (*Sabal dominguensis*). The walls of the house and the internal divisions are made of planks of royal palm (*Roystonea hispaniolana*) placed horizontally, overlapping and nailed to the *horcones* or posts, which in this region are usually made of mahogany (*Swietenia mahagoni*) or creole oak (*Catalpa longissima*). For the structure of the roof, we used uncarved sticks or poles from various local timber trees (Fig.2).

Figure 2. *Bohios* (B-1 and B-2) with a cana palm leaf roof.

Both *bohios* have a door in the middle of their main facade and four windows, two on each side of the door. On the back façade facing the patio, they also have a door placed in the center and four windows, two on each side of the door. The spatial distribution of the interior consists of a central area divided by two low walls, called handrails or *balaustres*, which define the living and dining areas. On both sides are the four rooms, one on the right and two on the left side of the *bohio*. The kitchens and latrines are located outside the *bohios*, where there is also usually an *enramada* or covered terrace.

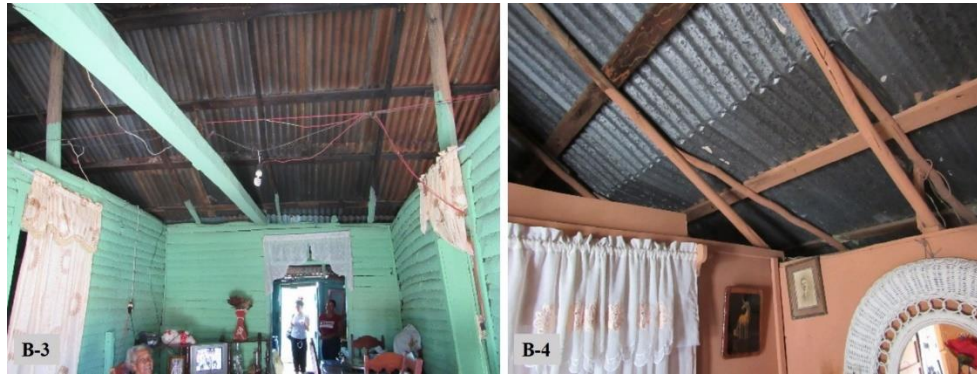
The B-3 and B-4 huts, located in Sabana Buey, have a supporting structure, materials and construction methods similar to those of the B-1 and B-2 huts, but with the difference that the roofs made of cana palm leaves were replaced years ago by corrugated zinc sheets, which are nailed to a structure made of already industrialized wooden rods and belts, usually made of pine. The roofs are gabled with short eaves, with the main facade being somewhat more pronounced (Fig.3). In these houses the zinc roofs are broken to achieve a greater speed in the fall of the water and move them away from the facades. Both cases have an annex at the back,

to integrate the kitchens into the house and add another bedroom. The interior walls, as in B-1 and B-2, remain at the height of the sills, allowing air to flow over them. The B-3 also has fans over the doors, which contribute to the good ventilation of the interior of the hut.

Figure 3. *Bohios* (B-3 and B-4) with corrugated zinc sheets on roofs.
