## TO REACH THE LIGHT: THE MONUMENTAL BYZANTINE STAIRS OF CAESAREA, A CONSERVATION AND RESTORATION PROJECT

**Keywords:** Caesarea, Byzantine Staircase, Maintenance, Sandstone, arch bridge, vault.

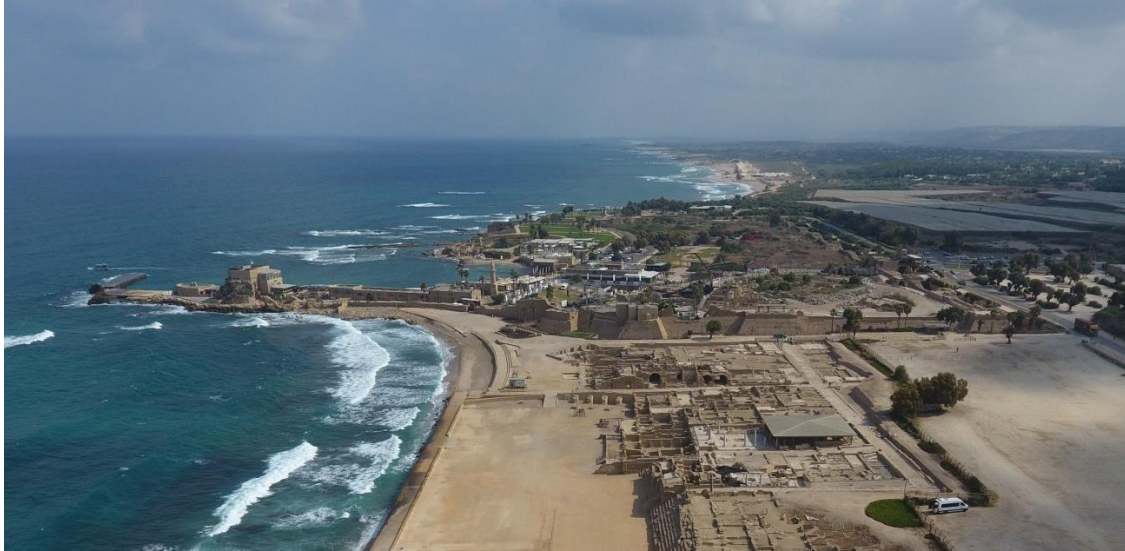
**Figure 1:** Caesarea antiquities heading north. Mites to Michael Peleg, Israel Antiquities Authority, 2019.

The city of Caesarea was founded adjacent to the Mediterranean Sea between Jaffa and Dor (Fig. 1), on the site of the abandoned Hellenistic town "Straton's Tower". Herod king of Judea under Roman aegis made Caesarea the administrative capital and the main harbor of his vast kingdom. The city was named after Caesar Augustus, Herod's patron, the first Roman emperor. It continued to develop and prosper even more in the Byzantine period. In this magnificent port city and its rural hinterland, "prices are low, their abundance obtains" (Jerusalem Talmud, Kil'ayim 9:4, 32c; Ketubot 12:3, 35d).

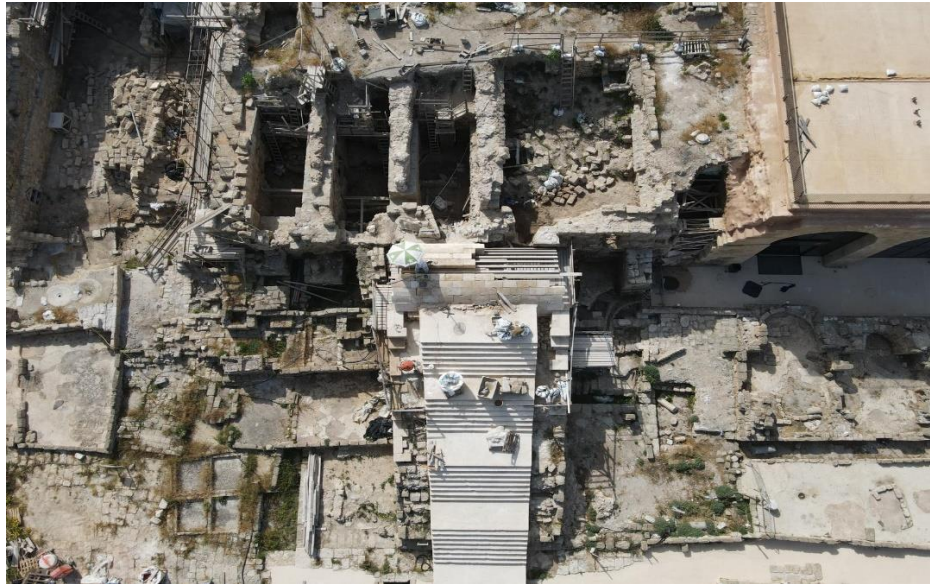
**Figure 1:** The monumental stairs, arch bridge, and the six small massive vault in the east side. Mites to Danial Siboni, Israel Antiquities Authority, 2020.

structures; an enormous pair on the west side near the quay and six smaller massive east-west vaults 20x2.5 m in the east side adjacent to the altar on the front of the Church central axis. The structures connected with a giant arch in dimensions; 8 meters width, 8-meter-high, and 4-meter long (Fig. 2).

The six massive vaults from the Roman period continue to be in use without any change in structure also in the Byzantine period. This vaults system bounded with four big vaults 25x5 m on both the north and south sides supported the Roman Temple platform (Fig. 2). These vaults were founded on bedrock and built of finely dressed Kurkar ashlar [1]. The surrounded wall is 2.6 m in thickness and constructs from ashlar stones with draft margins surrounding a high or shallow central boss on the exterior side and ashlar stone without boss internal. The vaults built above the wall in width 1.5 m and including passages with two arches in each wall the arch width of 2.3 m construct from ashlar stones, each one of the vault entrance and windows to the port at the west side. These walls and vaults built with different construction technology using ashlar stone integrated with lime, earth, and rubble casting, a similar technique on the first five vaults the casting incorporated in the carried wall its begins and ends at the height range of the aisles arch, despite the last vaults casting together with the carried wall (Fig. 2).

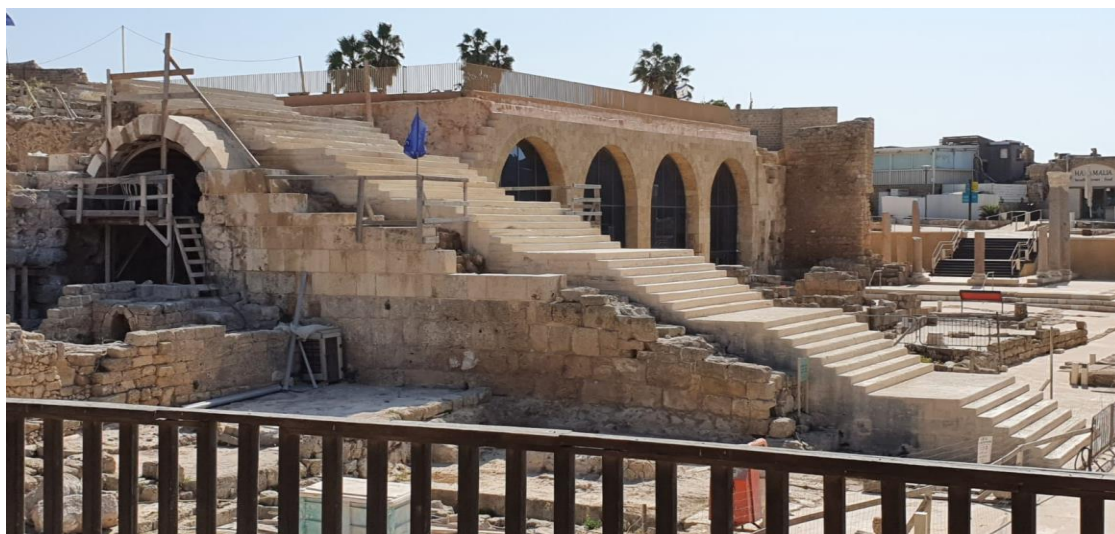
**Figure 3:** The stairs and the arch bridge heading south. Mites to Danial Siboni, Israel Antiquities Authority, 2020.

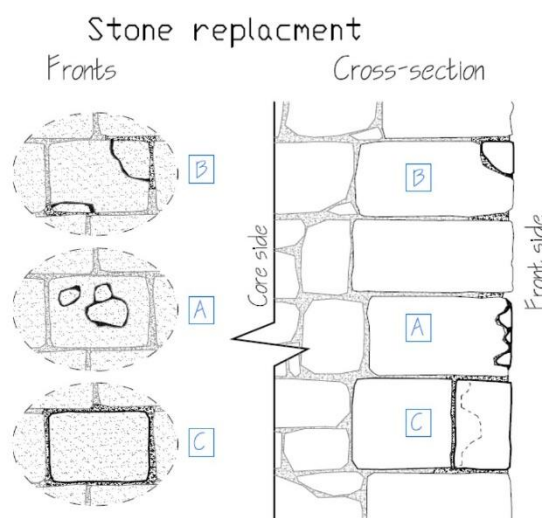
**Figure 4:** Sketch summarizes the intervention in stone.

A: A lightly weathered stone with 7-12 cm façade cavities.

B: Stone with edge cavities from 12 cm to half stone façade.

C: A severely damaged stone, over a half-face is missing.

Eventually, to install the new replacement stone, the cavity should be well damp, and then a bed of mortar (Table 3) is applied to the back of the hewn space, base, and other side joints. Previous to being into place, the replacement stone should be quite wetted to stop it sucking moisture from the material, especially with the Kurkar sandstone, which absorbs large amounts of water. If necessary, lead, stone fragments, or pottery can be set into the joints to maintain the position of the new stone and prevent the mortar from slumping. The process of stone replacement differs from one category to another: (Fig. 4).

A: complete small cavities in the stone façade with paired stone.

B: fill cavities at the edges using a stone with a straight face and sides.

C: removing the front of the damaged stone to a depth of 25-30 cm and complete it with antique ashlar stone.
