TREATMENT FOR RISING DAMP AND NATURAL HYDRODYNAMIC EQUILIBRIUM IN MASONRY WALLS

JOSE DOBÓN^{1*} AND MIGUEL Á. SORIA²

Kerakoll Ibérica S.A.

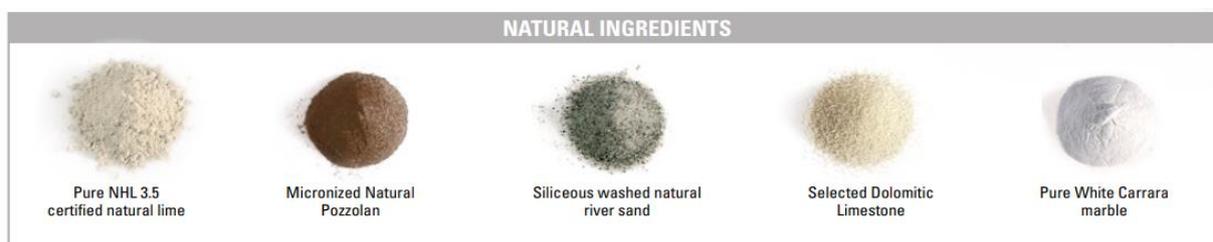
Figure 1. Natural Ingredients

The quality of the natural hydraulic lime NHL 3.5 and selection of the natural elements gives this mortars greater natural porosity, compared with cement based plasters and renders, acting as a true “hygrometric lung” on the wall and providing a perfect balance between strength and elasticity, making this line of natural products perfectly compatible with even deteriorated walls and increasing indoor liveability

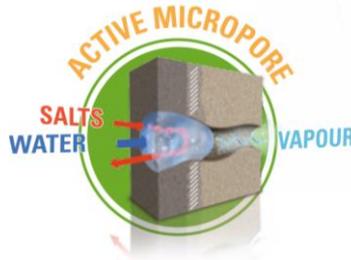
Figure 2. Active Micropore

The size of the ACTIVE MICROPORES in the special dehumidification mortar guarantee high levels of breathability and very low capillary absorption. The small diameter of the capillary channels blocks the passage of water, which does not get into the render, while it allows free passage of the vapour molecules.

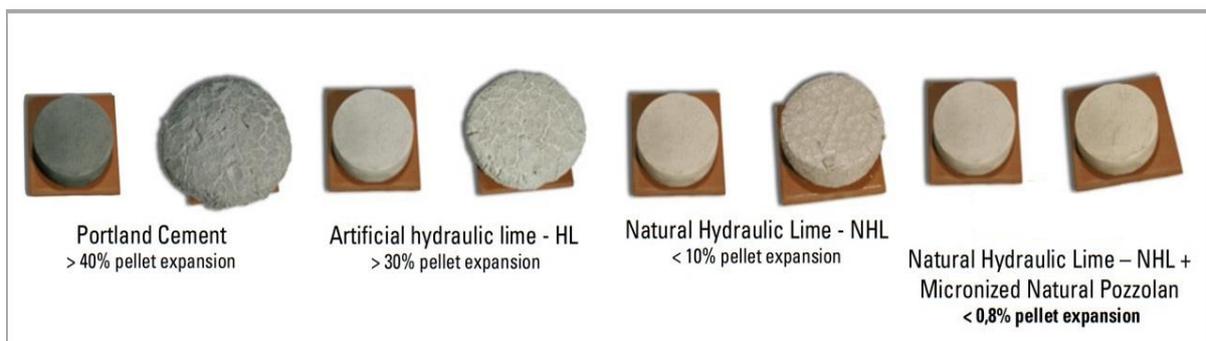
Figure 3. Anstett Sample

The chemical resistance of an hydraulic binder to attack by sulphate salts is determined using an analysis method known as the "ANSTETT TEST".

5. The method involves preparing test samples of binder (which is first hardened in water, dried and then ground) with 33% gypsum (sulphate). Support preparation
6. The new powder mixture is then damped with 6% water and compressed in a special mould to form a cylindrical pellet of standard dimensions (\varnothing 80 mm).
7. The test sample prepared in this way is placed on a porous septum (ceramic biscuit tile) in permanent contact with water.
8. The reaction to sulphates is checked by measuring the diameter of the pellet at regular intervals using a precision gauge (± 0.01 mm).

The measurement express the percentage increase in diameter from the start of the test.

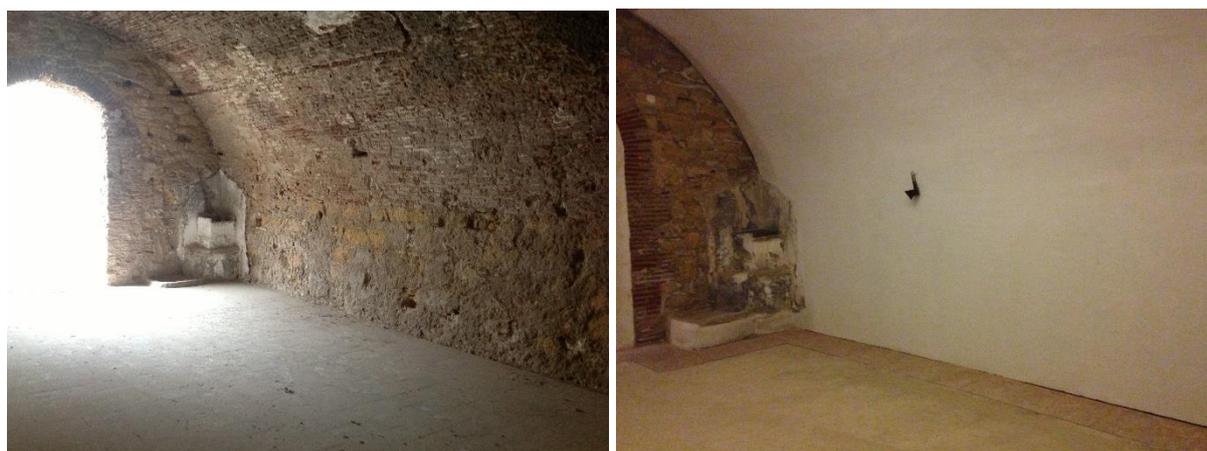
The intervention with this dehumidifying system is concentrated in the barrel vaults that form the galleries of the fort. These vaults are mixed with masonry base and brick arch, and there was moisture, both rising and roof water filtration. After waterproofing the roof, the strength of the support was evaluated and the suitability of the dehumidifying system was confirmed.

After applying the pure NHL lime and pozzolan dehumidifying mortars a lime-based render compatible with the system, was applied. As a decorative and projective layer, it was painted with breathable paint based on pure silicate according to DIN 18363 that guarantees the continuity of dehumidification.

Figure 4. Previous and current status of one of the vaults

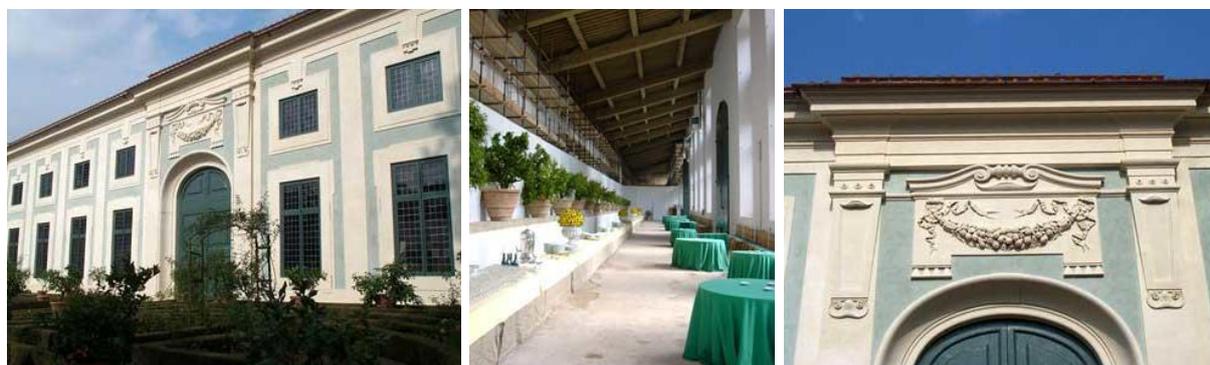
The building facade presented problems of moisture rising with presence of humidity marks, saline efflorescence, fall of mortars and paints, disintegration of mortars, cracks and fissures.

This natural line of products, based on pure natural lime NHL 3.5, has been proposed as a suitable solution for the conservative restoration of the mortars of historical and monumental buildings, thanks above all to its characteristics of porosity, breathability and hygroscoy that allow a continuous exchange of air and steam inside the masonry.

Figure 5. *Limonaia* post-restoration 2004
