# TYOLOGICAL CHARACTERIZATION OF ANCIENT TOWN WALLS FOR DISASTER PREVENTION AND MITIGATION: THE MO.M.U. PROJECT

ANNA DE FALCO<sup>1</sup>, FRANCESCA GIULIANI<sup>1\*</sup>, DANIELA LADIANA<sup>2</sup>, LEDIANA  
RJOLLI<sup>1</sup>, DAVIDE BORDO<sup>1</sup>, FRANCESCA GAGLIO<sup>1</sup> AND MICHELE DI SIVO<sup>1</sup>

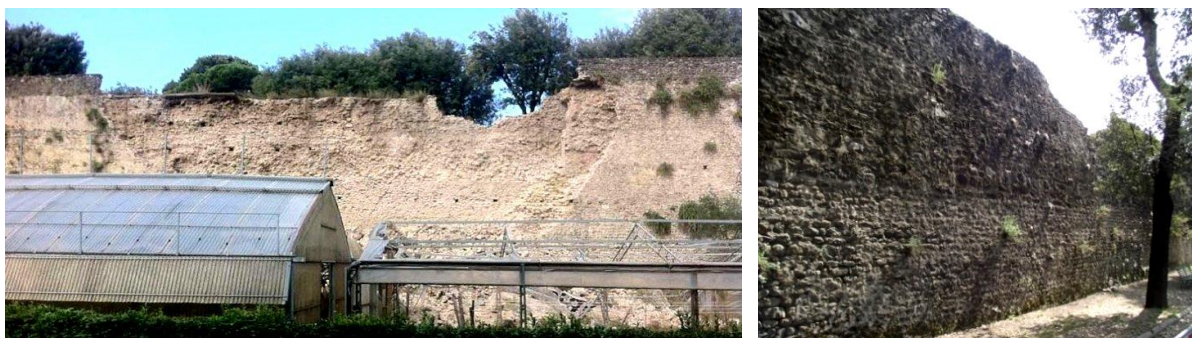
**Figure 1:** Collapse of the city walls of Pistoia (September 19, 2011). On the left: the failure seen from the outer side; on the right: the failure seen from the city centre.

Pistoia is an important city that still shows traces of its Gallic, Ligurian, Etruscan and Roman past. On September 19, 2011, a portion of about 25 meters of medieval town walls outwardly collapsed. The curtain wall facing the city centre remained standing and the outer layer crumbled (Fig. 1). The consequence did not result in deaths or injuries, but debris fell on some greenhouses, causing economic losses to agricultural activities. The collapse was triggered by heavy rain in an already critical situation. The main factors influencing the

collapse were the wall slenderness, its height, the difference between the floor levels on the two sides of the wall and the poor quality of the masonry. Walls are made of river pebbles and are weakened by texture irregularity, traces of poorly chosen interventions and lack of maintenance [7]. In September 2020, the same curtain completely collapsed for a length of 30 m. In this case, no extreme climatic events preceded the disaster.

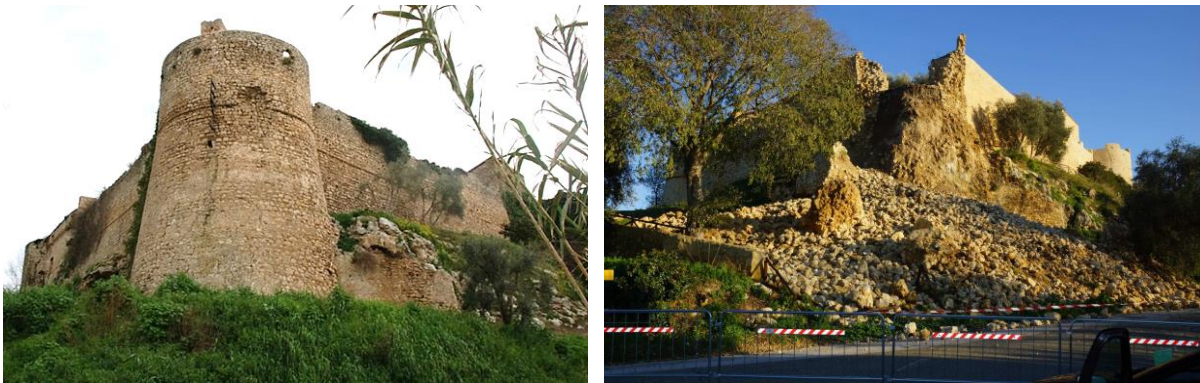
**Figure 2:** The collapse of city walls of Magliano in Toscana (November 13, 2012). On the left: the “Torrione” before the consolidation; on the right: the “Torrione” after the failure.

On November 13, 2012, the south-western tower of the medieval town walls of Magliano in Toscana collapsed. After the middle of the XVII century, they were no longer used for military purposes and their maintenance was neglected. This situation has favoured the construction of new masonry buildings adjacent to the curtain that was thus used as a load bearing wall. The so-called Torrione, about 20 m high and 9 m wide, was made of a stone masonry curtain covering a rocky outcrop in the lower part and containing the earth in the upper part. The structure suddenly collapsed following an extreme meteorological event. The upper part of the tower and the stone masonry debris fell on the road that luckily was not occupied by vehicles (Fig. 2). Consolidation works had been completed just before the disaster: the large and numerous full-height cracks had been closed and the joints repointed. The closure of these natural drainage holes probably caused the collapse during an exceptional rainfall, when the weep holes at the base were obstructed by a great amount of soil accumulated in the inner part of the tower.

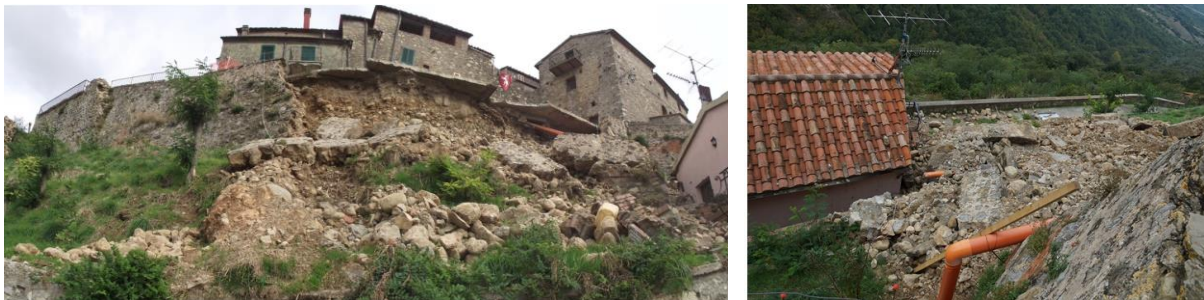
**Figure 3:** Collapse of the city walls in Cana di Roccalbegna (October 5, 2013). On the left: the collapse seen from below; on the right: the debris near the building below the wall.

On October 5, 2013 about 13 meters of town walls collapsed during a heavy rainfall in an ancient small town, Cana di Roccalbegna (Fig. 3). The system was made of a stone masonry retaining wall dating back to the XV century, surmounted by a reinforced concrete slab which formed the base of a panoramic viewpoint square. The masonry was inhomogeneous in terms

of material and construction techniques. The failure was caused by the erosion due to incorrect water drainage and increase of hydrostatic pressure behind the wall during the heavy rainfall event. The rubble reached a building, which fortunately was only hit by minute debris, and the street below, where a parked car was buried. On 21 August 2020 the reinforced concrete slab suddenly broke during the execution of the consolidation works. Four houses have been evacuated and a part of the village has become inaccessible due to debris.

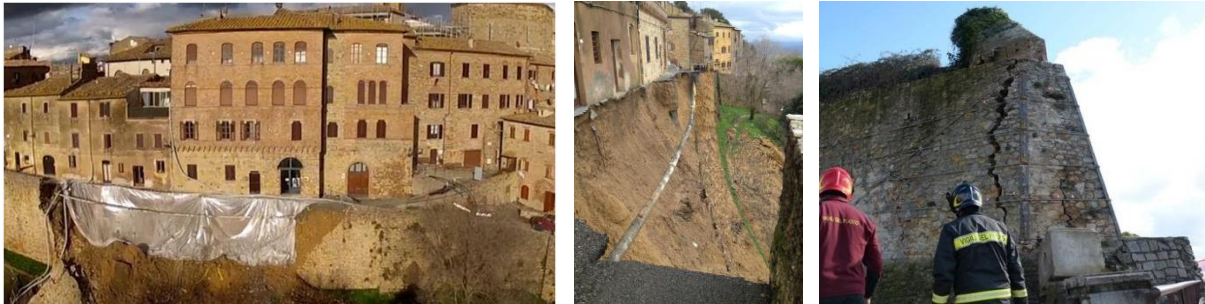
**Figure 4:** The collapse of the city walls of Volterra (January 31, 2014).

On January 31, 2014 about 35 meters of the town walls in the south-western side of Volterra suddenly collapsed, after a series of heavy rainfall events. Volterra is a walled hilltop town in Tuscany, one of the most important Etruscan settlements, successively developed as a medieval centre. The failure involved a 9.5 m high segment of a stone masonry retaining wall that embraces the city centre, laying bare the foundations of the historical masonry buildings above (Fig. 4). Luckily, there were no casualties, but the buildings located at a distance of a few meters from the wall were slightly damaged. The main causes of the collapse are the incoherent sandy terrain behind the curtain wall weakened by previous repeated water infiltrations due to the old sewer system of the historic centre, and the water from the heavy rains of January, which increased the hydrostatic pressure on the curtain [8]. Added to this is the intrinsic weakness of the masonry of the collapsed portion, due to the significant and repeated restorations during time, from the middle age up to now. On March 3, 2014 another

failure affected the unstable wall corner located about two hundred meters from the above-mentioned portion toward the South. The collapse was preceded by some cracks on the irregular and inhomogeneous masonry wall. In that circumstance, a part of the embankment slid downwards, despite the remedial works with steel anchors.
