## RESEARCH ARTICLE

# A new sensorized ceramic plug for the remote monitoring of moisture in historic masonry walls: First results from laboratory and onsite testing

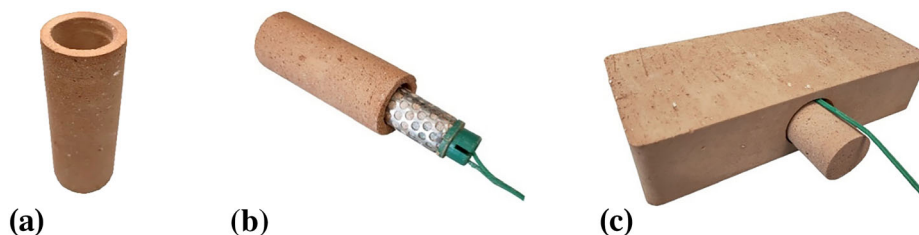
FIGURE 2 Sensorized ceramic plug and its way of insertion in brick: (a) the brick cylinder, (b) the moisture sensor housed inside and (c) turning and insertion of the sensorized ceramic plug (base towards the external surface) in a brick constituting the masonry

Therefore, the sensorized ceramic was designed and manufactured. As the moisture sensor is 22 mm in diameter and 76 mm in length, a cylindrical element was core drilled from a solid brick. The type of brick was selected after the preliminary tests described in Section 3.3. This cylindrical element has diameter 40 mm and length 100 mm, and a hole was drilled from one side, having diameter 24 mm and length 90 mm, as in Figure 2a. The moisture probe is inserted in the hole (Figure 2b), and the entire system constitutes the sensorized ceramic plug to be inserted in the masonry, as in Figure 2c. In this phase of the research, the cable can be simply hidden along the mortar joints and/or under the render. The temperature probe is constituted by a steel rod (diameter 6 mm, length 40 mm) that can be inserted in little hole drilled in the masonry close to the moisture sensors.

To select the brick to be used for the sensorized plug in Figure 2, the four different commercial solid fired-clay bricks described in Section 3.1 (Table 1) were tested and the results are reported elsewhere.<sup>49</sup> In brief, four identical sensorized ceramic plugs were manufactured using BRICKS 1–4. After bringing them to a constant and uniform moisture amount (10 wt%), the SWT values were measured. The brick exhibiting the lowest SWT was selected. The reason is that, according to the technical data sheet of the moisture sensor, the optimal measurement range is between 0 and 239 cbar, while for  $SWT > 239$  (corresponding to low moisture contents) the measurement is less reliable. The brick selected for the manufacturing of the plug was BRICK 1.

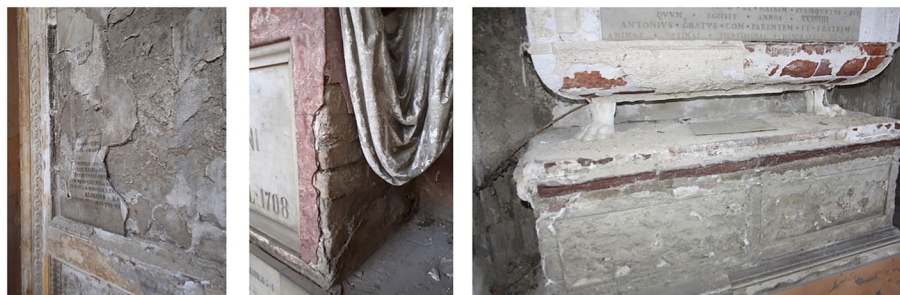
**FIGURE 5** Examples of damages due to the capillary rise of water and salts in masonries of the monumental Certosa cemetery in Bologna, Italy

The last phase was the pilot application of the sensorized ceramics in a real historical masonry. The location selected for the experimental campaign was the Monumental Certosa cemetery in Bologna, Italy, built at the beginning of XIX century and including structures and artefacts of different ages, having high historical and artistic value. Many masonries show evident signs of rising damp, salt crystallization phenomena (both efflorescence and subflorescence) and freeze–thaw cycles, which cause severe damage to materials and lead to the detachment of valuable surface layers (plasters, paints and stuccoes) (Figure 5).

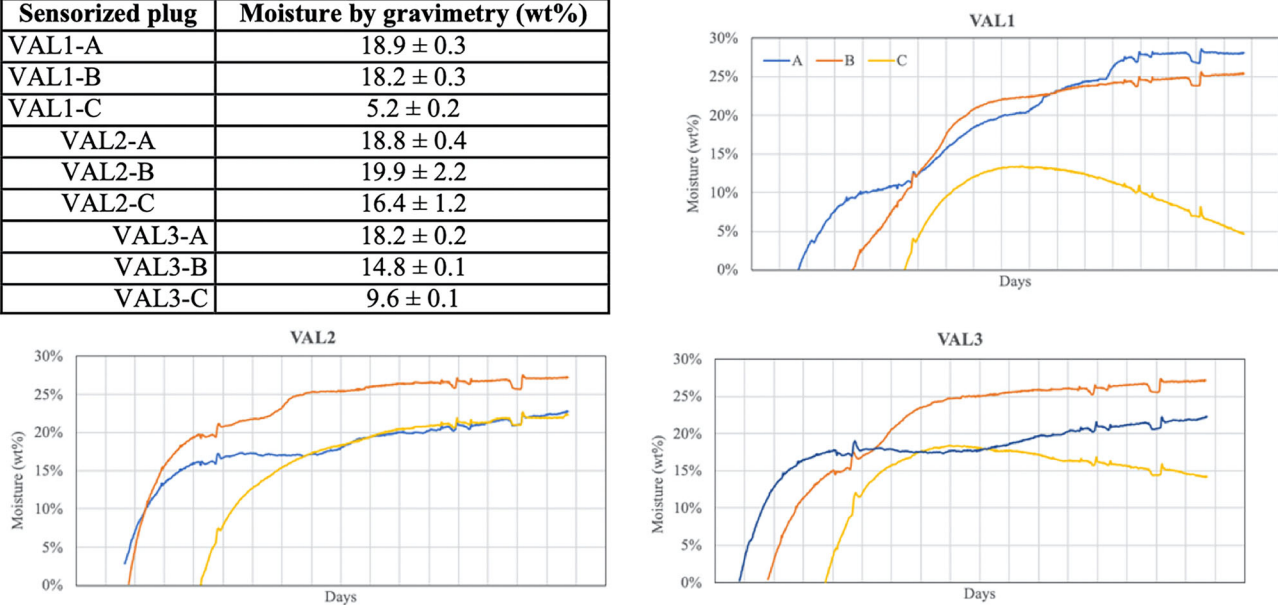
FIGURE 10 Walls VAL1, VAL2 and VAL3: moisture determined by gravimetry at the end of the test (in the table) and moisture measure in continuous by the sensorized plugs in the three measurement holes of each wall

The moisture amounts determined by gravimetry at the attainment of the equilibrium in walls VAL1, VAL2 and VAL3 are reported in Figure 10, together with the moisture values given by the sensorized probes inserted in the same measurement holes. The latter values are shown for the entire period of monitoring, that is, since the introduction of water in the basins under the walls. In terms of gravimetric moisture amount, VAL1 is basically saturated in the first two measurement points, while the highest point exhibits a limited moisture. VAL2 is saturated in the first two points and

As far as the sensorized plugs are involved (Figure 10), the sensors measured moisture starting from the lowest one, that is, as soon as they were reached by water, which happened in 7–10 days even for the highest point. During the initial progressive wetting of the walls, in which unsaturated water flow was present and absorption was quick, moisture did not constantly increase but some transient decrease was present, especially in points A and B, likely due to some temporary consumption of the water in the basins (weekends, evaporation higher than expected or simply unexpected

changes in laboratory temperature). At the end of the test, comparing the moisture values obtained by gravimetry and those provided by the sensorized plugs (Figure 10), some interesting remarks can be done. The moisture distribution with height found with gravimetry was found also by the sensors, but with some difference in the values. In VAL1, the points A and B seem similar and basically saturated, while point C exhibits a low moisture (about 5%), as in the gravimetric measurement. In VAL2, all the points exhibit basically saturated conditions and the highest moisture amount is in point B, as in gravimetry. In VAL3, points A and B are basically saturated, but there is a switch between them in the moisture values compared to gravimetry, while point C is correctly the less wet. However, it is clear that the values provided by the sensors almost systematically overestimate the moisture amount with respect to gravimetry, being the saturation at ~22–28 wt% rather than at ~19 wt%. This effect is thought to be due to two main reasons:

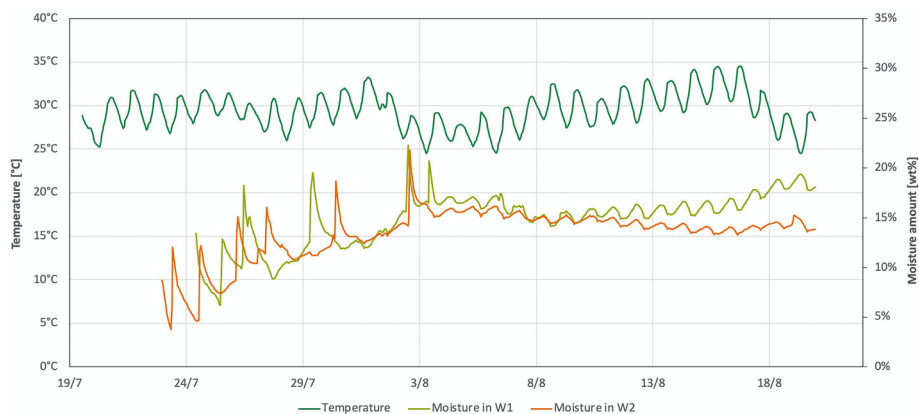
**FIGURE 11** Temperature and moisture amounts measured by the sensorized plugs in the masonry at the Certosa cemetery during the first month of monitoring

On 19 July 2021, the sensorized ceramic plugs and the T probe were installed in the selected locations in the masonry and the monitoring started. The collected data are shown in Figure 11 for the first month and in Figure 12 for the entire monitoring period July 2021–April 2022. For comparison's sake, the climatic data during the same period, collected close to the cemetery, are reported in Figures 13 and 14. All the data collected allow to make the following observations:

- The T probe in the masonry was clearly influenced by the daily thermal excursion (Figure 11), although in an attenuated way compared to external air in the area (Figure 13), as expected. The probe recorded the expected seasonal variation from summer ( $\sim 30^{\circ}\text{C}$  in August) to autumn ( $-5^{\circ}\text{C}$  or less in December), to spring ( $\sim 15^{\circ}\text{C}$  in April).

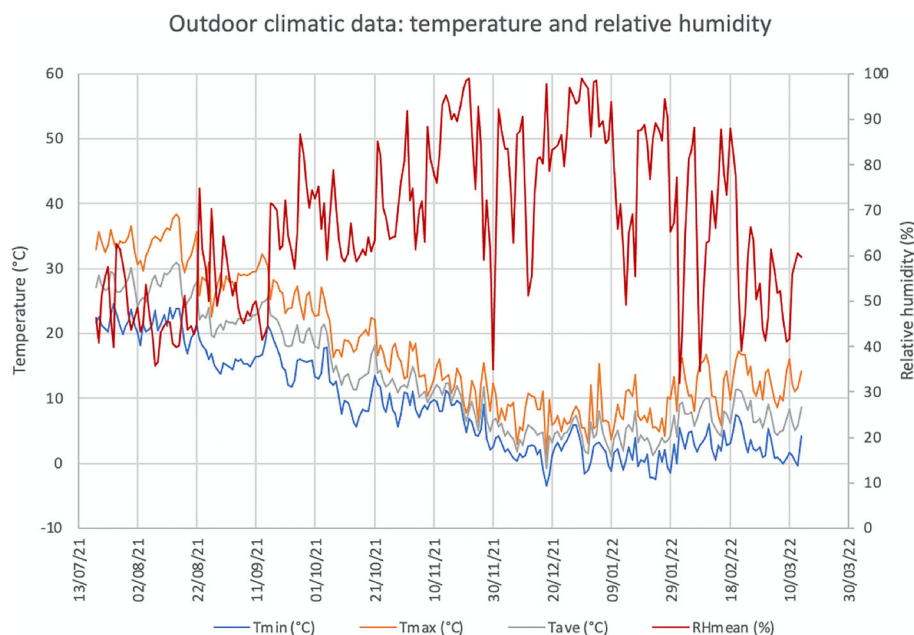
**FIGURE 13** Daily climatic data collected by the ARPAE monitoring network,<sup>53</sup> during the period of monitoring: minimum, maximum and average air temperature and average relative humidity
