Quasi-static compression tests of overwrapped composite pressure vessels under low velocity impact.

Quasi-static compression tests of overwrapped composite pressure vessels under low velocity impact

Auwalu I Mohammed¹, Kaarthikeyan Raghupathy¹, Osvaldo De Victoria Garcia Baltazar¹, Lawson Onokpasah², Roger Carvalho², Anders Mogensen², Farzaneh Hassani¹ and James Njuguna^{1*}

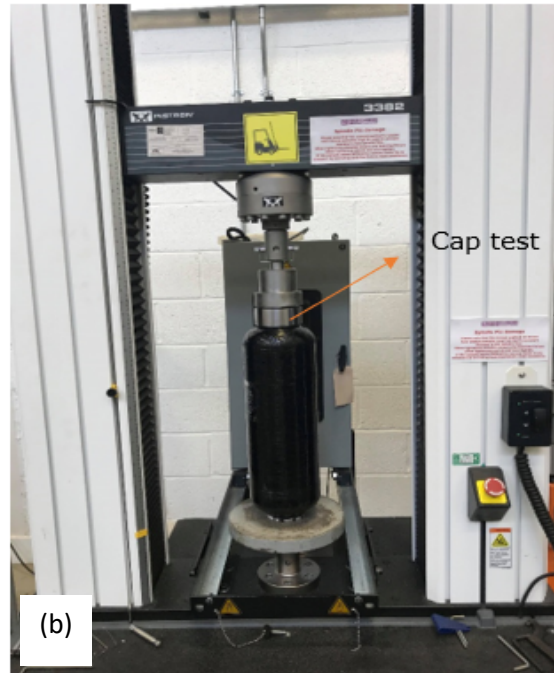
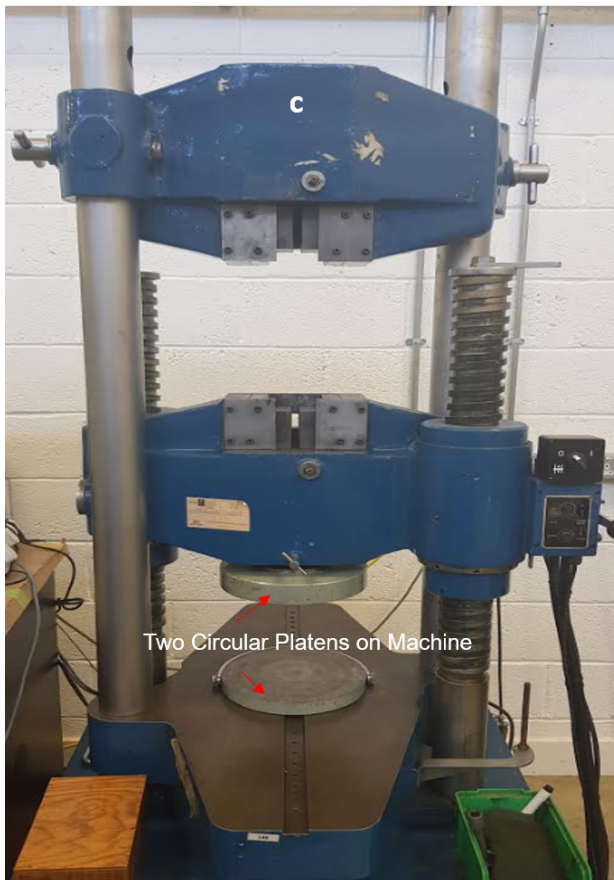
Figure 2 (a) Instron machine with the vessel ready for compression testing in the transverse (b) in the axial direction (c) Instron-XH03 equipment having a 600 kN load capacity (d) vessel in between two circular platens (e) round cut pressure vessel

The Instron device can be utilised for quasi-static indentation by applying a load at a desired speed based on either test standard or specific requirement. The samples were again visually inspected before the test and only samples with no visual damage were taken to testing. Test samples are then mounted in the test rig for compression tests as demonstrated on Figure 2. A hemispherical head with a diameter of 15 mm made of steel as shown in Figure 2b was used for the test in the transverse direction. The test simulates damage on the typical point load on the composite pressure vessels during its use, transportation, storage and in the event of other potential impact [18]. The compressed gas composites pressure vessels were mounted and supported by two V-block fixtures of 90° angle made of steel standing on a circular plate, as presented in Figure 2a to damage the pressure vessel. The Instron machine was set up to cause a static compression by applying loads of 1200 N, 2200 N, 3200 N and 4200 N at a constant speed of 500 mm/min as shown on Figure 2 under different test configurations.

Next, the indentation (puncture) compression tests were conducted according to ASTM D6264 to determine the damage resistance of the hydrogen pressure

vessels subjected to a concentrated indentation force in a set up shown in Figure 2 (a, b and d and e).

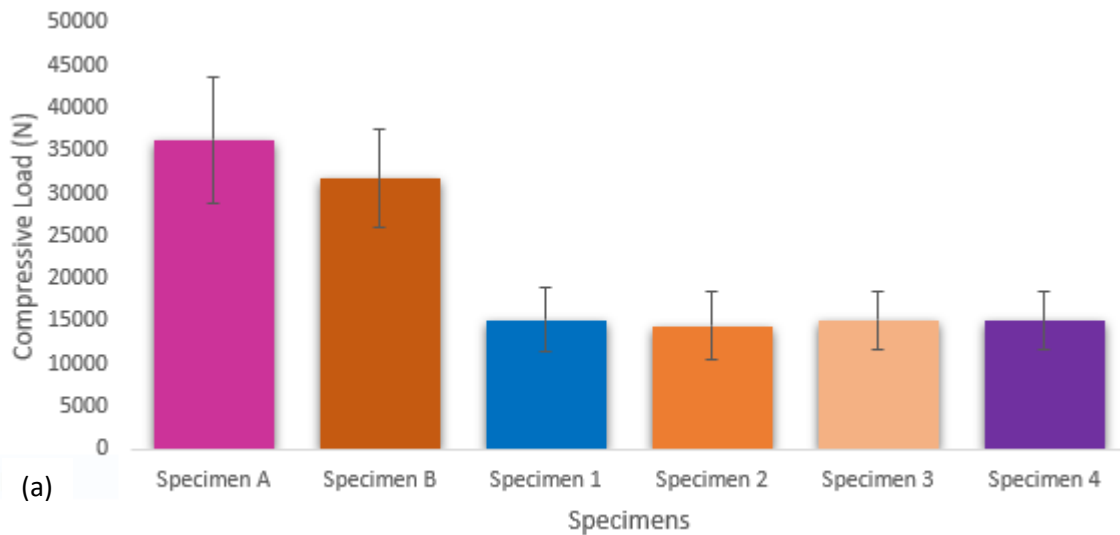
Figure 10 (a) shows that the compressive load is directly proportional to the compression applied to the specimens and the undamaged specimens tend to have a higher compressive load capacity compared to the impacted vessels. This was expected as the pressure vessels have similar physical and mechanical properties. The fibres are the major load-bearing component in the pressure vessel, the decrease in loading capacity is mainly identified by the extent of fibre damage (33). Figure 10b reveals a significant drop of 52% in loading capacity of all the impacted vessels. This is high as a result of two condition firstly the impacted vessels used had some imperfect from previous damage (Figure 2e) and secondly as a result of the current impact test.

Figure 10 (a) -Compressive Load Applied to the Specimens (b) compressive Load Percentage Change on the Specimens

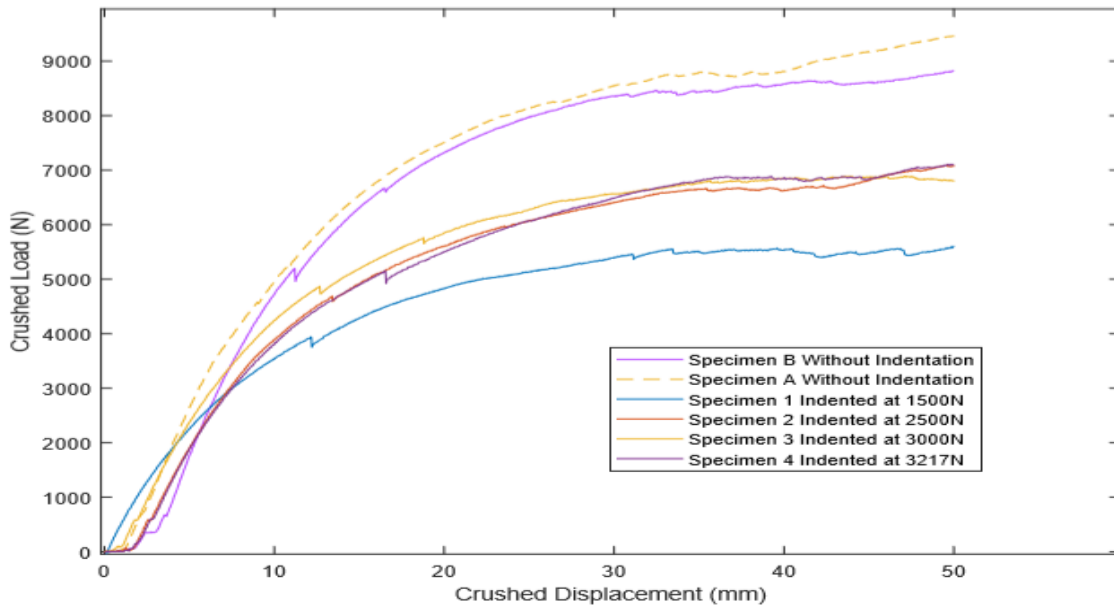
Figure 14 shows the crush load-displacement response of impacted and non-impacted vessels. For one of the non-impacted specimens (Specimen B), an initial elastic phase was observed up to 10mm displacement at which point a slope change occurred and a secondary regime of lower gradient continued up to 18mm displacement this was like the impact specimens. For specimen A (non-impacted) the elastic phase was extended up to 39mm before a slope change occurred and a secondary regime started. This could be as a result of specimen positioning in the machine. This behavior was analysed in Kim et al paper. The reason for the change of slope is as a result of the first failure which is identified as matrix cracks and delamination.

Figure 14 -Compared Crush Load-Displacement Response for with and Without Indentation Specimens

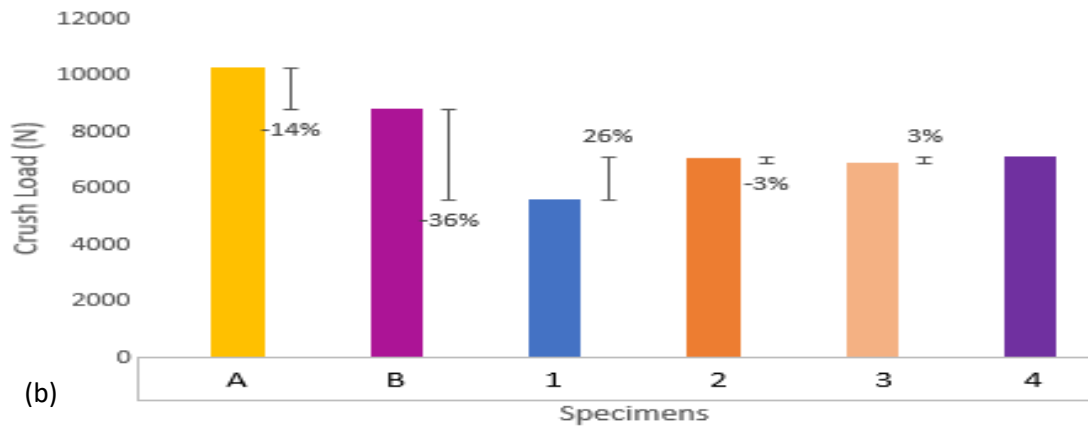
The presence of impact damage does influence the load bearing of the pressure vessel as shown in figure 15. A reduced value of the peak load can be noticed as compared to the non-impacted specimens. Also, the impact position has a significant result on the initiation of damages (the peak load), whereas its impact on the damages propagation is insignificant. Specimen 1 shows a reduced peak load compared to other impacted vessels indicating that it has damages in the crushed location.

Figure 15b reveals that specimen 1 seems to have more damage in hoop layer region as a result of its higher percentage change decrease of 36% compared to non-impacted vessel specimen B and a 26% decrease compared to another impacted vessel (specimen 2)

Figure 15 – (a) Crush Load applied to the Specimens (b) Crush Load Percentage Change on the Specimens

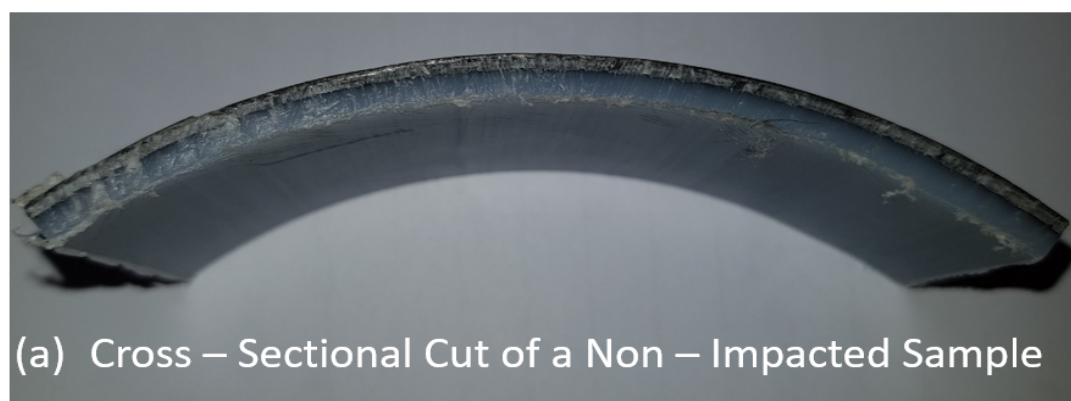
After the tests, a cross-sectional cut of one sample at the indented location with a force of 3217N (Figure 17b), and additional sample without indentation (Figure 17a), were studied by using non-destructive Micro Vickers hardness testing machine HM-200 Series. Microscopic inspection revealed details of the damage caused by a hemispherical head Indenter. There are three notable damage sustained by pressure vessels during impact, firstly fibre damage develops within the contact region (Figure 17b). The fibre cracking is shown on Figure 18a develop in the second layer in addition to that of the outer layer. In addition, Figure 18b reveals fibre debonding and lastly the overall length of fibre crack expand leading to fibre breakage (Figure 18c).

Figure 17 (a) Cross- Sectional Cut of the Indented Area (b) Cross-Sectional Cut of indented Sample

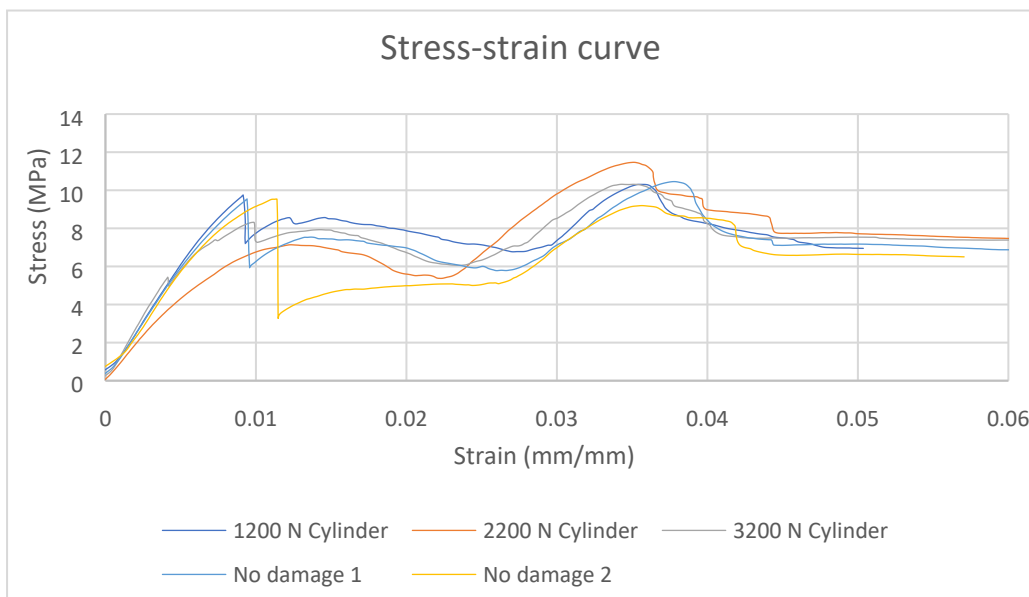
Figure 22: Stress-strain curve for the three cylinders damaged at loads of 1200 N, 2200 N and 3200 N and two cylinders without damage before the axial compression test.

Moreover, the stress-strain curve is presented in Figure 22, for the different cylinders, showing how it breaks initially and because it presents similar failure
