Sheathing and Pay Techniques in the Boa Vista 1 Ship (Lisbon, Portugal)

Abstract

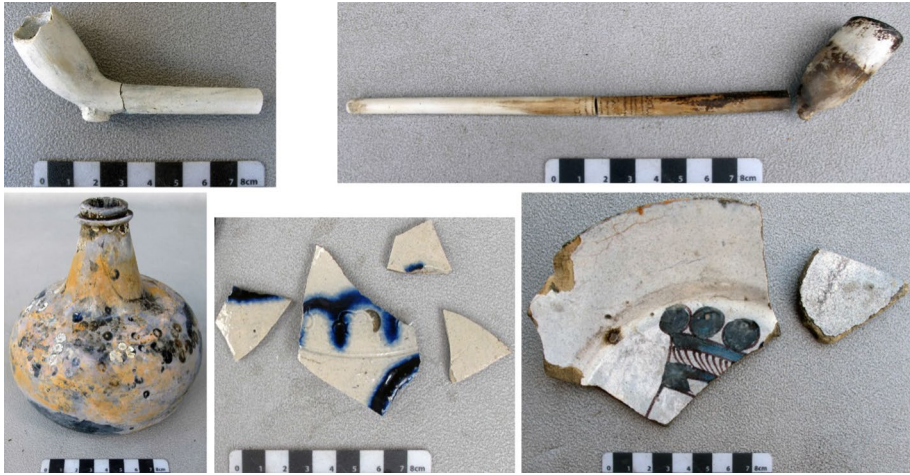
Fig. 2 Archaeological materials found above BV1 ship and therefore a *terminus ante quem* for the ship's chronology. (Adapted from Bettencourt et al. 2013, pp. 18–20)

ship were recovered during the excavation and include three pulley blocks and some associated cordage. The hull was sealed by deposits containing various materials, such as English onion bottles, Rhenish stoneware pots, Dutch and English kaolin pipes, and Portuguese faience (Fig. 2) (Fonseca et al. 2016, p. 962).

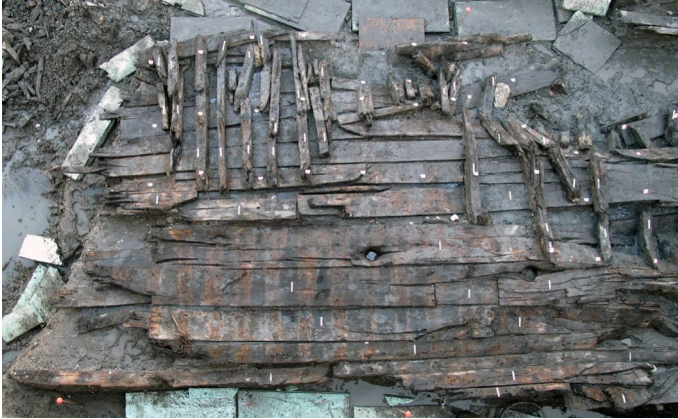
Fig. 3 Overall view of BV1 ship during the first stage of the archaeological intervention (photograph: CHAM archive)

The *Boa Vista 1* ship was preserved over a length of twelve metres, from north to south, and a width of five metres (m), from east to west. The preserved section includes the ship's stern, from the keel to the tenth strake of the planking on the starboard side and to the second strake on the port side (Fig. 3). The stern was located at the southern end, resting on the starboard side and including a terminal section of the keel, the heel, and the sternpost. A central section of the vessel, cut during previous phases of occupation in this space, was found at the northern end. The context was globally disturbed due to the placement of landfill piles dating to the eighteenth century and contaminated by naphtha, used as fuel at the Fábrica do Gás da Boa Vista. A total of 703 hull timbers belonging to the BV1 ship were recovered during the archaeological excavation. No frames were found crossing the keel;

the south-east portion of the scatter of timbers featured a chaotic assemblage of wooden elements, apparently collapsed from the starboard topsides. Thus, the only hull parts found in situ were a section of the keel, the hull planking, the sheathing, and some starboard futtocks, knees and stringers, and some fragments of Y-frames close to the heel (Bettencourt et al. 2021, pp. 101–102).

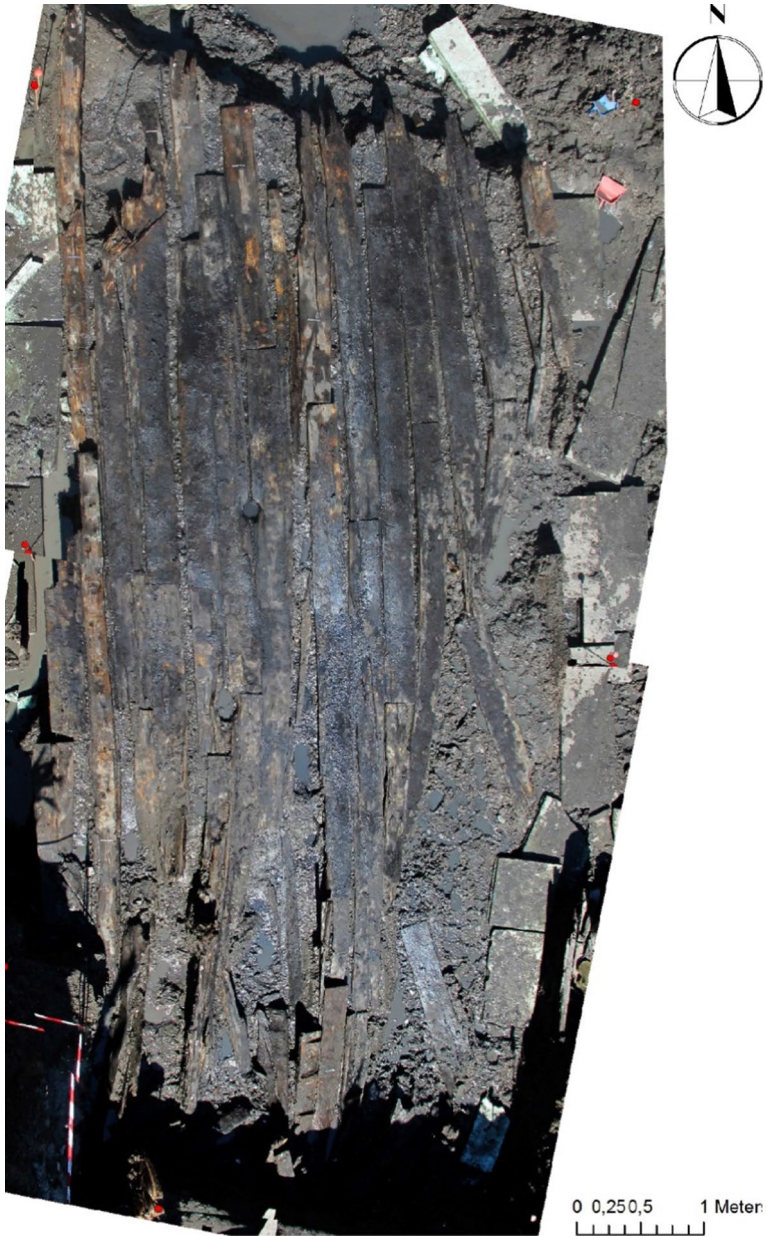
Fig. 4 The BV1 ship sheathing planks during the archaeological works (Photogrammetry: CHAM archives)

The exterior of the hull, including the keel and heel, was protected with a layer of wooden sheathing, consisting of 146 sheathing planks (Fig. 4). The length of the complete planks varies between 1.66 and 4.19 m, with widths between 20 and 28 cm and thicknesses between 2 and 3.5 cm. The sheathing was fastened mainly along the edges of the planks with small iron nails, with shafts squares in section measuring 0.5 to 0.7 cm in section and with the round heads measuring 1 to 1.3 cm in diameter. The nail heads were countersunk in the planks via pre-drilled fastening holes 2 to 3 cm in diameter. The nails were driven through the planks and probably correspond to the sheathing–hull planking–framing connection. As previously mentioned, small square wooden wedges, 1 cm in cross-section, were observed, which must have been provisionally used when the sheathing was being fitted, since they were driven from the outer face of the sheathing, crossing its entire thickness and ending in the middle of the hull planking (Bettencourt et al. 2021, pp. 104–105).

A layer of animal hair, 0.5 to 0.8 cm in thickness, was placed between the hull planking and sheathing planks, as well as between the keel/heel and sheathing. In some cases, there were circular holes 2.5 to 3.2 cm in diameter, crossing the whole thickness of the planks but not leaving any negative marks on the hull planking. Animal hair mixed with mud and naphtha, which covered the whole context, was also observed inside the holes. These orifices probably existed in all the sheathing elements, since the complete planks have two, and in some cases three such holes, while in the incomplete planks there is only one, or even just traces of one in the most fragmented planks, hence the conjecture. These holes were always placed in the same area, between 30 and 50 cm from the planks' ends.

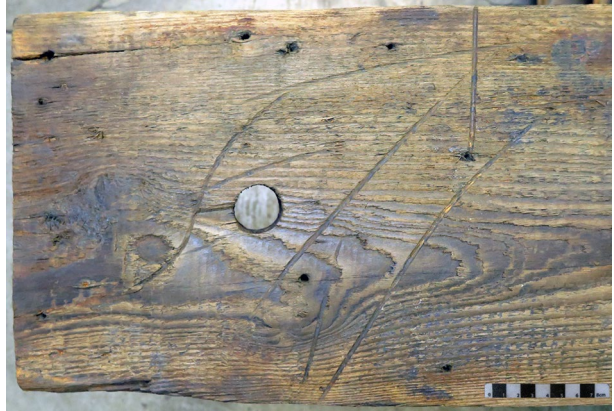
Fig. 5 Incised marking on inner face EDP_0247 sheathing plank (photographs by the authors)

Seven sheathing planks have incised markings (Fig. 5) of unknown meaning, but which could be the mark of the owner or of the naval carpenter who carried out the felling of the trees. The mark is always the same and is placed on the inside of one of the planks.

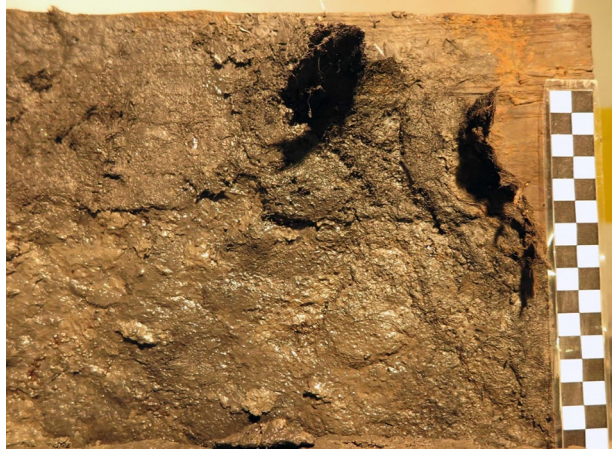
Fig. 7 Horse hair found between BV1's sheathing and hull planking (photographs by the authors)

During the individual cleaning and recording of BV1's hull timbers, dozens of hair samples were taken from the area between the hull planking and the sheathing (Fig. 7). These samples were analysed at the Centre for Ecology, Evolution and Environmental Changes (cE3c) of the Faculty of Sciences of the University of Lisbon, where there is a working group dedicated to the study of wolf ecology and conservation, focusing on predator/prey relationships. According to the known historical sources for the period concerned in the present study, the animals whose hair was mostly used for sheathing vessels were goats, sheep, cows, oxen, and horses. In other words, their common feature is that they are potential prey for wolves. Combining all these premises, we considered that a partnership would make sense, to identify the animal hair used in BV1 ship, and so it was. The samples were identified as horse hair.
