Characterization of low temperature high voltage axial insulator breaks for the ITER cryogenic supply line

P Fernandez Pison^{1,2}, S Sgobba¹, I Aviles Santillana^{1,2}, S A E Langeslag¹, M Su³, R Piccin³, J Y Journeaux³, A Laurenti³ and W Pan⁴

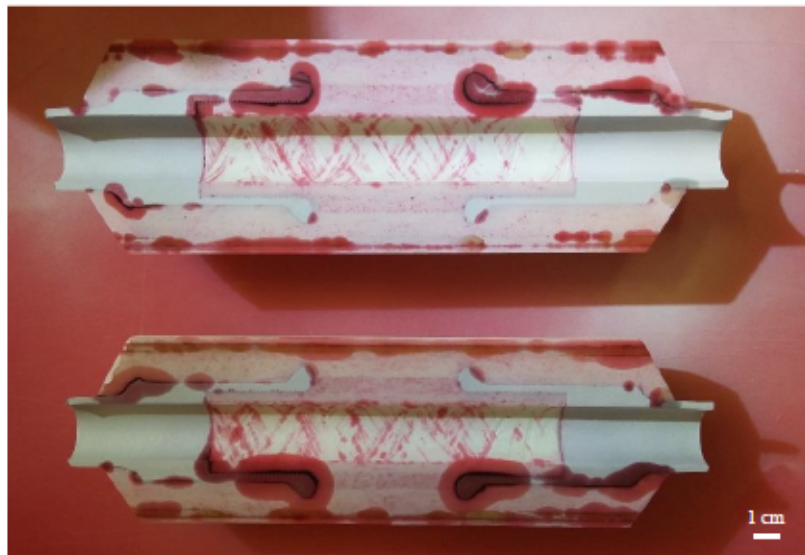
3.1.2. Penetrant Testing (PT). Both halves of the individual IBs were examined by dye penetrant testing, Type II (visible dye) method A (water washable) according to ASTM E1417. PT was applied before performing further cross-sectional cuts. For both tested IBs, 20 minutes after the developer was applied (solvent-based white-powder penetrant developer), very pronounced linear indications were observed. They were mainly located at the stainless steel to composite interfaces and in the GKG insulation layers, which agree fairly well with the location of the imperfections observed in the axial inspection. The large amount of dye penetrant observed in some regions revealed deep discontinuities associated to the respective indications. Figure 8 shows the results obtained for IBDH109.

Figure 8. IBDH109 after application of developer. Dwell time: 20 minutes.

In both axial and radial planes several cracks and discontinuities were observed (figure 5 to figure 9), being of a considerable depth for most of them as revealed by PT. This confirms that although the observations were carried out in a single cross section per direction (axial and radial), the imperfections extend within the bulk. The most critical defects for both individual IBs were observed around the stainless steel fittings, towards the interface between them and the composites. Due to their axial orientation and their location, these discontinuities seem to have been induced by the hundred thermal cycles to liquid nitrogen to which the IBs were submitted prior to destructive examination. They are likely a consequence of high stresses induced by the difference in thermal expansion coefficient between the dissimilar materials. However, these cracks do not form a continuous network along the interfaces, and therefore they do not impair the strength and the leak tightness of the assembly [5]. Another critical region where imperfections were observed is the GKG insulation layers, which showed less soundness for IBDH251 compared to IBDH109. In general these imperfections present an ellipsoidal shape and did not evolve into long imperfections. They are generally small and their geometry is more favorable than elongated defects such as sharp cracks in terms of stress concentration.
