Mapping of stones and their deterioration forms: the Clock Tower, Venice (Italy)

Keywords *Torre dell'Orologio*, Ancient stones and marbles, Deterioration forms, Weathering, Total Deterioration Rank

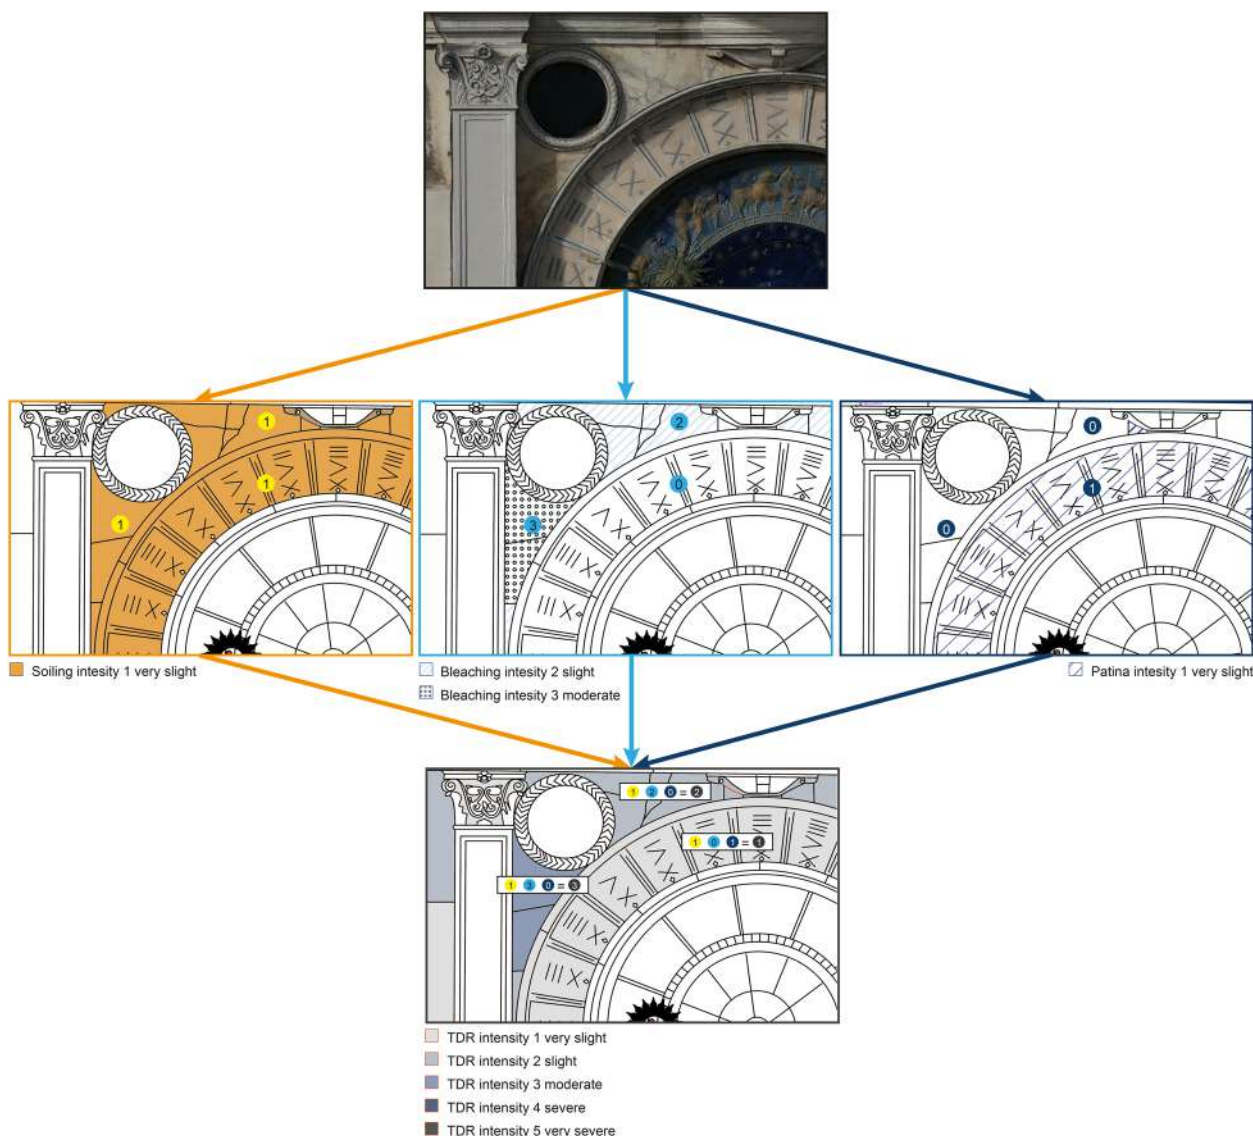
Fig. 2 Illustrative scheme of the procedure followed for the attribution of the TDR

To summarise, a specific map was produced for: (I) lithologies; (II) each group of deterioration processes and forms (a total of five maps); (III) Total Deterioration Rank (TDR). The latter is an attempt to produce an overview map which shows the general conservation condition of the building. The TDR value was obtained by taking into account all the deterioration patterns that can be observed contemporaneously on the same elements of the building, and attributing the highest of the values ascribed to the deterioration forms observed (Fig. 2). The legend for each map includes, where necessary and in addition to the colour selection, a series of patterns created specifically for each intensity (Table 1); this proved useful where the overlapping of different deterioration typologies made drawing and reading the map difficult. Small differences (such as the slope of stripes and colour) were provided to the patterns to facilitate distinction of the different subcategories in each thematic map.

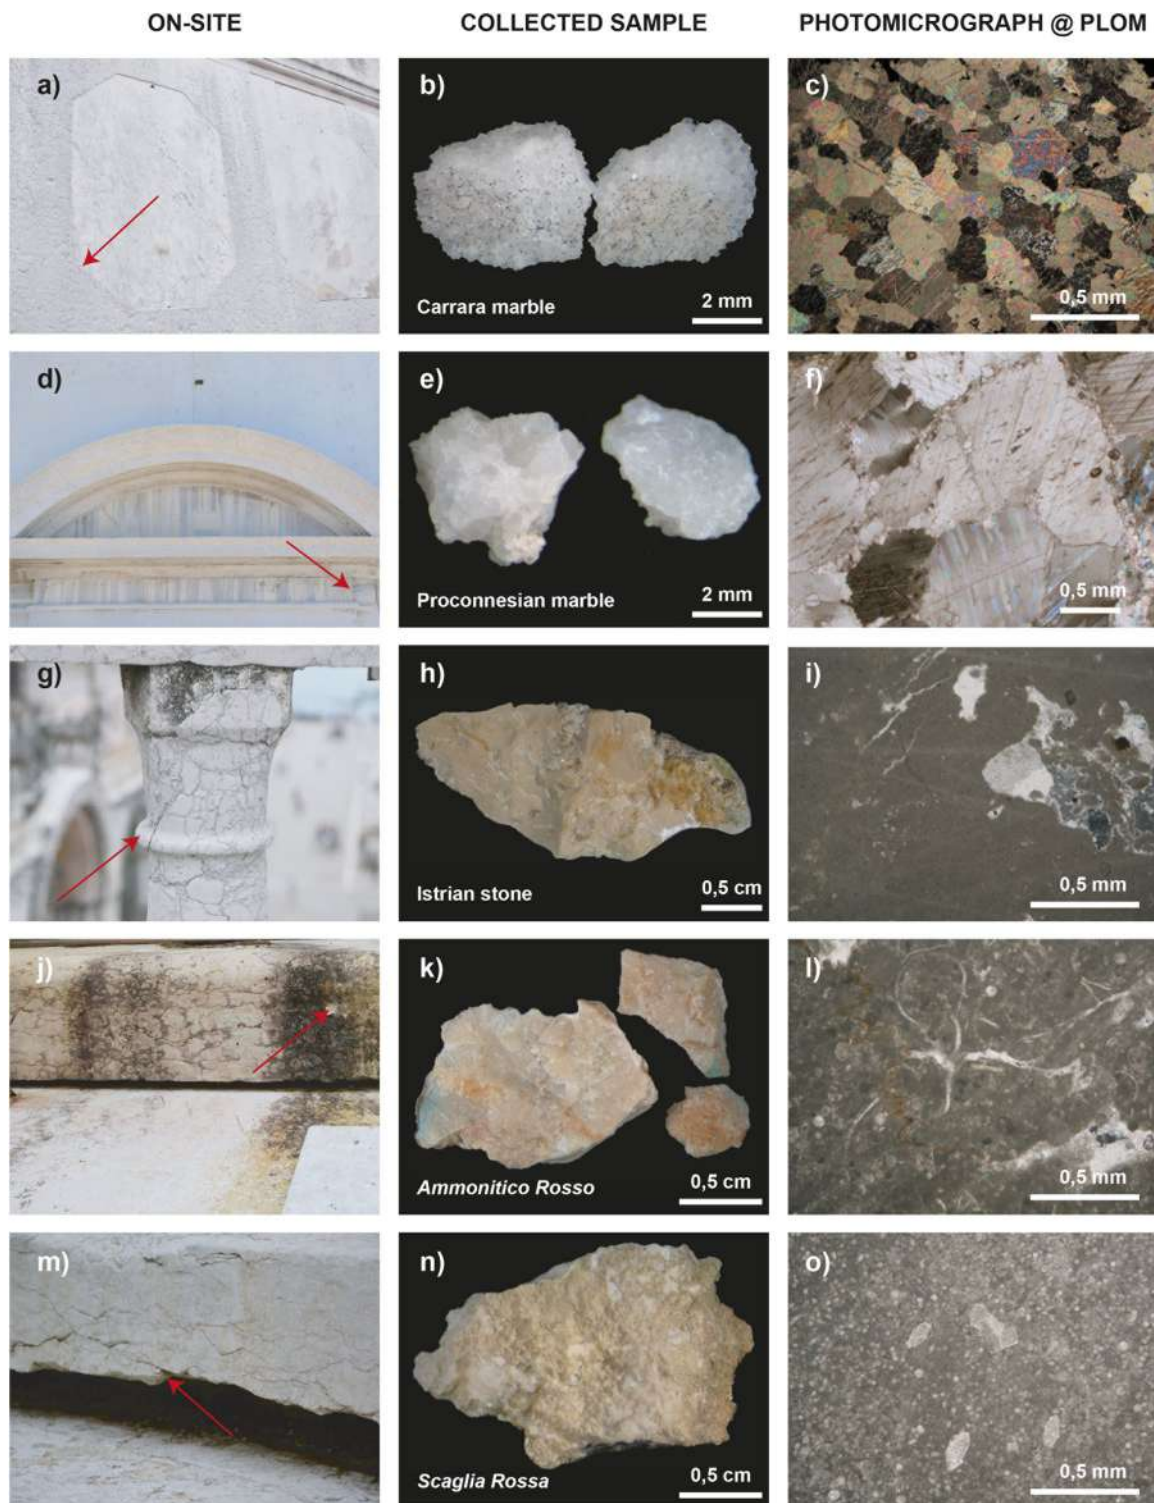
Fig. 3 Sampling points (red arrows), stereomicroscope photos, and transmitted polarized-light microscope microphotographs (crossed-polarised light) of: sample 2E, Carrara marble (a–c); sample 9W, Proconnesian marble (d–f); sample 5E, Istrian stone (g–i); sample 2N, Ammonitico Rosso from Verona (j–l); sample 1N, Scaglia Rossa (m–o)

This stone (samples 2E, 1S) corresponds to a pure calcite (sometimes partially dolomitic) fine-grained marble with isotropic fabric and Grain Boundary Shapes (GBS) mainly straight, in a homeoblastic and polygonal mosaic microstructure made of calcite crystals often forming triple points (120°). The Maximum Grain Size (MGS) is 0.36 mm. The few accessory minerals observed are pyrite, graphite and quartz (Fig. 3a–c), the latter also detected by XRPD analysis, as well as a limited amount of dolomite (Table 3). These petrographic features identify this material as *Carrara* marble, from the Italian Apuan Alps [23].

Another calcite marble is present (sample 9W), showing heteroblastic fabric, mortar microstructure and GBS mainly sutured and, secondarily embayed. It is a coarse-to medium-grain marble with MGS around 4.50 mm. The mineralogical composition comprises calcite with graphite as accessory mineral (Fig. 3d–f). XRPD analysis shows predominant calcite and rare quartz (Table 3). The samples are recognizable as Proconnesian marble fragments from the Island of Marmara [23].

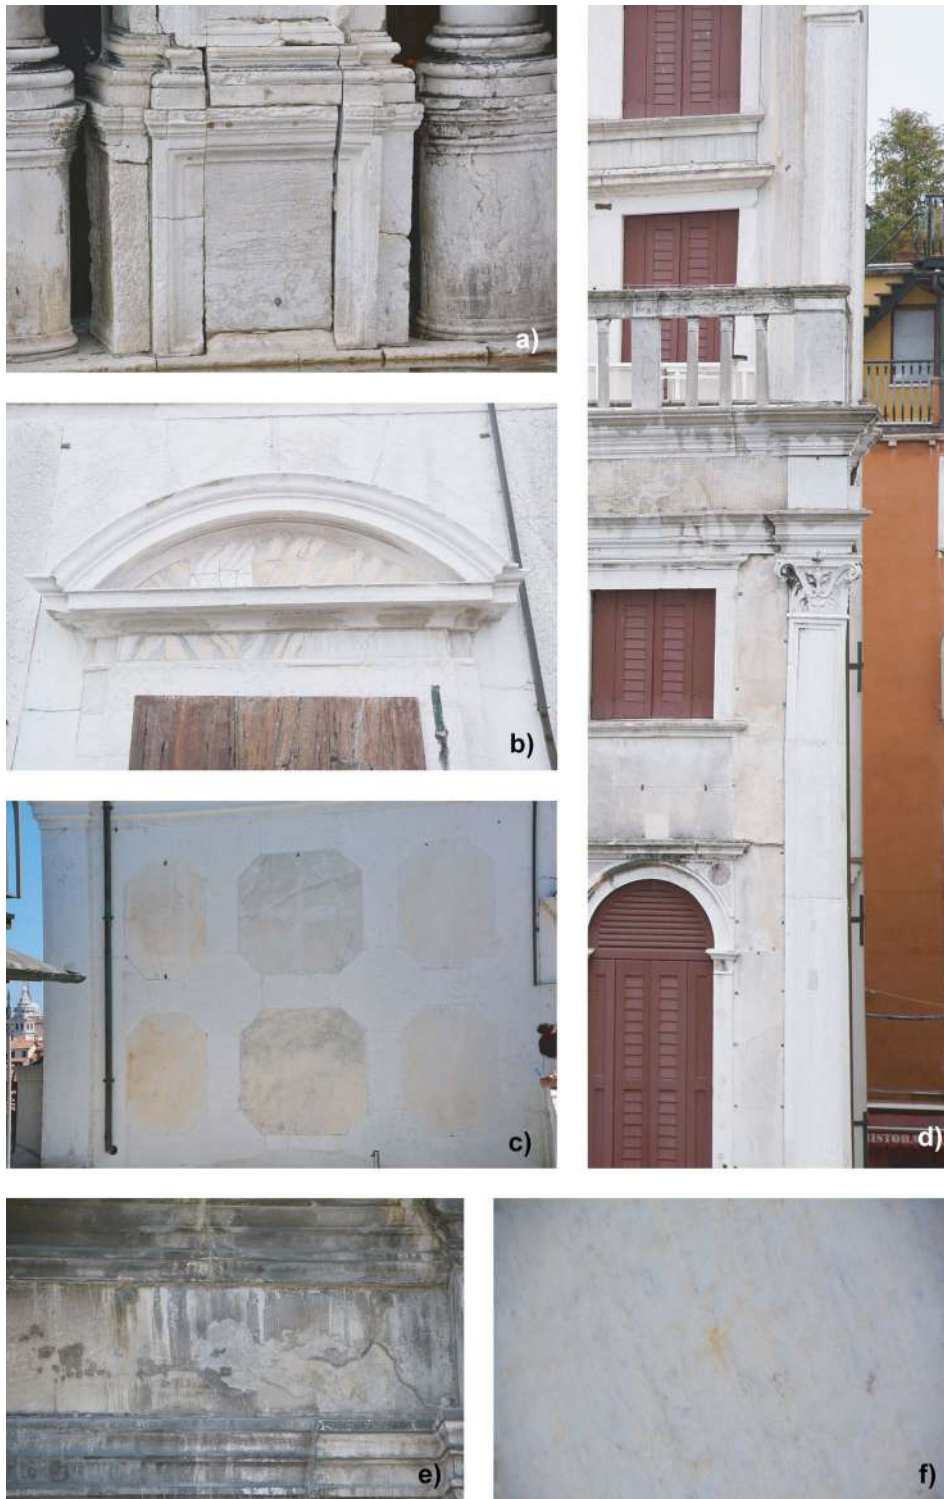
In this group the most abundant morphologies are due to cracks, more specifically fractures (Fig. 4a, b), with deterioration level (DL) value between 1 and 2. The façade more afflicted by this phenomenon is on the southern side (Fig. 5a). Following, morphologies related to deformation, mainly as a bowing phenomenon (i.e., a convex deformation essentially due to thermal shocks) affect the median section of the marble slabs in particular and show DL 1 to 2 (Fig. 4c). The latter deterioration pattern is more evident on the eastern façade. A more intense deformation (DL 3) affects the extreme NE *lesene*, where one stone block appears to be slightly tilted (Fig. 4d).

Fig. 4 Crack and deformation: **a** fractures on a pillar base (southern façade), and **b** on the marble slabs decorating the doorframe arch (eastern façade); **c** faint convex deformation on marble slabs (western façade); **d** lesene deformation (southern façade). Detachment: **e** blistering phenomena (southern façade); **f** sugaring phenomena on marble slabs (western façade)

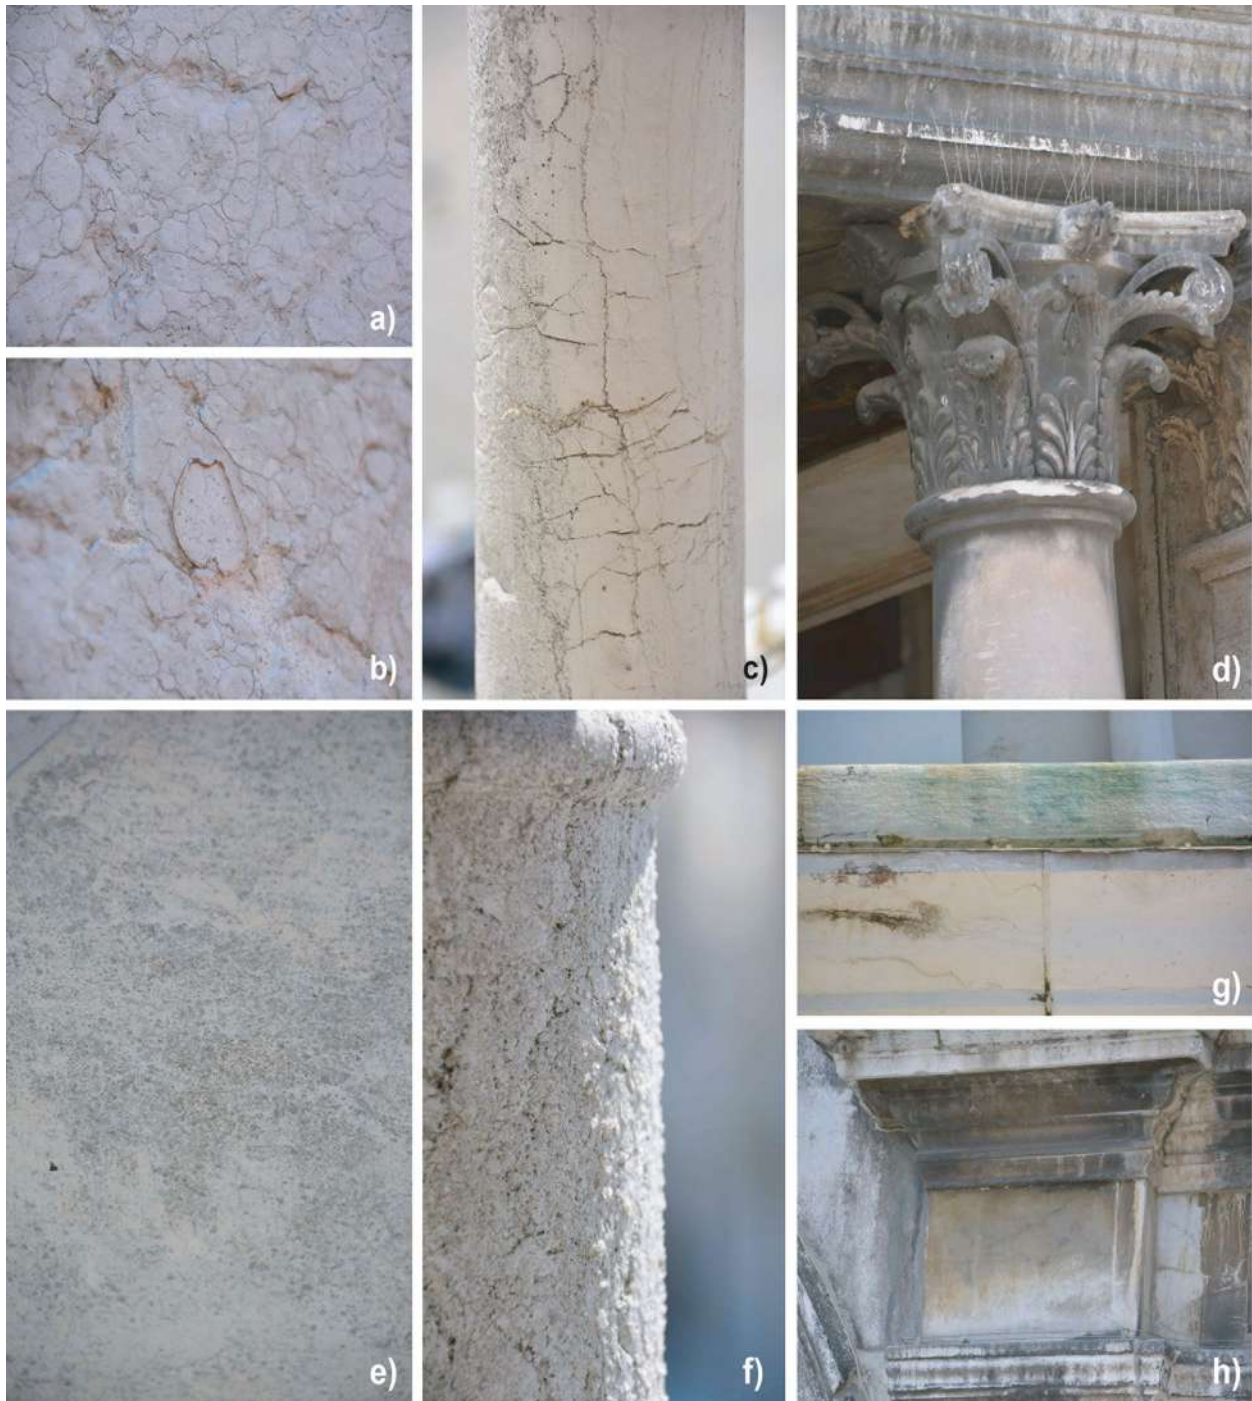
The mapping revealed that the main forms belonging to this group are differential erosion with a DL of between 1 and 2, in particular as a consequence of a greater recession rate (due to a dissolution effect) of the fine-grained calcite portions of limestone (Fig. 6a, b) with respect to those with average-to-coarse grained carbonate. This decay morphology is more common in the eastern and western façades (Fig. 7a). Microkarst of slight intensity (DL 2) is also present, affecting all the small columns of the balustrades in Istrian Stone (Fig. 6c). Finally, missing parts with an intensity varying between very slight and very severe (DL 1 to 5) were identified; in particular, some *rotae* of *Fior di Pesco* are partially or completely missing.

Fig. 6 Features induced by material loss: **a, b** differential erosion on *Ammonitico Rosso* from Verona slabs (eastern façade), **c** microkarst on Istrian Stone small columns (western façade). Discoloration and deposit: **d** black crusts on Istrian-stone Corinthian capitals (southern façade); **e** soiling on Scaglia Rossa slabs (western façade); **f** efflorescence on Istrian Stone small columns (western façade); **g** greenish staining on Istrian Stone (western façade); **h** yellowish patinas (southern façade)

On the other hand, staining creates greenish and reddish localized halos due respectively to the dispersion of copper from the statues of the Moors (Fig. 6g), and iron products (mainly hydroxides), deriving from the weathering and dispersion of metallic elements of inserts. The elemental mapping by SEM–EDS of samples with macroscopically green surface deposits revealed the presence of Cu, Cl and Na (Fig. 8g, h). The DL values of this

decay product range from 1 to 3. Another type of deposit is represented by efflorescence which appears mainly as whisker-like crystals (Fig. 6f) of very slight and slight intensity (corresponding to DL 1 and 2, respectively) on the surface of the small columns of the balustrades (Fig. 7b). Table 4 lists the anions detected by IC that identify the main salts constituting the different types of efflorescence. The samples were tested for all the following ions: fluorides, chlorides, nitrites, bromides, nitrates, phosphates, sulphates, lithium, sodium, ammonium ion, potassium, magnesium, calcium. The main contents are of chlorides and sulphates for the anions, and sodium and calcium for the cations, compositions that are consistent with halite (NaCl) and gypsum (CaSO₄·2H₂O) crystallizations. In addition, sample 5E showed a significant amount of magnesium, which could be linked to the presence of dolomite (Ca,Mg(CO₃)₂), a Mg and Ca carbonate, in this sample, as also indicated by its XRPD (Table 3). Finally, all the samples show significant calcium content, which can easily be linked to the carbonate nature of most of the samples and/or their stone substrates.

Patinas, resulting from the ageing of ancient treatments, appear as a yellowish colour alteration of crystalline marble slabs and columns/pilasters (Fig. 6h). The DL values of this decay product range from 1 to 3. The study performed by FTIR compared with EDS elemental mapping enabled the nature of the past treatments applied on the marble columns to be determined with great accuracy. The abundance of fluorine diffused in the superficial micro-cracks and detected by EDS (Fig. 8i, l), combined with the recognition by FTIR of an acrylic-siloxane mixture (3432 cm⁻¹ due to ν Si–OH, 2959–2928–2873 cm⁻¹ related to ν C–H chemical bond, 1737 cm⁻¹ linked to ν C=O, 1260 cm⁻¹ related to ν Si–(CH₃), 1161 cm⁻¹ linked to ρ C–H and

Finally, soiling is the most widespread deterioration morphology in the whole building (Fig. 6e). It appears as a tenuous blackish-grey layer (DL between 1 and 4) that confers a dirty appearance to the stone.

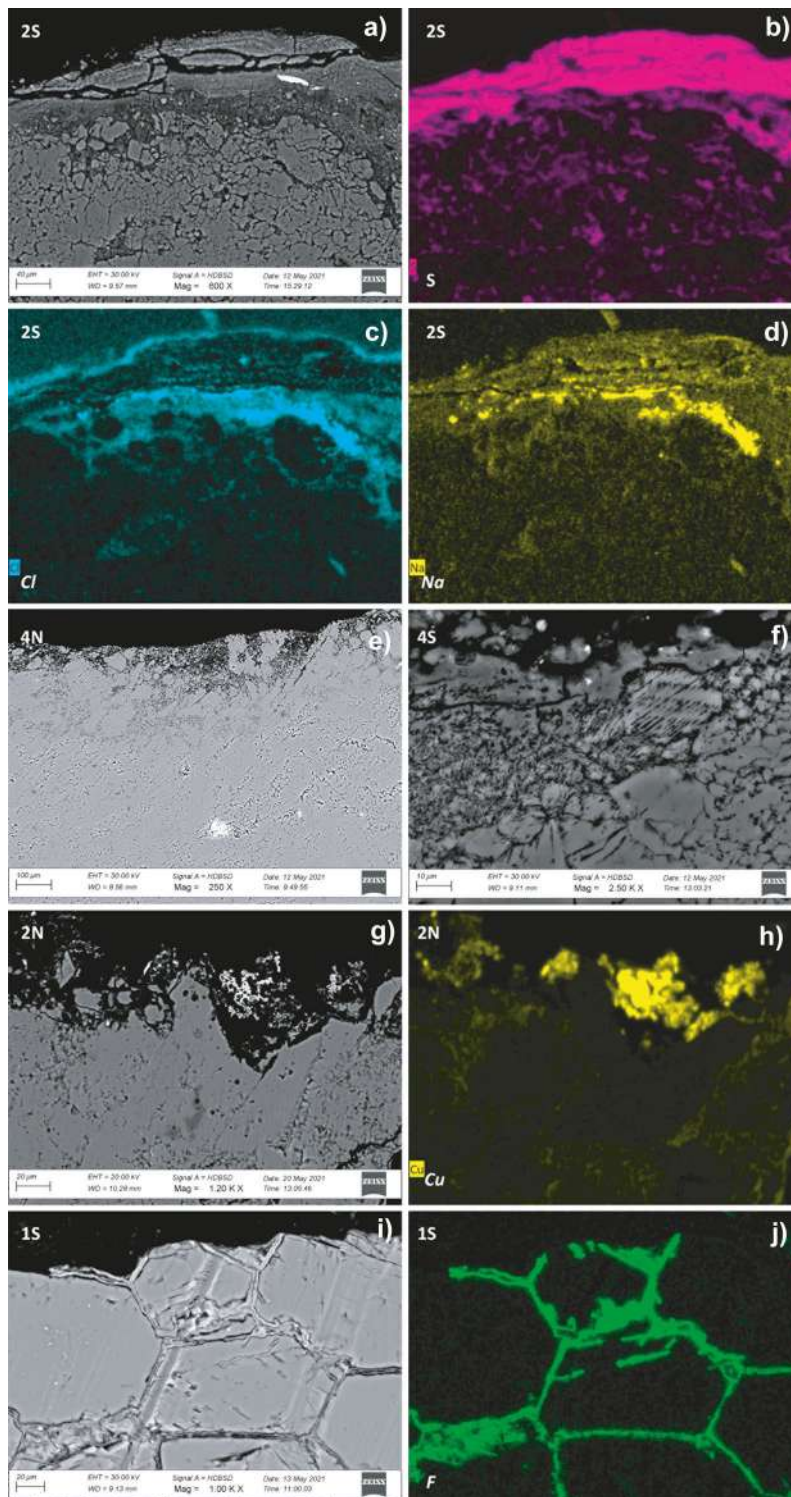
Fig. 8 **a** SEM-BSE image of the black crust in sample 2S, and elemental distribution maps of **b** sulphur (S, pink), **c** chlorine (Cl, light blue), and **d** sodium (Na, yellow); **e** SEM-BSE images of sample 4N where discoloration phenomenon are displayed; **f** SEM-BSE images of sample 4S showing micro-cracks in the surface crystals; **g** SEM-BSE image of staining deposits in sample 2N, and elemental distribution map of **h** Cu (copper, yellow); **i** SEM-BSE image of past treatment residue in sample 1S, and elemental distribution map of **j** F (fluorine, green)

SEM-BSE images obtained from extensive SEM investigations revealed peculiar micro-damage patterns in the Carrara marble samples from the ground floor columns. These are micro-cracks concentrated only in the superficial crystals clearly guided by the cleavage planes of the mineral (Fig. 8f).

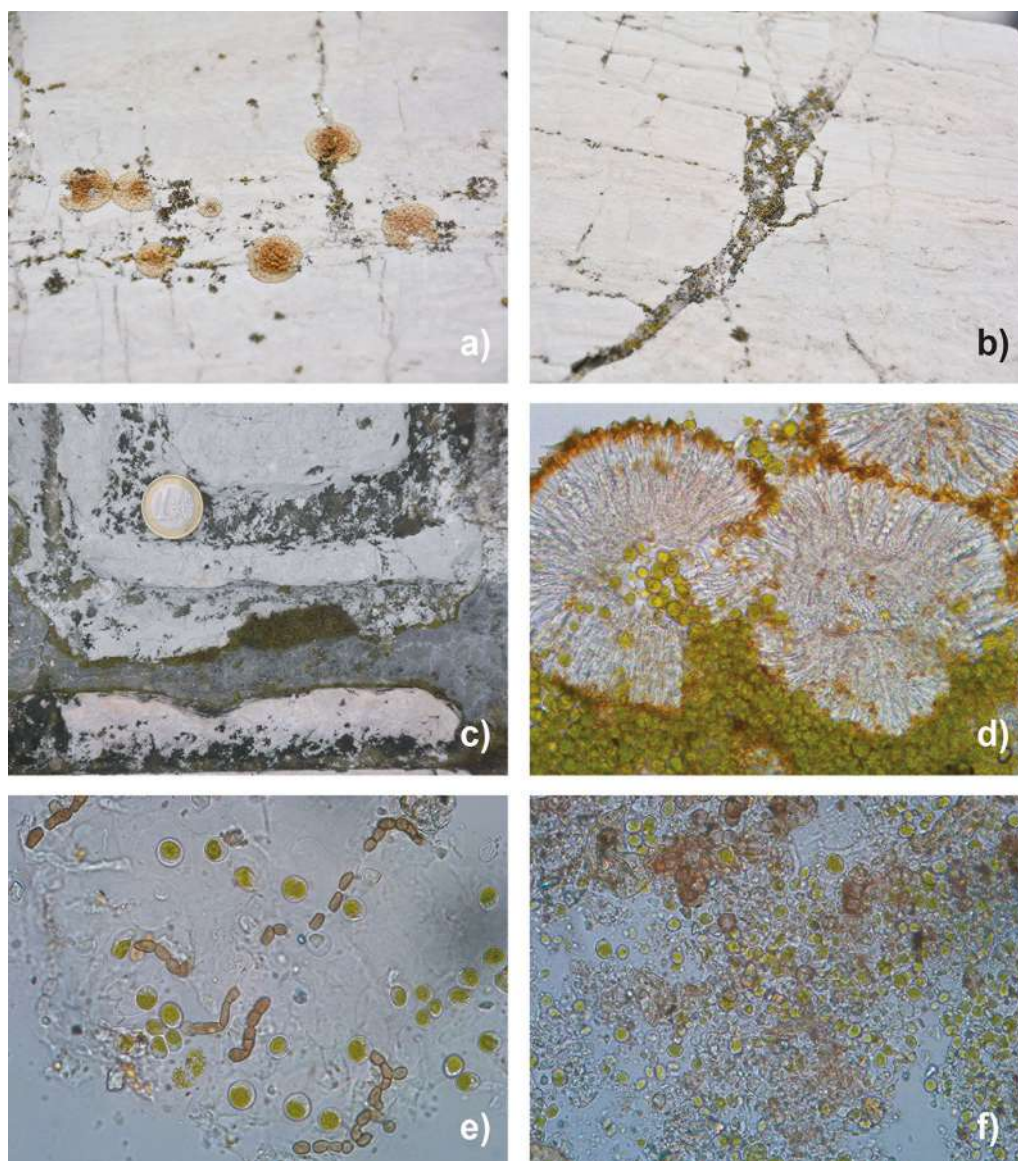
Fig. 9 **a, b** Lichen and fungus colonization (western façade); **c** moss colonization (eastern façade); **d** optic microscopy microphotographs of fresh slides of sample 9E showing lichen apothecia in cross-section; **e** optic microscopy microphotographs of fresh slides of sample 3W showing hyphae of meristematic fungi and cells of green algae; **f** optic microscopy microphotographs of fresh slides of sample 1W green algae cells, cyanobacteria colonies and a few fungal hyphae.

The colonization of lichens and fungi (DL between 1 and 2) is mainly found on Istrian Stone (Fig. 9a, b) with homogeneous distribution on the three façades (Fig. 10). Rarely, mosses were identified and when present are visually impactful (Fig. 9c); they were found mainly in the walkways between the balustrades of the two wings of the building so they cannot be mapped on the elevations. More in detail, five different microorganisms were detected by OM investigation, as follows below.
