Living Shoreline Design Guidelines for Shore Protection in Virginia's Estuarine Environment

Version 3.0

Special Report in Applied Marine Science and Ocean Engineering #473

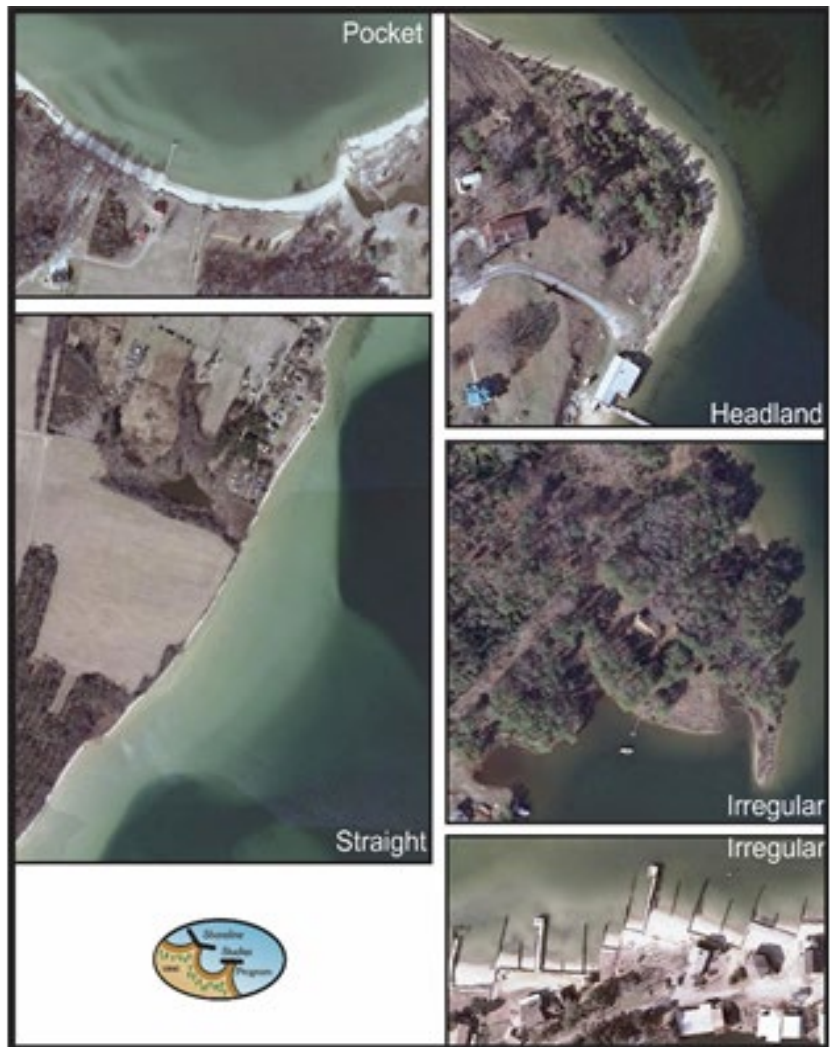
Figure 2-2. Photo illustrating four different kinds of shoreline morphology in Chesapeake Bay. Photos: VGIN 2009.

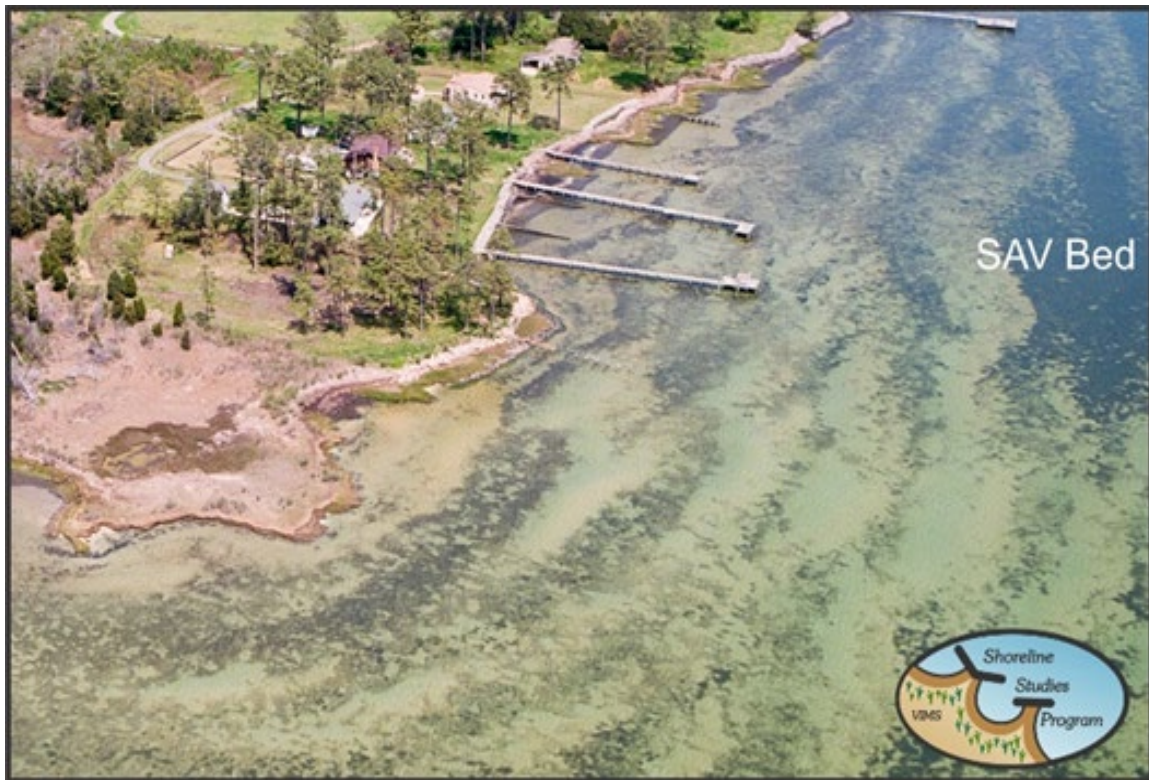
Figure 2-5. A VIMS aerial photo of Pond Point on the East River in Mathews County, VA (dated 21 April 2009) showing extensive SAV in the nearshore, as well as sandbars.

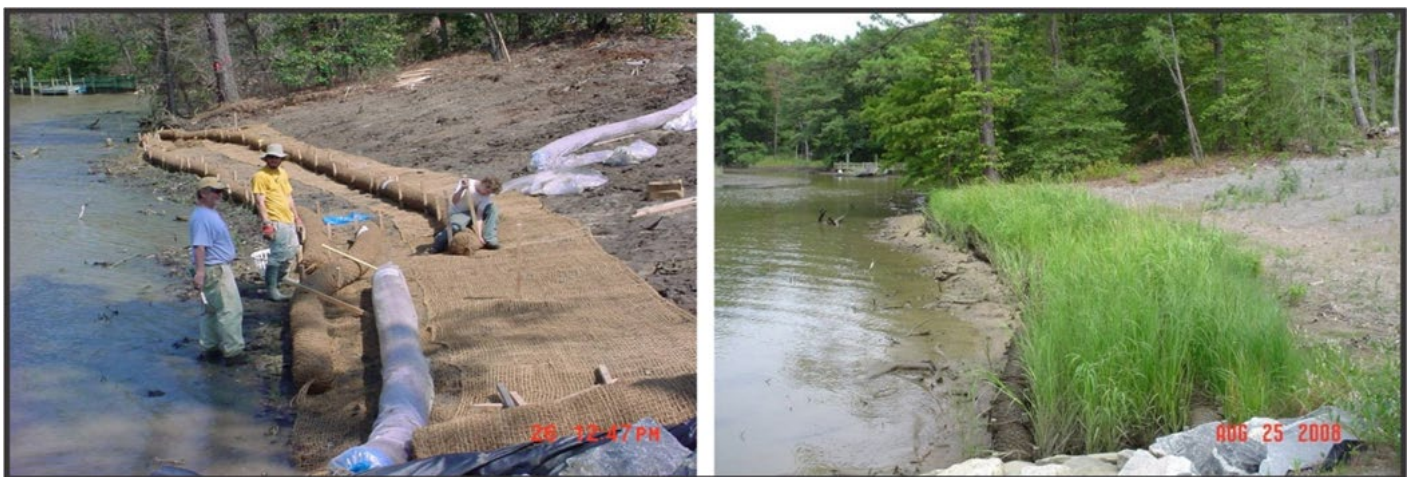
Figure 3-3. Coir logs and mats placed at toe of a graded bank for temporary stabilization while planted tidal marsh and riparian buffer become established. Photos by P. Menichino.

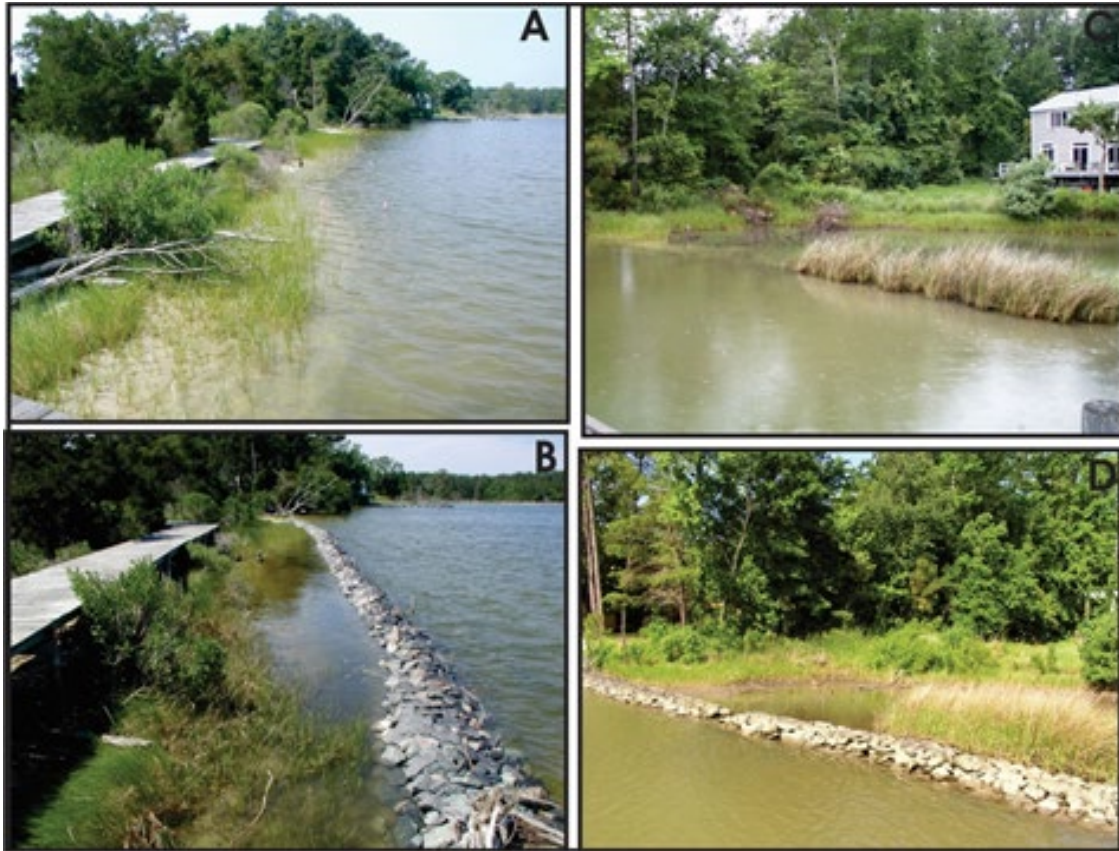
Figure 3-6. Photos showing marsh toe revetments A) before and B) after a project on Cranes Creek in Northumberland County and C) before and D) after a project on Mosquito Creek in Lancaster County, Virginia.

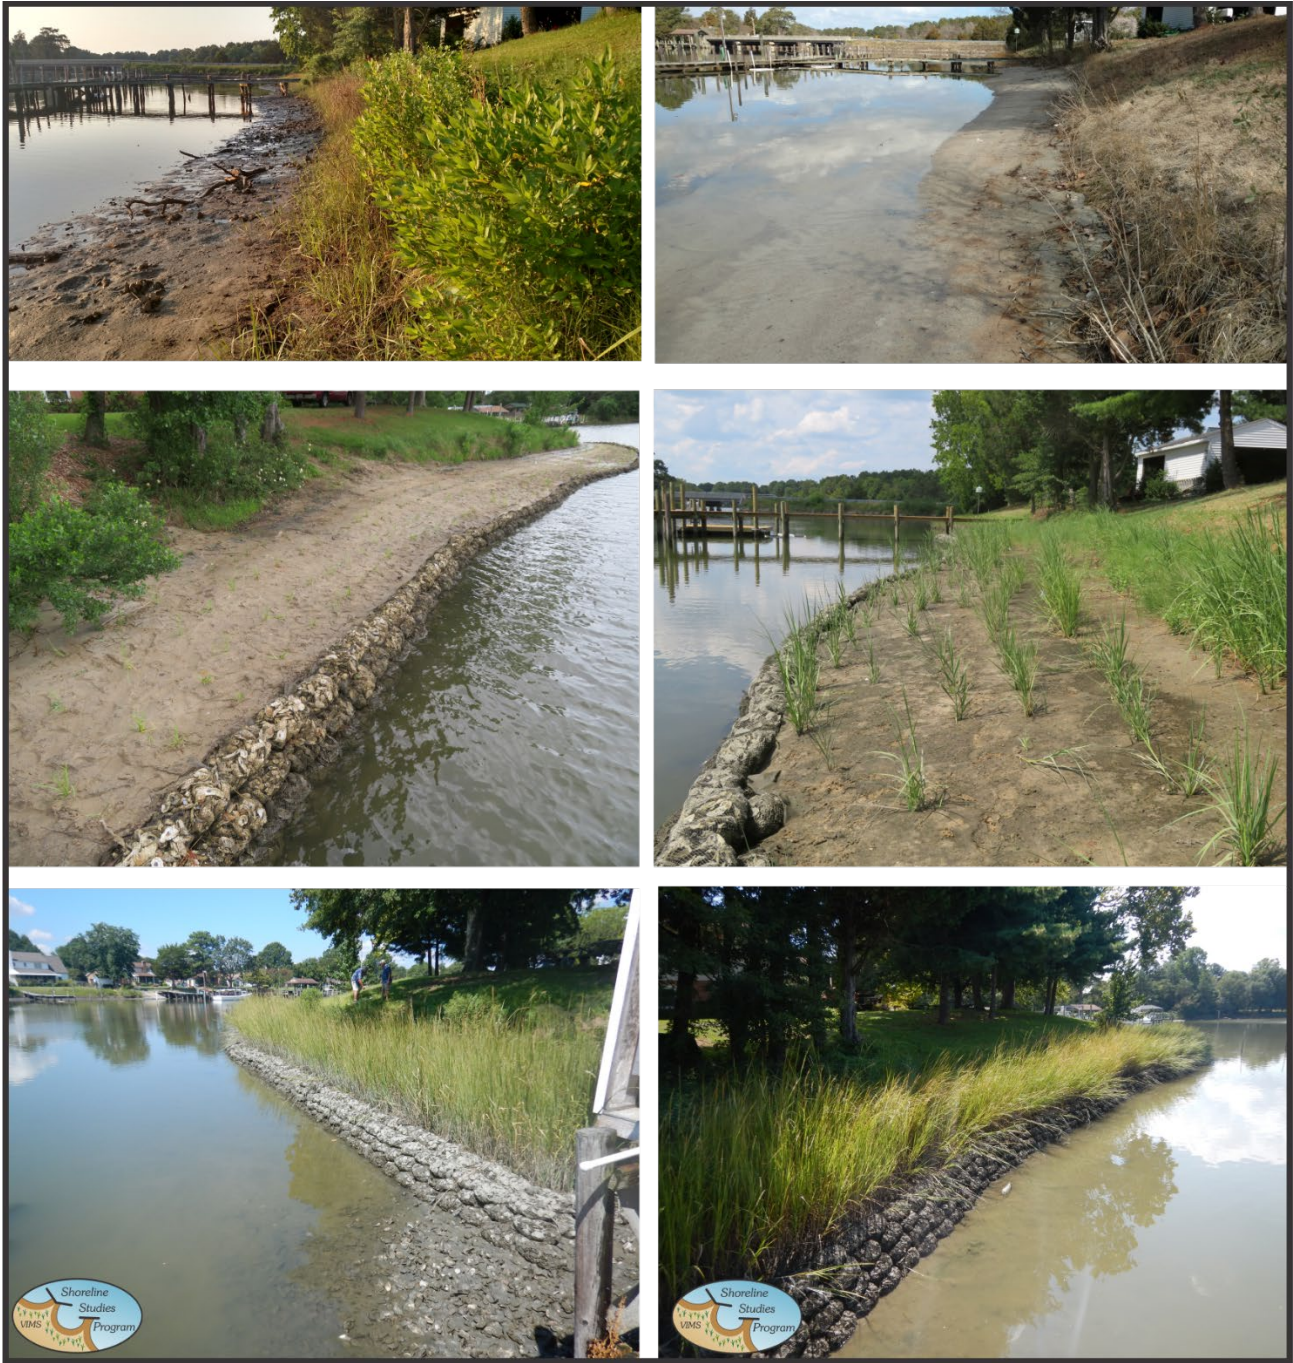
Figure 3-7. An example of the construction of oyster reef bags with sand fill and marsh grasses planted behind the structures. Top left: Shoreline prior to the project on 26 May 2016; Top right: after the sand fill was placed May 2017; Middle left: after bags were placed in May 2017; and Middle Right: after the grass was planted in July 2017. Photo credit: Walter Priest.

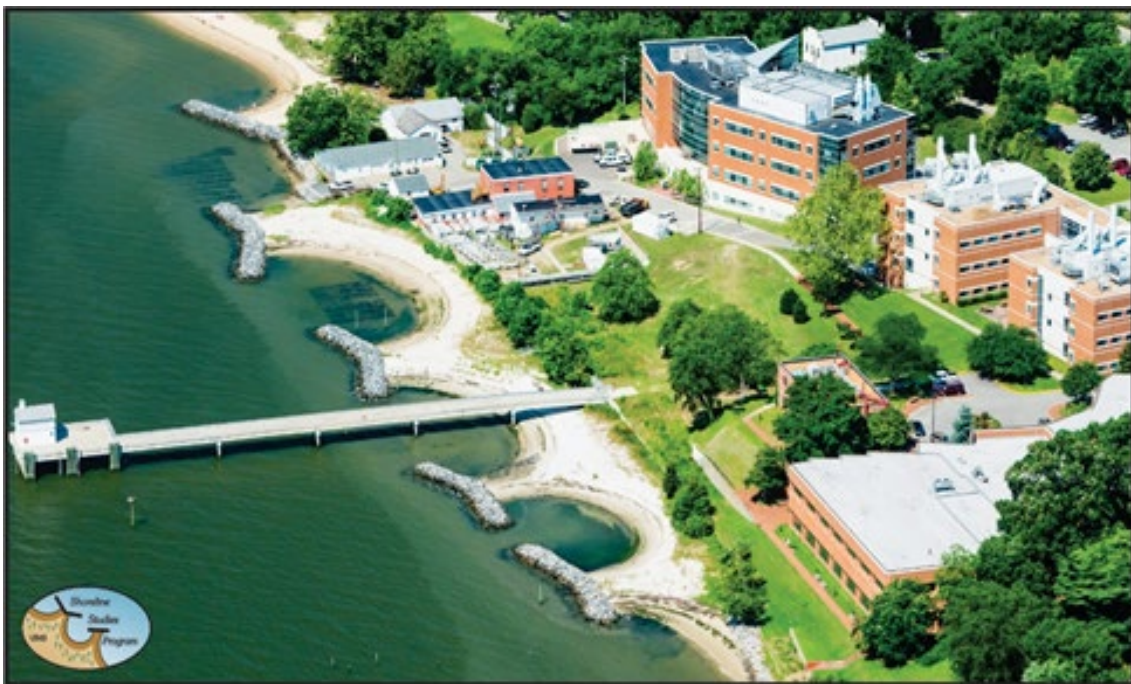
Figure 3-8. Aerial photos of breakwaters at the Virginia Institute of Marine Science campus on the York River. While the physical characteristics of breakwater sites differ, the goals are the same: protect the upland bank/marsh with a wide recreational/ protective beach.

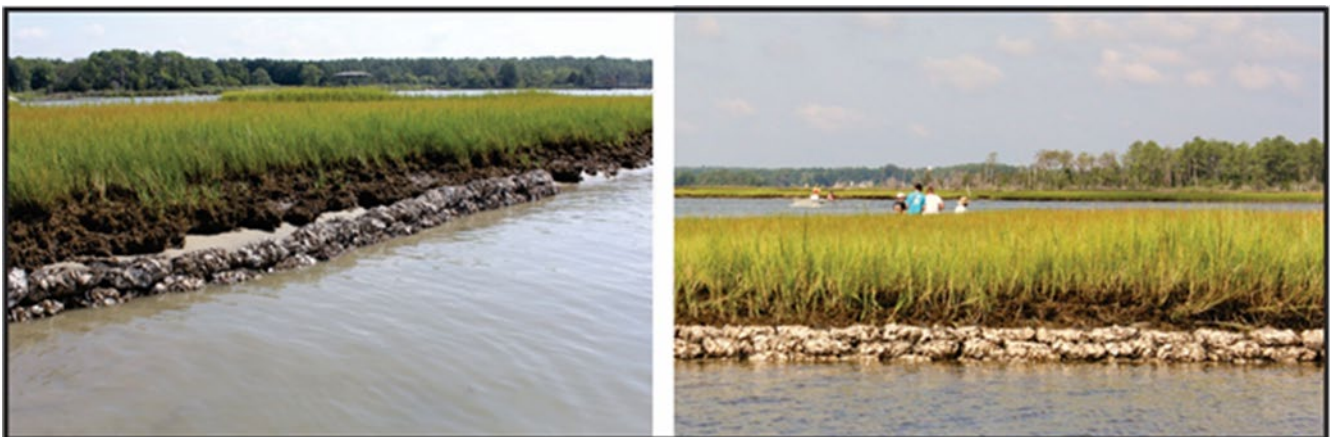
Figure 4-2. Construction of the 3-bag sill (left) and 6-bag sill (right) in August 2017. From Milligan et al. (2018). Photo credit: Linda Tjossem

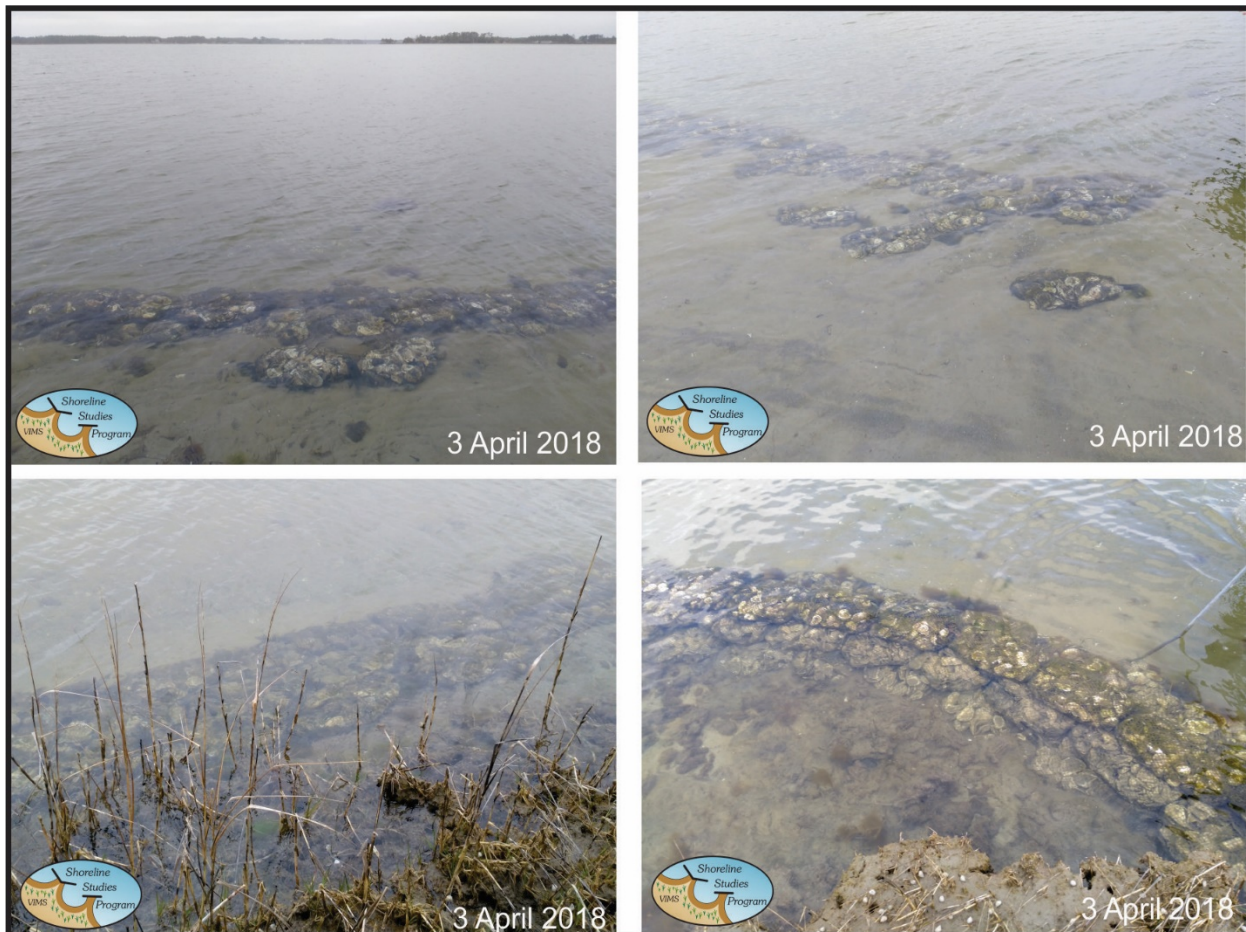
Figure 4-3. Captain Sinclair's Recreational Area oyster bag sill. The three-bag sill (top) that was placed on the southwest-facing shoreline has not been as stable. The top bag of some sections were rolled toward the shoreline. The six-bag sill (bottom) on the point and the southeast-facing shoreline has remained intact. From Milligan et al. (2018).

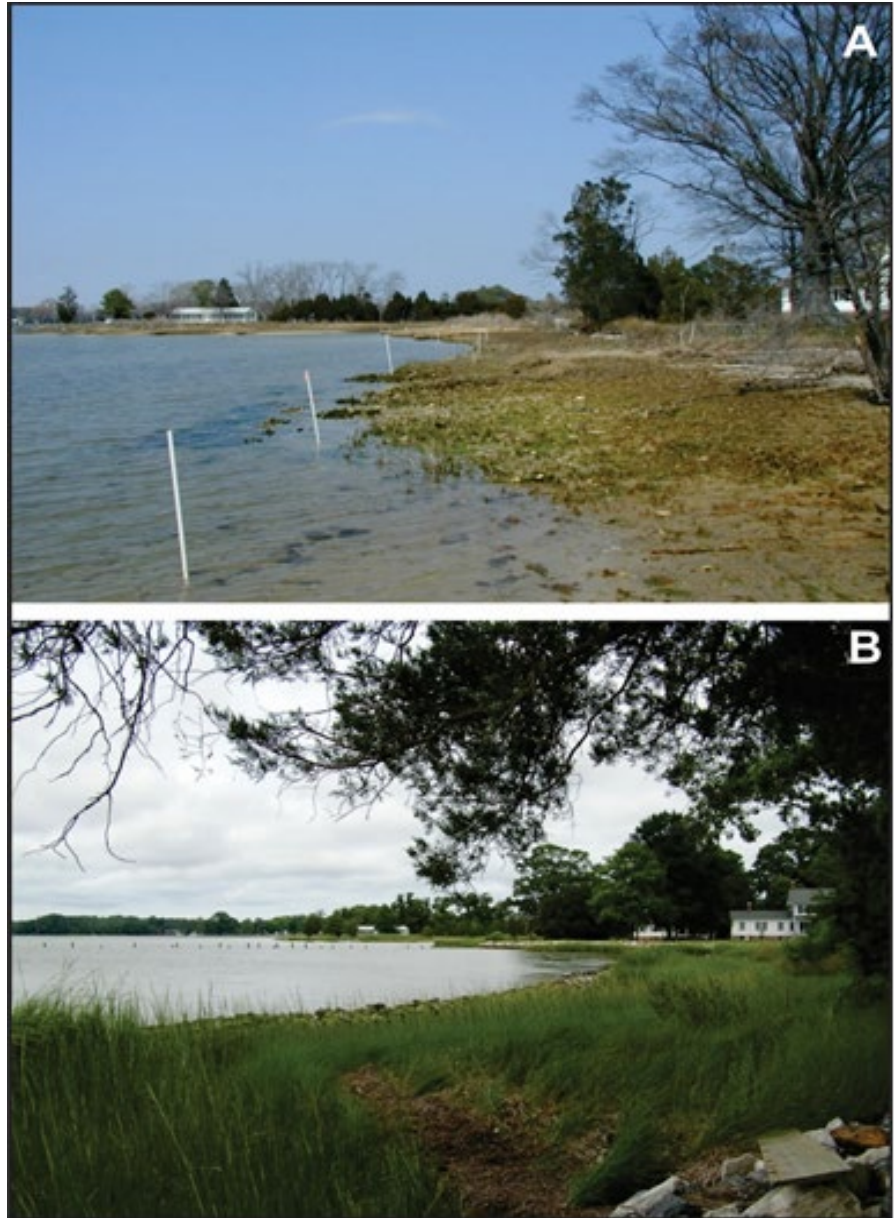
Figure 4-4. Hollerith marsh toe revetment/sill site A) before project with eroding fringing marsh in winter and B) after construction.

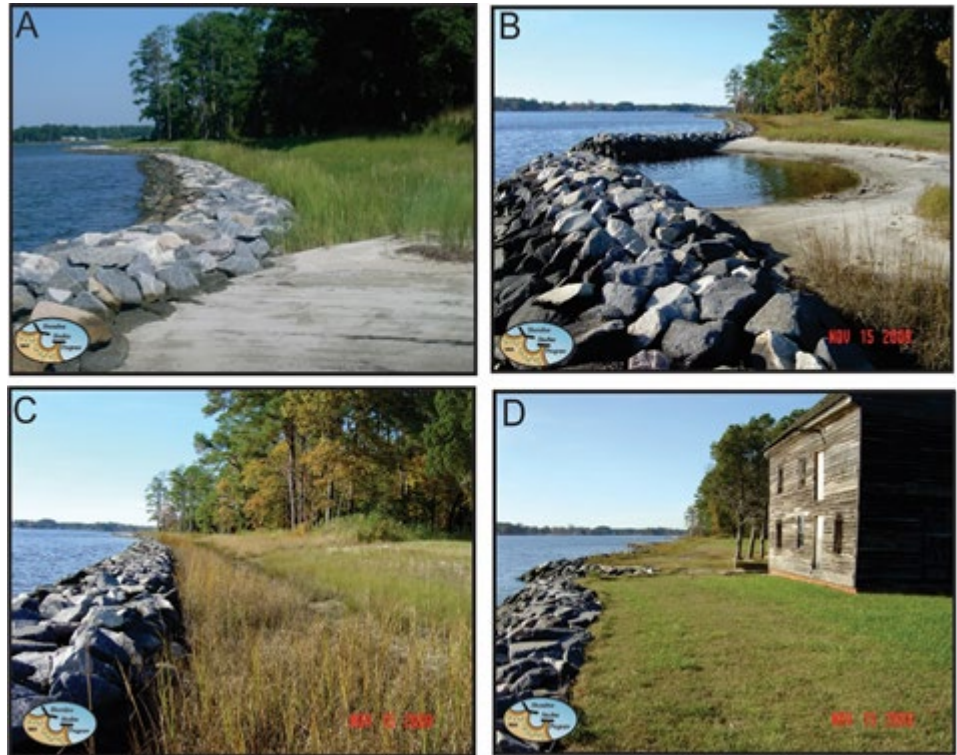
Figure 4-5. Sill system at Poplar Grove on the East River in Mathews County, Virginia six years after completion. A) The sill and marsh fringe provide a wide buffer between the water and the upland. B) The wide gap in the sill provides a pocket beach access area along the shoreline. C) The project zones are clearly visible: stone sill, *S. alterniflora*, *S. patens*, and upland/wooded. D) The old mill sits close to the shoreline. In this area, a revetment was chosen to protect the shoreline.

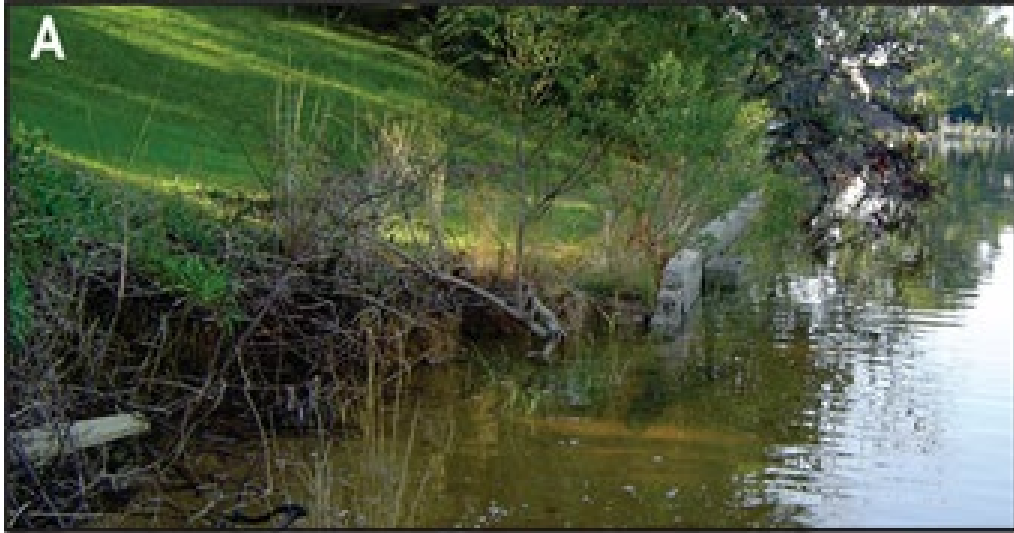
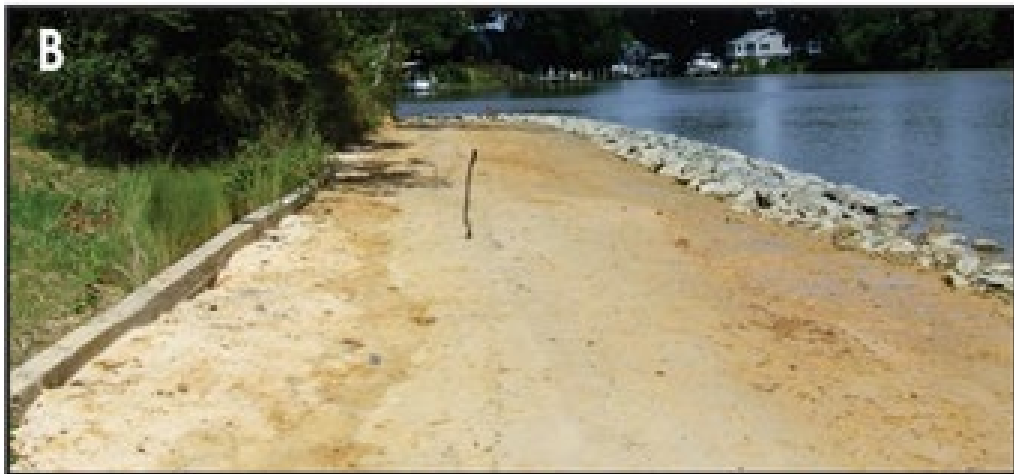
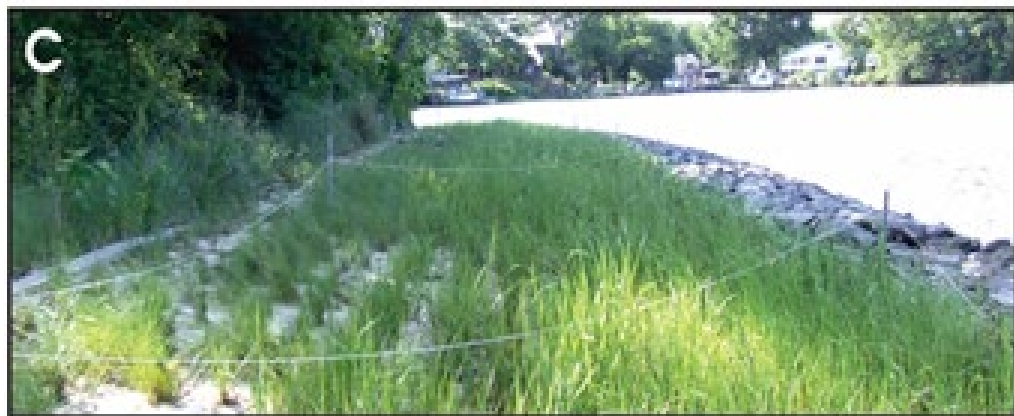
Figure 4-9. Hull Springs Farm shoreline A) before construction, B) after construction of the sill and placement of sand, and C) after planting.

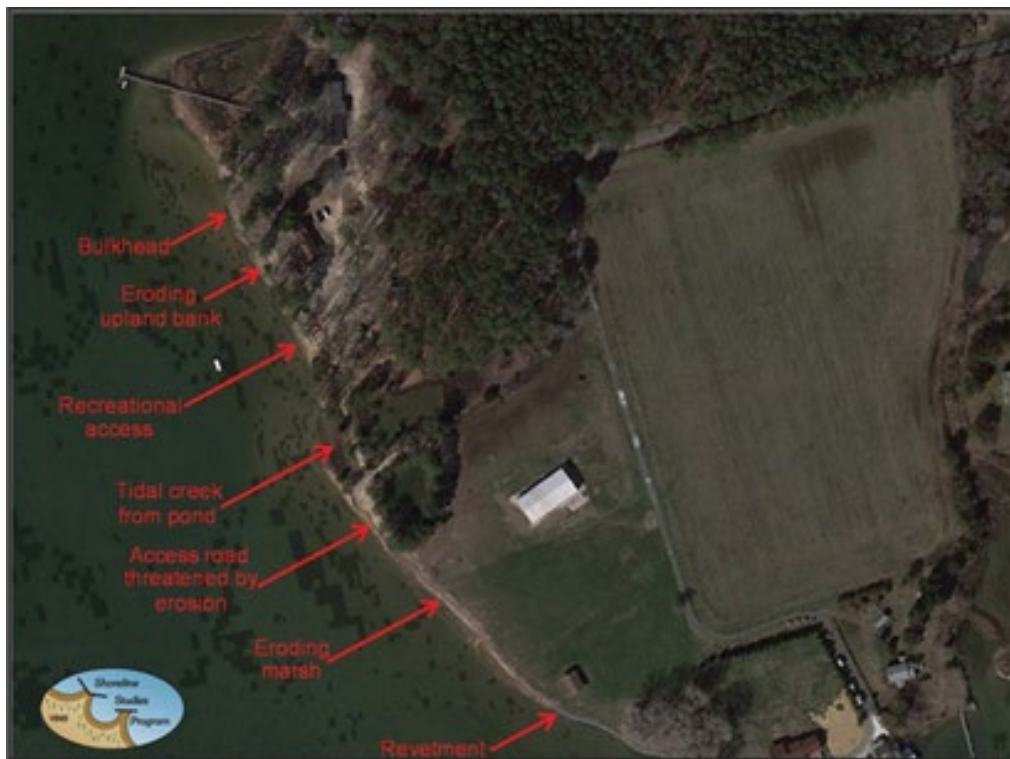
Figure 5-2. Considerations for shore protection design along the project area.

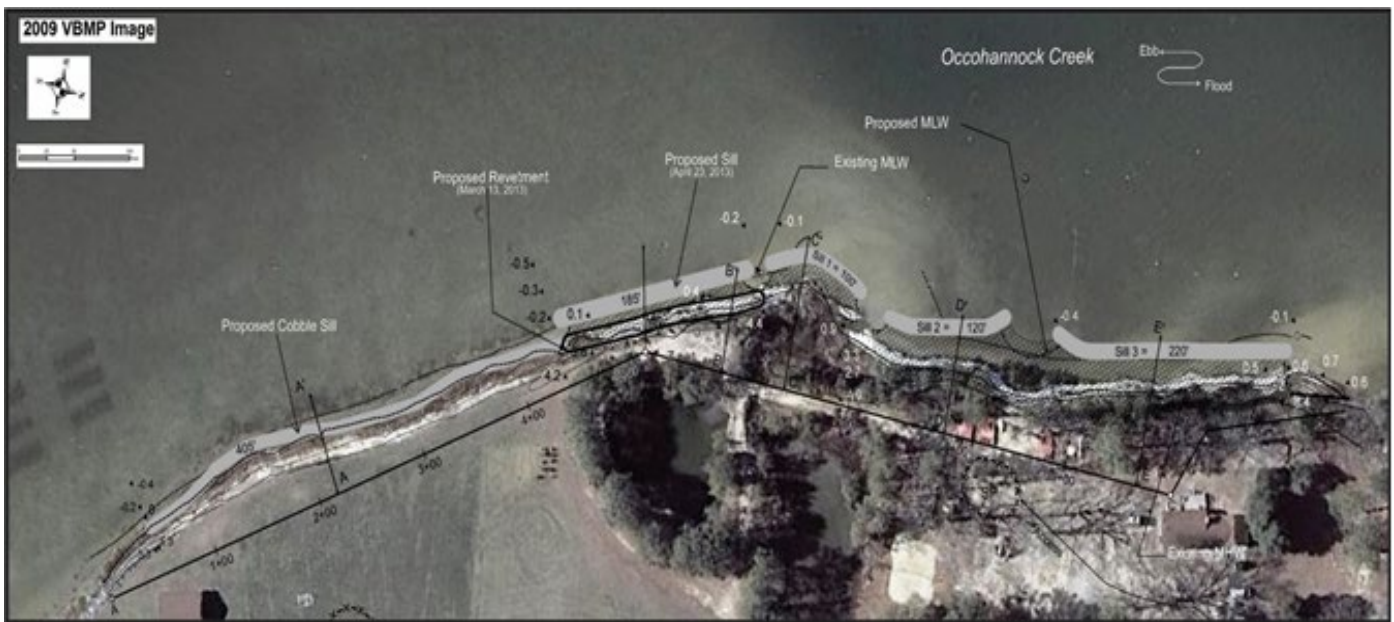
Figure 5-4. Design for shore structures at Occohannock on the Bay.

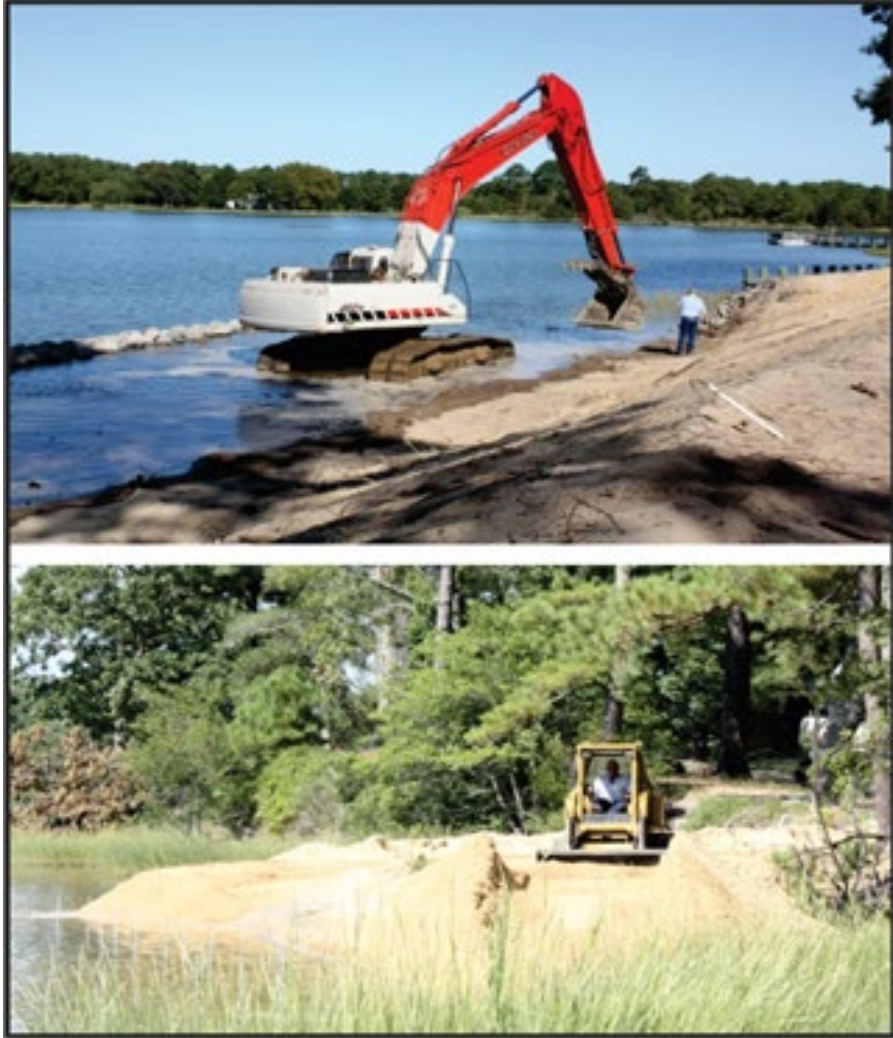
Figure 5-5. Construction of the shore structures at Occohannock on the Bay.

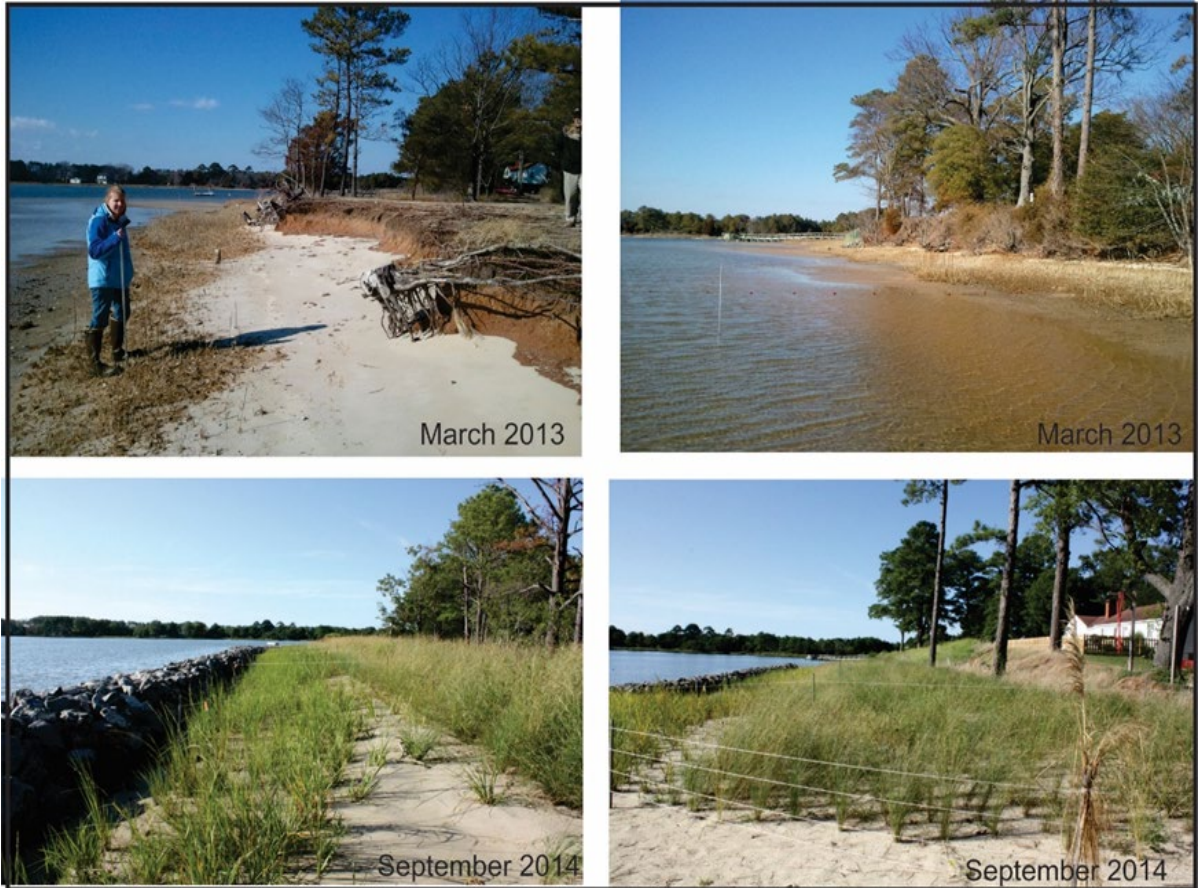
Figure 5-6. Occohannock on the Bay shoreline before (top) sill construction and after (bottom) construction.

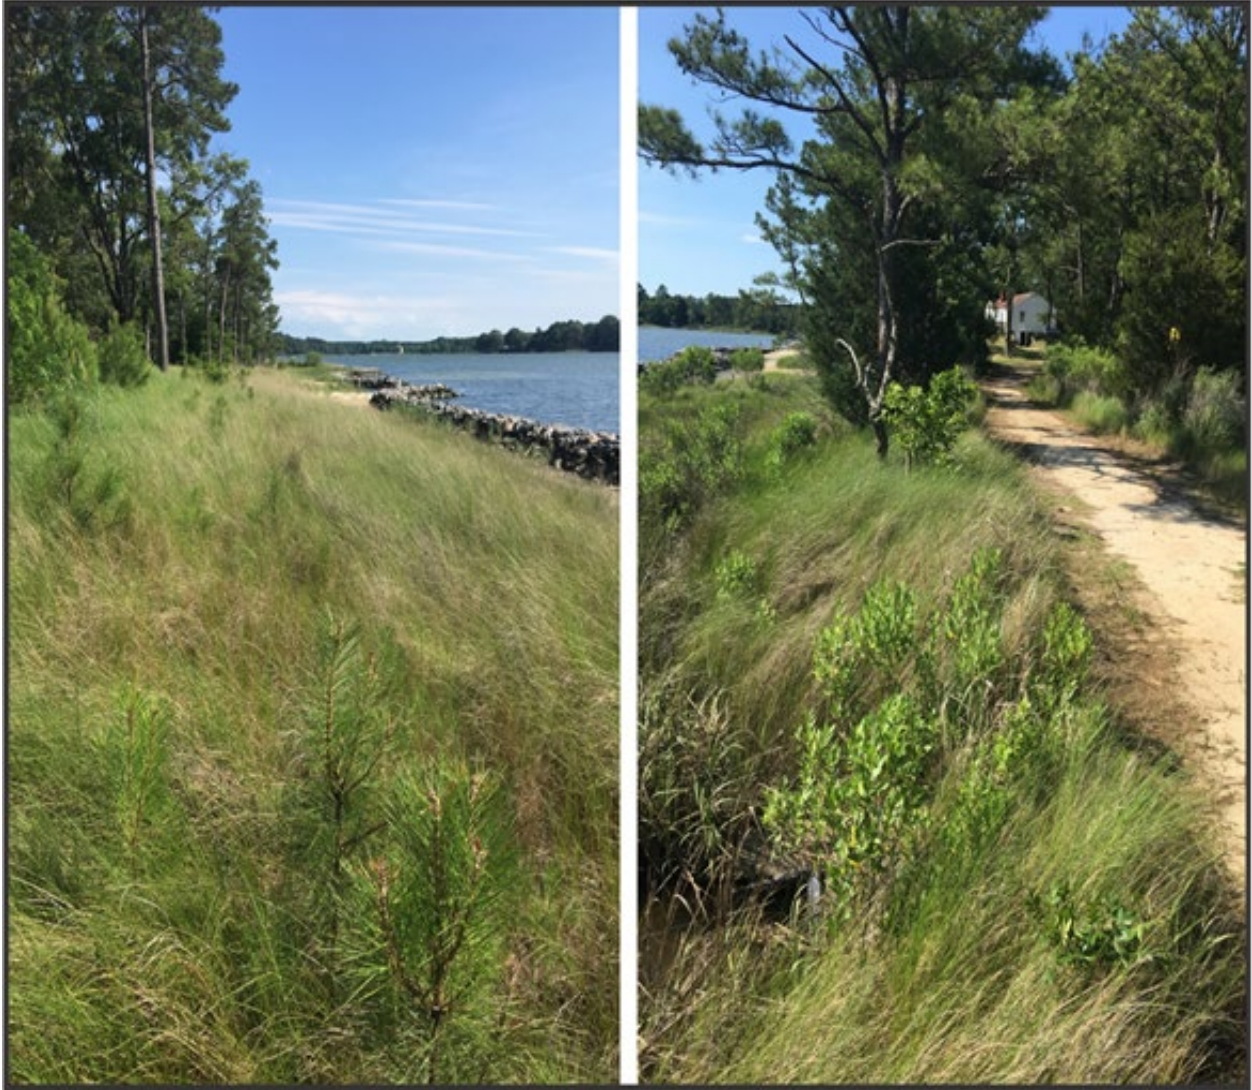
Figure 5-7. Photos of the project three years after installation in May 2017. The marsh behind the sill is expansive (left) and the access road is no longer threatened (right).

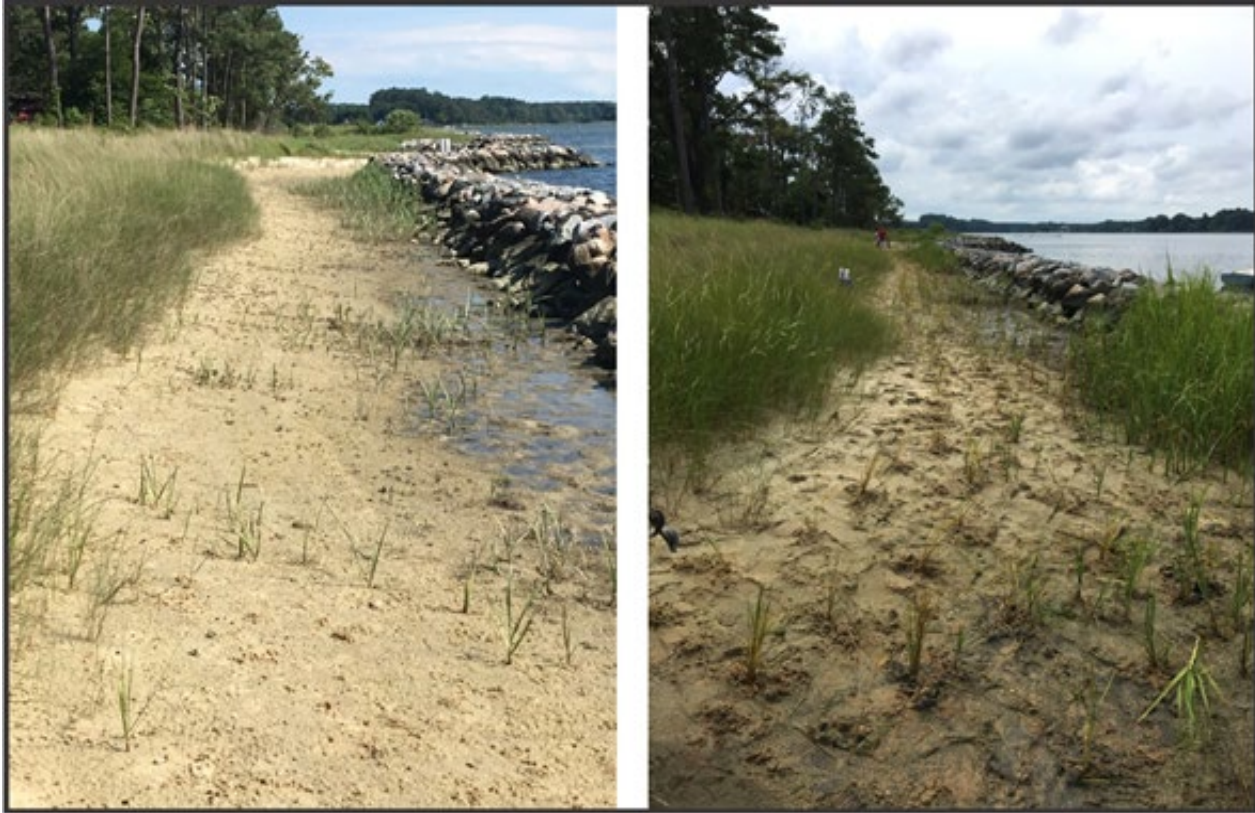
Figure 5-8. Photos showing a bare spot behind the sill (left) in May 2017, and the grasses replanted in July 2017 (right).

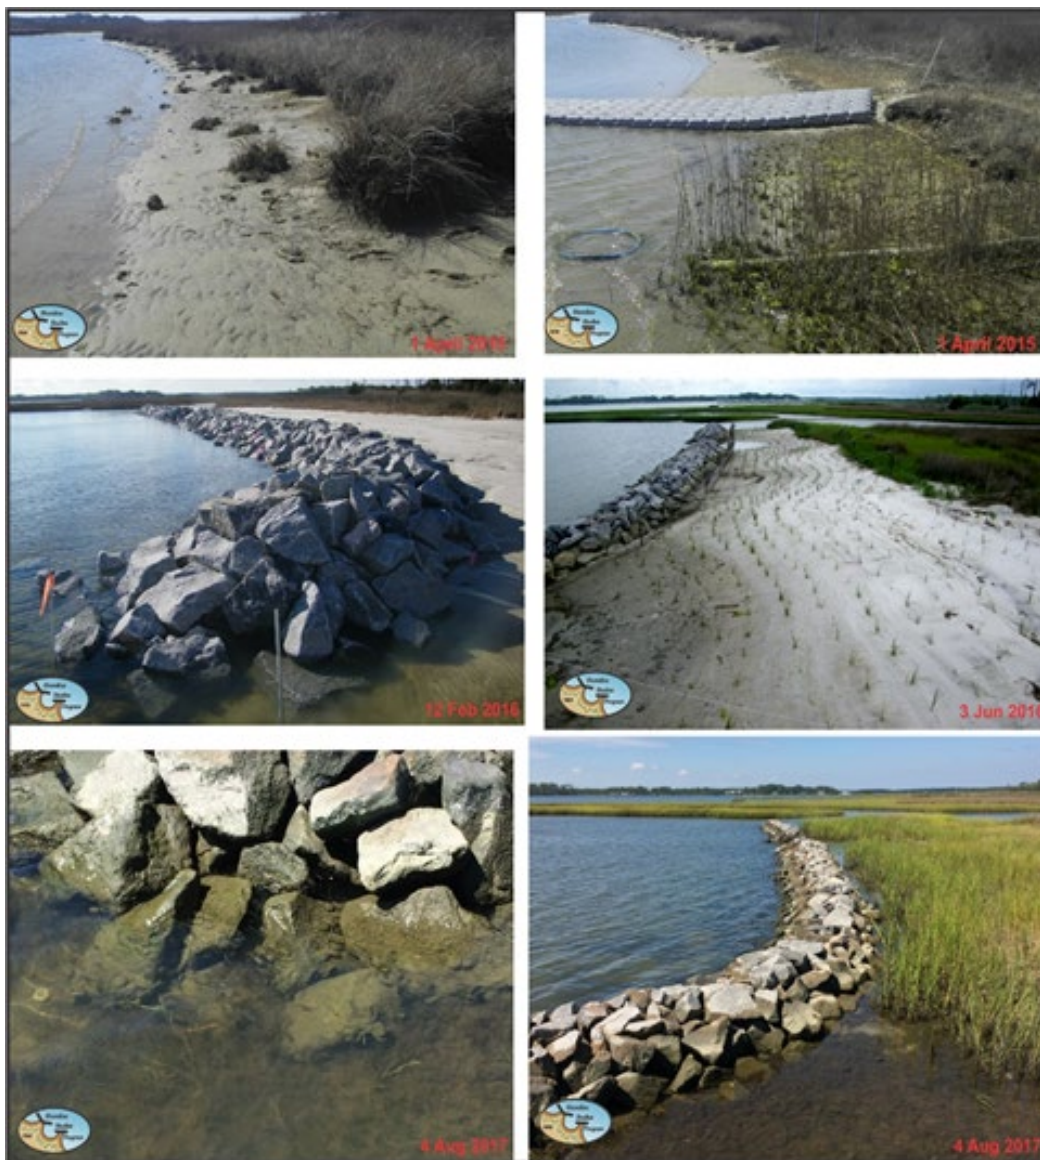
Figure 5-10. Captain Sinclair's Recreational Area pre-construction (top), post-construction (middle), and a year later (bottom). The marsh grasses are lush, SAV has grown behind the structure, and fauna are utilizing the rocks and the marsh.

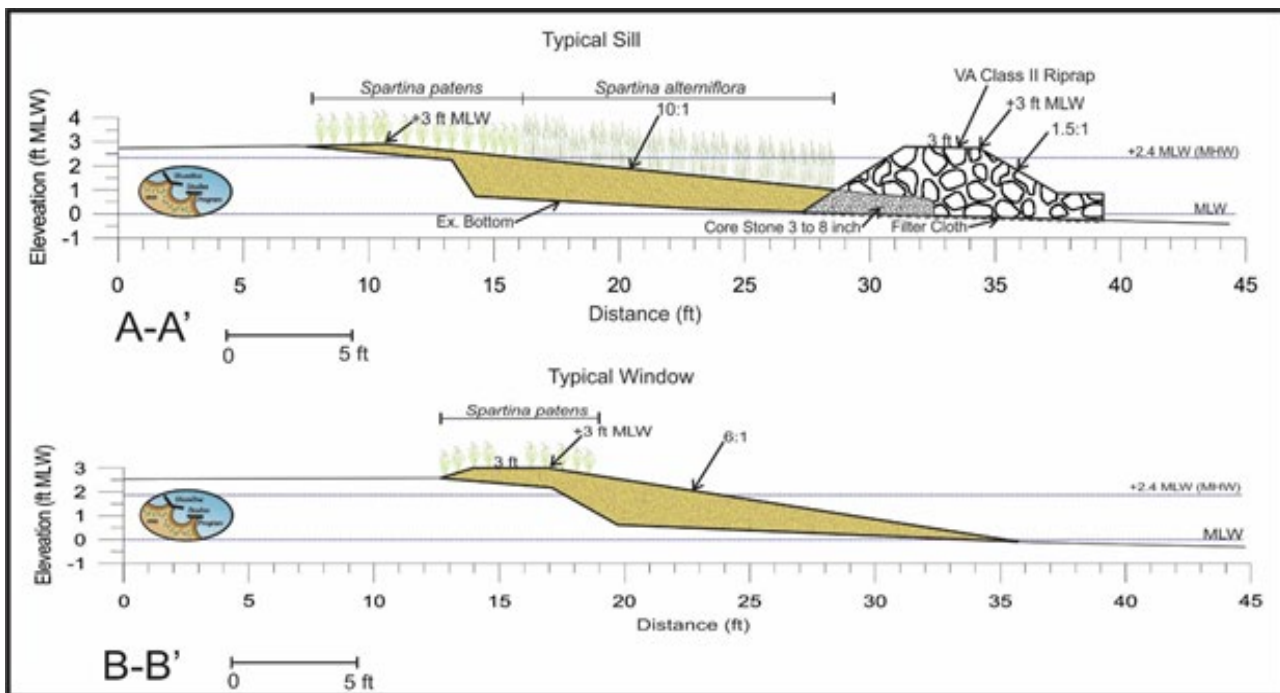
Figure 5-12. Typical cross-section of shore protection structures proposed at Captain Sinclair's Recreational Area.

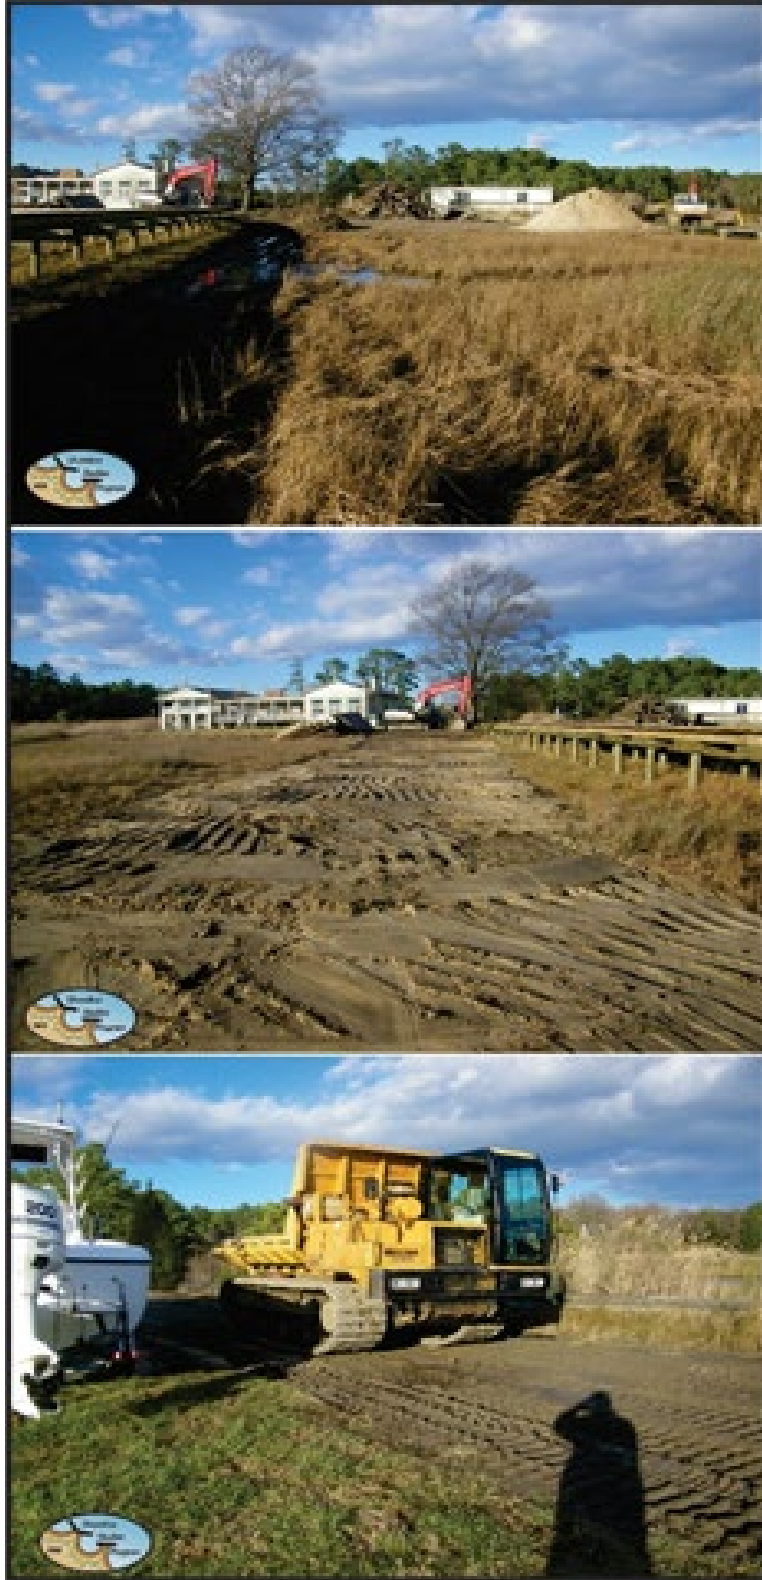
Figure 5-13. Photos taken during construction at Captain Sinclair's Recreational Area on 29 Jan 2016.

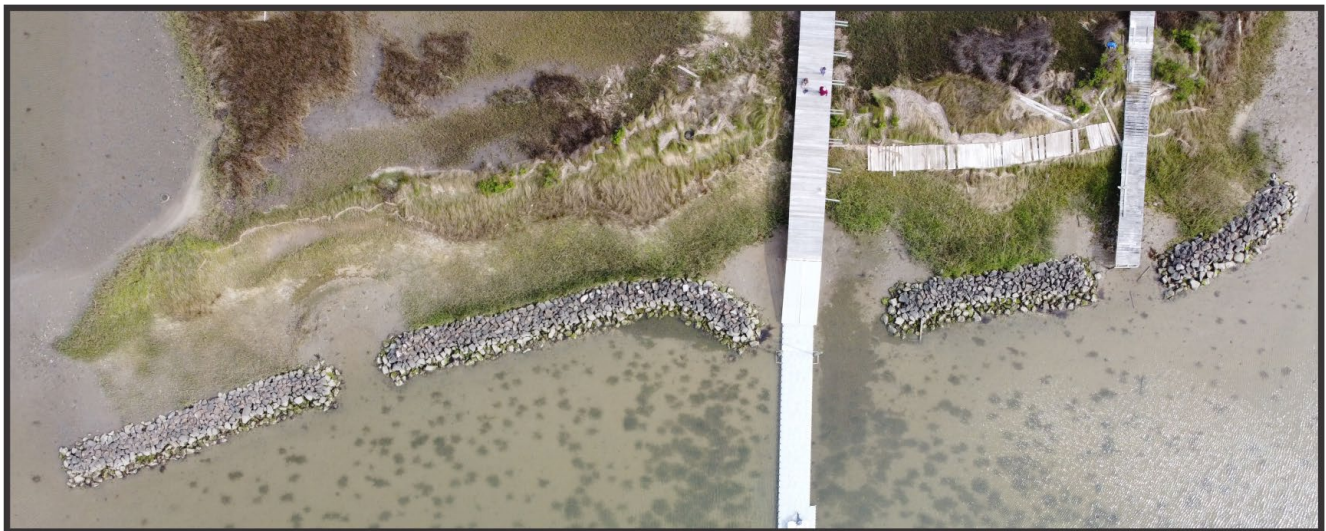
Figure 5-14. Drone imagery of the Captain Sinclair sills taken about 4 years after project installation (12 May 2020).
