Investigation of the origin and magnitude of debris flows from the Payhua Creek basin, Matucana area, Huarochirí Province, Perú

L. Fídel Smoll, A. Guzman Martinez, J. Zegarra Loo & M. Vilchez Mata

Instituto Geológico Minero y Metalúrgico, Dirección de Geología Ambiental, San Borja, Lima, Perú

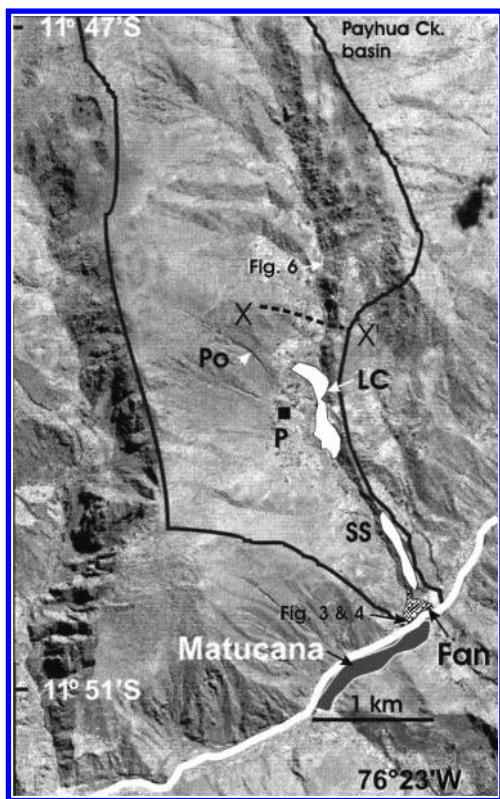
Figure 2. A Quickbird satellite image of the Payhua Creek area, Aug. 13, 2004: X-X'- boundary between upper and lower basin, P- Payhua village, Po- Patipunco ravine, LC- Payhua landslide complex, SS-sagging slope block, white line-Rimac River (Ferrocarril Central and Carratera Central). Payhua Creek joins Rimac River and the extreme southwest point of the fan.

PC has built an extensive fan at the upstream end of Matucana where PC joins RR (Fig. 2). It is about 400 m

The most active and continuous areas of landsliding in PC basin occur along the reach of the PC canyon adjacent to the village of Payhua about 2.2 km north of and 1000 m in elevation above Matucana. This will subsequently be referred to as the Payhua landslide complex (Fig. 2, LC). Approximately 16 ha of active rock and debris slides, rockfall and complex landslides that include old debris-flow-fan remnants and portions of active debris flow fans border on approximately one kilometre of the channel. This reach contributes the greatest amounts of coarse and fine sediment to the PC channel in the basin. These landslides have locally dammed PC in the past and may have the potential to create breakout floods. Furthermore, several rapidly expanding ravines within talus slope/debris-flow cone complexes above Payhua village have produced debris flows that directly entered PC during the 1959 and 1983 debris flow disasters. A debris flow from the largest of these ravines (*Patipunco*) may have been the ultimate source of the 1959 debris flow according to longtime Payhua village residents (Fig. 2, Po).

The upper basin (Fig. 2) is underlain by massive cliff-forming andesite flows or flow complexes that apparently overlie the recessive rocks of the lower basin. Agricultural terracing extends to ridge crests along the east side of the basin. Archaeological evidence

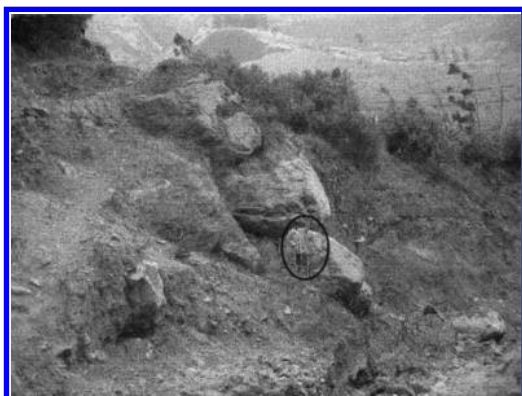
Figure 3. Bouldery debris flow diamicton near the confluence of Payhua Creek with Rimac River. Oval indicates a man standing next to a 2 m stadia rod.

in length from apex to its southernmost extent. Its overall surface slope is approximately 9° (it has been extensively modified into terraced fields for agriculture). It terminates in a cliff bank created by incision of the fan by RR. The fan is almost entirely underlain by bouldery debris flow diamicton sediments. Poorly sorted bouldery gravel beds, associated with muddy turbulent stream flow, are locally interstratified with diamictons. Boulders 1 m in diameter are common within the diamictons. Individual boulders up to 3 m are present (Figs. 3–4).

Any estimates of historic debris flow magnitudes must be tempered by evidence of prehistoric event based upon exposures of sediments comprising the PC fan. Exposures along the channels of PC and RR reveal only massive debris flow diamiction that commonly contain boulders exceeding 1 m in length (Figs. 3–4) and lacking obvious flow boundaries or breaks in sedimentation. Based on these observations, the fan has largely been built by debris flow events that covered parts of the fan to depths of 3 m or more and greatly exceeded the volumes of the historic ones. The lack of buried soils or other indicators of long term breaks in debris flow deposition and the rapid uplift rates in the region suggest that the debris flow deposits that have built the fan are geologically recent i.e. hundreds or thousands of years old. At the regional rate of uplift, deposits tens or hundreds of thousands of years old would likely have been deeply incised and would presently form terraces.

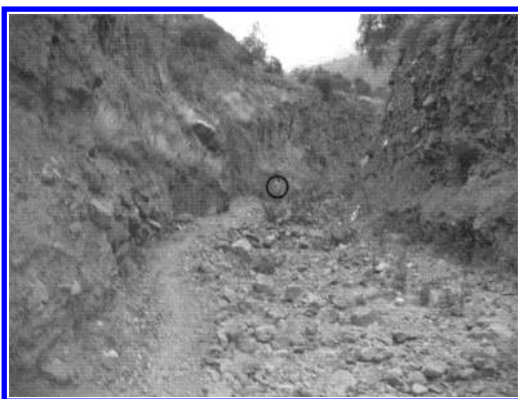
Figure 4. Looking up the channel of Payhua Creek in the opposite direction from Fig. 3. The channel is deeply incised into Payhua fan. Circle indicates a 1.5 m tall man. Cross sectional area of the channel is approximately 300 m^3 . The 1983 debris flow exceed the capacity of the channel.

An order of magnitude volume estimate for the size of the 1983 debris flow (the 1959 event is assumed to be of similar magnitude because of similar effects) can be made based upon field observations in and around the channel of PC. The channel incises PC fan to a depth of about 14 m over a total distance of approximately 400 m. Its mean cross-sectional area is about 300 m². In order for a flow to spill out on to the fan surface, it would fill the channel and would consequently have a minimum volume of about 120,000 m³. Assuming similar incised channel dimensions, this volume was exceeded during the 1983 event with the burial of adjacent fields on the fan surface. Such a discharge would be sufficient to dam and divert RR. However, filling of the PC fan channel to overflow represents the peak discharge of an event with an

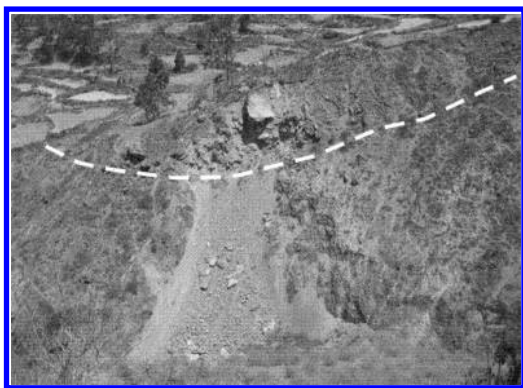
Figure 5. Dashed line indicates the contact between a coarsely jointed andesitic flow unit and the underlying pervasively fractured red tuff unit. The slope is about 70 m high. The rockfall occurred within the past 20 years and continues to grow as the failure in the red tuff undermines the andesite flow. Bouldery debris from the rock fall blocks the channel of Payhua Creek.

The ultimate cause of failure along the approximately 70 m deep canyon of PC is the incision of the inherently unstable configuration of pervasively fractured red tuff that is overlain by more coarsely jointed andesitic lava flows (Fig. 5). The red tuff is approximately 40 m in thickness. Incision of this resistant over recessive succession leads to undermining of the andesite flows and rock falls along near vertical canyon walls or rotational or translational type failures with the failure plane(s) seated within the red tuff. The latter varieties are expanding rapidly into slopes immediately east of Payhua village.

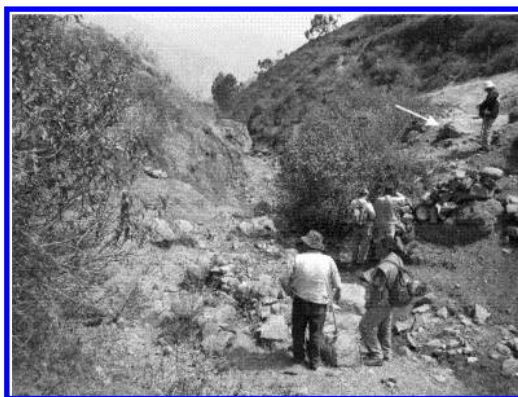
Figure 6. Channel of Payhua Creek near the downstream limit of the upper basin (see Fig. 2). Arrow indicates a boulder levee marking the upper limit of debris flow deposits. Compare channel cross sectional area to the fan channel in Figure 4. The boulder indicated by the arrow is about 3 m above the floor or the channel.

Agricultural terraces have been built to within about 5 vertical metres of the channel bottom of PC in the upper basin. The highest debris flow levees are about 3 m above the channel floor in this area. Debris flow deposits are distinctive in the basin because they contain clasts from all lithologies occurring in the basin up-stream from any given point. These polymictic deposits are absent from pre-Inca agricultural terraces immediately above the channel. Therefore, the uppermost levees define the upper limits of the largest debris flow event during at least the last 600 to 800 years in the upper basin. They define a channel cross-section less than one-tenth the area of the cross section of the PC channel across the PC fan. Consequently, more than about 90% of the volume of the 1983 debris flow that reached the PC fan apparently had its origin farther downstream in the PC basin.
