A full-scale case study of vibration-based structural health monitoring of bridges: prospects and open challenges

Vibration Monitoring, Full-scale bridge application, Data-driven damage diagnostic, Controlled damage scenarios

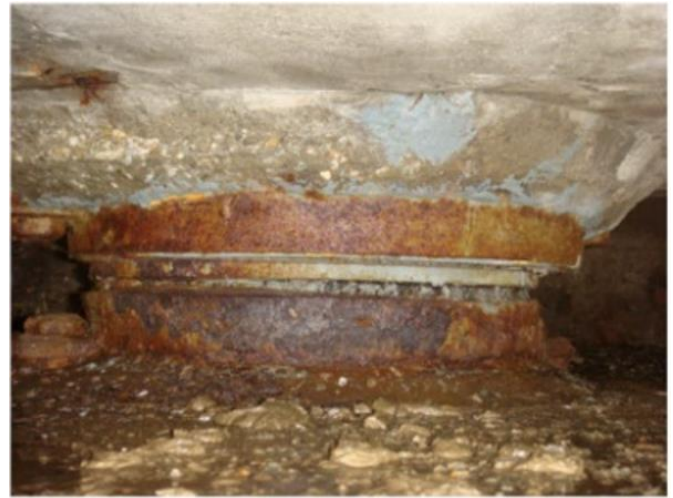
Figure 2 State of the bridge bearings before the start of the monitoring campaign.

The bridge deck was connected to the piers through bearings that were intended to offer primarily vertical support. Thus, the bridge deck was considered to function as a continuous beam with simple supports. However, the deteriorated state of the bearings, showing advanced corrosion, possibly compromised their decoupling performance (see Figure 2).

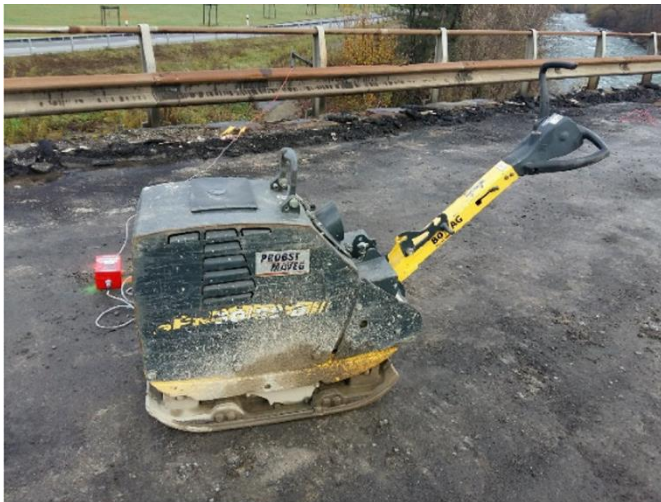
Figure 3 A portable plate vibrator has been used to generate two different levels of forced vibrations: low-frequency excitation that produce low amplitudes of vibration and high-frequency excitation that lead to higher amplitudes of vibration.

While the data was recorded continuously, the activities on the bridge were regularly halted for five minutes to ensure ambient conditions. In addition to ambient vibrations, a portable plate vibrator (see Figure 3) was used to generate forced vibration measurements that exceed ambient vibrations by an order of magnitude (see Figure 4). The vibrator was placed at two fixed positions, corresponding to the middle points of the central span and the east span, respectively. Additionally, roving excitation was done by moving the vibrator next to all sensors. While the amplitude and the frequency of the applied force could not be fully controlled, two different amplitude levels were applied, namely lower and higher amplitude. The two amplitudes of forced excitation resulted from increasing rotating frequency, which in turn increased the centrifugal force, leading to higher excitation amplitude.

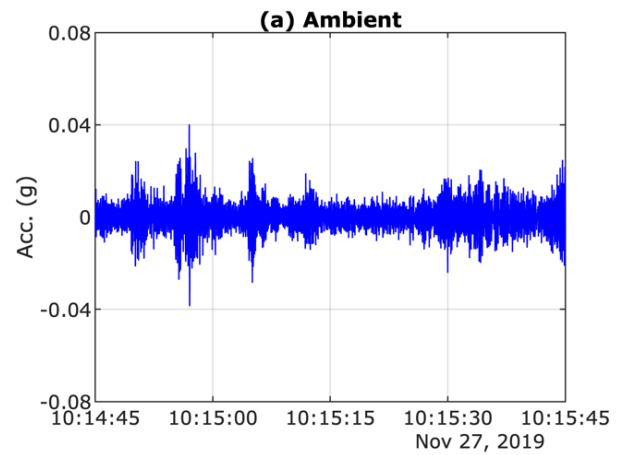
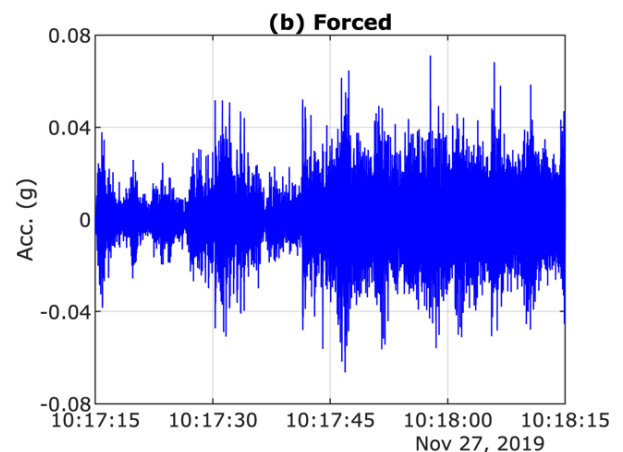
Figure 4 Example of acceleration recordings at mid-span of the bridge under ambient vibrations (a) and vibrations induced by the vibrator plate shown in Figure 3 (b).

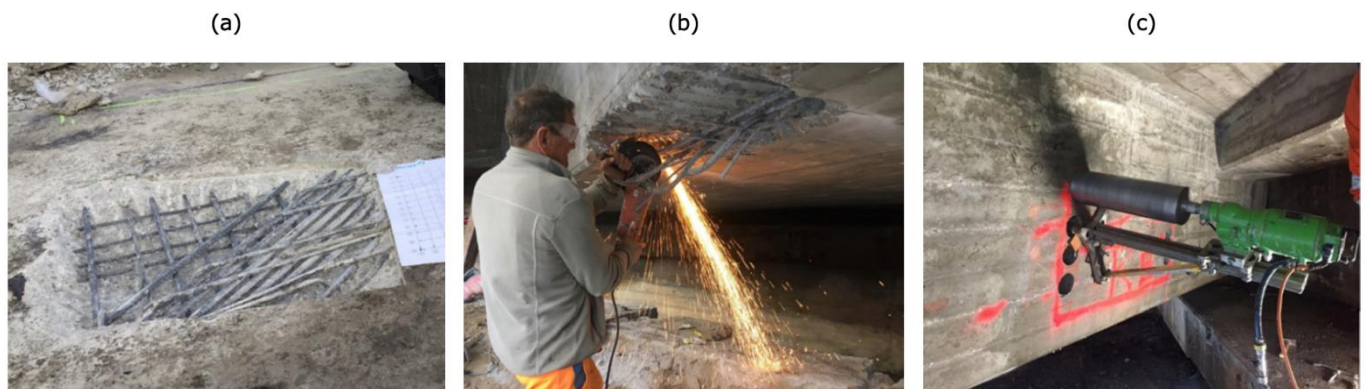
Figure 5 Example of the three damage patterns: rebar exposure (a), rebar cutting (b), and concrete drilling (c).

Before the planned demolition of the bridge, three types of damage patterns were successively introduced in several positions of the bridge: exposure of rebars and tendons by removing the concrete cover (see Figure 5a); cutting of rebars (see Figure 5b) and one prestressed cable, and local reduction of the concrete web by drilling bore-holes (see Figure 5c). These artificial damage scenarios have been progressively introduced and, thus, define a wide range of damage states from varying failure mechanisms.

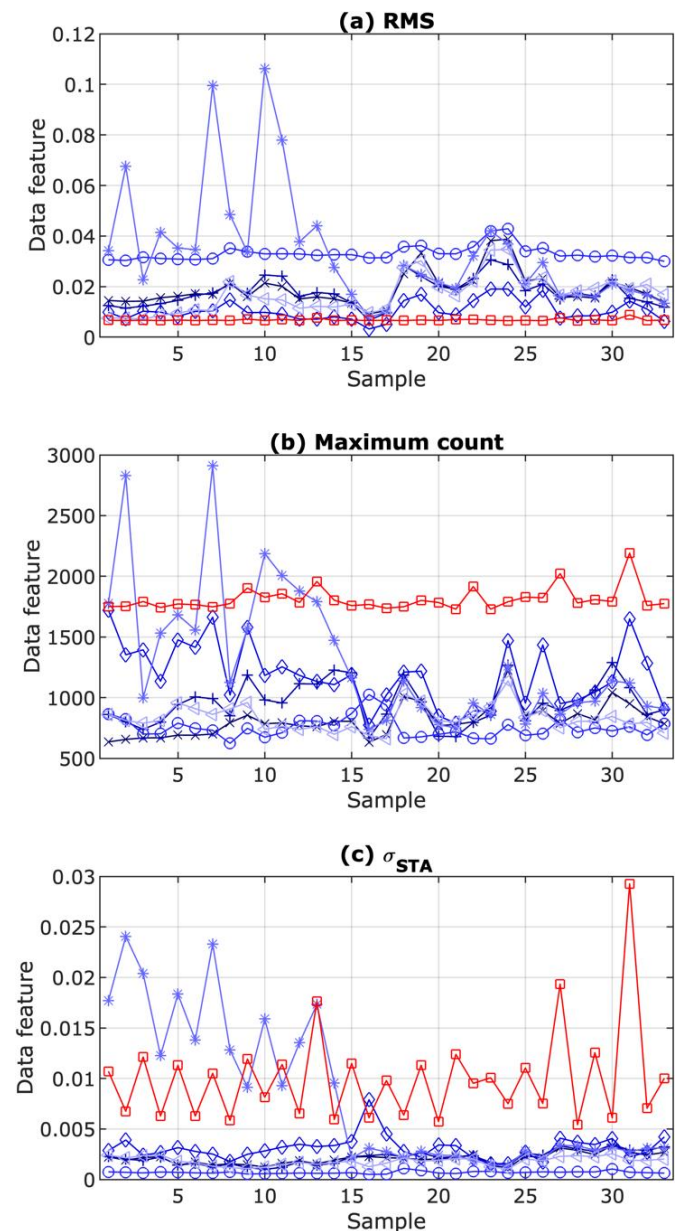
Figure 7 Comparison of three data features to diagnose the sensor health (a: root-mean square, b: maximum bin count, when splitting the signal into 200 bins, and c: standard deviation of short-time averages) derived from the seven acceleration sensors. These features may contribute to detect sensor malfunctioning, as the red values that correspond to a malfunctioning sensor can be visually separated from the blue lines.

The values of the three data features for 30 minutes of data stemming from all seven sensors are shown in Figure 7. The dataset contains one sensor that had been found to be malfunctioning a-posteriori and is highlighted in red in Figure 7. The highest-counted bin (Figure 7b) and the standard-deviation of short-time averages (Figure 7c) successfully separate normal from abnormal sensor behavior. The RMS (Figure 7a), on the other hand, plays an essential role to avoid false alarms for well-functioning sensors that may be perturbed by excitation sources in the near vicinity of the sensor. This shows the potential of the sensor diagnosis framework to be applied on permanently monitored pre-stressed box-girder bridges in the future. The dataset of the PMC may serve as a benchmark to validate automated sensor diagnosis frameworks.

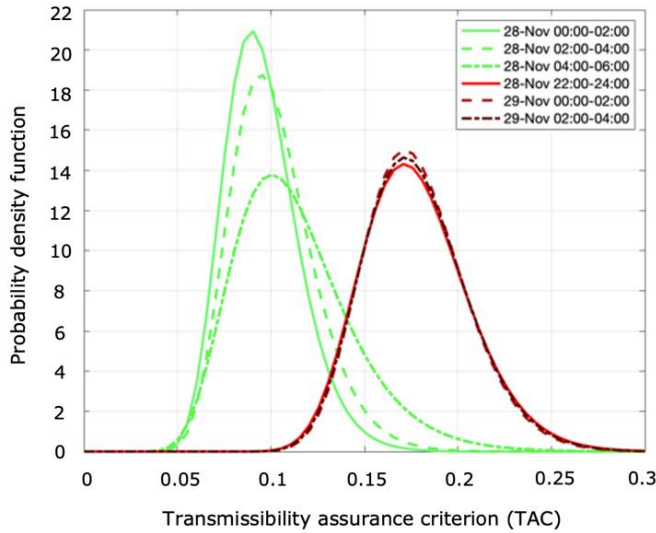
Figure 9 Example of acceleration recordings at mid-span of the bridge under ambient vibrations (a) and imposed by the vibrator plate around mid-span (b).

In Figure 9, the probability density functions (PDFs) of two-hour intervals of TAC values are presented. The TAC is evaluated for transmissibility functions that are derived on 30-second signal windows of a given sensor pair. In Figure 9, a clear separation can be observed between the PDF for signals that recorded during the nights of two consecutive days – before and after cutting the pre-stressed cables. This confirms the potential of transmissibility-based indicators to pick up structural damage, even if it is local.
