## Degrees of Risk of Environmental Impacts Arising from Irregular Occupations in the Northern Zone of Manaus- Amazonas

Brena Karine Pires Gaspar; Fabiana Rocha Pinto; David Barbosa de Alencar; Gisele de Freitas Lopes

Therefore, the objective of the present study is to identify the environmental impacts intensified by anthropic actions in the Cidade de Deus and Cidade Nova neighborhoods, with the purpose of dividing the areas into quadrants and defining their risk levels directly affected by urban growth and occupations. irregular in the last ten years. The risk degrees of the impacts caused by this situation will be compared at grade I (low), II (moderate), III (medium) and IV (high).

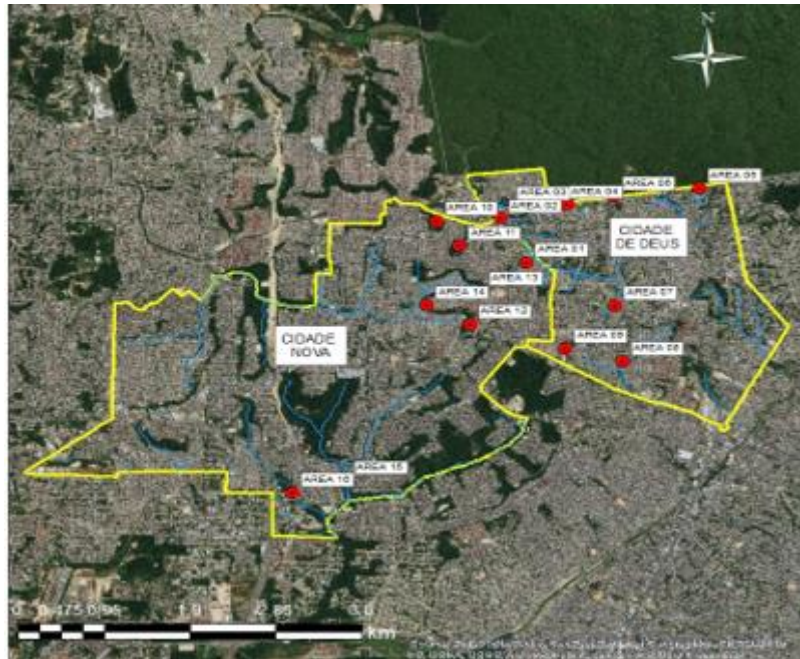
Figure 01: Areas analyzed.

All areas of this study have their uniqueness, with some features also found elsewhere. However, four strongly draw attention because it contemplates most of the aspects analyzed in the places, being them in red color (figure 01).

The quadrants, called A, B, C and D, have four areas each, encompassing similar aspects between them, which is the first criterion for subdivisions. The second criterion is the proximity between the areas. From the extent of loss of vegetation cover in the last ten years, described in table 4, it is possible to delimit the environmental impacts and risks of each quadrant.

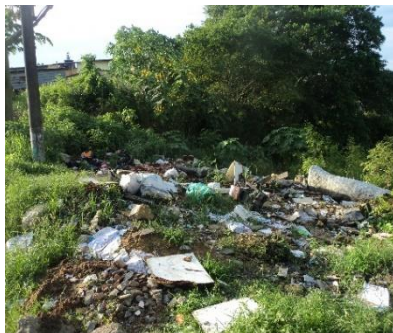
Figure 06: situation of area 01 (quadrant C) in 2017.

Quadrant C, which has the second highest rate of gullet occurrences, differs from quadrant A because it has a total of occupied areas 7 times larger. In addition, it has the highest land use index in the last ten years, in which 40.35% of the vegetation cover has been lost. Allied to factors that occur after occupation, such as improper dumping of solid waste and effluents, this aspect promotes an increase in the percentage of soil losses, favorable to the increase of the size of erosion areas, as in area 01 (figures 06 and 07 ).

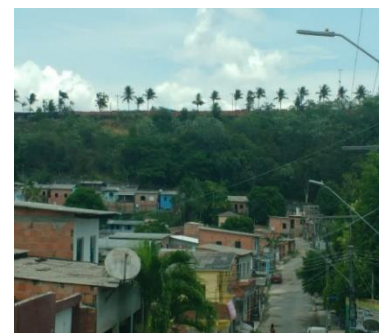
Figure 08: Area 09, Quadrant B

In quadrant B, which has only one area without vegetation cover and ravine type erosion, it was possible

to observe an area unique to the others in this work. It was observed the occupation of the base of a steep slope, of approximately 55 °. The area, which is the division of a collective garage and the Cidade de Deus neighborhood, has native vegetation - sustaining the slope - at the same time as the occupation, also receives effluent discharge without any treatment, resulting in destabilization of the slope. (figure 08).

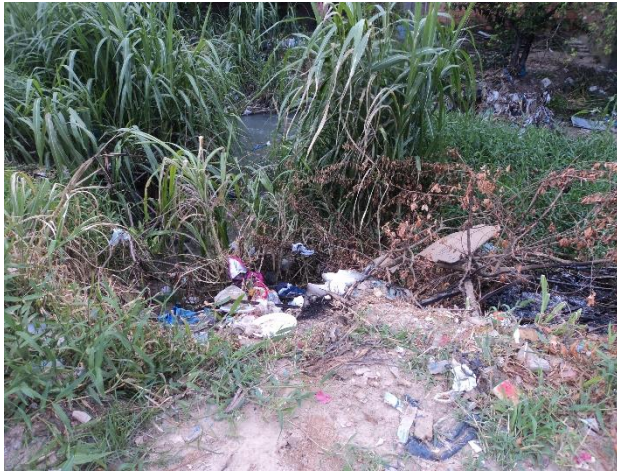
**Figure 09:** Area 01 stream margin situation (quadrant C)**Figure 10:** Excerpt from area 07 stream (quadrant B)

In this quadrant, which is the most worrisome, there is also the loss of vegetation cover on the banks of water bodies for the occupation of simple and many precarious dwellings, which are flooded during torrential rain, which impairs the natural water cycle. As reported in table 03, the watercourses analyzed in quadrants B and C are silenced due to loss of vegetation cover, and it is possible to locate solid waste and

tailings (figure 09), as well as the discharge of untreated effluents. due basic treatments, causing the eutrophication of water bodies near inhabited areas.

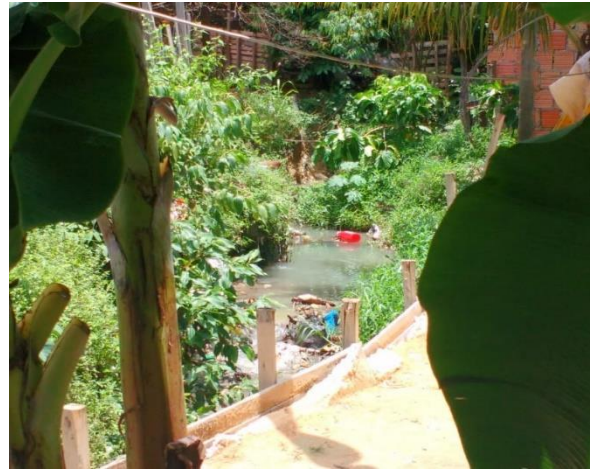
In relation to watercourses, it was observed that in quadrant B the impacts on streams are the most significant, where they are at serious risk of not being able to resist anthropic actions if they continue to receive the current level of impacts. about them. One of the factors that warns of the resistance of streams over the years is the width of the streams, because all, in the dry season, reach less than 10 m wide.

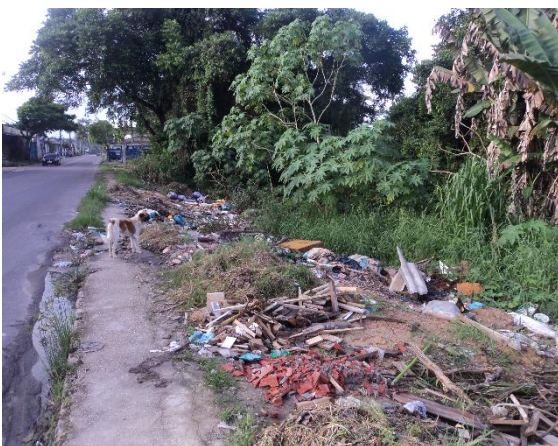
**Figure 11:** Area 12, in 2017;

During the visits to the analyzed areas, solutions were also found for the areas. Area 11, located in quadrant 03, received a large volume of tailings and solid waste, mainly from civil construction and furniture used until early 2019 (Figure 09). In mid-June of that year, the City Hall installed prohibition signs regarding the disposal of these materials on the area, which has a high conservation index of the vegetation that protects the soil from exposure and possible erosion, as it has rugged relief. .

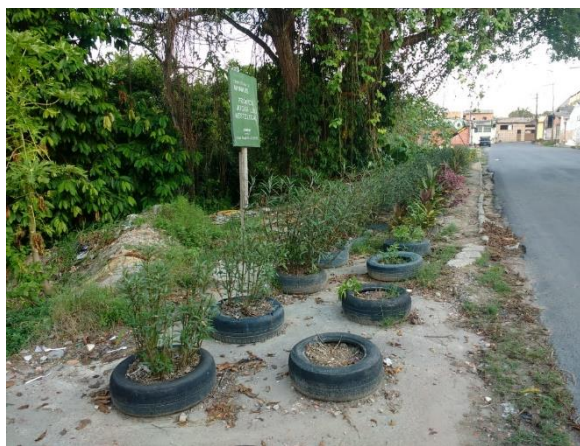
**Figure 12:** Area 12, after City Hall Action

In addition to the plaques, ornamental plants were inserted in the area as a measure of sensitization to the residents of the region (figure 12) so that there is no disposal of tailings in this area.

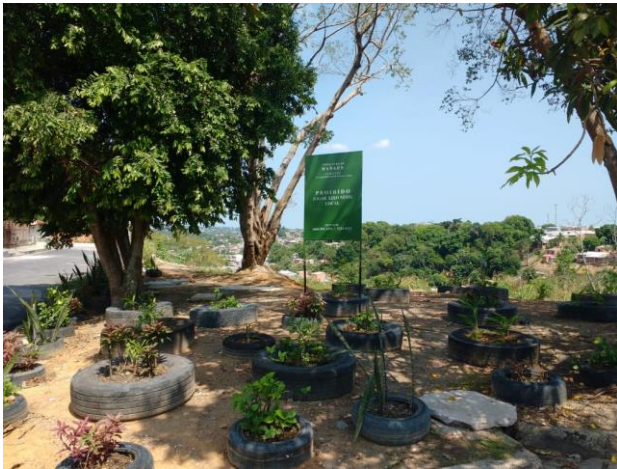
**Figure 13:** Area 12 (Quadrant D) Recovered.

Another example of recovery attempt was found in area 14, located in quadrant D, where ravine-type erosion that served as an open-air dumpster occurs. As in area 12, waste disposal boards and tire-wrapped ornamental plants were installed (figure 13). However, the area also received the Green Area sign (Figure

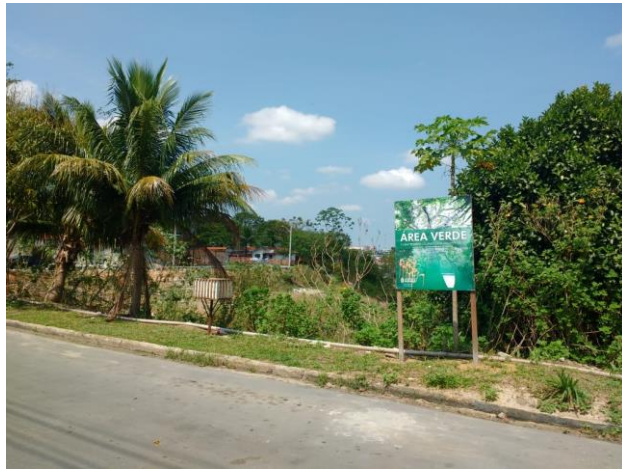
**Figure 14:** Green area code in area 12.

14).

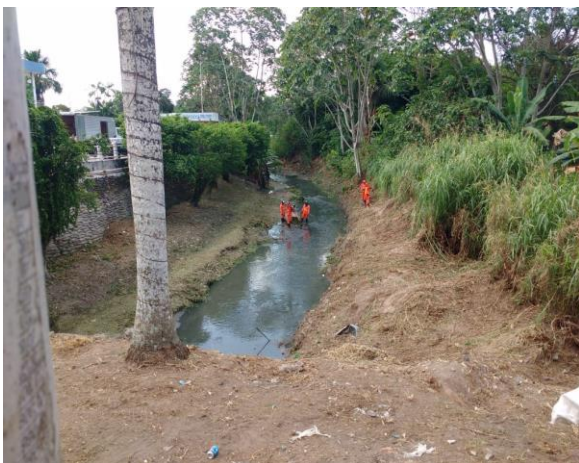
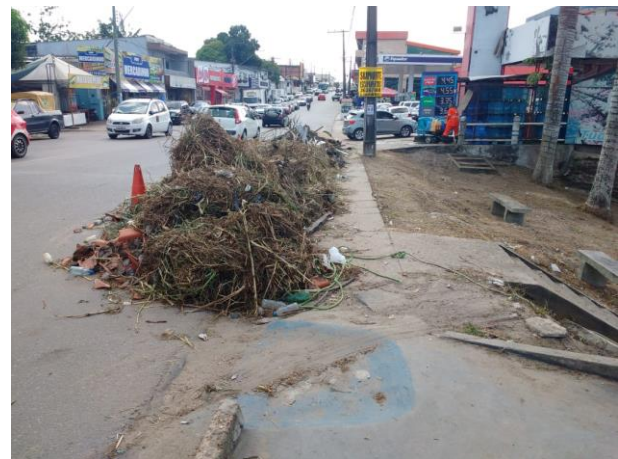
**Figure 15:** Stream cleaning action in area 15 (quadrant D). **Figure 16:** Amount of vegetation and waste removed from site.

Differently from the areas described above, both previously receiving solid waste, recovered by awareness actions of the city hall, in area 15, there was a work of cleaning the local stream (Figures 15 and 16). The action improved the flow velocity of the stream, removing the vegetation that covered it and the solid waste suspended or trapped in the vegetation.
