EVALUATION OF SURFACE WATER QUALITY OF THE AREA OF INFLUENCE OF THE LANDFILL OF THE CITY OF MANAUS/AM

Abstract

Evaluation of Surface Water Quality of The Area of Influence of The Landfill of The City of Manaus/Am

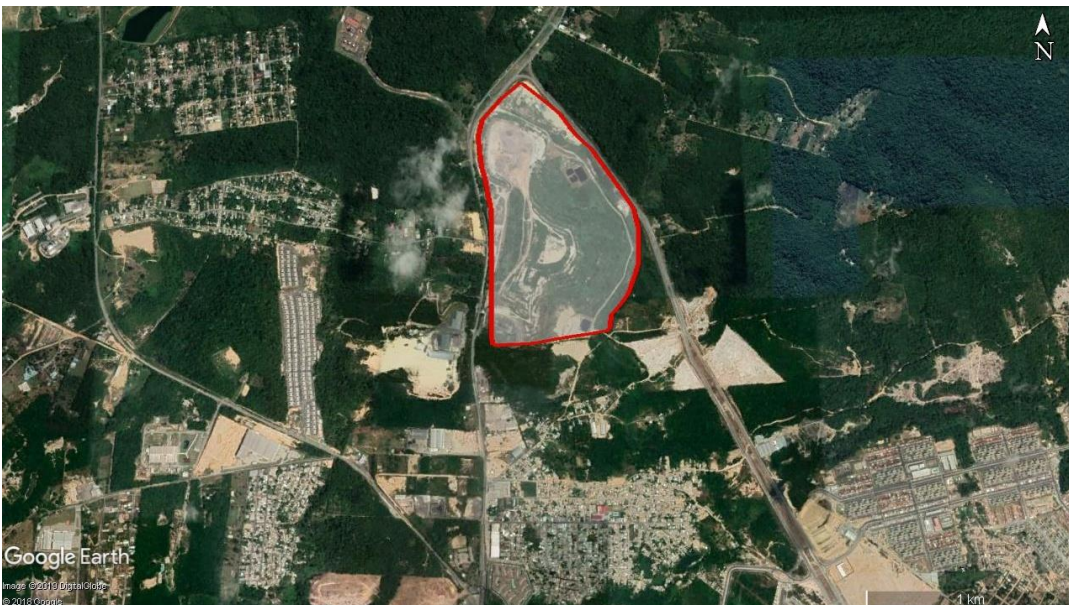
The Solid Waste Landfill of Manaus (ARSM), is located at km 19 of the am-010 state highway, at the expansion limits of the urban area, and currently occupies an approximate area of 66 hectares (Figure 1). It is inserted in the Matrinxã creek basin, a tributary of the Acará creek, which joins with the creek of Santa Etelvina to form the creek of Bolivia. Arsm is bordered to the east and north by the Matrinxã creek valley; to the south by a small tributary of this same creek, and to the west by the AM-010 highway. A small portion of the land, closer to the highway, is drained by an arm of the Aracu creek, a tributary of Bolivia's creek.

Figure 1: Satellite image indicating the location around the red line, the landfill of solid waste in the city of Manaus/Am (Google Earth Pro -2019).

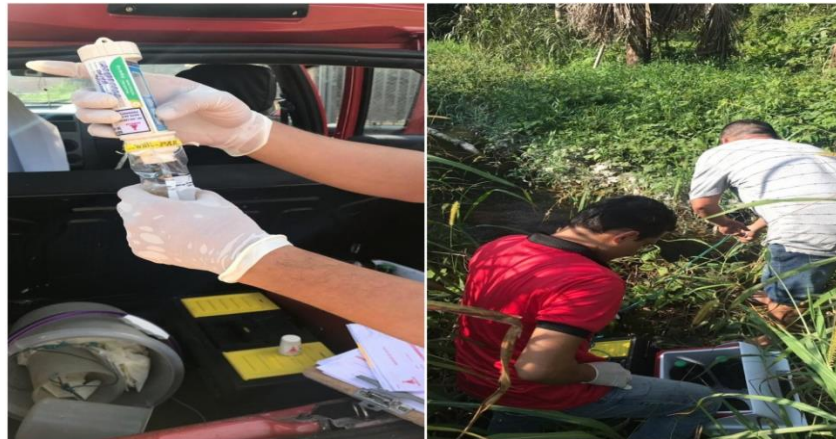
Figure 3: Collection and monitoring of surface water temperature.

Preceding the surface water sampling activities, on-site measurements of three physicochemical parameters were performed: pH, dissolved oxygen (OD) and temperature, made through a digital device kit. These parameters serve to reveal, in preliminary, evidence of possible chemical contamination in the water bodies sampled.
